- [54] **PLATED STRUCTURE EXHIBITING LOW HYDROGEN EMBRITTLEMENT**
- [75] **Inventors:** **Grace F. Hsu, Seattle; Richard C. Colonel, Renton, both of Wash.**
- [73] **Assignee:** **The Boeing Company, Seattle, Wash.**
- [*] **Notice:** The portion of the term of this patent subsequent to Aug. 23, 2005 has been disclaimed.
- [21] **Appl. No.:** **773,504**
- [22] **Filed:** **Sep. 4, 1985**

[57] **ABSTRACT**

PLATED STRUCTURE EXHIBITING LOW HYDROGEN EMBRITTLEMENT

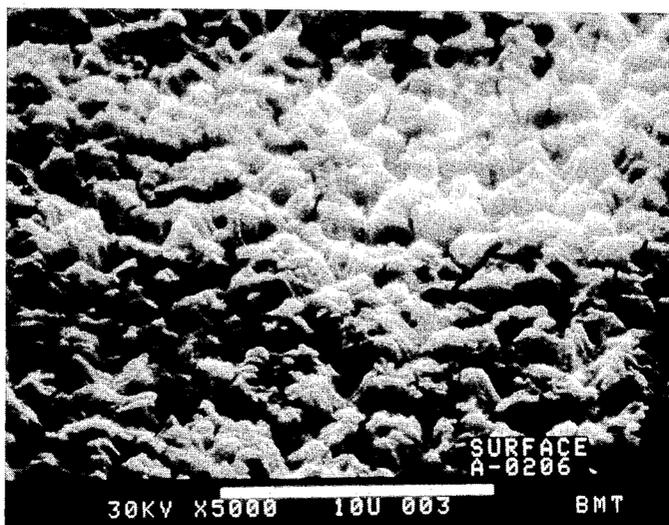
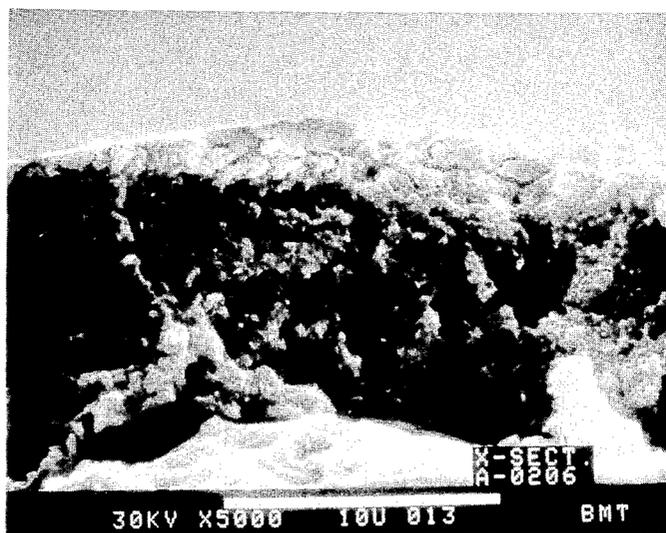
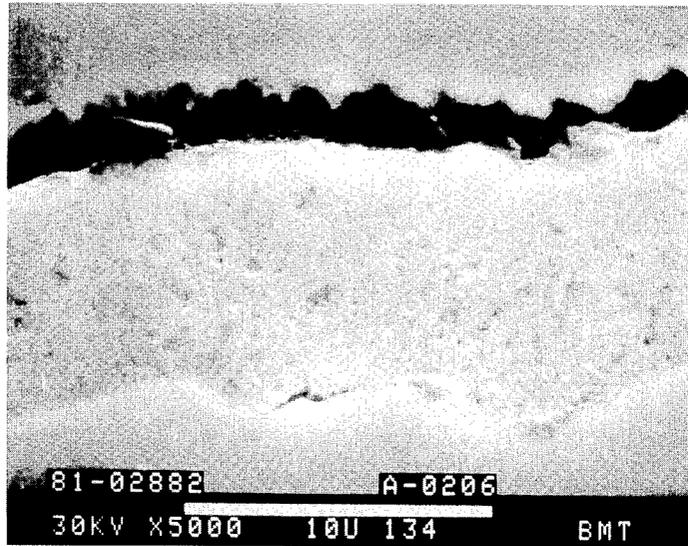
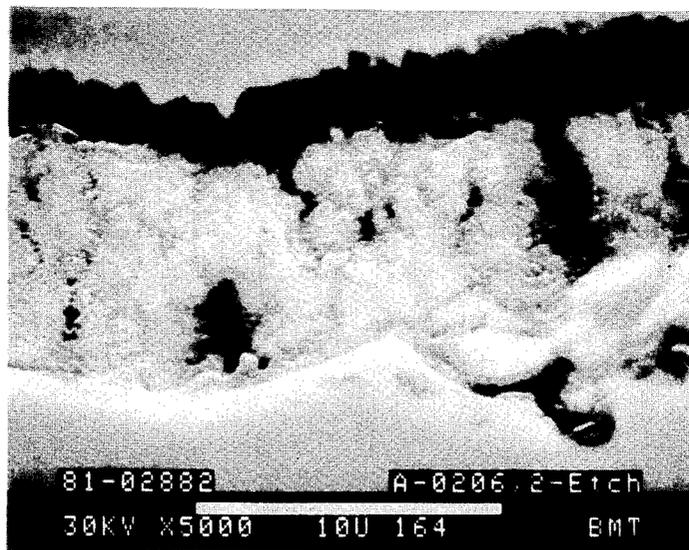
FIGS. 1, 2, 3 and 4 are respectively photomicrographs magnified to 5000× of the top surface, a fractured cross section, a polished cross section, and a polished and etched cross section, respectively, of the specimen. The fractured cross section has a fine grained appearance. When measured by the Videoplan machine, a mean image area of 0.81 square microns was recorded. The polished and etched cross section was etched with a solution containing 2.5 milliliters per liter of sulfuric acid (specific gravity 1.84) and 5 grams per liter of potassium dichromate. The specimen was etched at ambient temperature for approximately 3 seconds.

The interconnecting escape channels are discernible in the polished and etched cross section extending from the metal substrate at the lower portion of the photomicrograph upwardly to the surface of the coating. Lateral interconnections are also observed.

Similar zinc-nickel specimens were manufactured and identified as specimens A-3660 and A-3303. They were plated and processed in accordance with the above procedures except that the bath in which the A-3303 specimen was plated contained no surfactants. The mean image area of the grains recorded on the fractured cross section for each of the foregoing specimens were 1.66 square microns and 149.01 square microns, respectively. The presence of surfactants reduces the grain size.

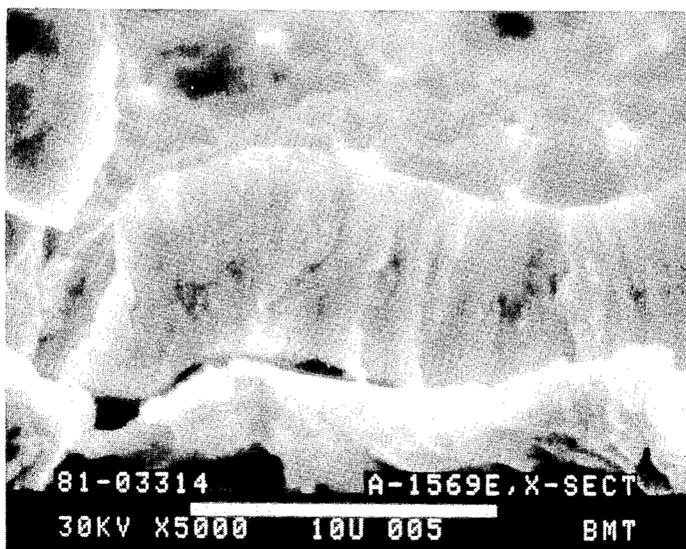
Fig. 5.

FIG. 5 is a photomicrograph of a fractured cross section of the specimen. Cleavage fracture is evident. Although not readily identifiable, the specimen also appears to be fine grained.

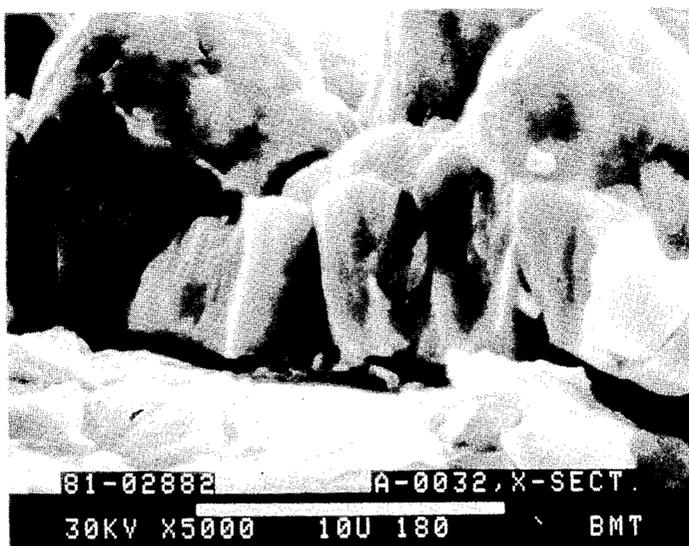
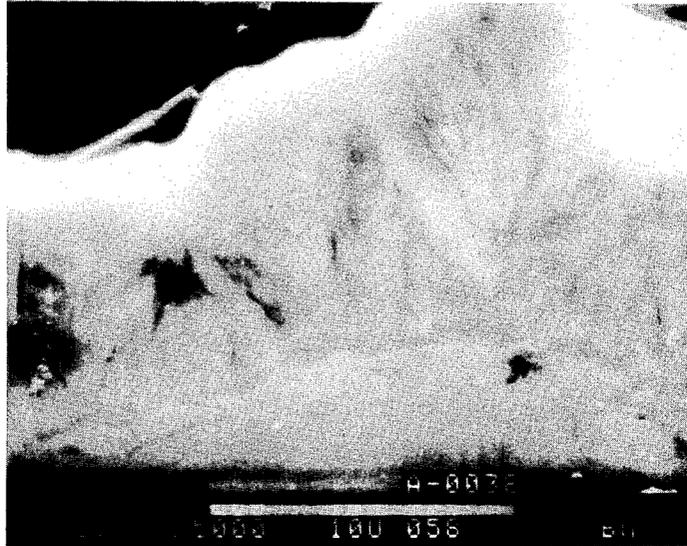
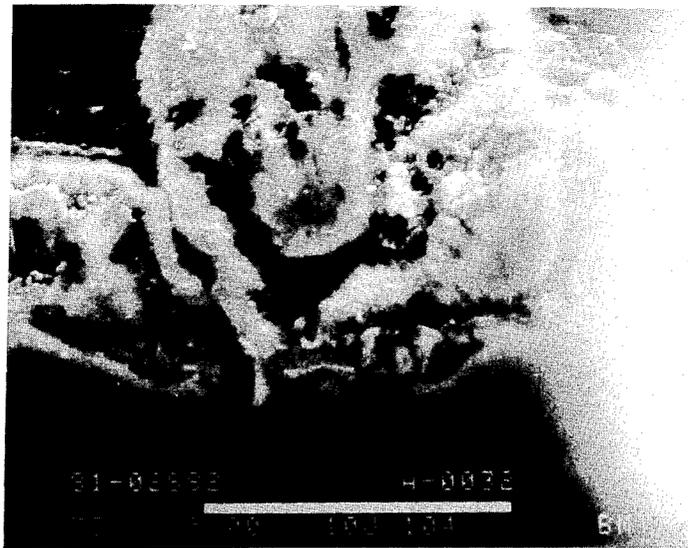
FIGS. 6, 7 and 8 are respectively photomicrographs of a fractured cross section, a polished cross section and a polished and etched cross section of the notch tensile specimen. Cleavage fracture is evident in the fractured cross section. A fine grain is also discernible. Interconnecting escape channels for hydrogen can be observed in both the polished and polished and etched cross sections, but they are more evident in the polished and etched cross section. The interconnecting escape channels extend from the surface of the substrate to the surface of the coating. Their interconnecting structure is readily apparent.

The same specimen was tested for hydrogen levels in the substrate and the plated coating in accordance with the procedure set forth above. The substrate was found to contain 0.8999 ppm of hydrogen while the coating

contained 3.7055 ppm for a total of 4,6054 ppm of hydrogen.

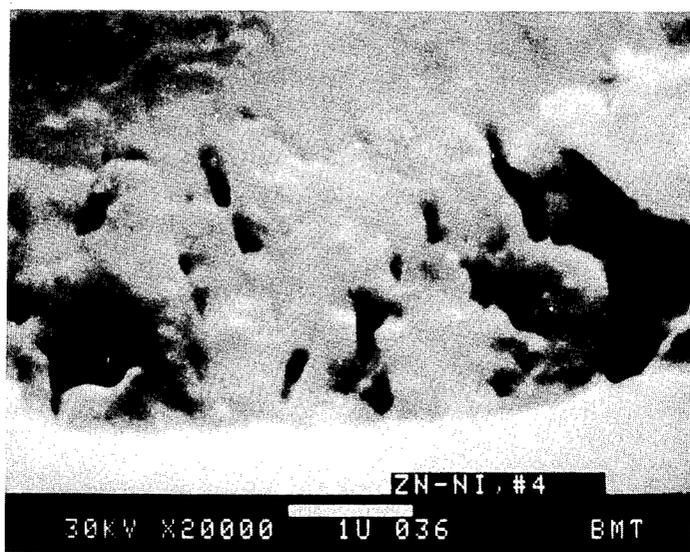
Fig. 9.

The procedure of Example 1 was repeated with the exception that the Igepal and Duponol surfactants were absent from the bath. Steel (1020) panels (4"×6") were plated at 2.0 amperes per square decimeter for approximately 4 hours. The panels were cross sectioned, polished and etched. FIG. 9 is a photomicrograph of a first specimen identified as "Zn-Ni#4" magnified 20,000×. The interconnecting escape channels are barely visible. The Videoplan machine was utilized to survey and calculate the area of the escape channels exposed on the surface of the polished cross section. The percentage of exposed channels was found to be about 8.2 percent of the total area of the coating exposed on the cross section.

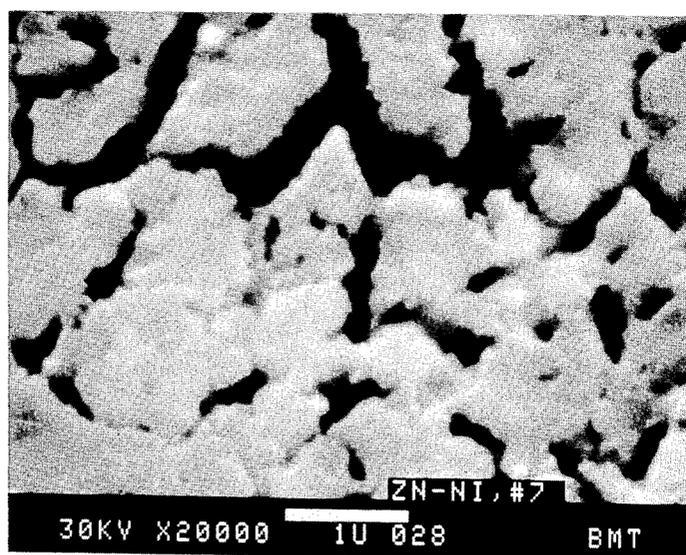
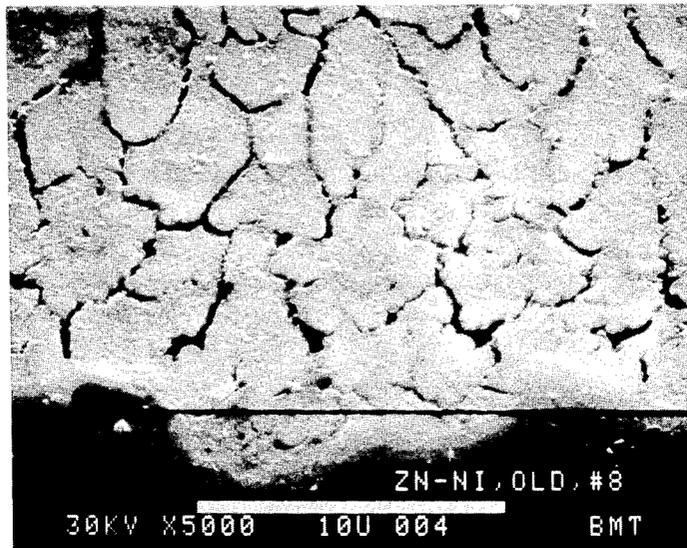
A second specimen identified as "Zn-Ni#7" was plated in a similar bath containing the two surfactants. A cross section of the specimen is shown in the photomicrograph of FIG. 10 magnified to 20,000×. The interconnected escape channels are clearly observed in FIG. 10. The area of escape channels exposed on the surface of the cross section is 18.9 percent of the total coating exposed on the cross section. This increase in the area of escape channels is attributable to the presence of the surfactants in the plating bath. A third specimen identified as "Zn-Ni#8" was prepared using the bath containing surfactants. The escape channels are clearly visible in the photomicrograph of FIG. 11.

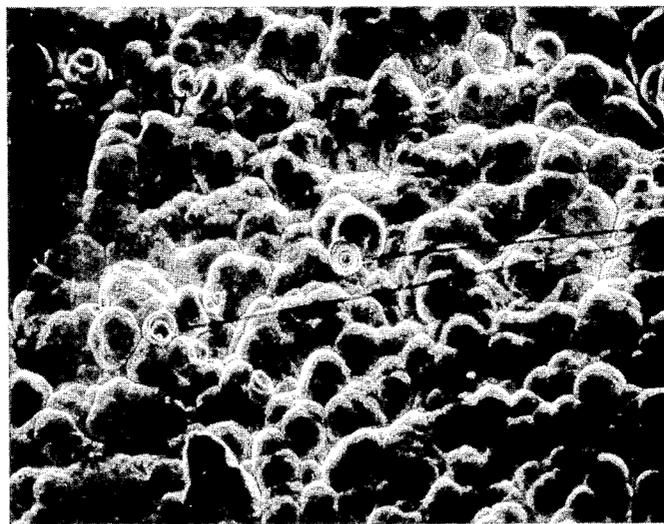
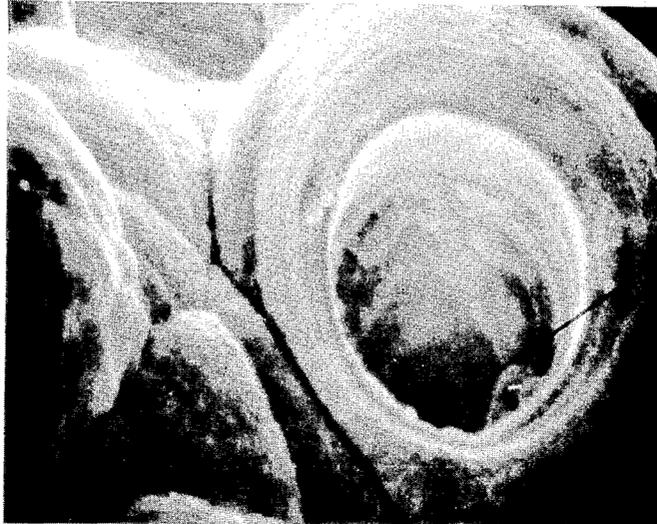
FIGS. 12 and 13 are photomicrographs at 400× and 5000×, respectively, of the tops of one of the surface panels plated in accordance with the procedure of this example. Circular openings are observed at the termini of the lead lines superimposed on the figures. These are believed to be openings from the interconnecting escape channels onto the surface of the coating.

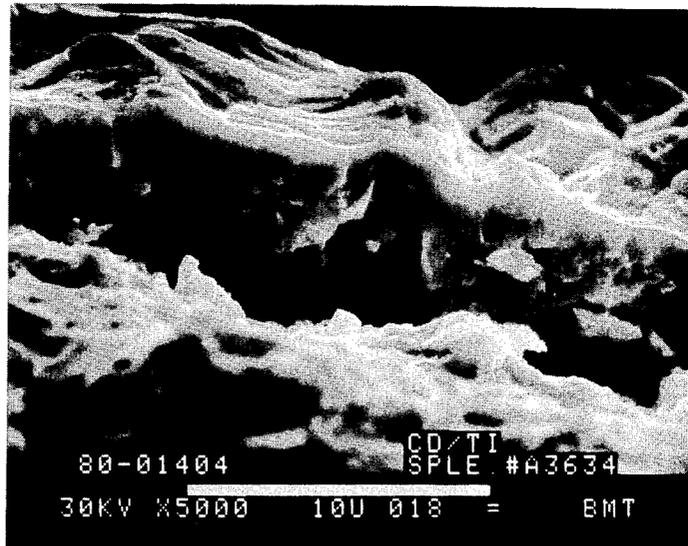
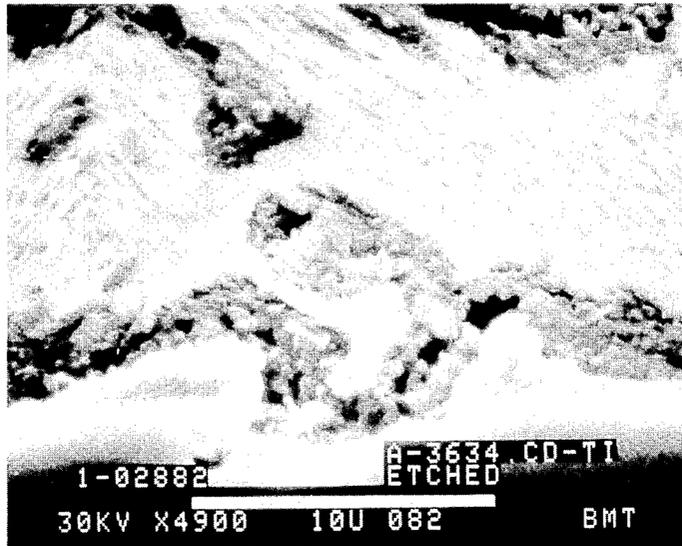
FIG. 14 is a photomicrograph of a fractured cross section of the specimen, while FIG. 15 is a photomicrograph of the polished and etched cross section. Both photomicrographs are at a magnification of 5000×. As is readily observed, the fractured cross section shows a layered structure. This structure can similarly be found in zinc-nickel coatings on high strength steel having

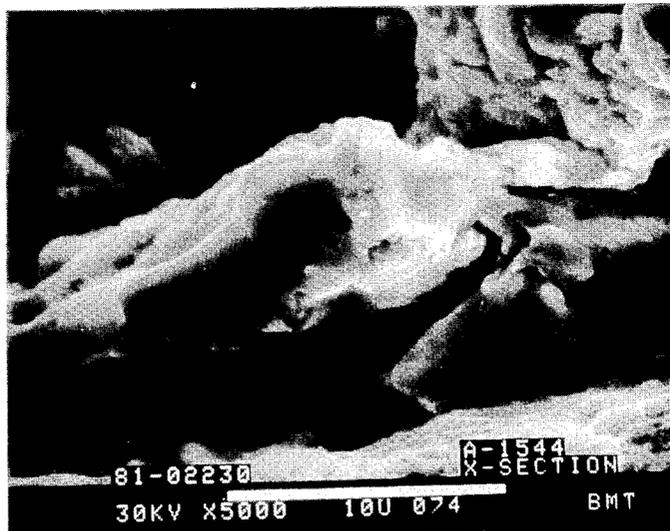
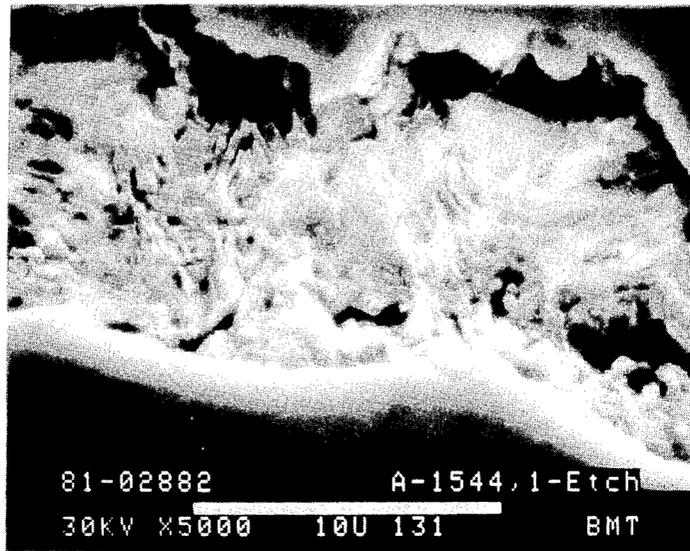
FIG. 16 is a photomicrograph of a fractured cross section of the specimen while FIG. 17 is a photomicrograph of a polished and etched cross section. Both photomicrographs are at a magnification of 5000×. A layered microstructure similar to that in the previous example is observed in the fractured cross section, while irregular large voids are discernible in the polished and etched cross section.

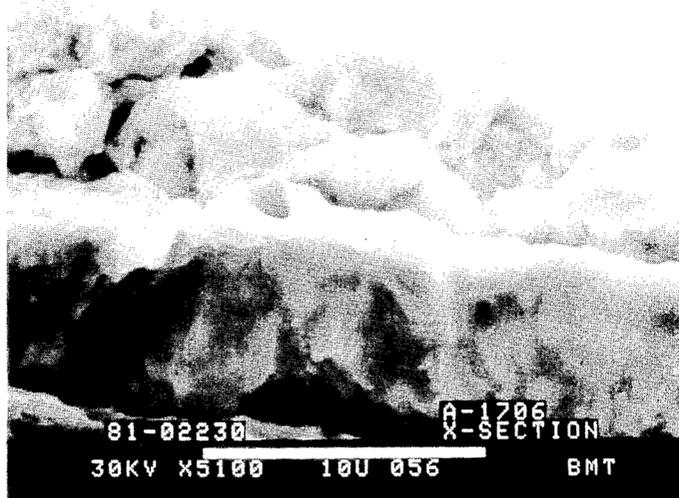
Fig. 18.

FIG. 18 is a photomicrograph of a fractured cross section of the specimen. The magnification is 5000×. A layered microstructure is clearly discernible.

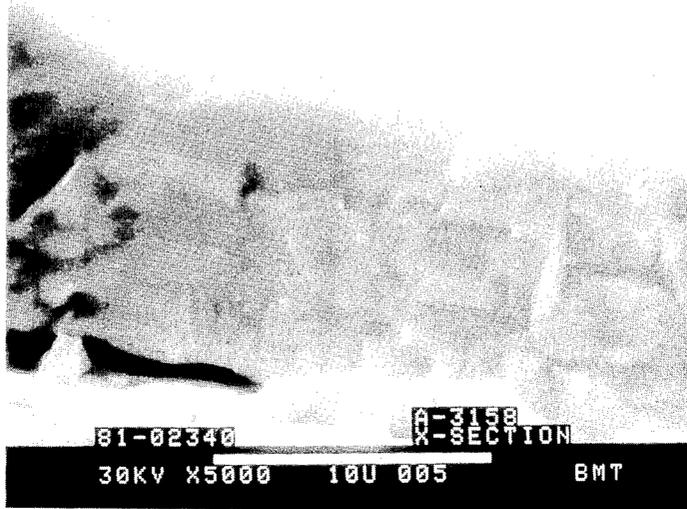
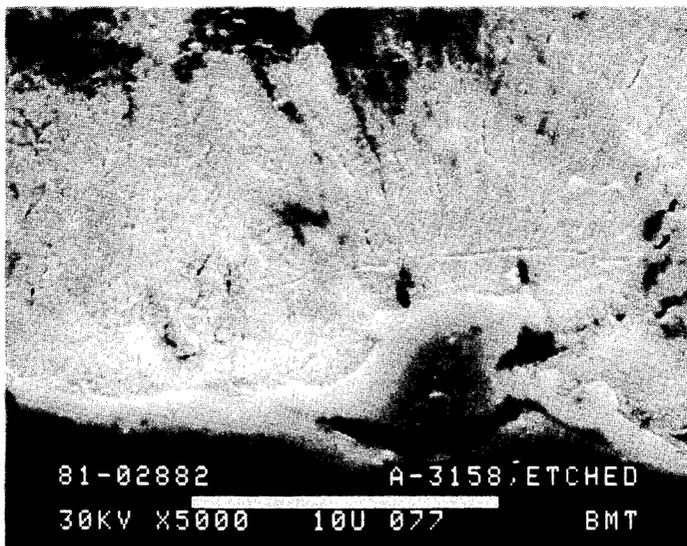
FIG. 91 is a photomicrograph of a fractured cross section of the notch tensile specimen, while FIG. 20 is a photomicrograph of a polished and etched cross section of the specimen, both magnified 5000×. The microstructure of the fractured cross section exhibits a geometric configuration while isolated voids and restricted flow channels can be observed in the polished and etched cross section. These microstructures indicate that a coating having these microstructural characteristics will not provide an environment that will allow a coated substrate to exhibit low hydrogen embrittlement.

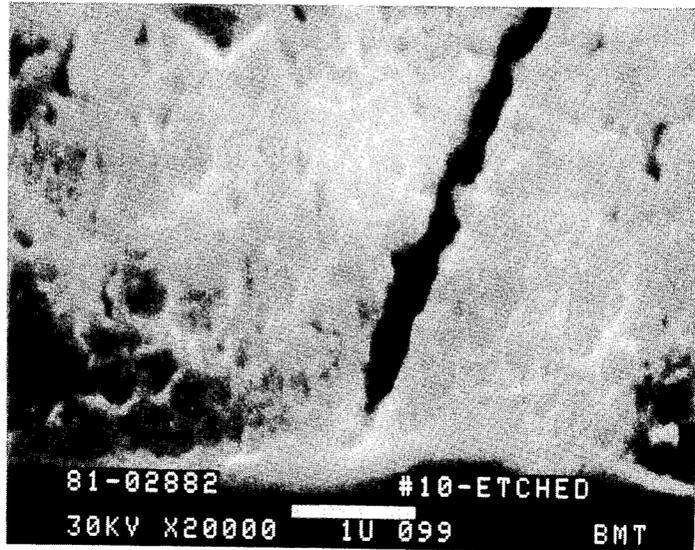
Fig. 21.

A 1020 steel panel (4"×6") was plated in the same plating bath. It was plated at a current density of 2.0 amperes per square decimeter for approximately 4 hours. FIG. 21 is a polished and etched cross section of the coating magnified to 20,000×. Isolated small voids can be observed in the microstructure with no interconnected escape channels.

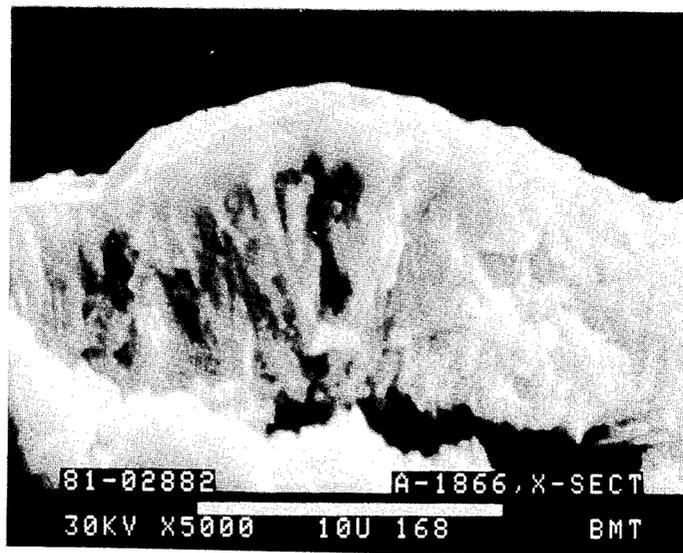
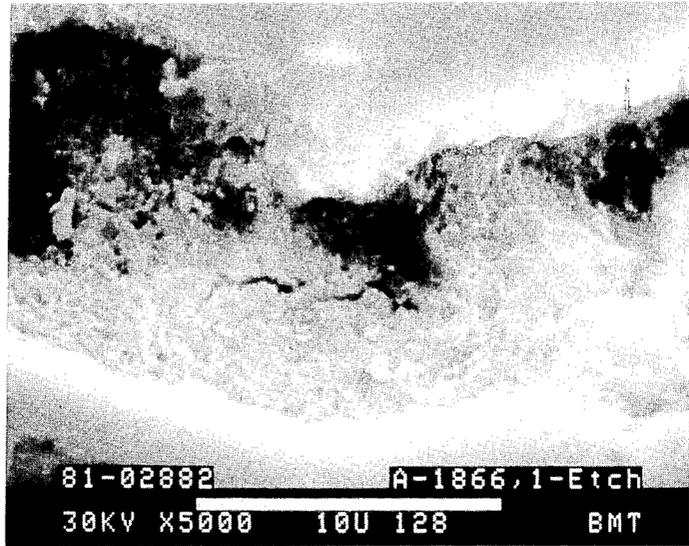
FIG. 22 is a photomicrograph of a fractured cross section of the specimen, while FIG. 23 is a photomicrograph of a polished and etched cross section. Both photomicrographs are at a magnification of 5000×. A radiating columnar microstructure is observed in FIG. 22. Small isolated voids and the absence of interconnecting escape channels are noted in the photomicrograph of FIG. 23.

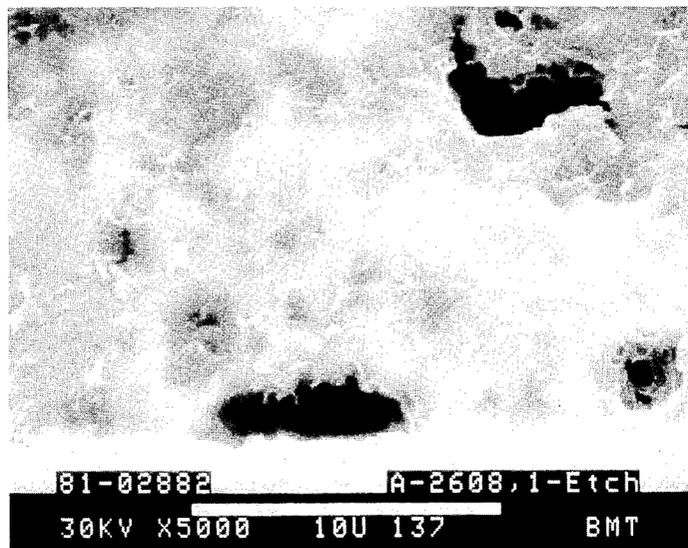
FIG. 24 is a photomicrograph of a fractured cross section of the specimen, while FIG. 25 is a photomicrograph of a polished and etched cross section of the specimen. The photomicrographs are at magnifications

of 5100× and 5000×, respectively. A straight columnar microstructure is noted in the fractured cross section, while again, only small isolated voids can be observed in the polished and etched cross section. Both of these microstructures indicate that the coating will not provide a coated article with low hydrogen embrittlement characteristics.

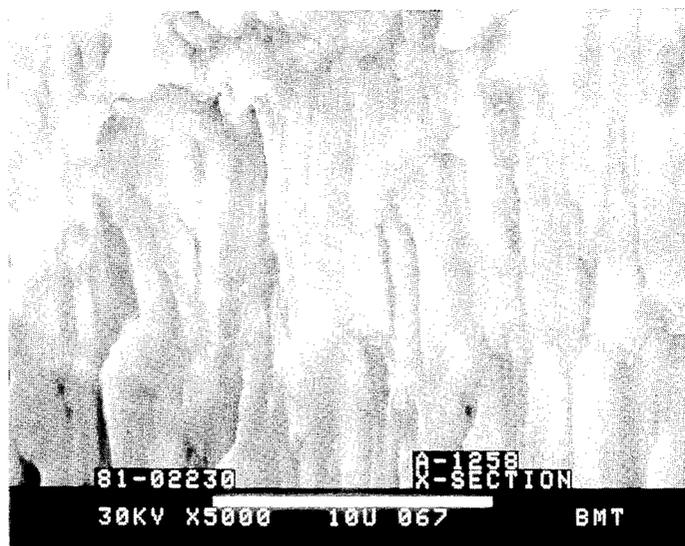
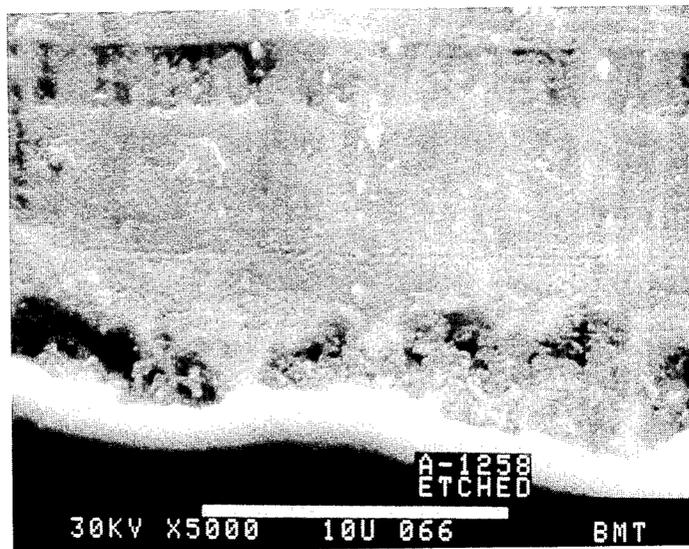
FIG. 26 is a photomicrograph of a fractured cross section of the specimen, while FIG. 27 is a polished and etched cross section of the specimen. Both photomicrographs are at a magnification of 5000×. Similarly to Example 10, the fractured cross section exhibits a straight columnar microstructure, while only small isolated voids can be observed in the polished and etched cross section.

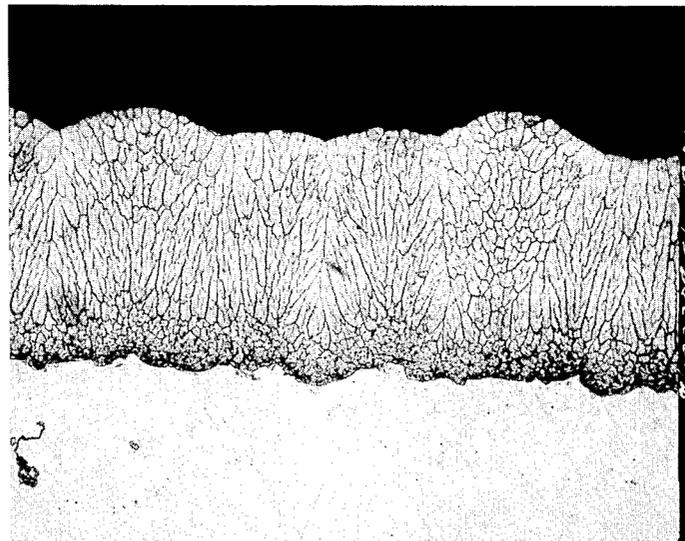
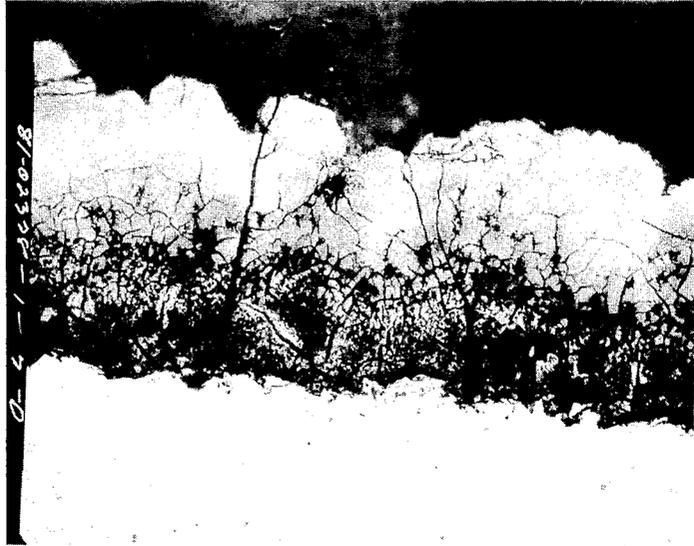
Two specimens were plated in the bath of Example 1. The photomicrographs of cross sections of these specimens are FIGS. 28 and 29, respectively. The coatings have a dendritic microstructure that indicates the presence of low hydrogen embrittlement characteristics. Interconnecting escape channels for hydrogen are clearly observed in FIGS. 28 and 29.

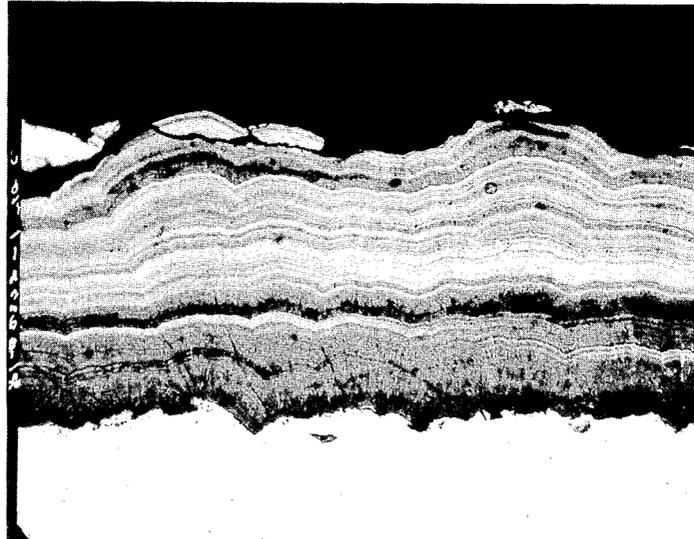
Fig. 30.

FIG. 30 is a photomicrograph of the cross section of a panel plated in the bath of Example 8. An undesirable banded microstructure is evident, which indicates the absence of low hydrogen embrittlement characteristics.

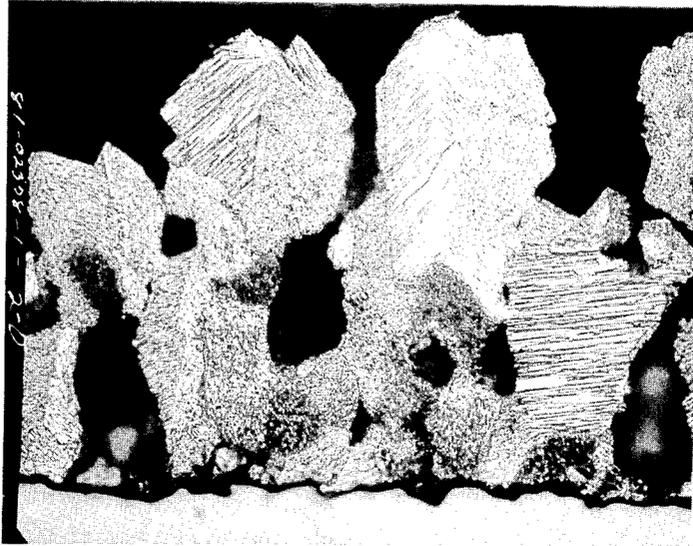
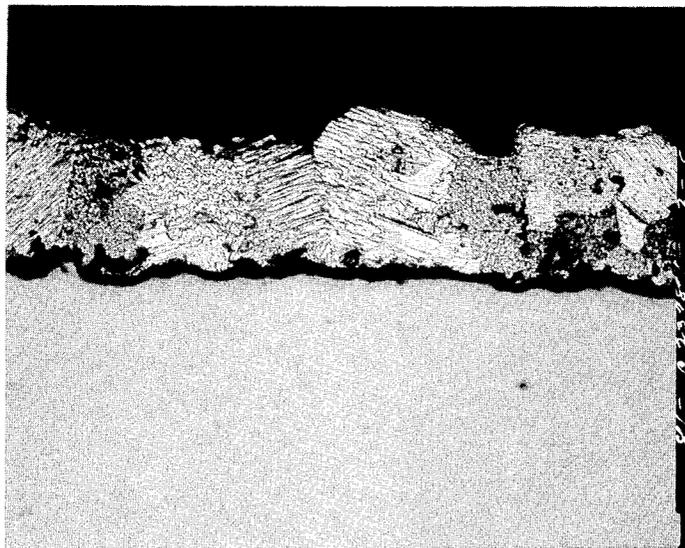
FIG. 31 is a photomicrograph of the cross section plated in the bath of Example 6. Coarse grain deposits, which indicate the presence of low hydrogen embrittlement characteristics, are observed. FIG. 32 is a photomicrograph of a cross section of a specimen plated in the bath of Example 5. A coarse grain deposit is again observed. While the bath of Examples 5 and 6 produced cadmium-titanium and a cadmium coating, respectively, these coatings do exhibit low hydrogen embrittlement characteristics.

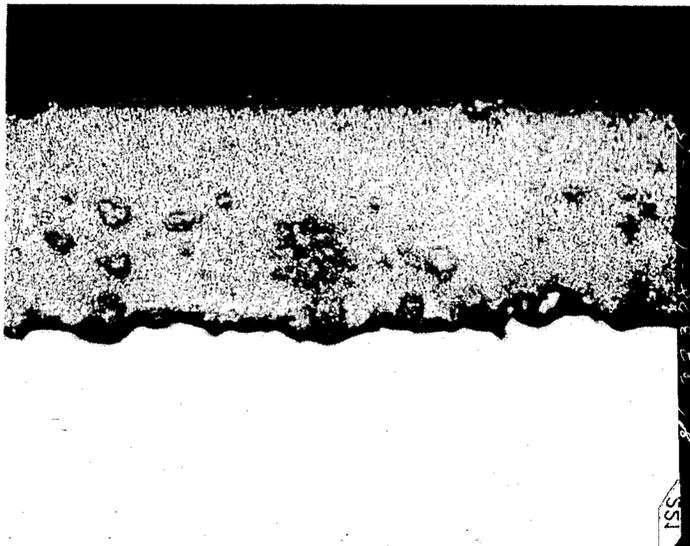
FIG. 33 is a photomicrograph of a coating plating in the bath of Example 11. FIG. 34 is a photomicrograph

of a coating plated with the bath of Example 10. Both photomicrographs of the coatings display uniform fine grained deposits that are indicative of a coated article that will exhibit unacceptable hydrogen embrittlement.

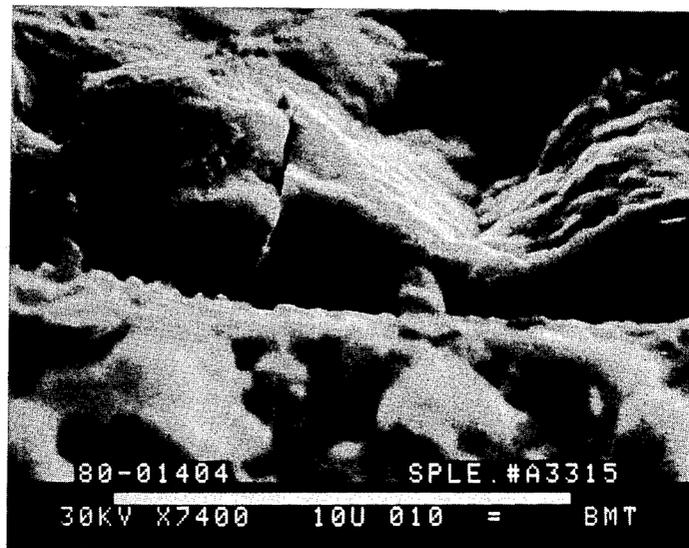
Fig. 35.

low hydrogen embrittlement. See, for example, the layered structure of FIG. 35, which is a photomicrograph of a Zi-Ni coating prepared in accordance with the procedure of Example 1, but omitting the surfactants. Irregularly shaped large voids and flow channels can be discerned in the polished and etched cross section. While this structure is different from the interconnected escape channels exemplified in the zinc-nickel microstructure, the layered fractured cross section and the irregular large voids and flow channels in the polished and etched cross section are indicative of a coating that allows the underlying substrate to exhibit low hydrogen embrittlement.
