[11] Patent Number: **5,723,078**

[54] **METHOD FOR REPAIRING A THERMAL BARRIER COATING**

[73] Assignee: **General Electric Company**, Cincinnati, Ohio

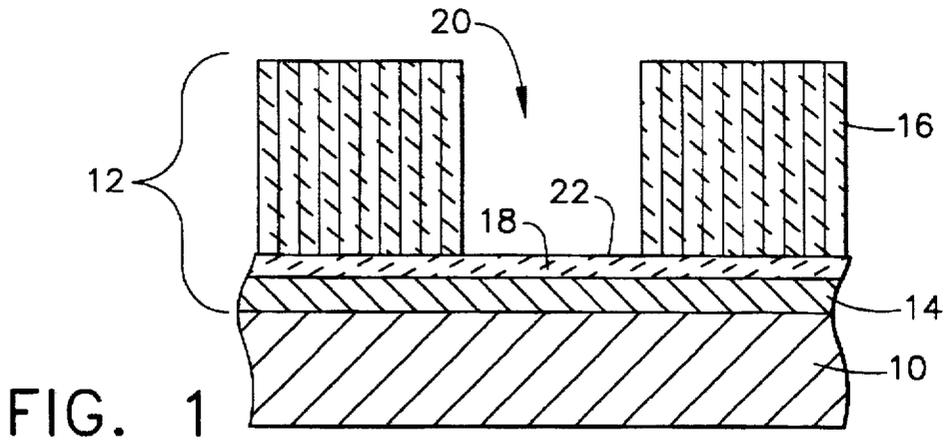
FIG. 1 shows a cross-sectional representation of a component that has suffered localized spallation; and

As represented in FIG. 1, the method of this invention is particularly suited for the repair of a thermal barrier coating system 12 composed of a metallic bond layer 14 formed on the surface of the article 10, and a columnar ceramic layer 16 overlaying the bond layer 14. As is the situation with high

temperature components of a gas turbine engine, the article 10 may be formed of a nickel-base or cobalt-base superalloy. The bond layer 14 is preferably formed of a metallic oxidation-resistant material, so as to protect the underlying article 10 from oxidation and enable the ceramic layer 16 to more tenaciously adhere to the article 10. A preferred bond layer 14 is formed by a nickel-base alloy powder, such as NiCrAlY, or an intermetallic nickel or platinum aluminide, which has been deposited on the surface of the article 10 to a thickness of about 20 to about 125 micrometers. Preferred methods for depositing bond layers of the type described above include vapor deposition techniques for aluminide coatings and low pressure plasma spray (LPPS) techniques for a NiCrAlY bond coat, though it is foreseeable that other deposition methods such as air plasma spray (APS) or physical vapor deposition (PVD) techniques could be used. Following deposition of the bond layer 14, an oxide layer 18 such as alumina may be formed on the surface of the bond layer 14 at an elevated temperature. The oxide layer 18 provides a surface to which the columnar ceramic layer 16 can tenaciously adhere, thereby promoting the resistance of the coating system 12 to thermal shock.

As a component of a gas turbine engine, surfaces of the article 10 are subjected to hot combustion gases during operation of the engine, and are therefore subjected to severe attack by oxidation, corrosion and erosion. Accordingly, the article 10 must remain protected from the hostile environment of the turbine section by the thermal barrier coating system 12, and loss of the ceramic layer 16 will lead to premature and often rapid deterioration of the article 10. Localized spallation 20 of the ceramic layer 16 is represented in FIG. 1, with the repair process of this invention being represented in FIGS. 2 and 3.

The repair method of this invention begins with cleaning the bond layer 14 exposed by the localized spallation 20 so as to remove oxides and any residual fragments of the ceramic and oxide layers 16 and 18. While various techniques can be used, a preferred method is to grit blast the exposed surface of the bond layer 14, such as by a technique known as pencil grit blasting. This step is selectively performed to ensure that the remaining ceramic layer 16 is not subjected to the procedure. It may be desirable to mask the surrounding ceramic layer 16 with, for example, tape masking, during the grit blasting operation. In addition to providing a level of protection to the ceramic layer 16, tape masking would also serve as a proof test for the integrity of the ceramic layer 16 immediately surrounding the spallation 20.

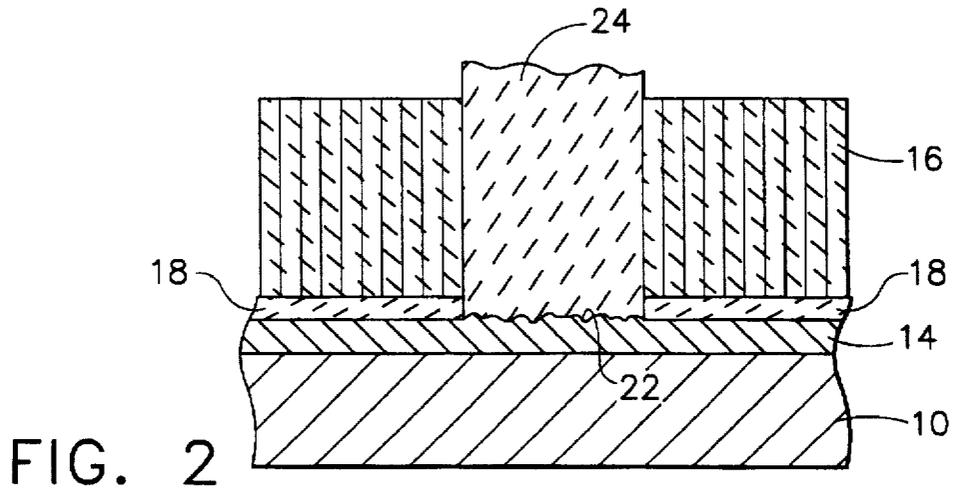
FIGS. 2 and 3 are cross-sectional representations of repair steps entailed in a preferred embodiment of this invention.

Once free of contaminants, the bond layer 14 is then treated such that its surface 22 becomes textured, as represented by FIG. 2. Preferred treating methods include grit blasting, micromachining, photolithography, laser etching and water jet techniques. Preferred grit blasting media include alumina, though other materials could be used. Suitable micromachining techniques include the use of

Finally, as represented in FIG. 2, a ceramic material is then deposited on the textured surface 22 of the bond layer 14 so as to form a ceramic repair layer 24 that completely covers the bond layer 14. A preferred deposition method is a plasma spray technique process, though physical vapor deposition techniques can be used to deposit the ceramic material such that the repair layer 24 has a columnar grain structure. With either technique, the ceramic layer 16 is masked to prevent deposition of the repair material on the ceramic layer 16. According to this invention, the preferred repair method is to form the repair layer 24 by plasma spray, the random ceramic grain structure of which is represented in FIGS. 2 and 3. Generally, masking of the surrounding surface of the ceramic layer 16 is less complicated if a plasma spray deposition technique is used. For example, if any holes are intentionally present in the article 10, such as cooling holes often present in airfoils to reduce their operating temperature, fibers can be placed in the holes or a gas can be flowed through the holes in order to prevent closure by the deposited ceramic. Furthermore, physical vapor deposition techniques generally result in the entire article 10 being heated to a high temperature, whereas plasma spray techniques directly heat only the localized region being repaired on the article 10.

The treatment selected should sufficiently texture the surface 22 of the bond layer 14 to yield macro surface features, resulting in an average surface roughness R_a of at least about 300 micrometers. With laser techniques, such macro surface features can be in the form of a groove pattern that is selectively developed on the surface 22 of the bond layer 14. Laser techniques, and to a lesser extent grit blasting and water jet techniques, are also capable of producing a desirable combination of macro and micro surface features, as discussed below.

Due to process control limitations, the ceramic material will typically be deposited until the surface of the repair layer 24 projects above the surrounding surface of the ceramic layer 16, as shown in FIG. 2. Afterwards, the surface of the repair layer 24 is polished or otherwise abraded until the repair layer 24 is substantially level with the ceramic layer 16, and the repair layer 24 merges with the ceramic layer 16 as portrayed in FIG. 3.
