(54) Titre : AVERTISSEMENTS DETECTABLES  
(54) Title: DETECTABLE WARNINGS

A detectable warning tile which aims to solve the problem of buckling and cracking associated with different thermal expansion properties of the tile and the substrate in which it is installed. Said tile is provided with underside flanges on only some of the outermost vertical surface of the tile. The tile need not be a quadrilateral, the tile may have more or fewer than fours edges.

## DETECTABLE WARNINGS

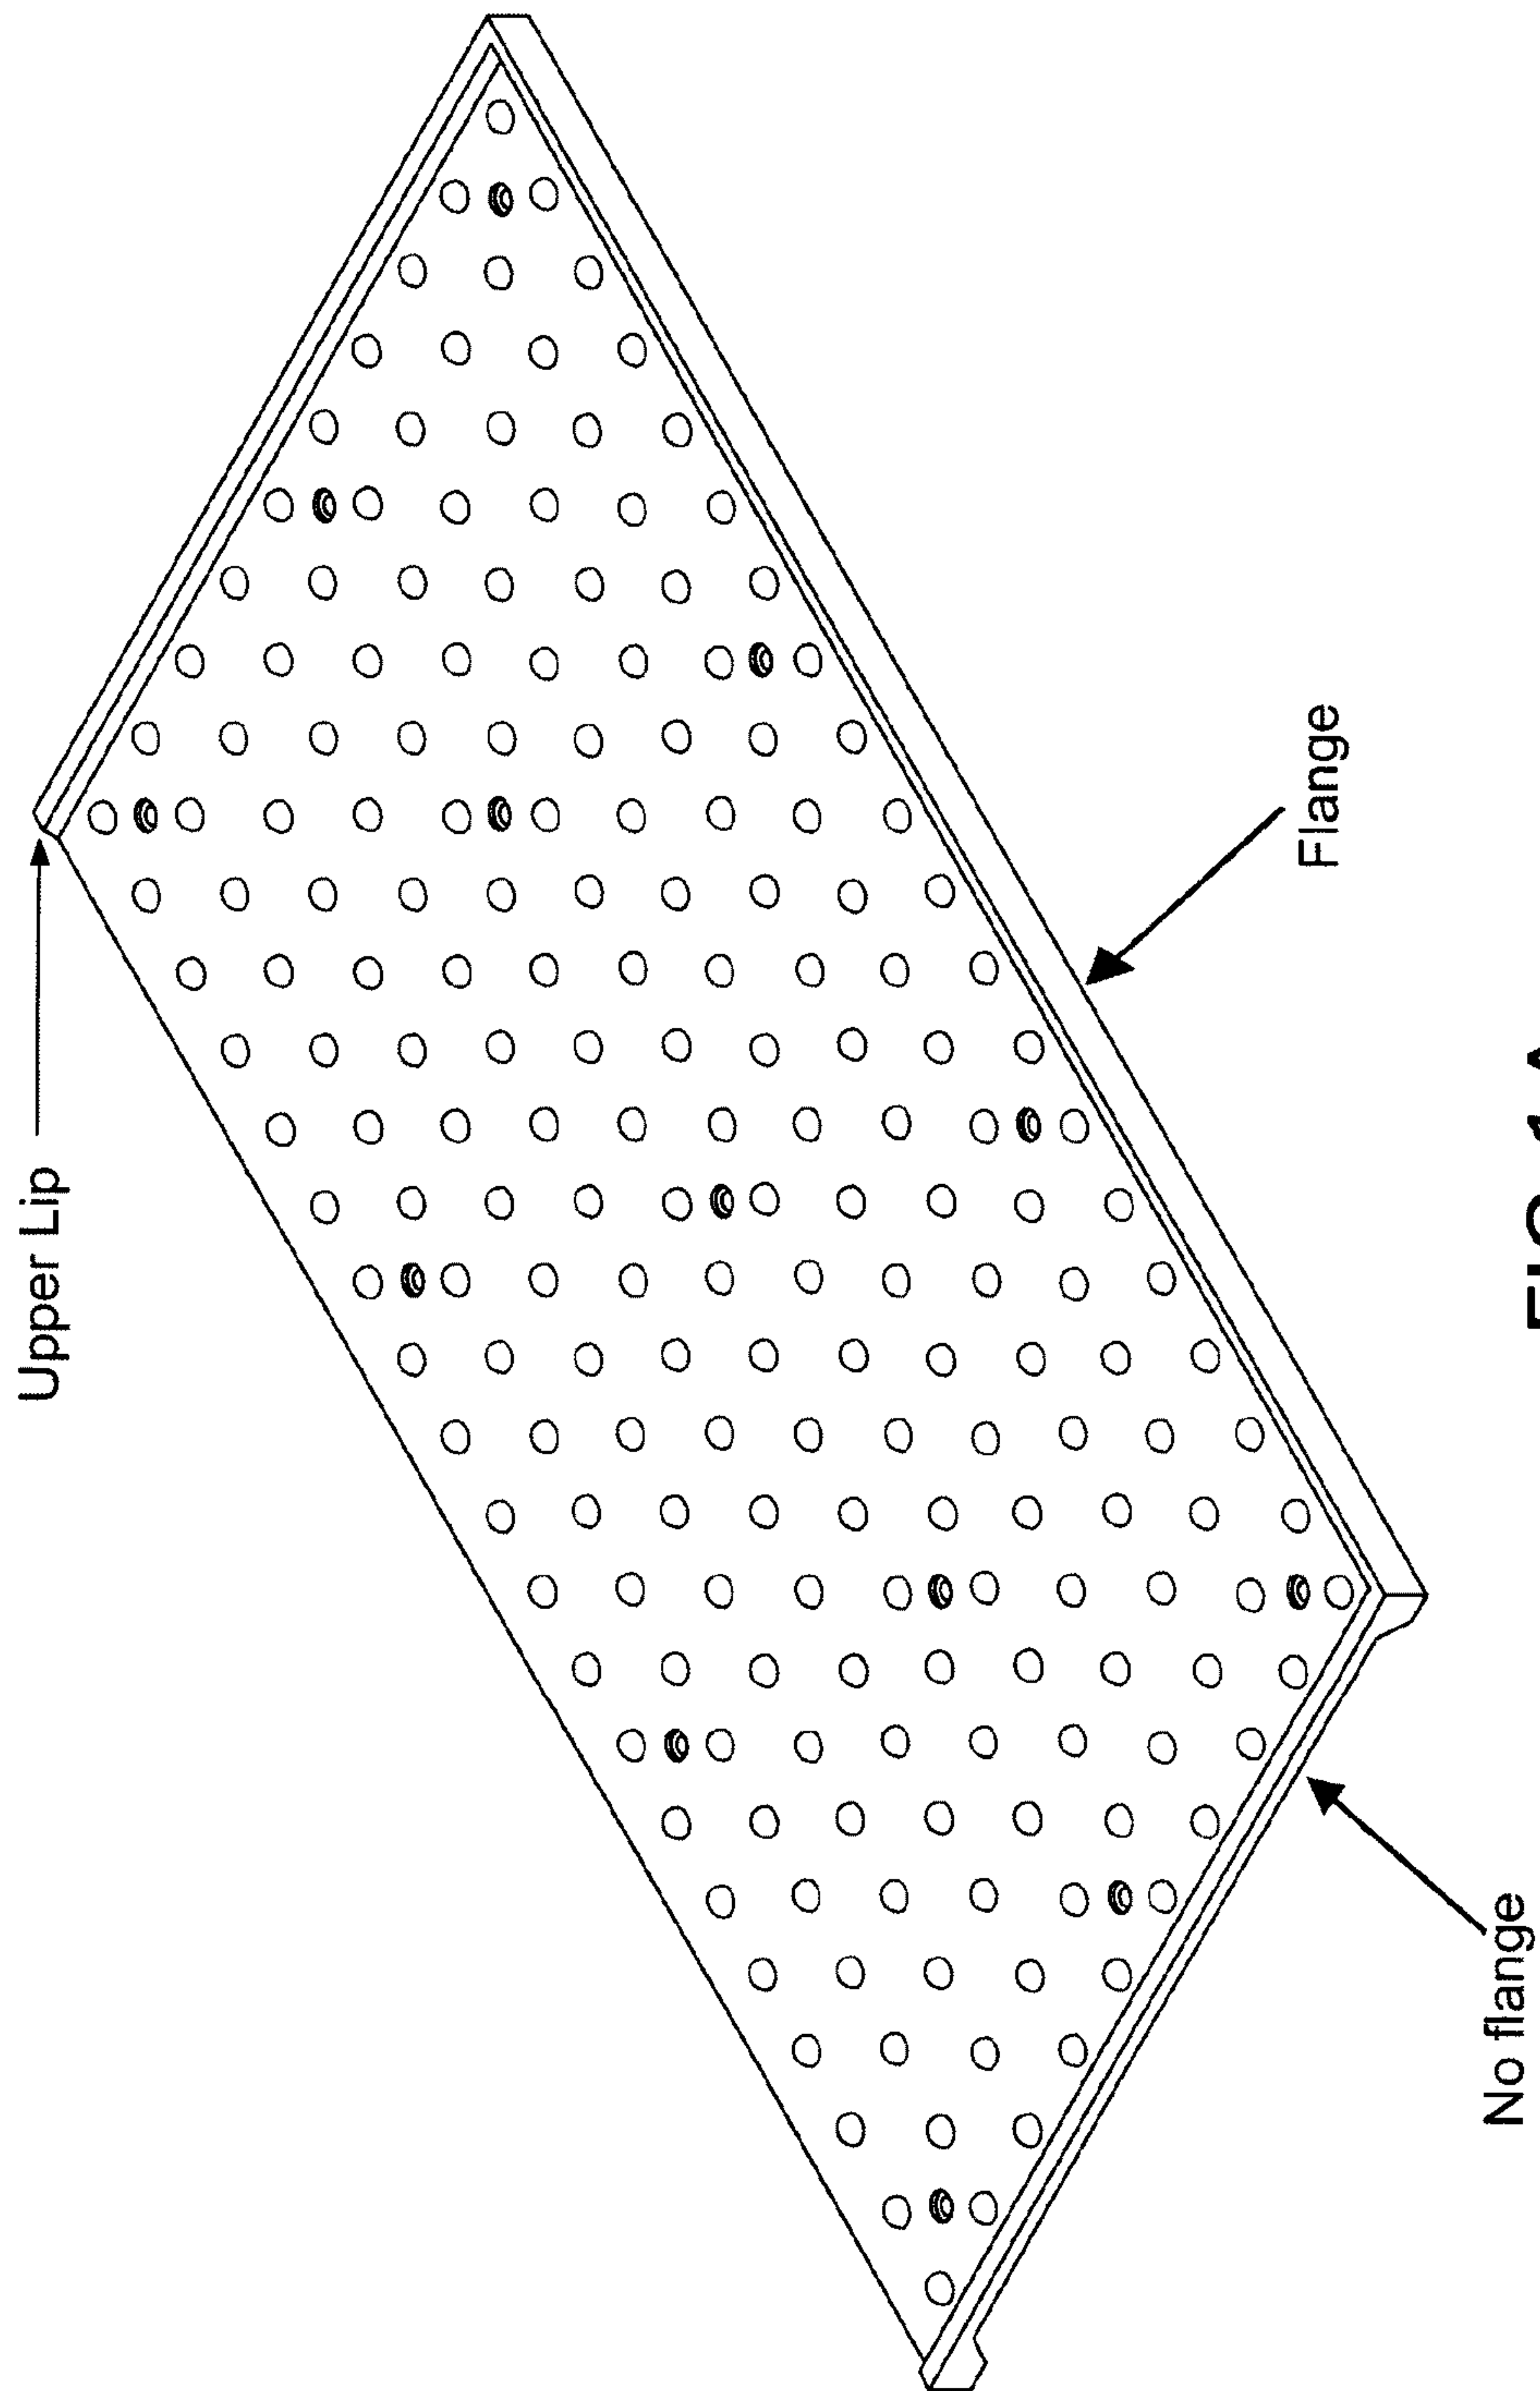
[0003] FIG. 1A is a schematic picture of a replaceable detectable warning tile with a protective upper lip and lower flanges on two opposing edges but not on the other two edges.

**[0026]** FIG. 1A shows schematically a tile with underside flanges on only two opposing sides, with the other two opposing sides left without any flange. Some wet-set, replaceable, detectable warning tiles have underside flanges on all (typically four) sides of the tile. By leaving some sides of the tile with no underside flange, buckling may be reduced. In particular, FIG. 1A shows a tile with a long direction, presumably perpendicular to the direction in which pedestrian will walk over the tile, and a short direction, parallel to the direction of pedestrian traffic. In FIG. 1A, the tile has underside flanges on the long sides, running perpendicular to the direction pedestrian traffic, and no flanges on the short sides parallel to pedestrian traffic. As shown in detail in FIG. 1B, the underside flanges are separated by the shorter horizontal dimension of the tile. Longer flanges separated by the shorter direction of the tile may cause less buckling than shorter flanges separated by the longer direction of the tile. But in either case, leaving one or more sides with no flange,

FIG. 1A shows a detectable warning tile with an upward facing lip to address this problem.

The upper surface of the tile is generally flat, punctuated by truncated domes. The lip protrudes upward from the tile to a greater height than the truncated domes. In this way, the blade of a snow plow or shovel may ride along the upper lip without ever contacting the truncated domes. Thus the lip protects the truncated domes from damage. Where tiles are intended to be installed adjacent to one another, the upper lip may extend only along some sides of the tile. In that way, an upper lip can be formed around a collection of tiles with no upper lip along the internal seams between tiles. FIG. 1A shows a tile with an upper lip along only three of its four sides.

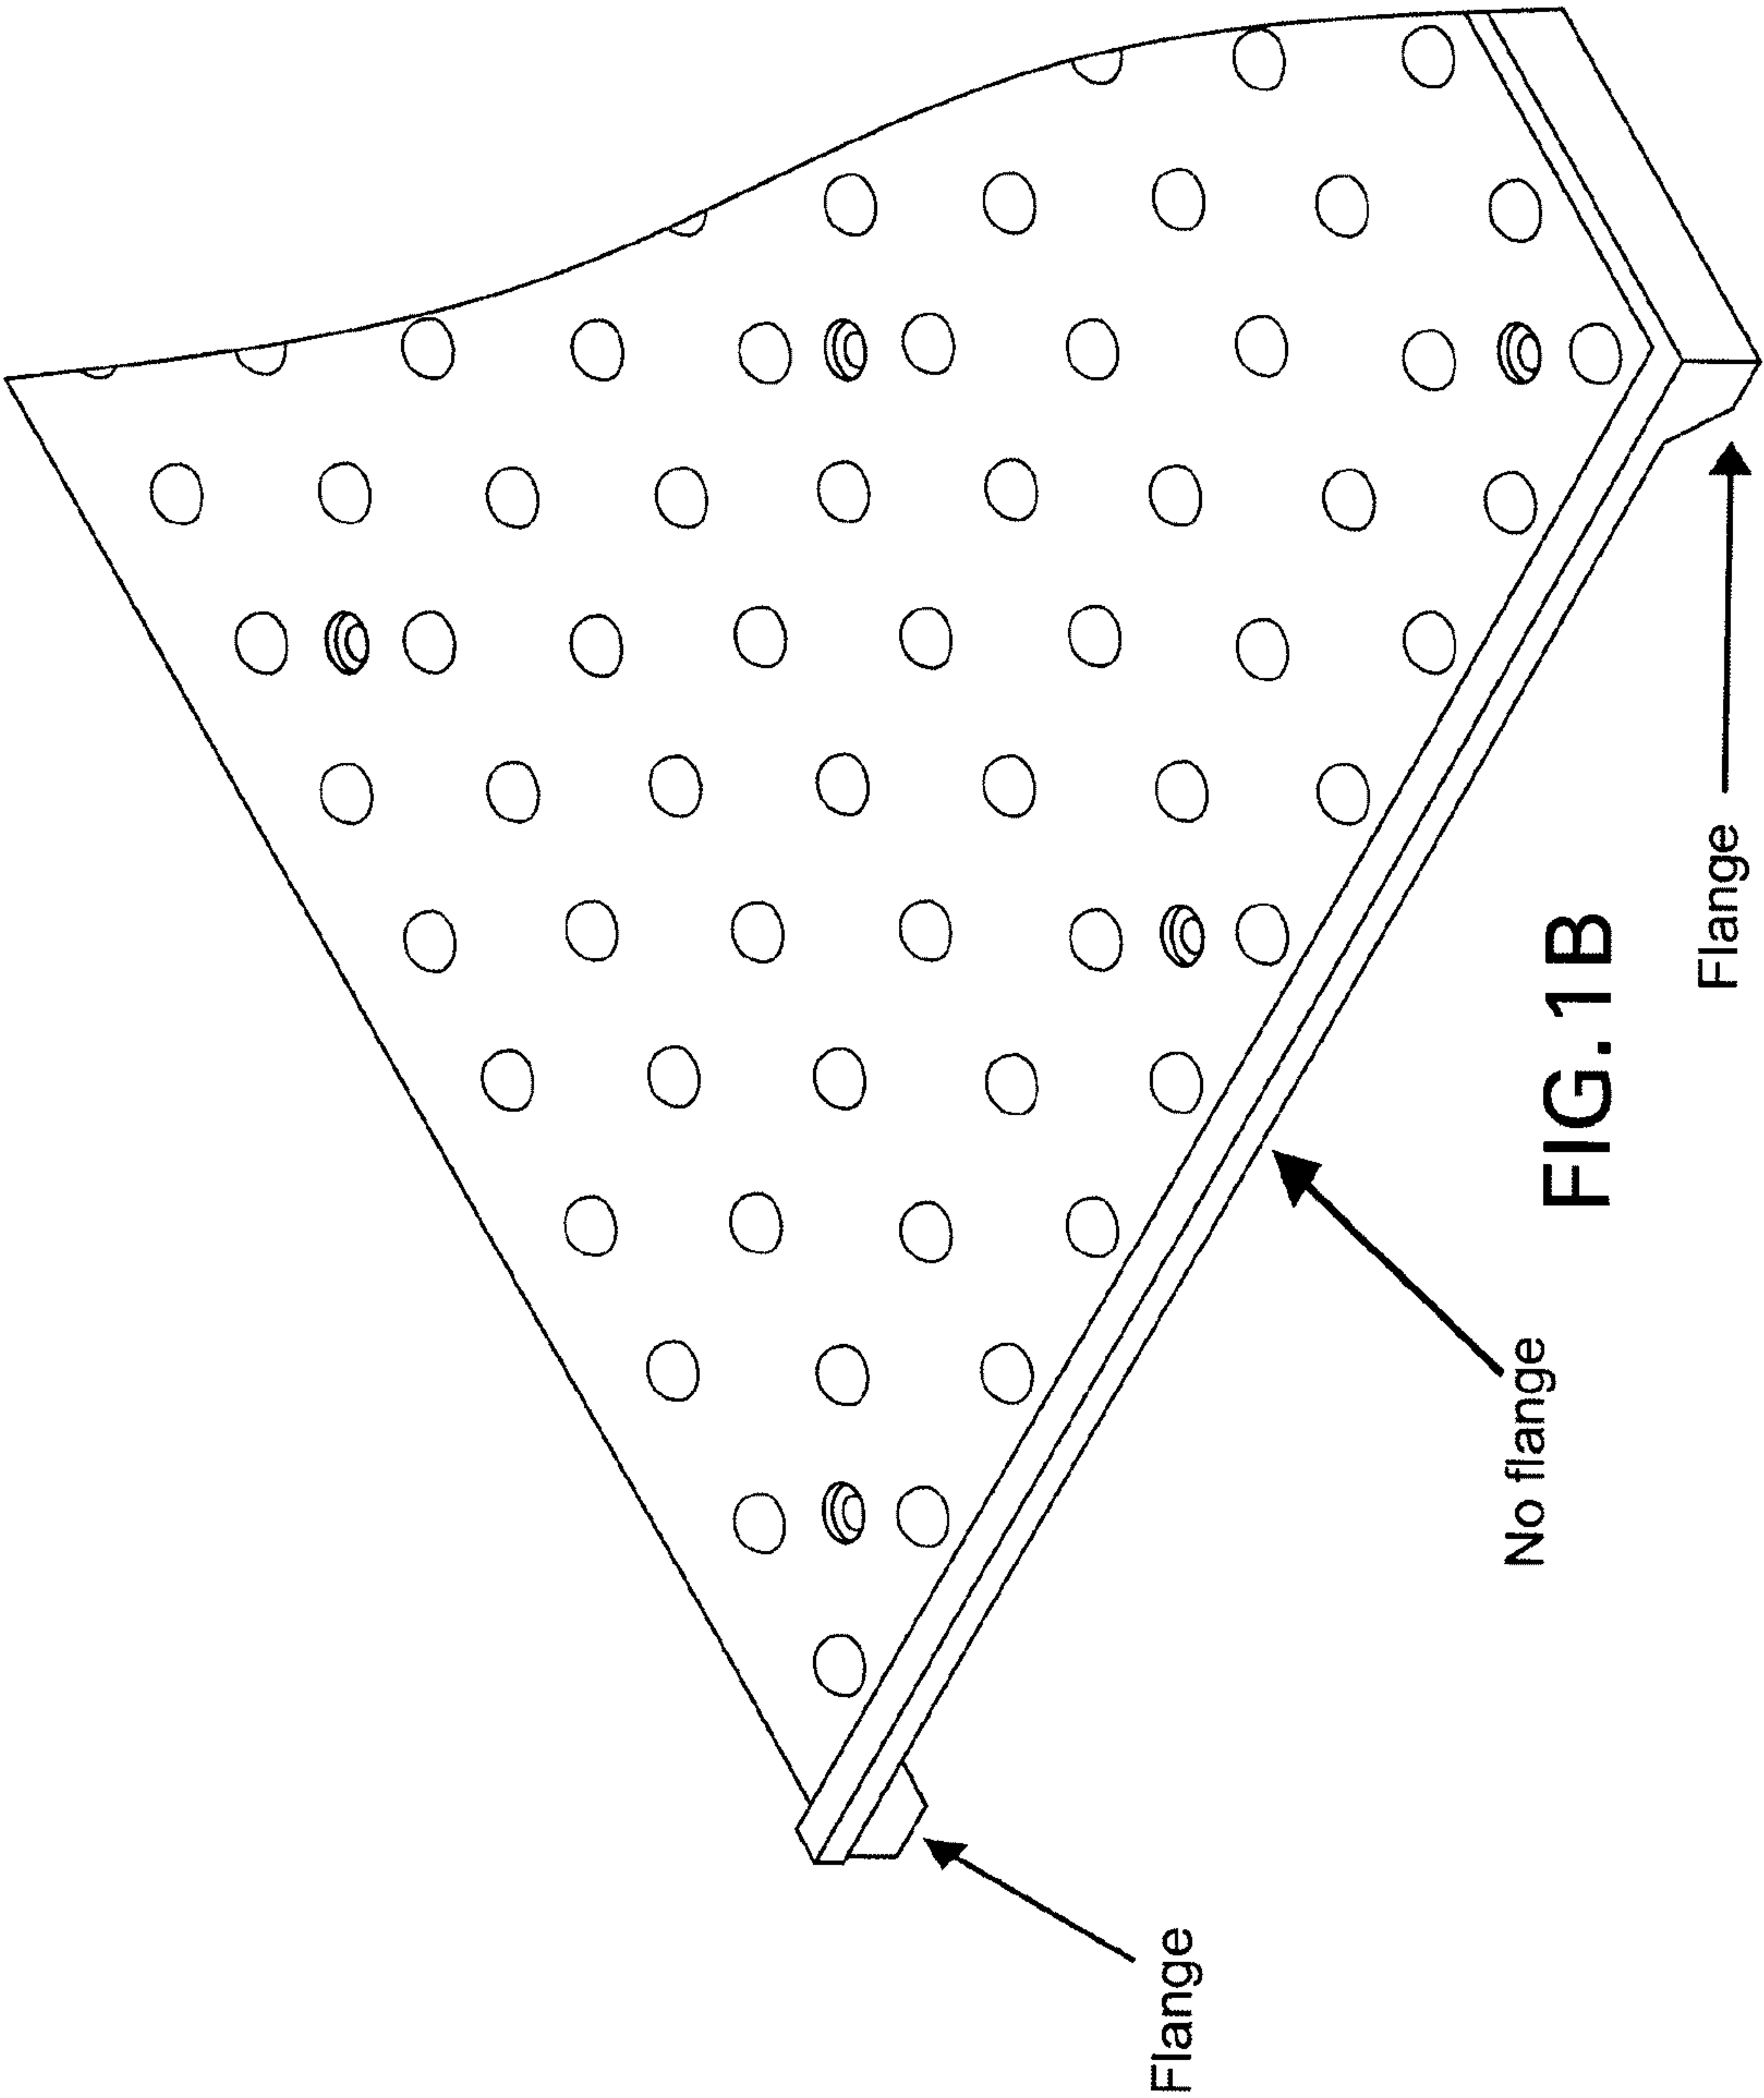
[0004] FIG. 1B is a close up schematic picture of the same tile depicted in FIG. 1A.

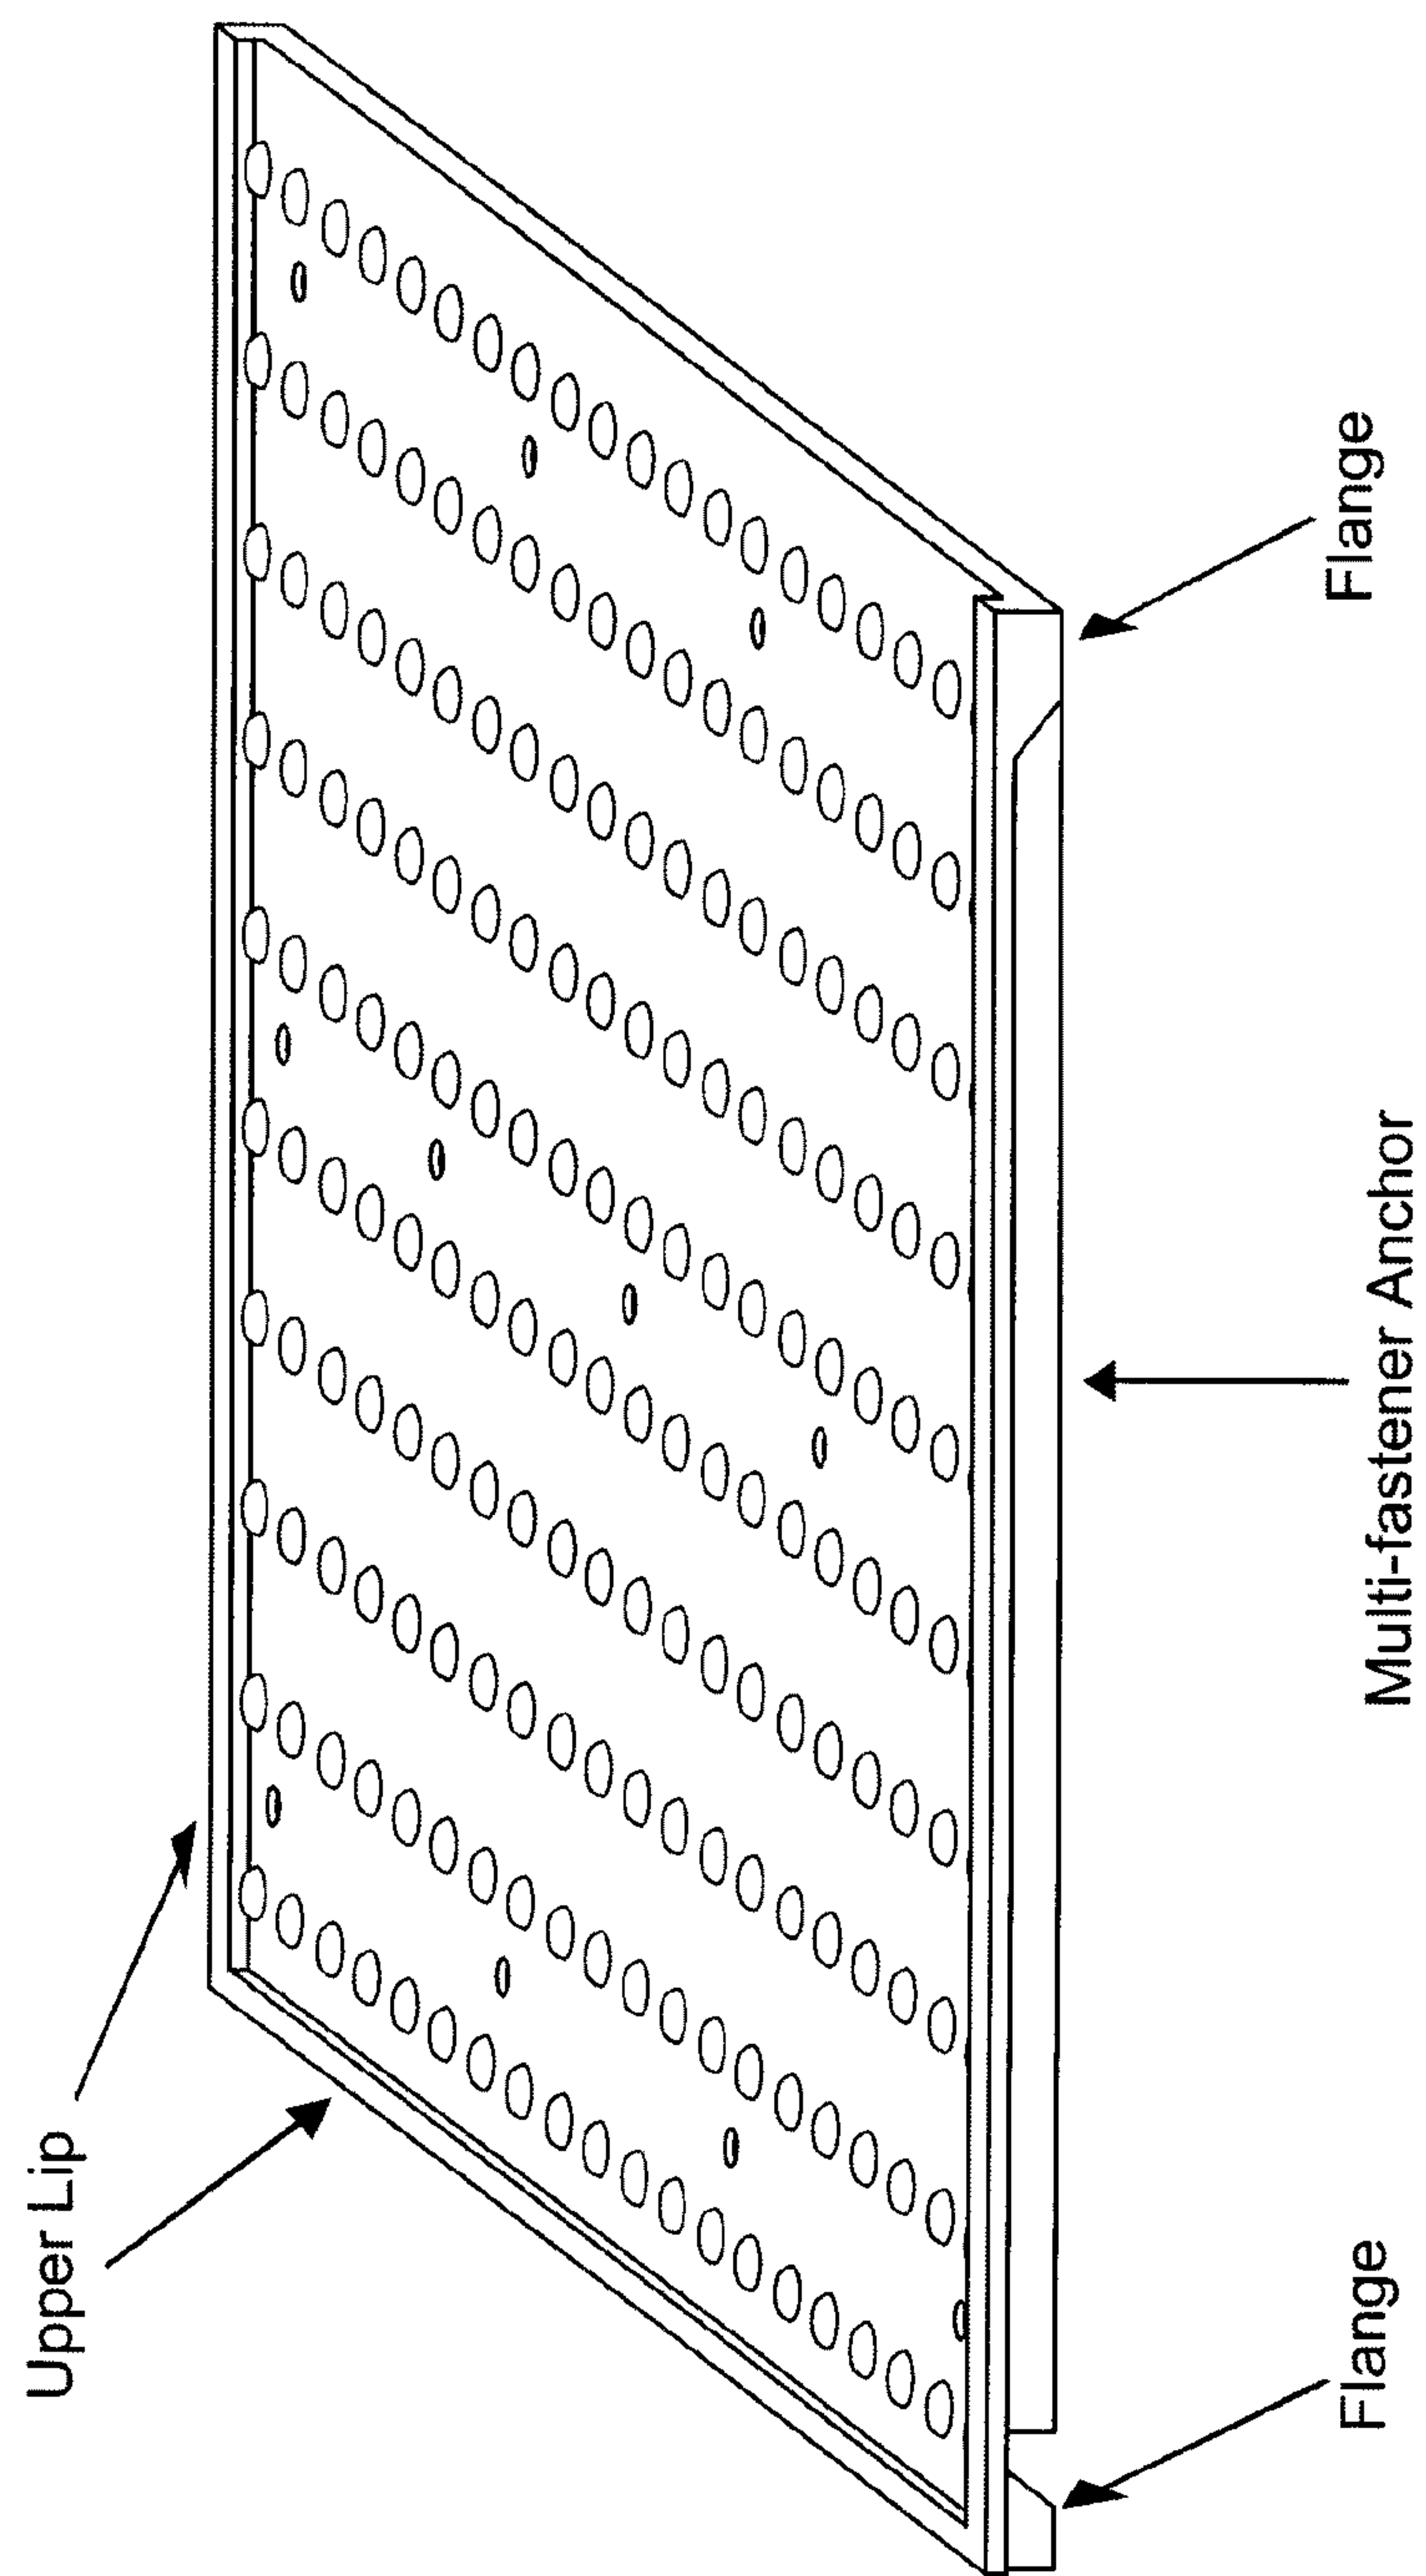
[0005] FIG. 1C is a schematic picture of the same tile depicted in FIG. 1A looking along the long axis of the tile.

**[0019]** FIGS. 1C and 1D also show a different type of anchor that mimics a rib on the underside of the tile. This rib-anchor is fastened to the tile by multiple fasteners at different locations unlike the single-fastener, hexagonal anchors also shown. Ribs can be used to provide stiffness or strength to the tile, and the multi-fastener anchor can mimic those effects.

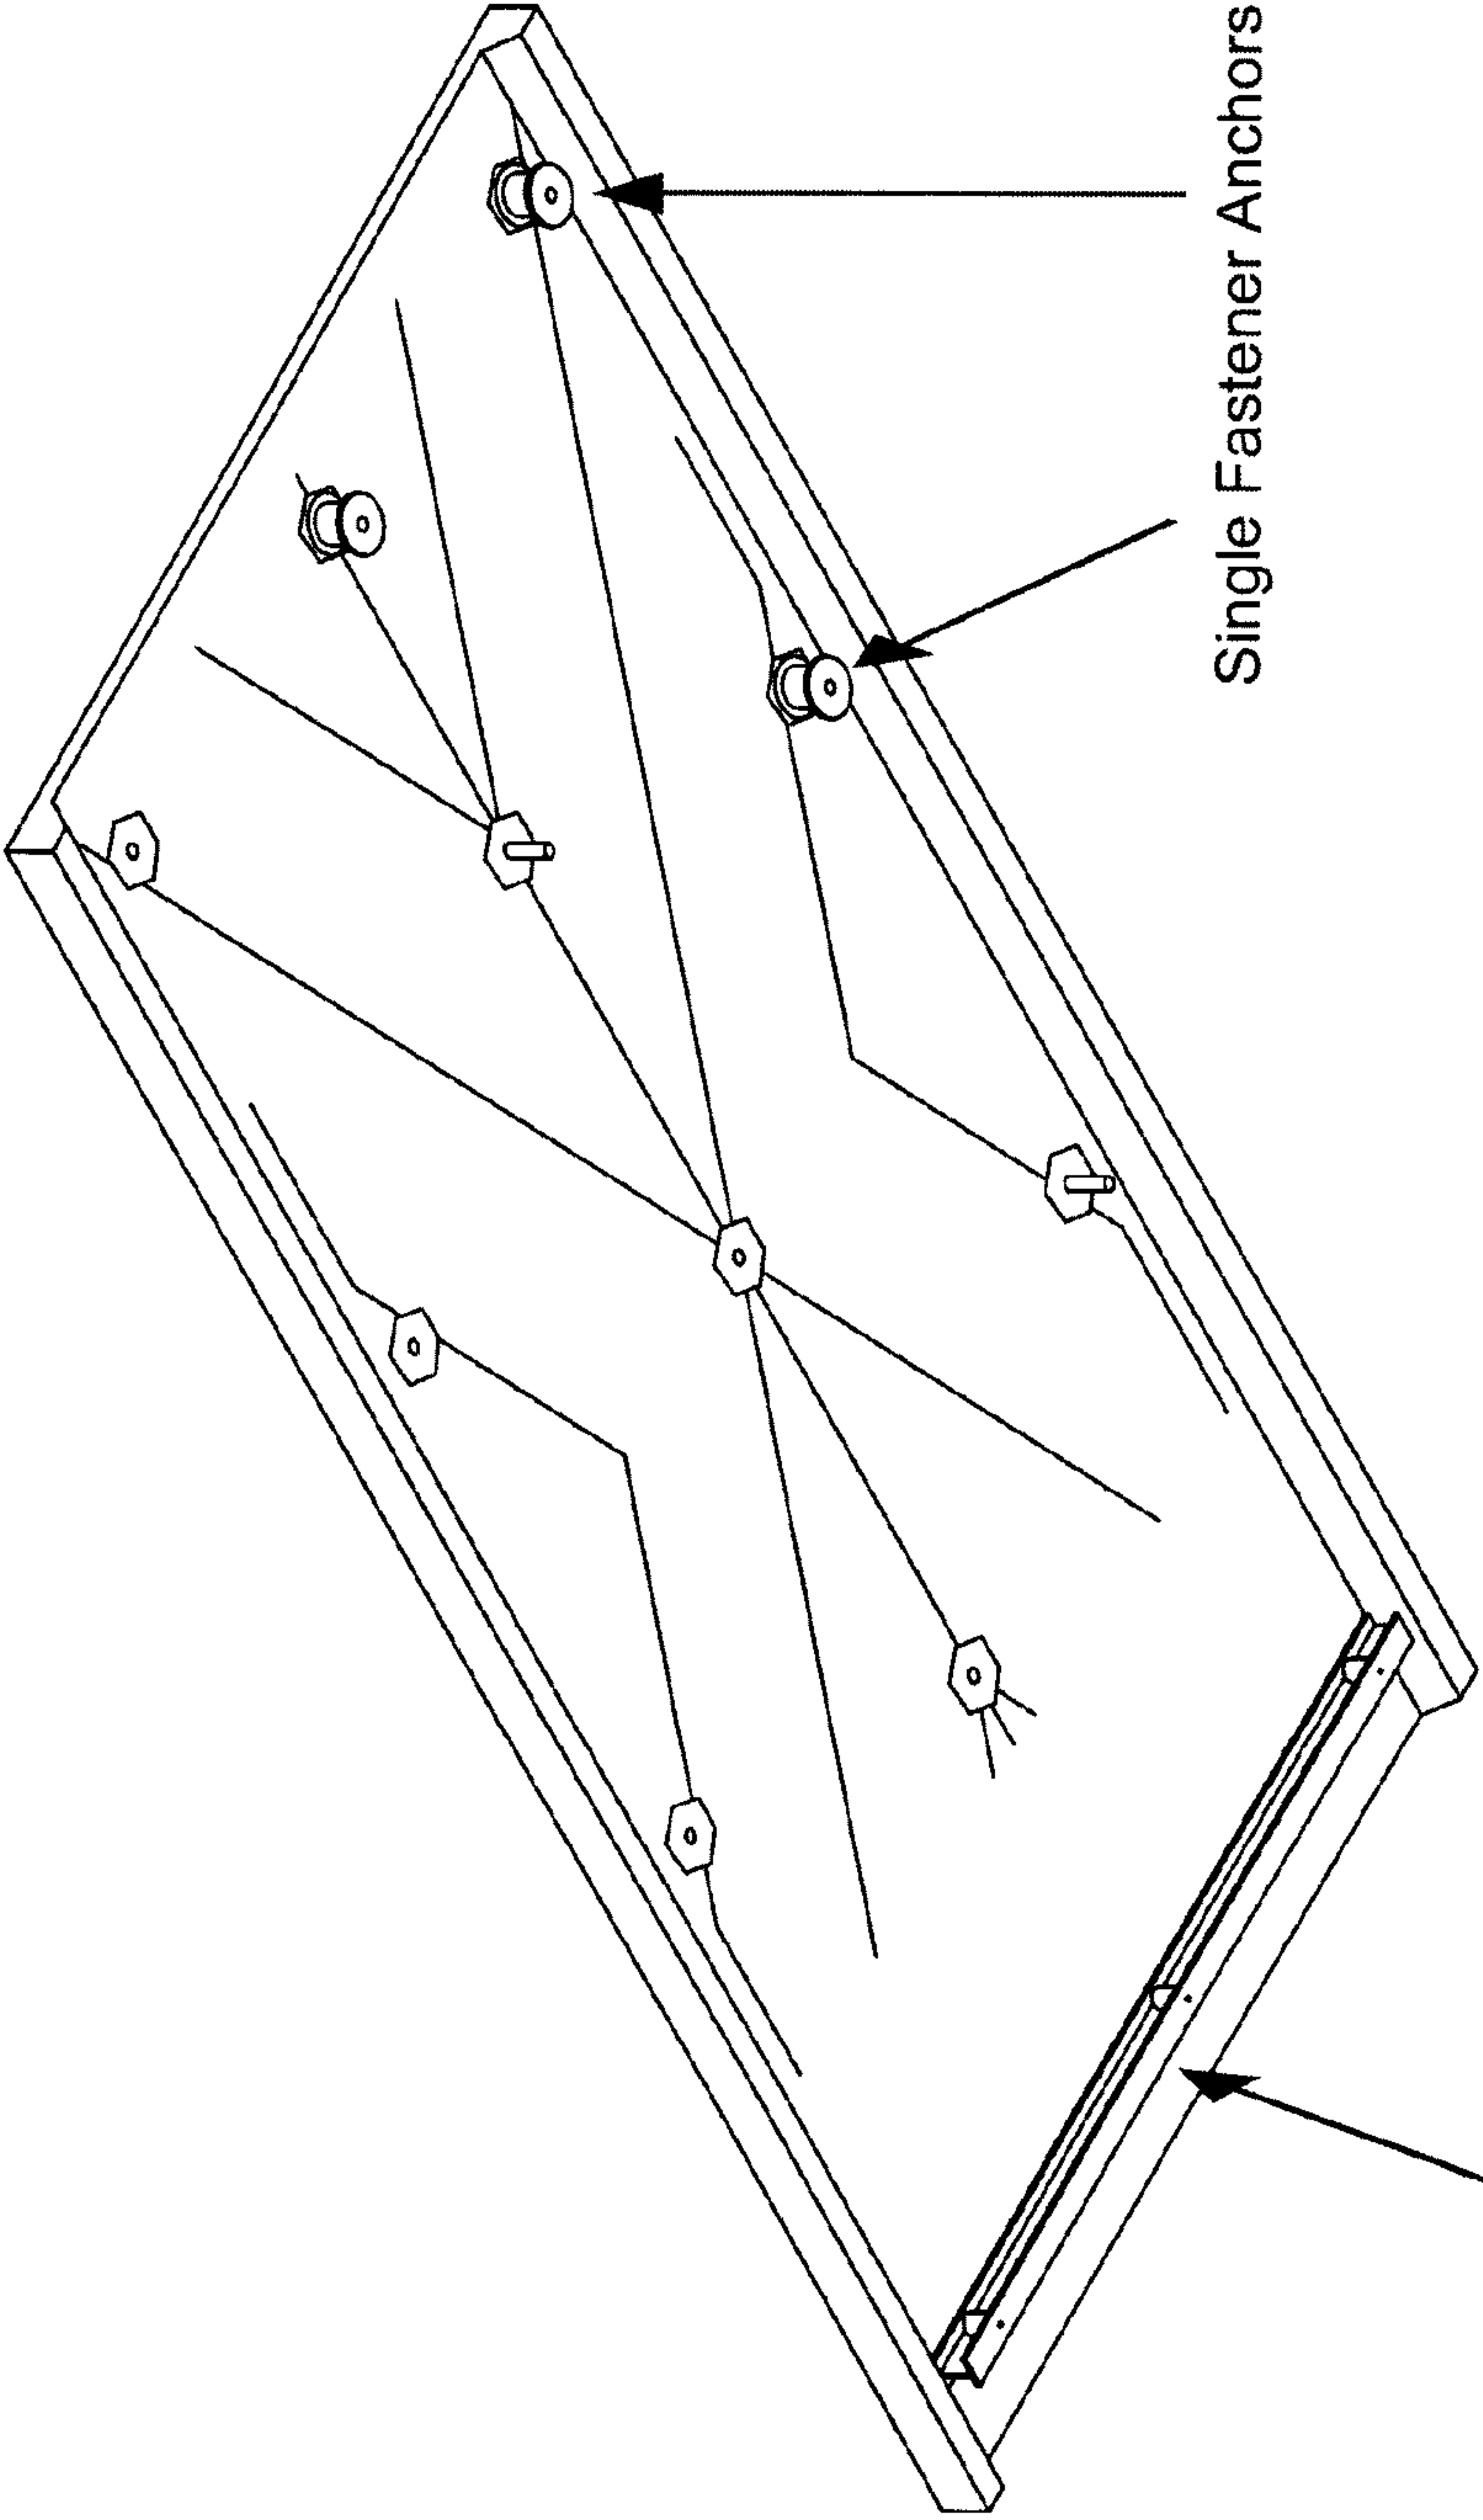
FIG.1D

[0006] FIG. 1D is a schematic picture of the same tile depicted in FIG. 1A looking from underneath.

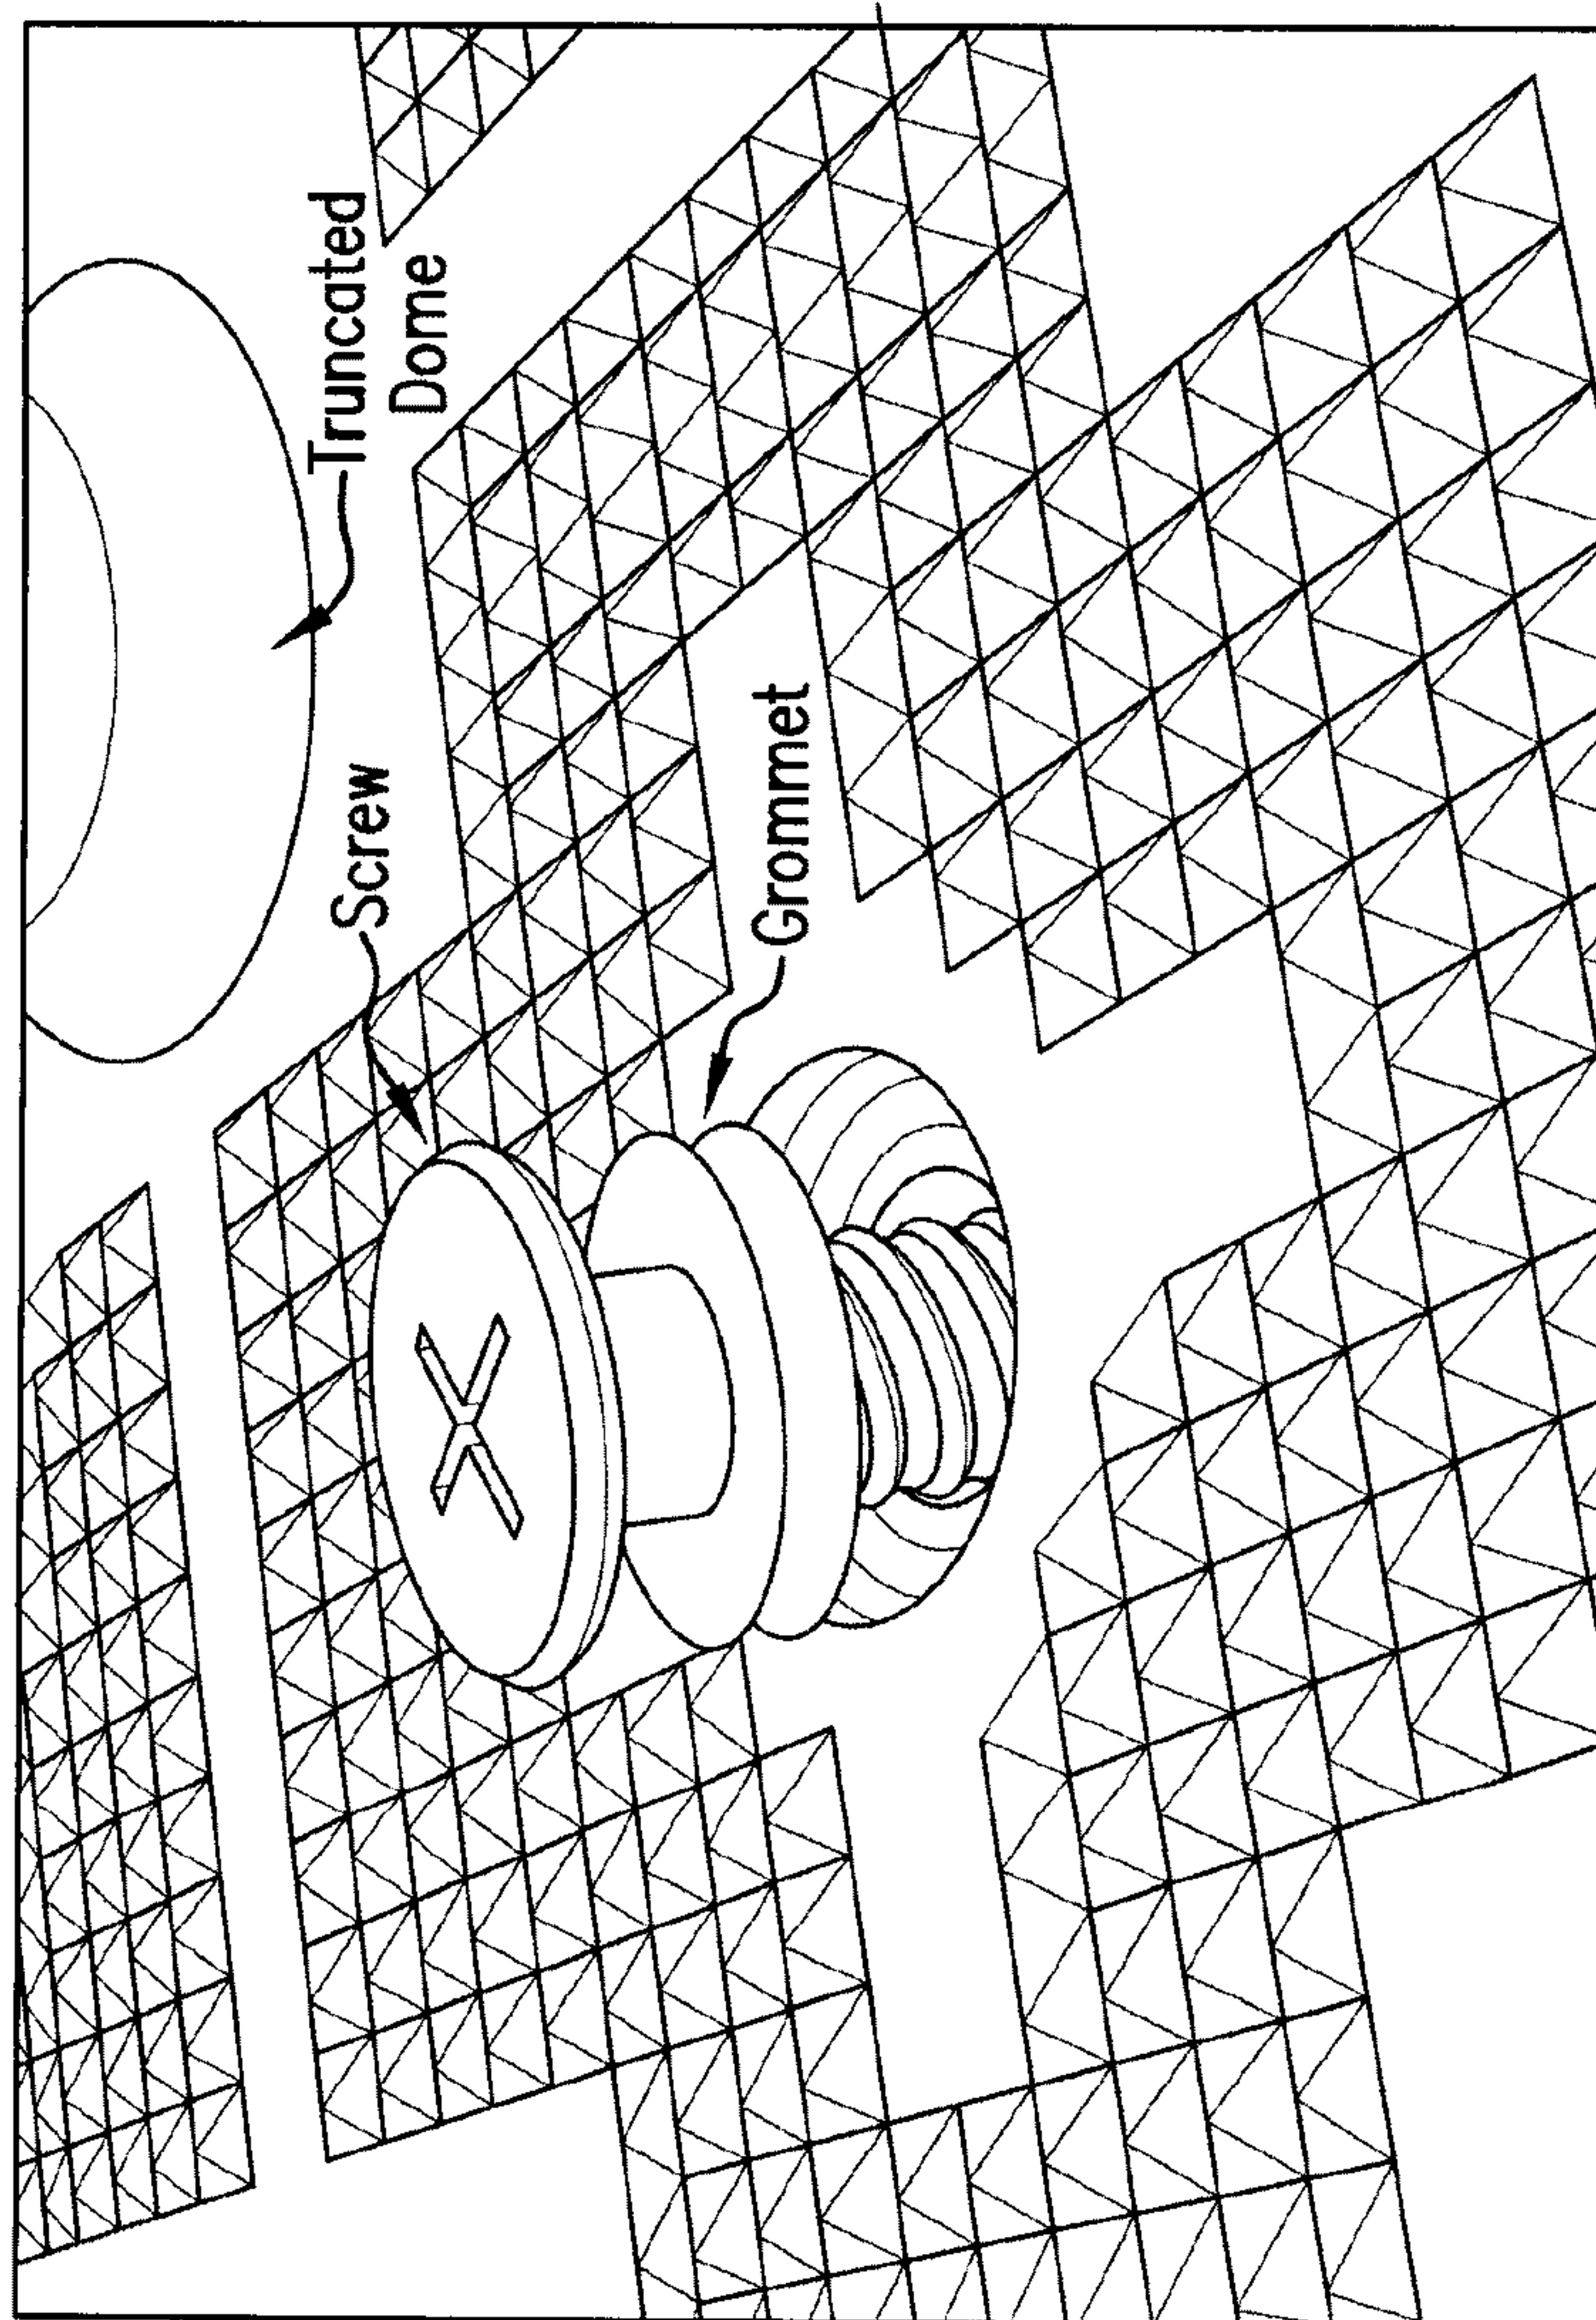
[0007] FIG. 2 is a photograph of an example of a tile including a flexible grommet surrounding a fastener.

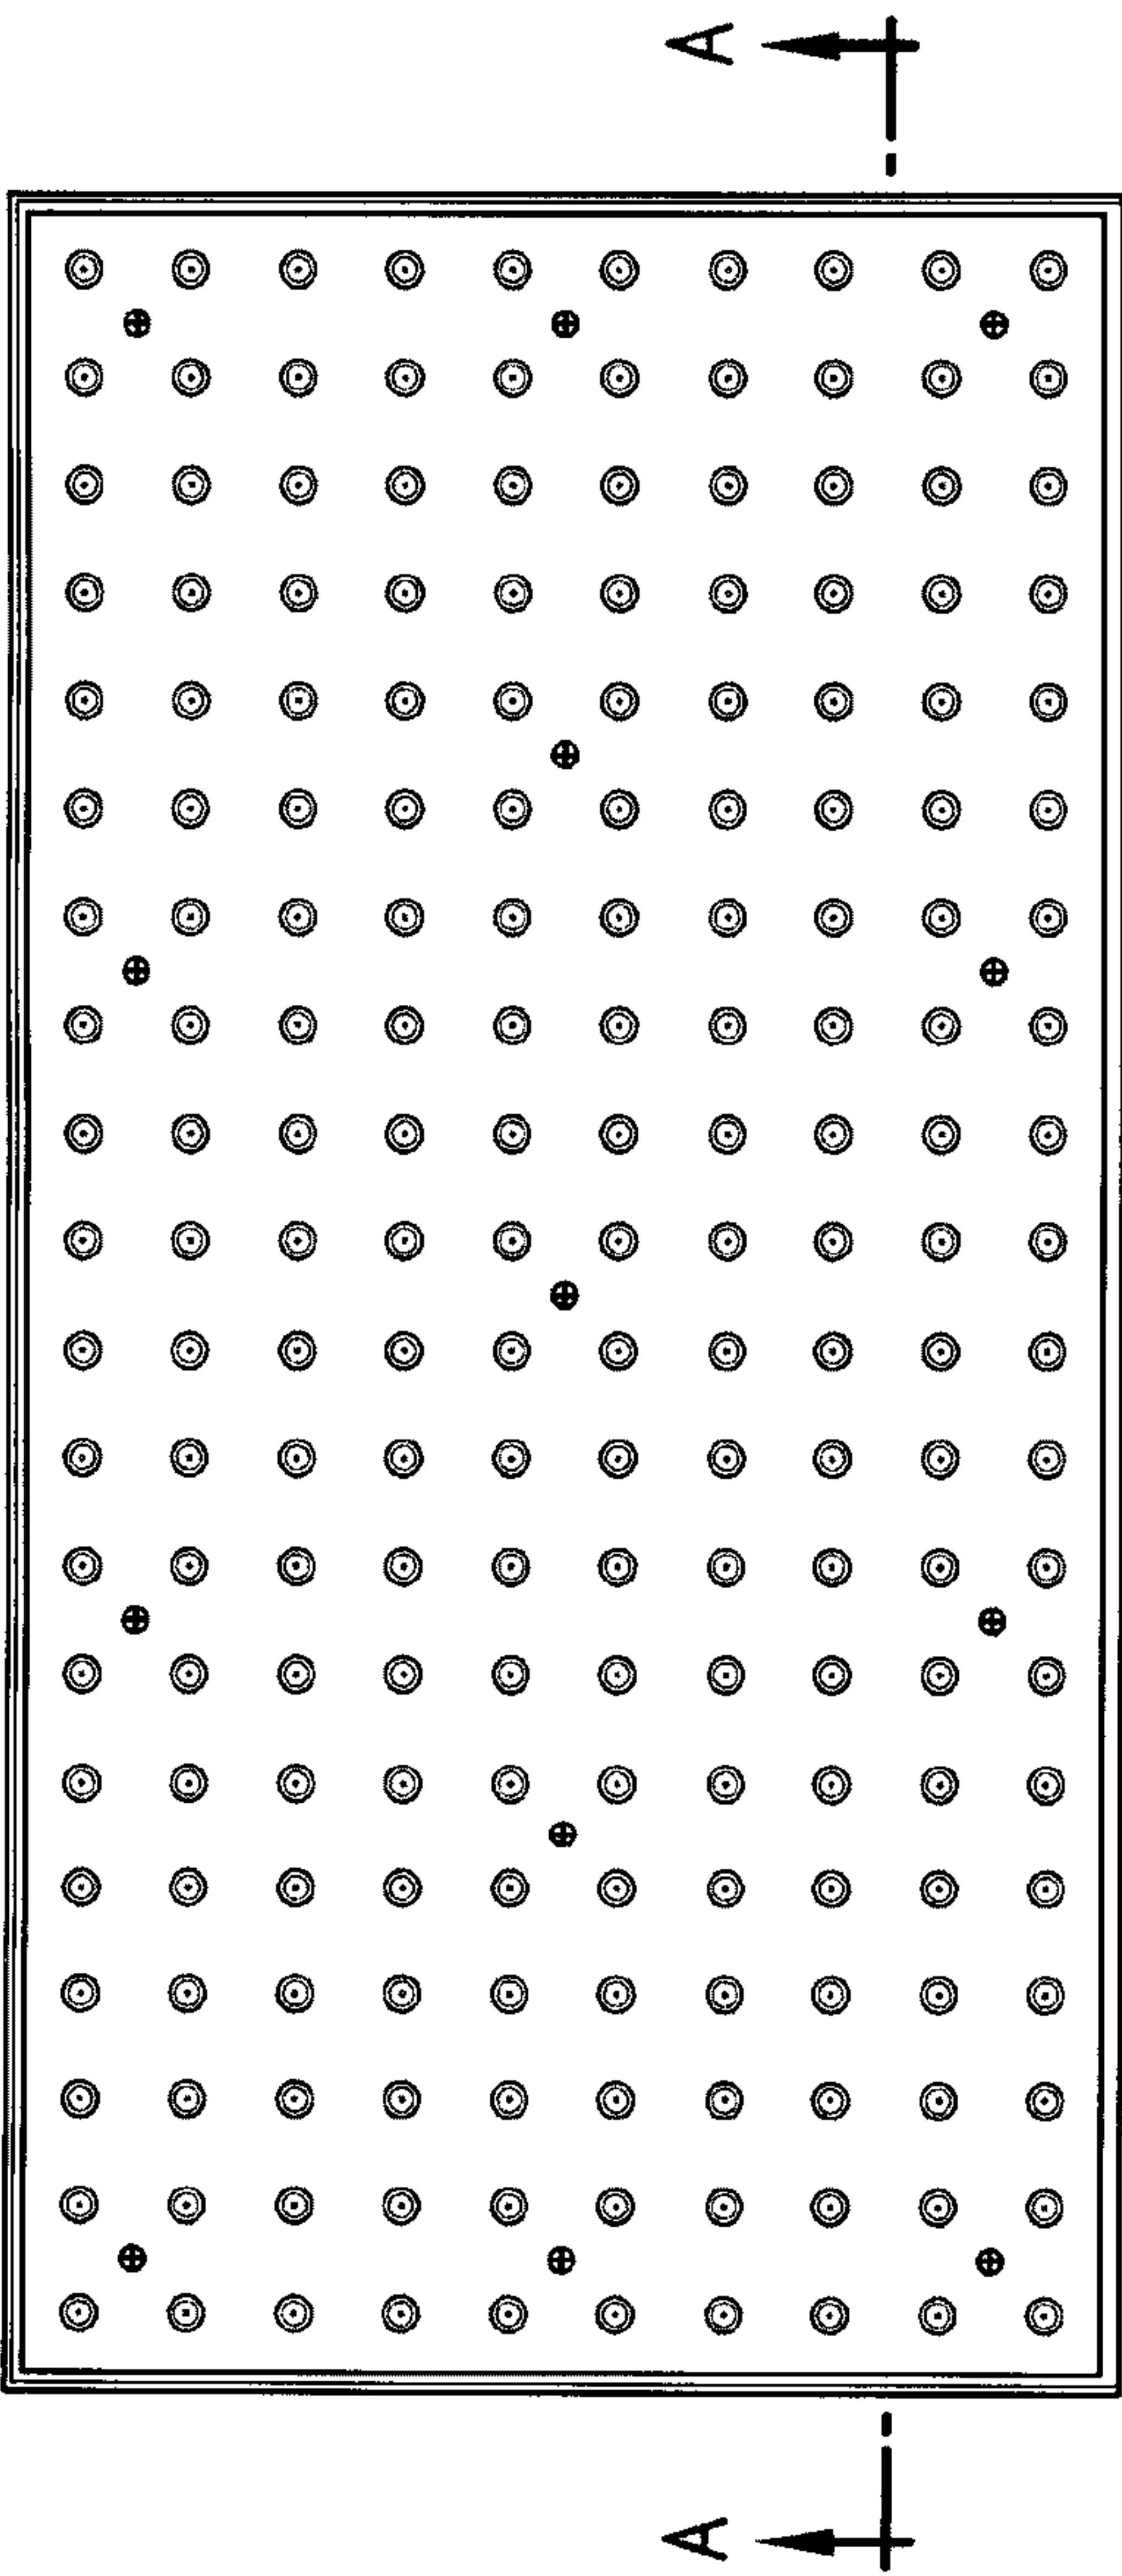
[0008] FIG. 3, FIG. 3A, FIG. 3B, FIG. 3C show a series of schematic drawings of a tile assembly including an isolation tray.

**[0031]** FIG. 3 shows yet another way of addressing the problem of buckling, by installing the tile in an isolation tray. In this embodiment, a tray is affixed to the tile. The fasteners pass through the tile, through the tray and then into the anchors. The isolation tray is larger than the tile, leaving room for the tile to expand and contract horizontally inside the tray. An exposed gap between the tray and the tile can be sealed, for example with a flexible caulking that allows for expansion and contraction of the tile while preventing debris from falling into the tray. The presence of the tray leaves a horizontal gap between the tile and

the surrounding concrete, allowing the tile to expand and contract relative to the concrete without buckling. This is also beneficial when used with a replaceable tile in that the tray keeps the tile from coming directly in contact with the concrete, making the tile easier to remove. Moreover, because the tile is not embedded directly in the concrete, underside protrusions can be any shape, including wider at their lowest point, without compromising replaceability. The isolation tray may be made from a variety of materials, and in particular, could be made from a material whose thermal expansion characteristics mimic those of concrete.
