(54) Titre : AVERTISSEMENTS DETECTABLES  
(54) Title: DETECTABLE WARNINGS

A detectable warning tile which aims to solve the problem of buckling and cracking associated with different thermal expansion properties of the tile and the substrate in which it is installed. Said tile is provided with underside flanges on only some of the outermost vertical surface of the tile. The tile need not be a quadrilateral, the tile may have more or fewer than fours edges.

## DETECTABLE WARNINGS

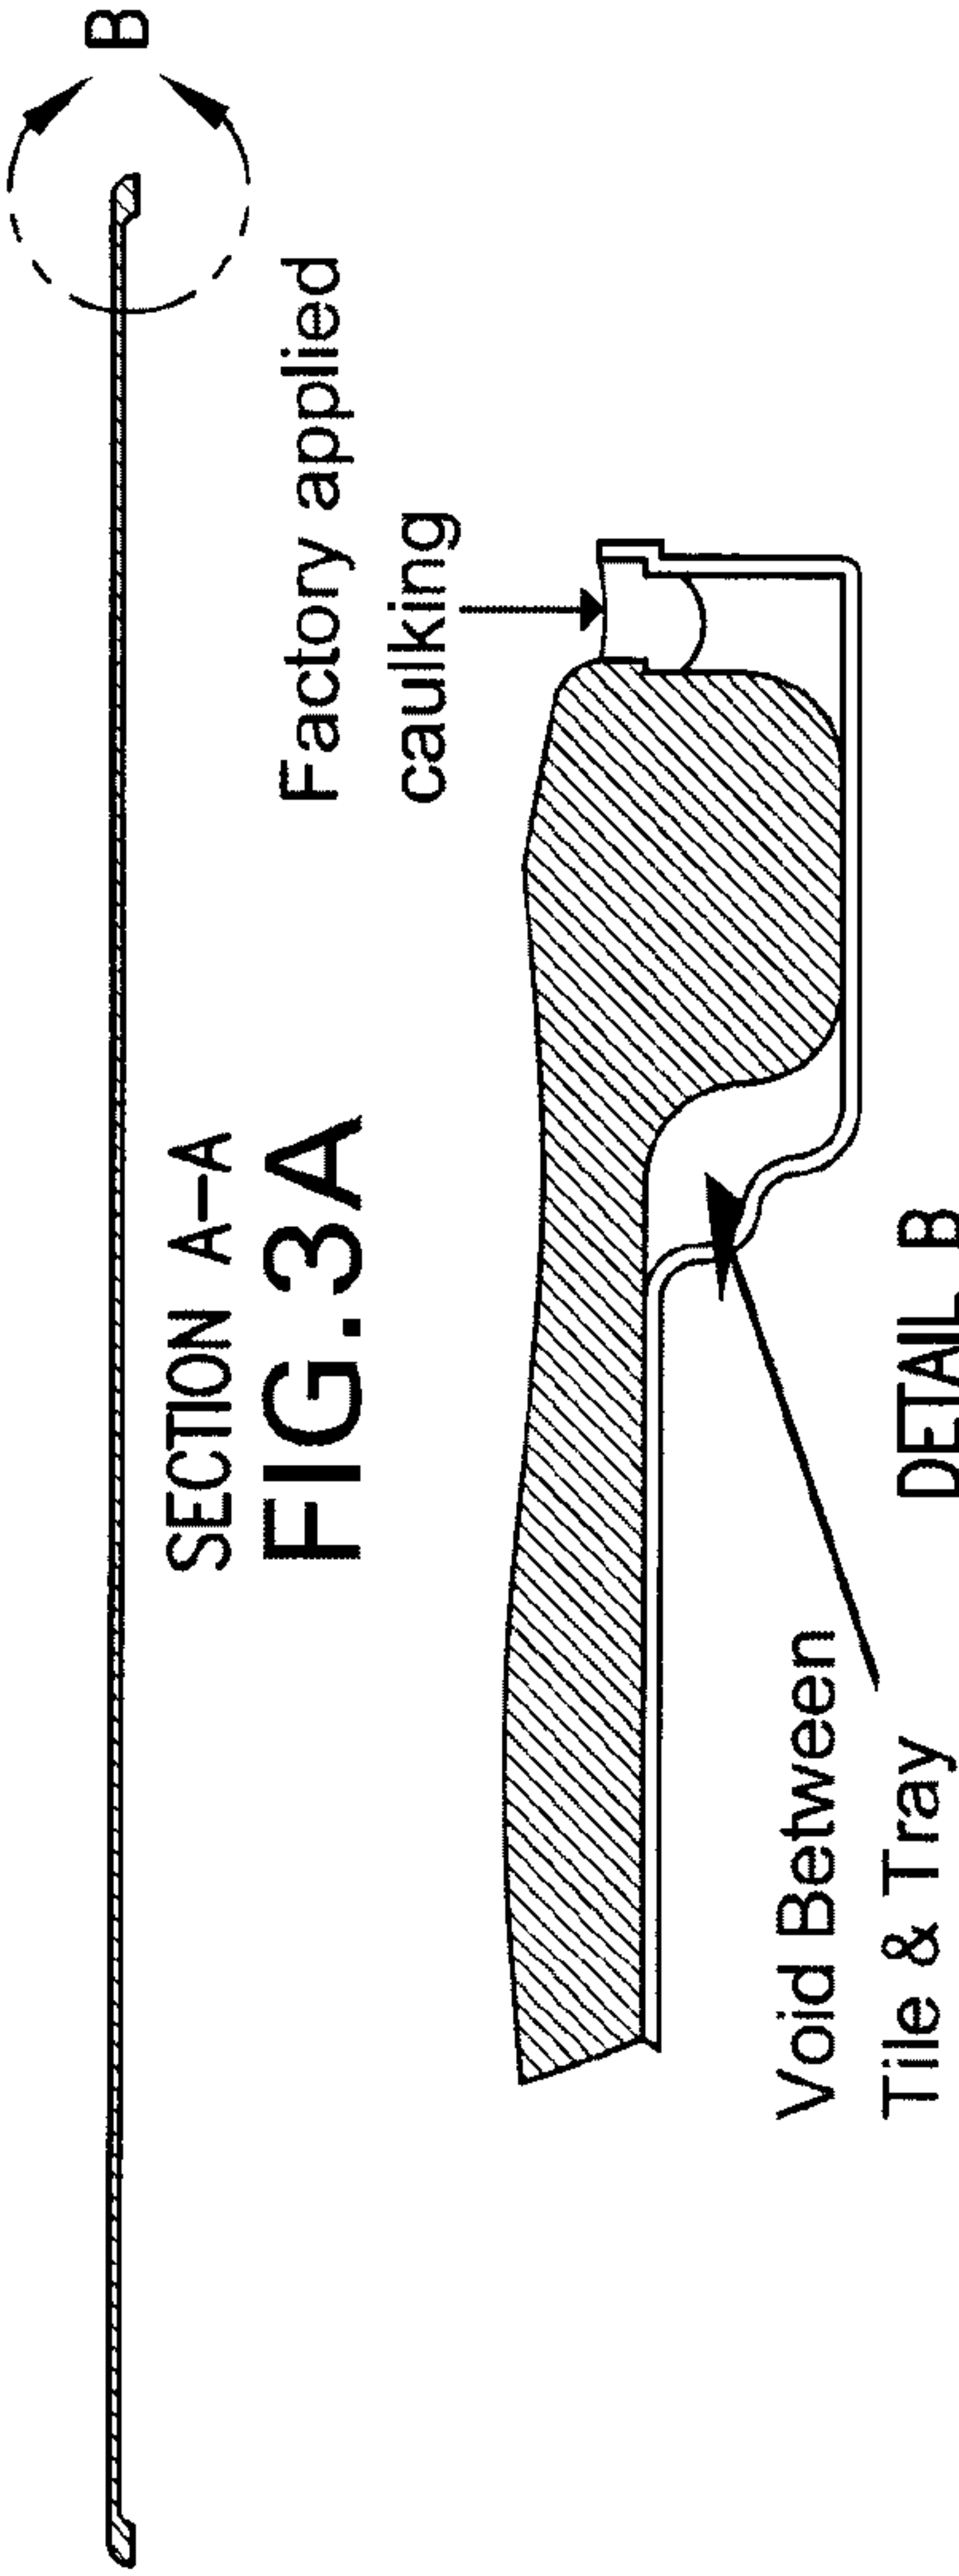
SECTION A-A  
FIG. 3A

[0008] FIG. 3, FIG. 3A, FIG. 3B, FIG. 3C show a series of schematic drawings of a tile assembly including an isolation tray.

**[0031]** FIG. 3 shows yet another way of addressing the problem of buckling, by installing the tile in an isolation tray. In this embodiment, a tray is affixed to the tile. The fasteners pass through the tile, through the tray and then into the anchors. The isolation tray is larger than the tile, leaving room for the tile to expand and contract horizontally inside the tray. An exposed gap between the tray and the tile can be sealed, for example with a flexible caulking that allows for expansion and contraction of the tile while preventing debris from falling into the tray. The presence of the tray leaves a horizontal gap between the tile and

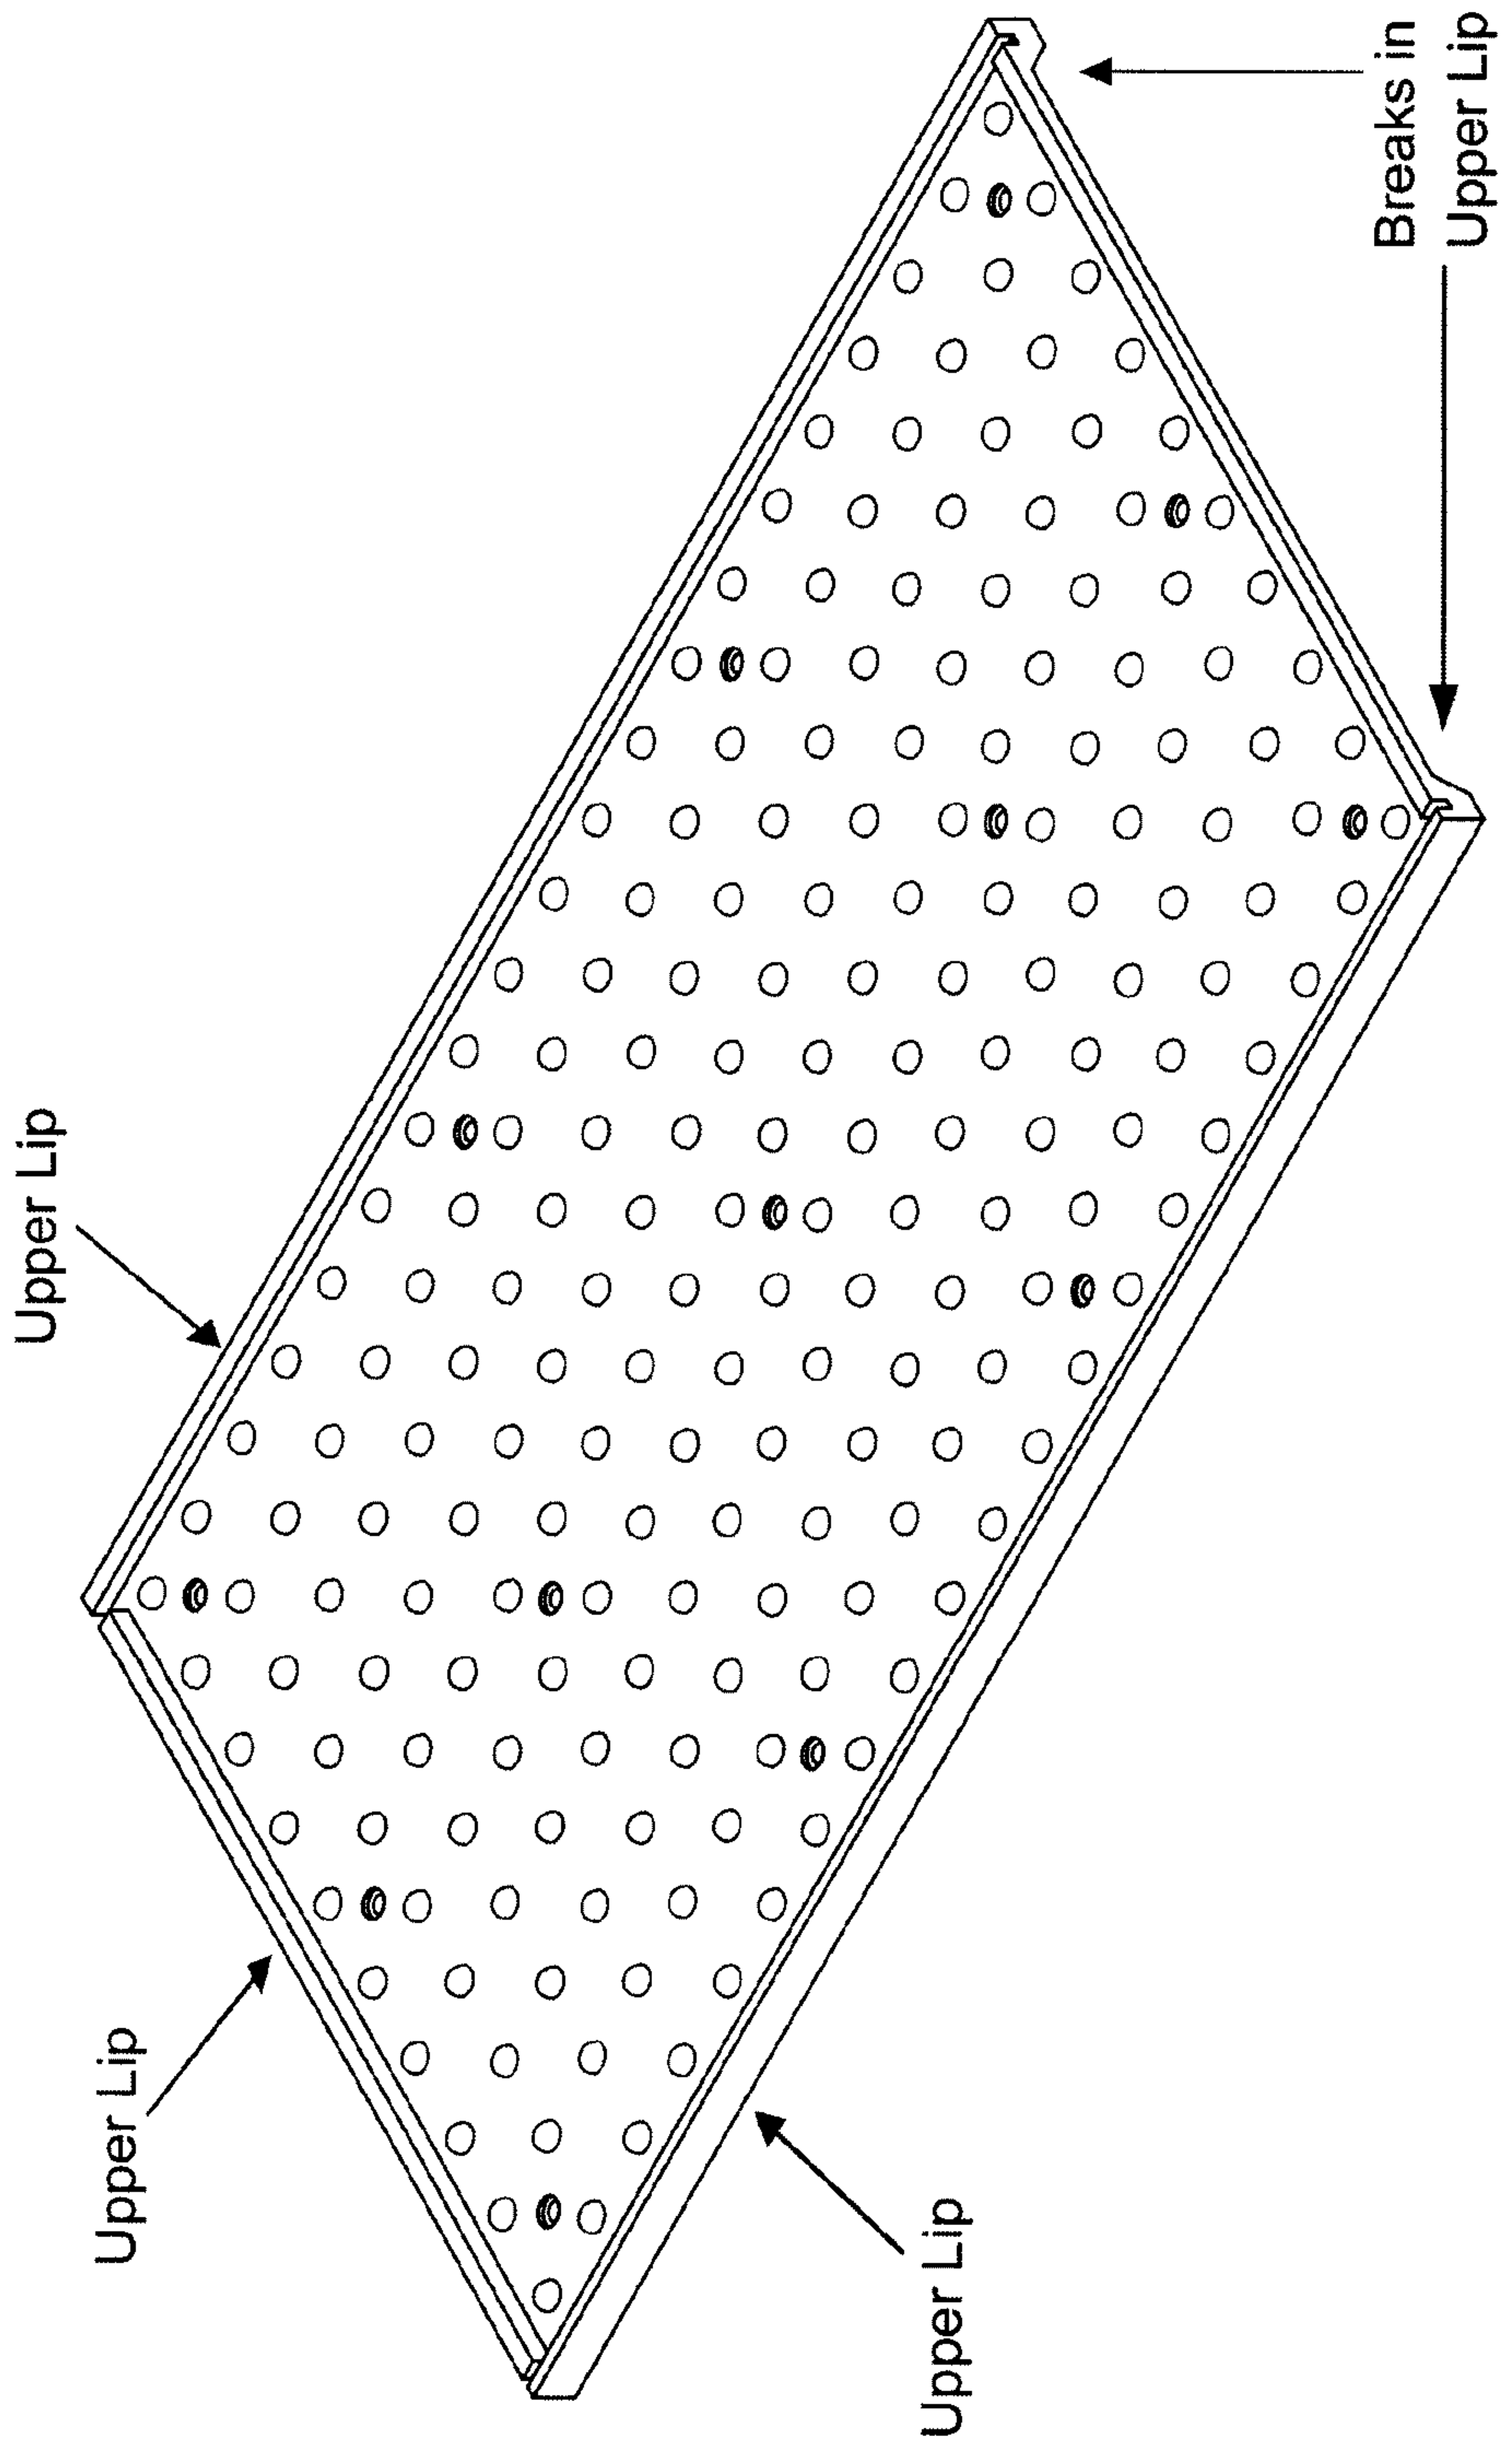
FIG.4A

[0009] FIG. 4A is a schematic picture of a replaceable detectable warning tile with a protective upper lip designed to promote self-cleaning.

**[0035]** A third problem with some detectable warning tiles is the difficulty of cleaning the tile. FIG. 4A shows a detectable warning tile designed to be at least partially self-cleaning. The unit has an upper lip to protect the detectable warnings from snow plows as described above. In this case, the upper lip is broken at locations on the long sides of the tile, near the corner. In this way the upper lip defines one or more openings. The upper lip along the long sides of the tile is also wider at the center than at the corners. In FIGS. 4A-4C the long sides of the upper lip have triangular peaks, but many such shapes will suffice. When such a tile is installed on a slope, for example in a curb ramp, or curb cut, with one long side below the other long side, debris will roll or flow down the slope, hit the lip on the lower edge of the tile, then roll or flow along the sloped lip down to the corner where it can be

channeled away through the break in the lip. In this way, the upper lip can be shaped to promote self-cleaning when installed on a slope. Although only the downhill side of the tile needs to have the above-described shape and openings to work as described, the upper lip as shown in FIGS. 4A-4C is symmetrical for ease of installation, so that the tile can be installed with either long edge at the top or bottom of the slope.

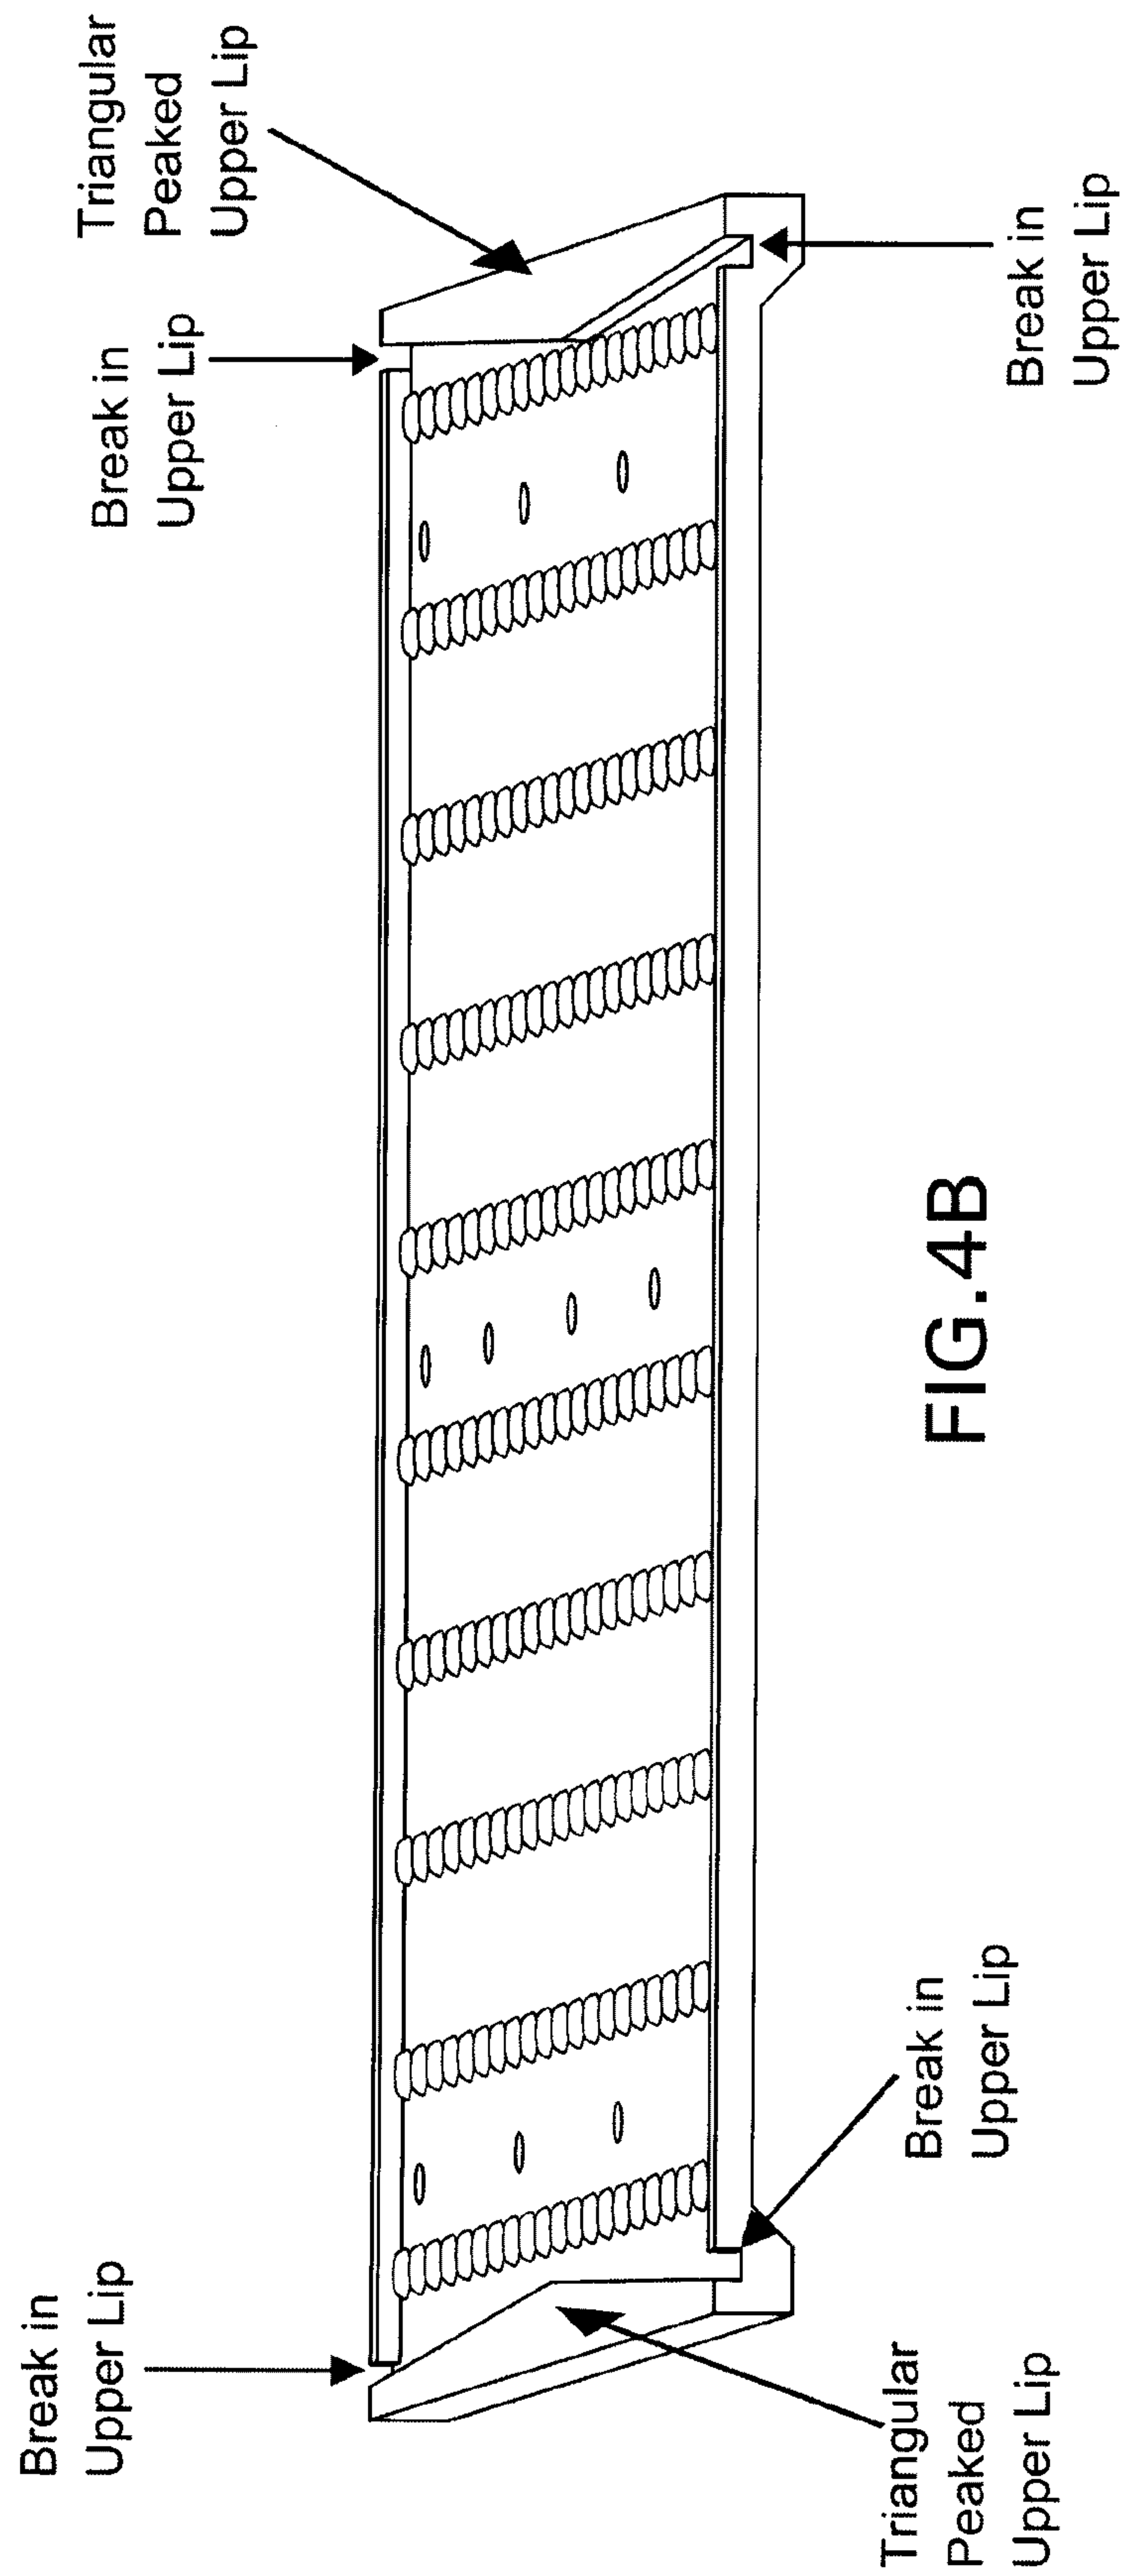
[0010] FIG. 4B is a schematic picture of the same tile depicted in FIG. 4A looking along the long axis of the tile to emphasize the triangular shape of the upper lip.

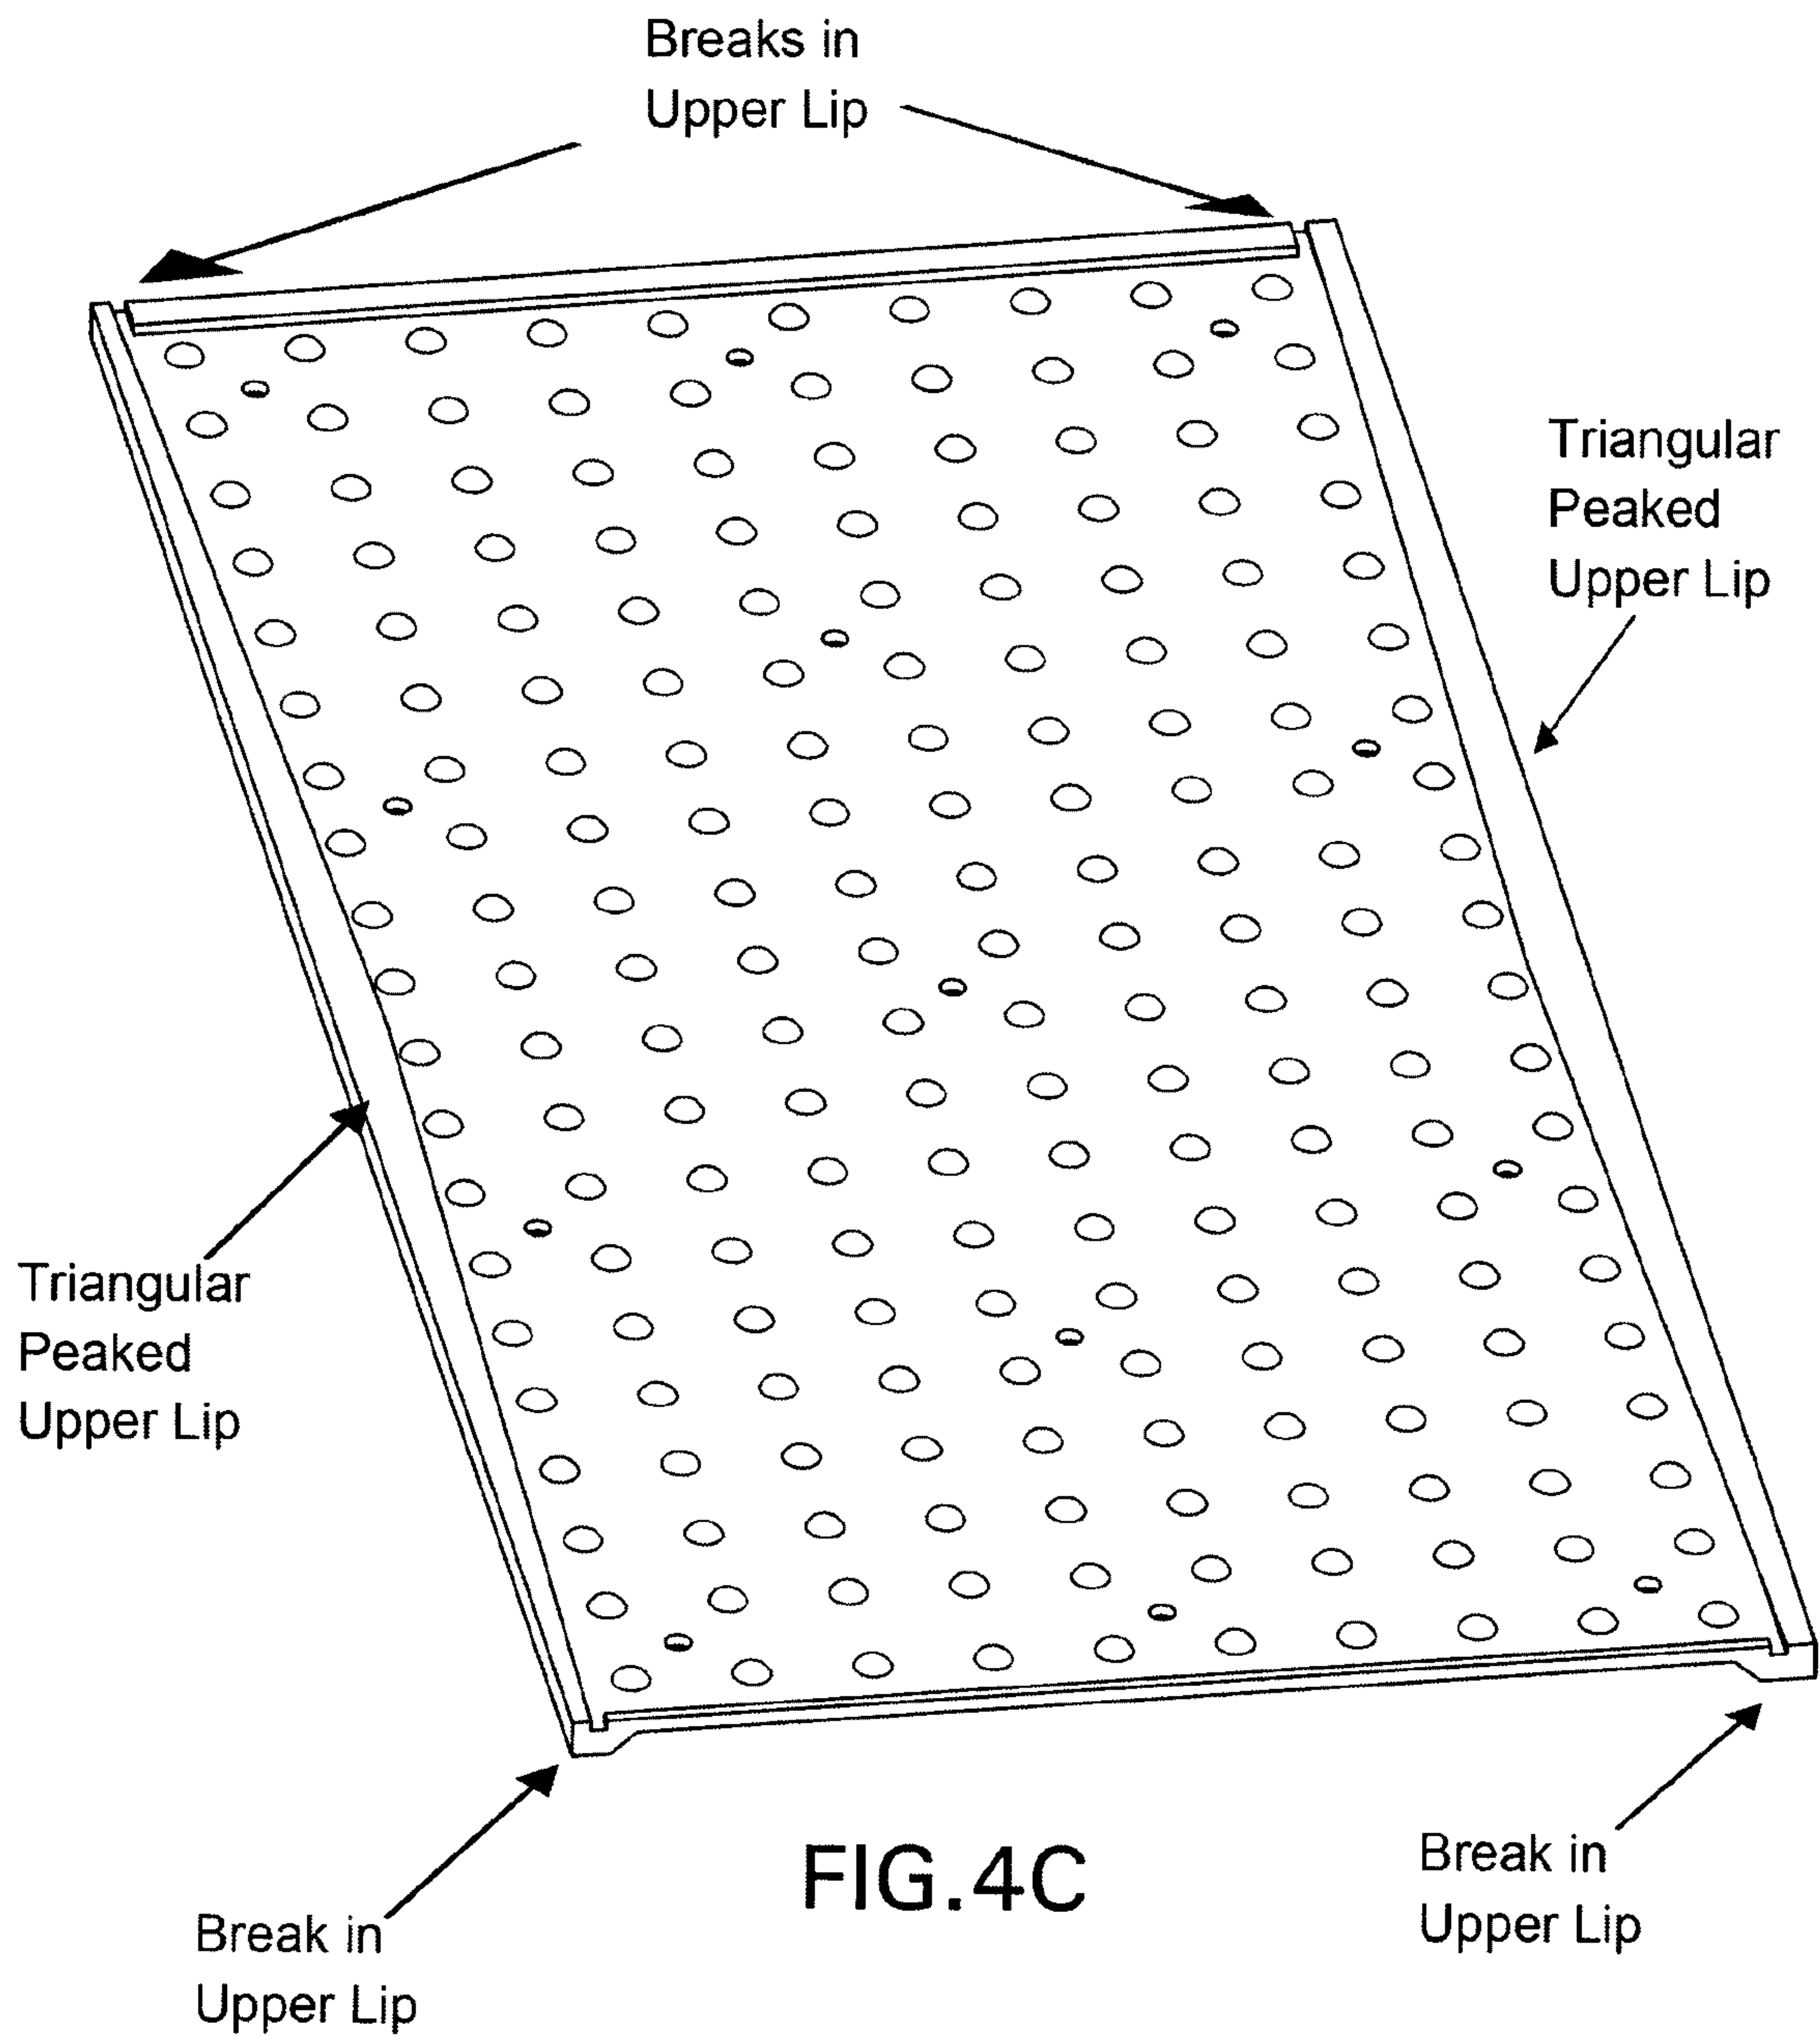
[0011] FIG. 4C is a schematic picture of the same tile depicted in FIG. 4A.

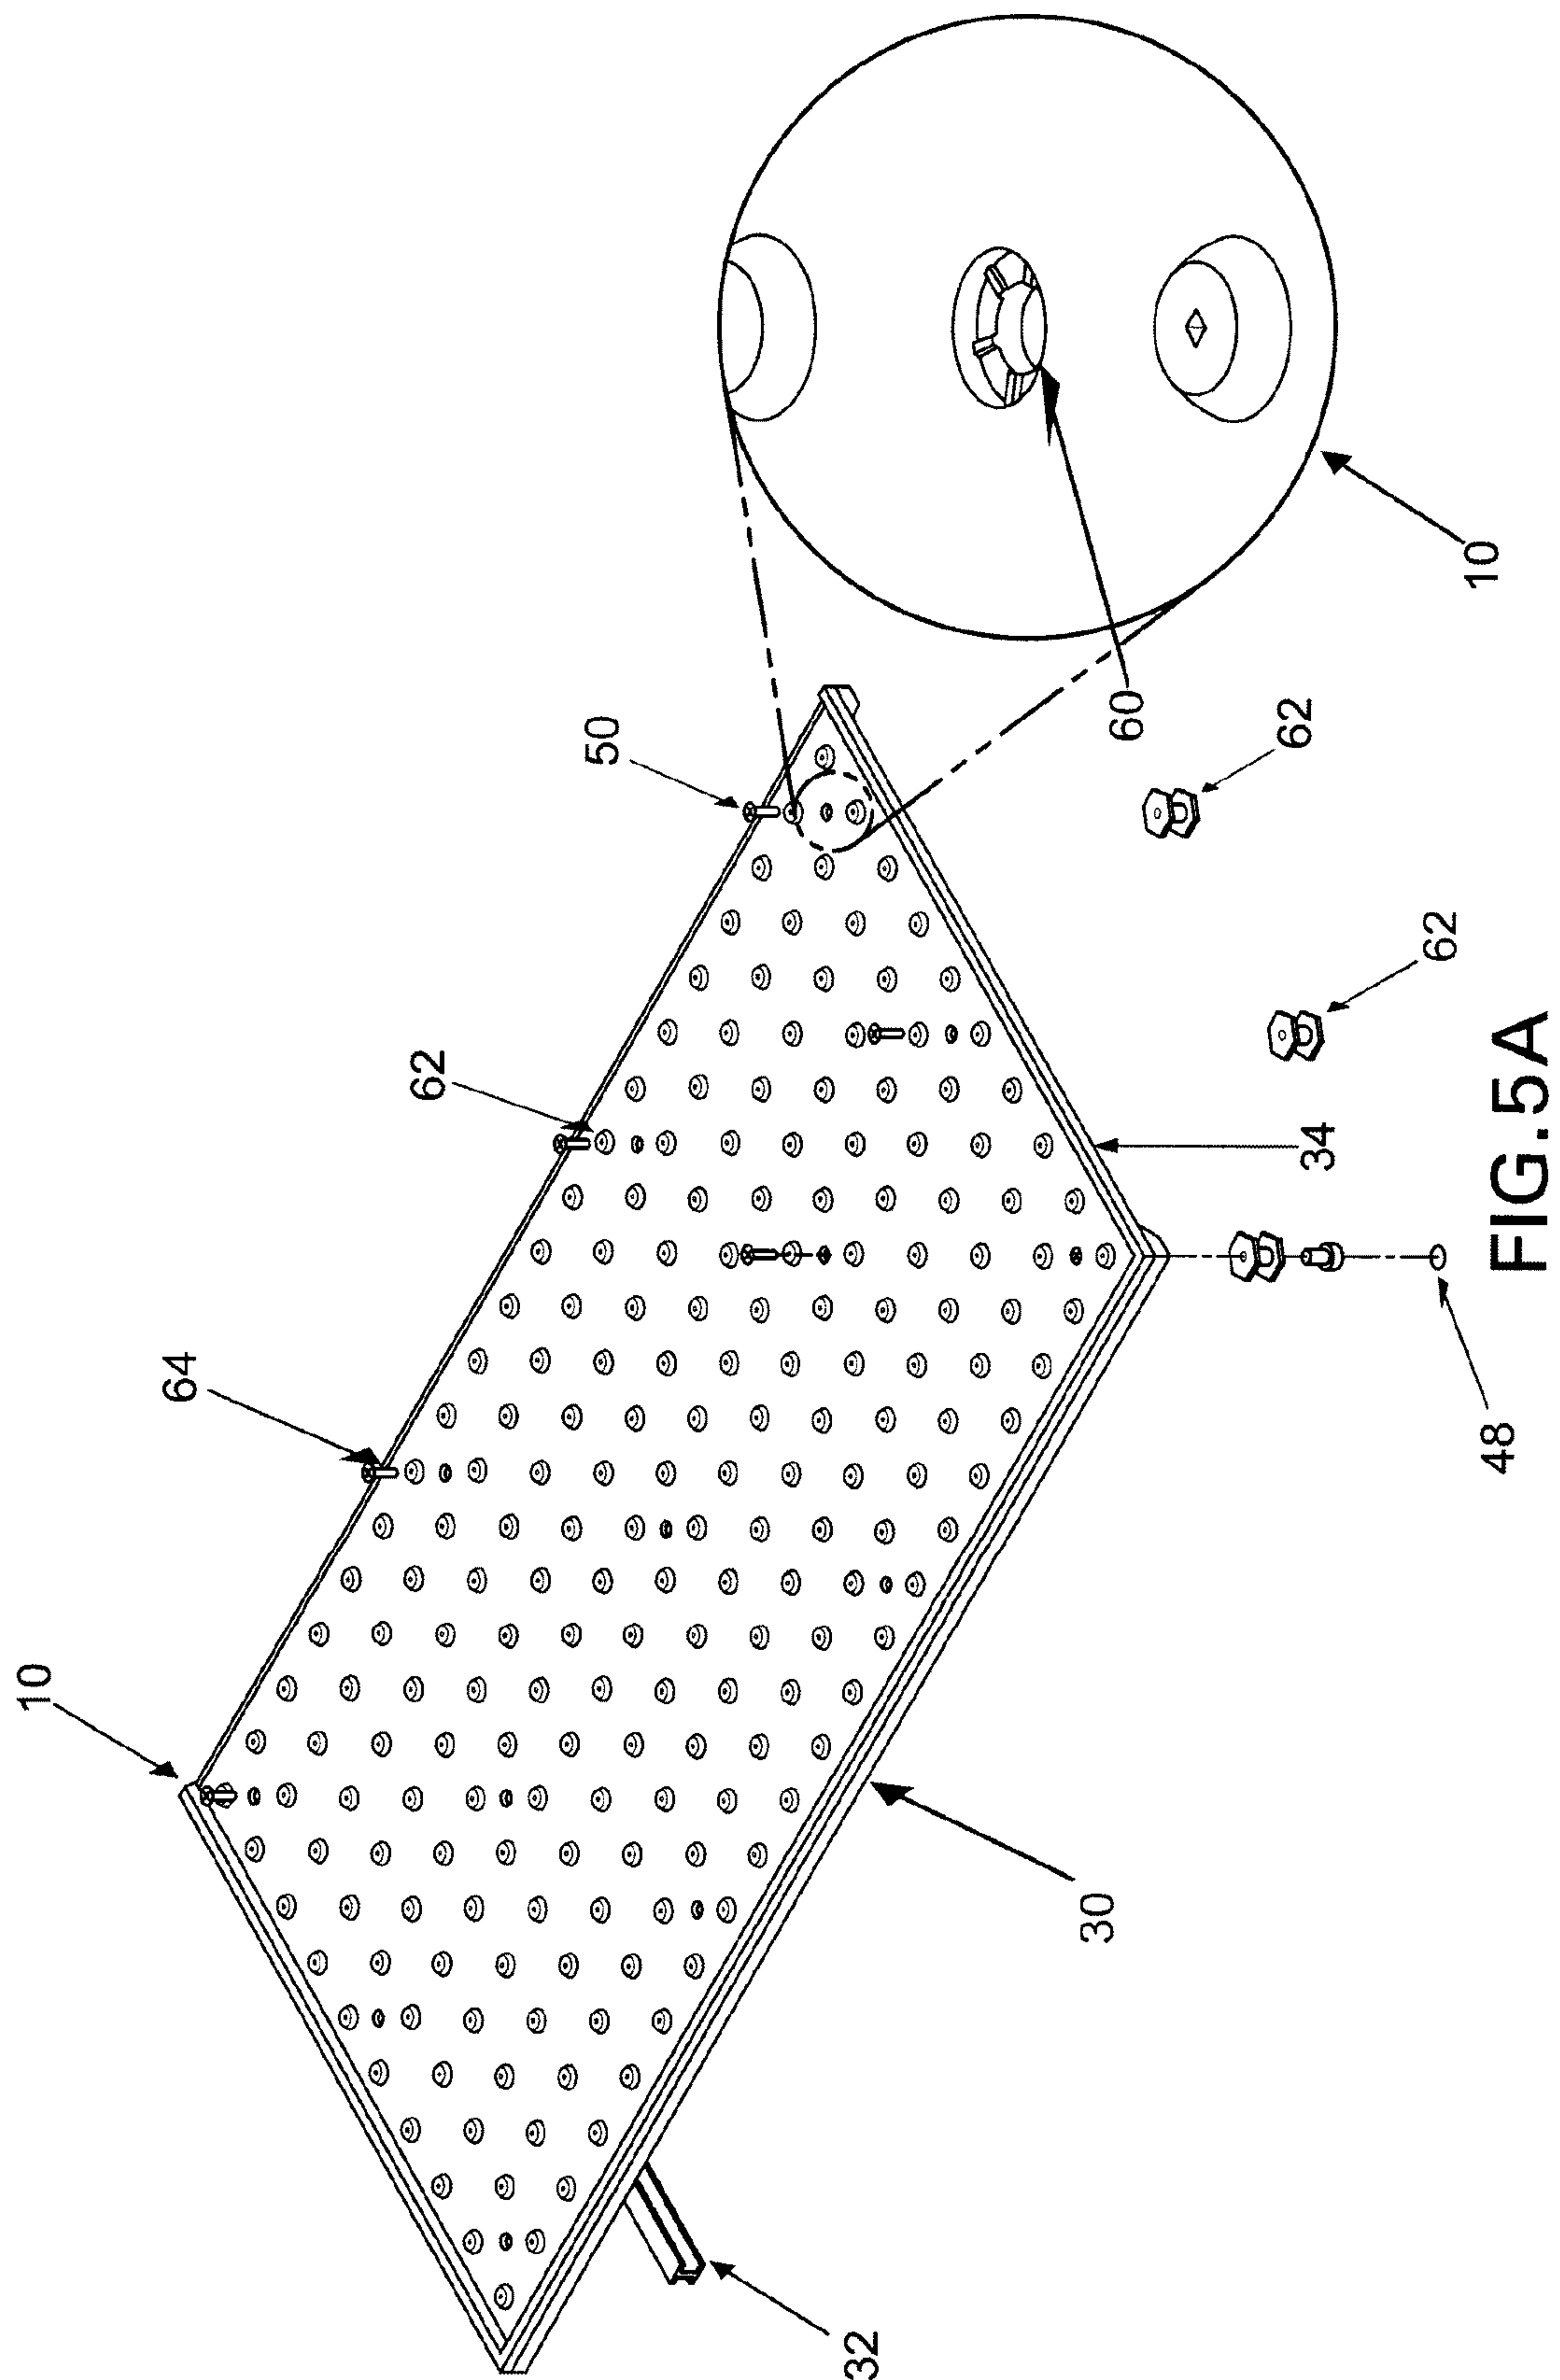
[0012] FIG. 5A is a schematic picture of a replaceable detectable warning tile with features designed to allow venting from below to above the tile.

**[0038]** Venting can also be achieved by leaving room for air to flow around the fasteners. Figure 5A illustrates a snow recess tile 10 which includes detectable dome projections for warning protection. The tile 10 has side flanges 30 which are provided without venting, and stiffener rib/anchors 32. The ends 34 of the tile 10 are provided without flanges, or alternatively with a non-continuous flange. FIG. 5A shows two ways of allowing venting around the fasteners (i.e. screw heads 50). Detail A of FIG. 5A shows a hole 60 formed through the tile 10. The hole 60 has venting space integrated therewith, and may be oversized to allow for expansion and contraction. An anchor assembly 48 including a fastener having screw head 50, a neoprene-like grommet 52 and an anchor 62 allows the anchor 62 to move with the tile 10 and has integrated venting. The fastener passes through the hole 60 and attaches to the anchor 62. As the fastener is tightened in the anchor 62, the anchor 62 becomes held to the tile 10. But the hole 60 shown in Detail A is not merely a countersink to allow the screw head 50 to be recessed. The screw head 50 is provided with a flat underside to allow for unrestricted tile expansion and contraction, and venting space is integrated into the underside of the screw

head 50. The horizontal and vertical surfaces of the hole 60 include channels that allow air to flow from below the tile 10 to above the tile, even when a screw fastener is seated in the countersink 64. When the screw fastener is tightened down, it seats against the horizontal surface of the countersink 64, leaving channels underneath the screw that continue to the underside of the tile 10. This is shown in more detail in FIG. 5B.

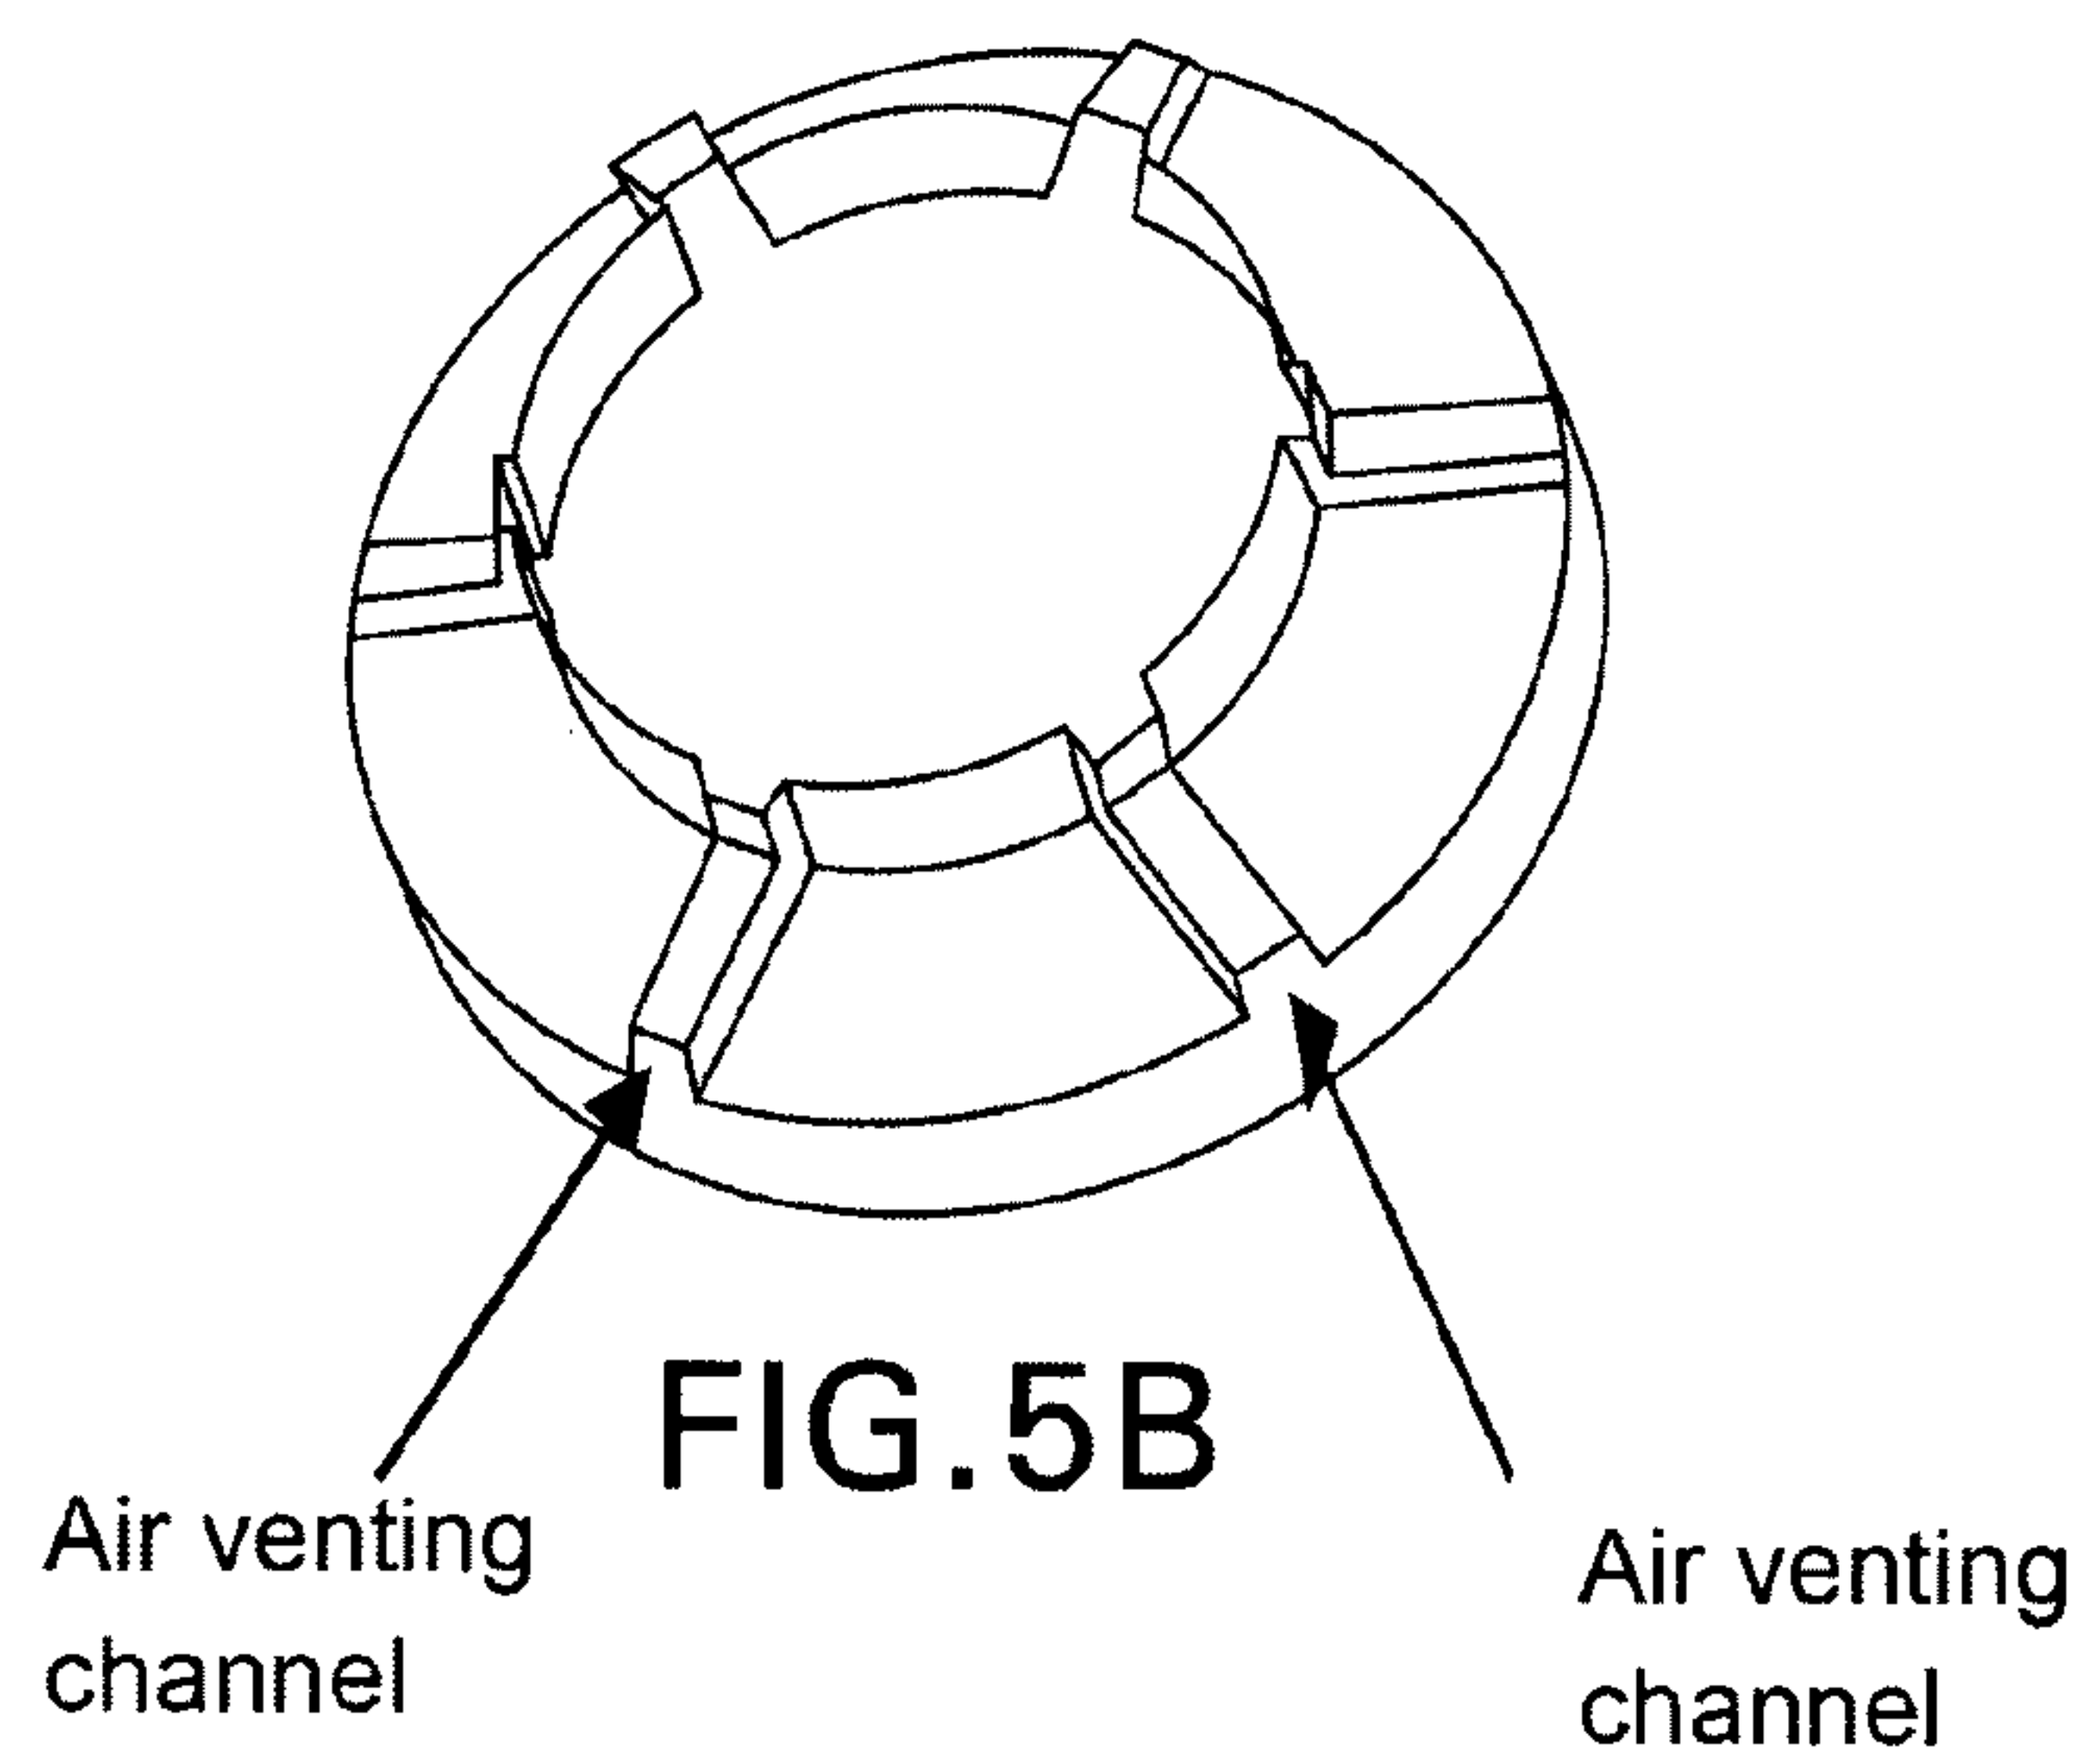
[0013] FIG. 5B is a close up schematic picture of the tile depicted in FIG. 5A.
