(54) Titre : AVERTISSEMENTS DETECTABLES  
(54) Title: DETECTABLE WARNINGS

A detectable warning tile which aims to solve the problem of buckling and cracking associated with different thermal expansion properties of the tile and the substrate in which it is installed. Said tile is provided with underside flanges on only some of the outermost vertical surface of the tile. The tile need not be a quadrilateral, the tile may have more or fewer than fours edges.

## DETECTABLE WARNINGS

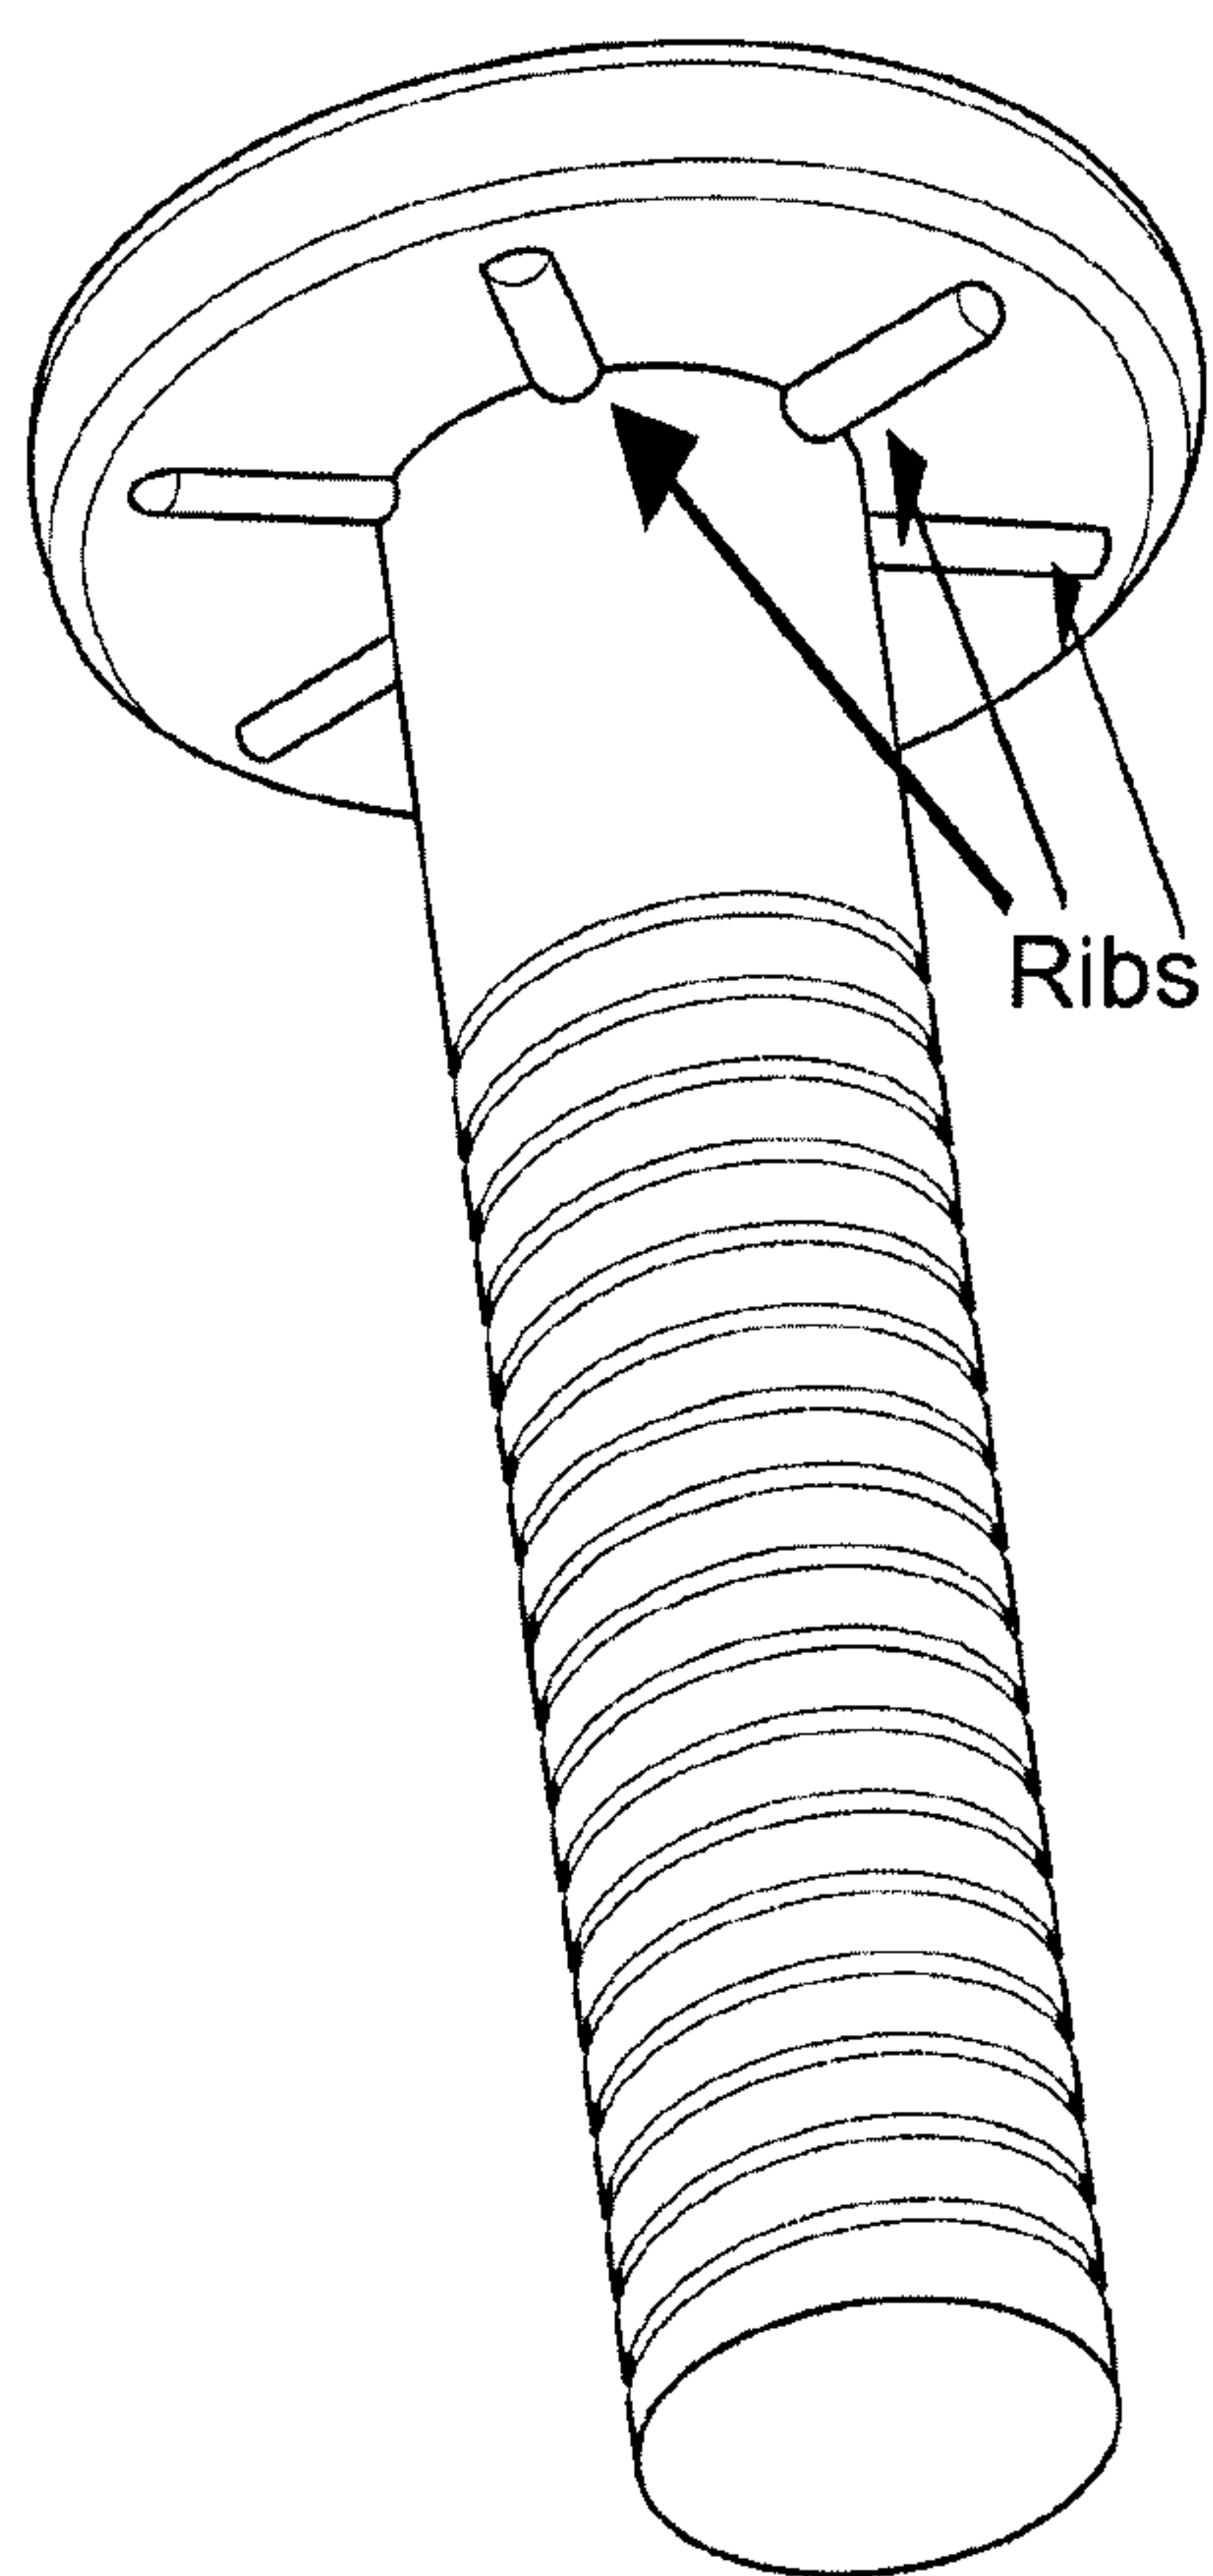
[0014] FIG. 5C is a schematic of a screw with ribs on the underside of the screw head.

[0039] FIG. 5C shows a screw with protruding ribs on the underside of the screw head. This screw similarly serves to allow venting around the screw from below to above the tile. When the screw is tightened down against the tile, the ribs contact the horizontal surface of the countersink, leaving the rest of the screw head removed from the tile. As long as the screw does not completely fill the through hole and the head does not completely fill the countersink, the ribbed screw will thus leave openings for air to flow from below the tile to above the tile.

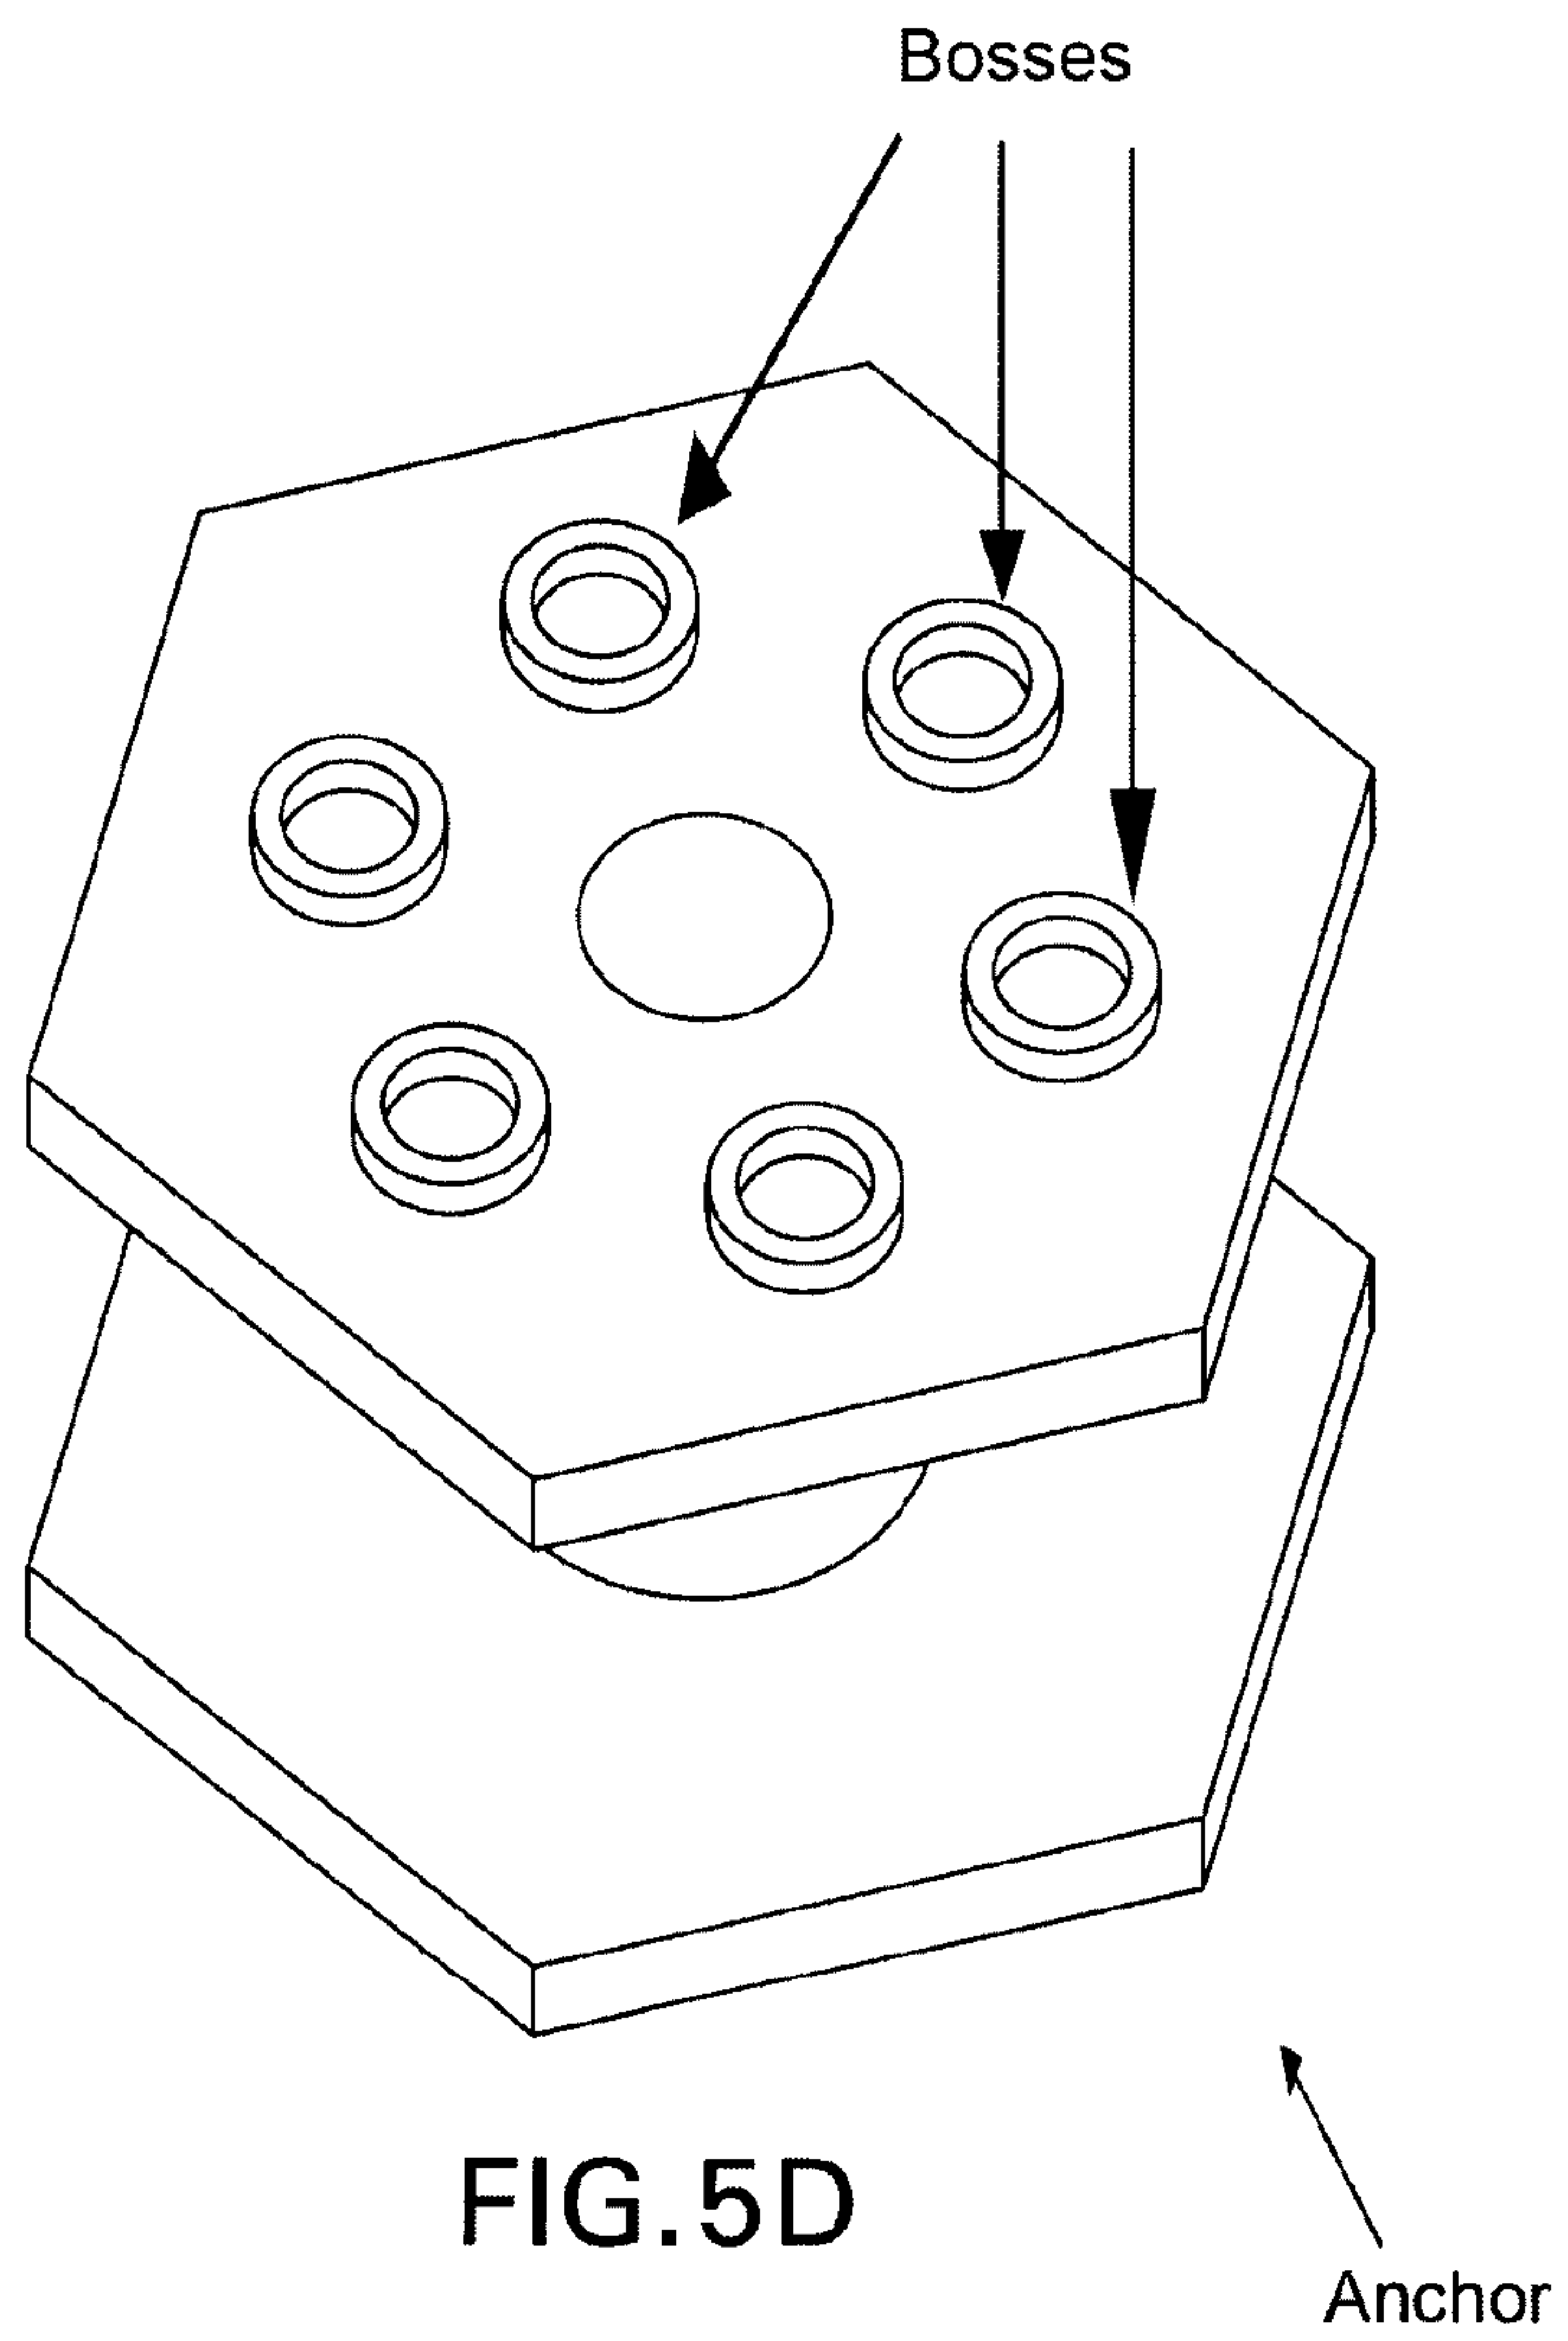
[0015] FIG. 5D is a schematic of an anchor that allows venting.

[0041] The fasteners attach to anchors that seat tightly against the underside of the tile. In order for air to flow around the fastener, the anchor cannot be allowed to completely block the hole. FIG. 5D shows an anchor with six circular bosses that allow the anchor to stand off from the underside of the tile even when firmly attached to the tile. An anchor like the one in FIG. 5D can be used with any combination of fasteners and holes that allows for venting.
