(54) **Title:** ROBOTIC MAGNETIC FLUX LEAKAGE INSPECTION SYSTEM FOR EXTERNAL POST-TENSIONED TENDONS OF SEGMENTAL BRIDGES AND ROADWAYS

**ROBOTIC MAGNETIC FLUX LEAKAGE INSPECTION SYSTEM FOR  
EXTERNAL POST-TENSIONED TENDONS OF SEGMENTAL BRIDGES  
AND ROADWAYS**

**[0001]** The present invention relates to the field of bridge inspection devices, and, more particularly, to a robotic magnetic flux leakage inspection system for external post-tensioned tendons of segmental bridges and roadways.

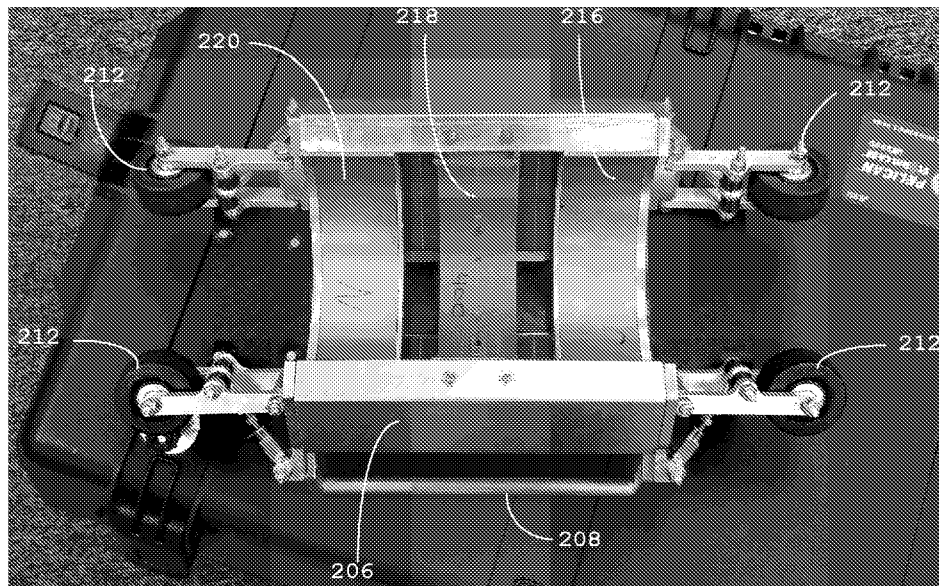
- [0013]** FIG. 7 is an elevational side view of an open side of the sensing device;
- [0014]** FIG. 8 is a top perspective view of the sensing device; and
- [0015]** FIG. 9 is an exemplary graph generated by the sensing device.

**[0026]** In particular, the sensing device 200 comprises an annulus sector shape of 240 degrees and having a 120 degree opening as shown in FIGs. 7 and 8. In other aspects of the sensing device 200, the annulus sector shape can vary to be anywhere between about 180 degrees to about 300 degrees.

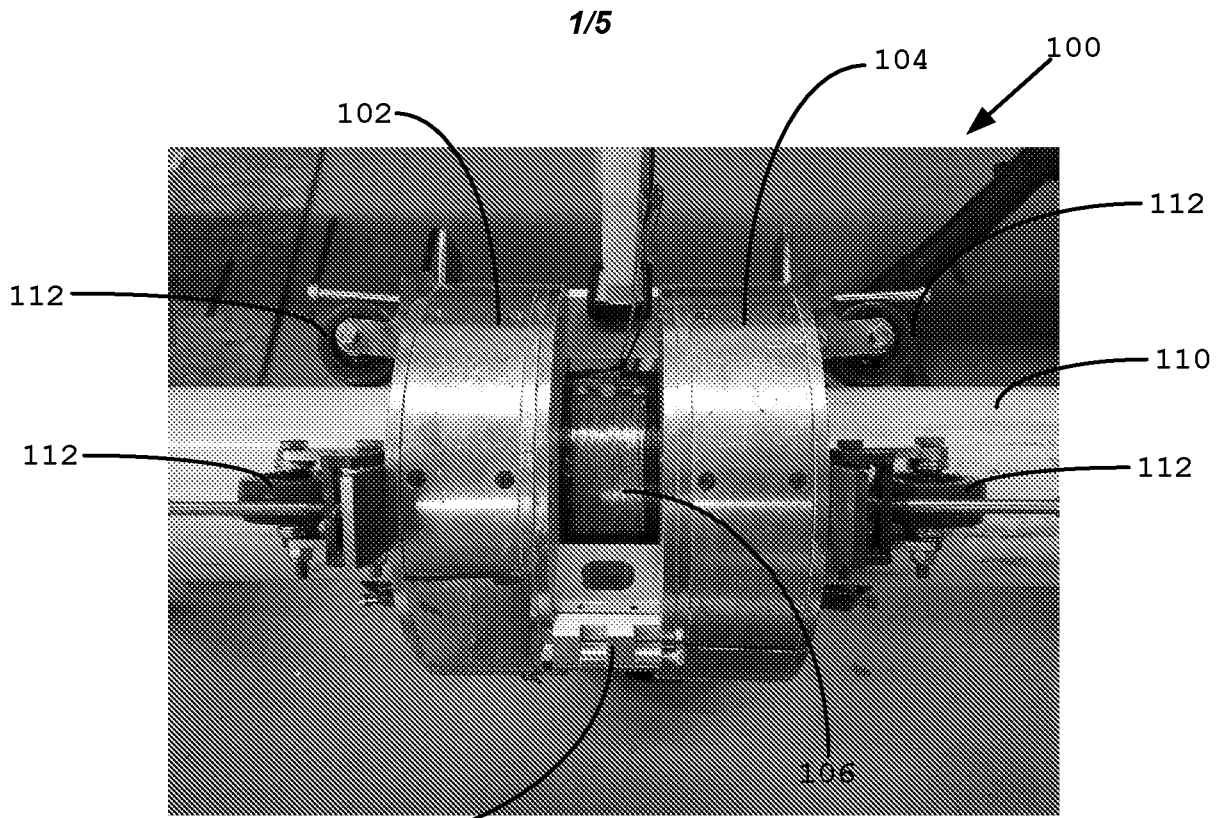
**[0007]** FIG. 1 is a elevational side view of a first embodiment of a sensing device of the present invention secured around a tendon;

**[0019]** Referring now to FIGs. 1-4, the robotic system includes a sensing device 100, which may be a wireless and battery operated mobile transport. In a particular embodiment, the sensing device 100 is coupled completely around (360 degrees) a bridge tendon 110 and travels along the bridge tendon 110 performing an inspection of the condition of the steel cables within the bridge tendon 110.

**[0020]** A first embodiment of the sensing device 100 is shown in FIG. 1 secured around the bridge tendon 112 and performing an inspection. The sensing device 100 may be self-propelled, and operate on battery power with wireless connectivity to a control station. Alternatively, the sensing device 100 can be rolled along the bridge tendon 110 by the inspector. The inspections are real-time with minimum back office processing.

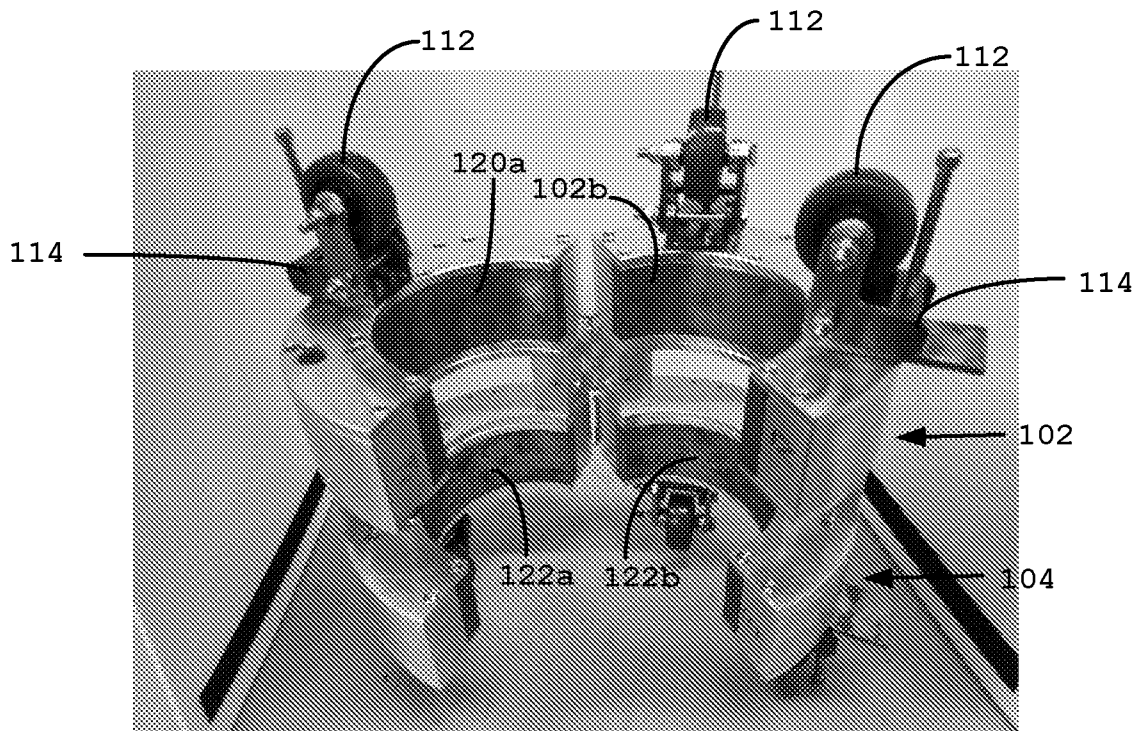
**[0008]** FIG. 2 is a top perspective view of the sensing device in an open position;

**[0023]** As shown in FIGs. 2 and 4, the first magnet 102 comprises two halves 120a, 120b, that are hingedly coupled to each other by clasp 108. Similarly, the second magnet 104 comprises two halves 122a, 122b that are hingedly coupled to each other by clasp 108. Accordingly, the first and second magnets 102, 104 can be swung apart so that the sensing device can be secured completely around the bridge tendon 110.

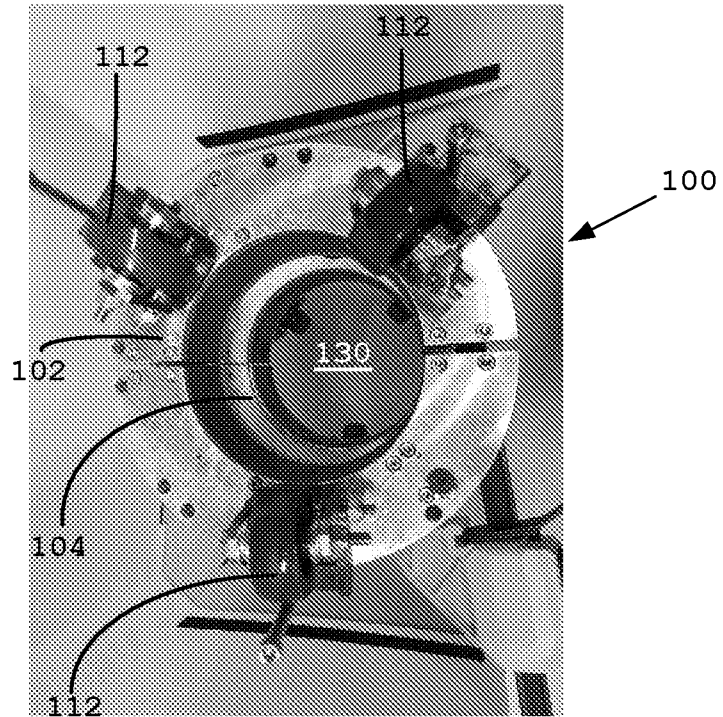
**[0009]** FIG. 3 is a top perspective view of the sensing device in a closed position;

**[0024]** Once the sensing device 100 is secured to the bridge tendon 110 creating a center aperture 130 as shown in FIG. 3, the wheels 112 can be adjusted using respective wheel clamps 114 so that the first and second magnets 102, 104 can be rolled along the bridge tendon 110 passing adjacent within a few inches of the exterior surface of the bridge tendon 110.

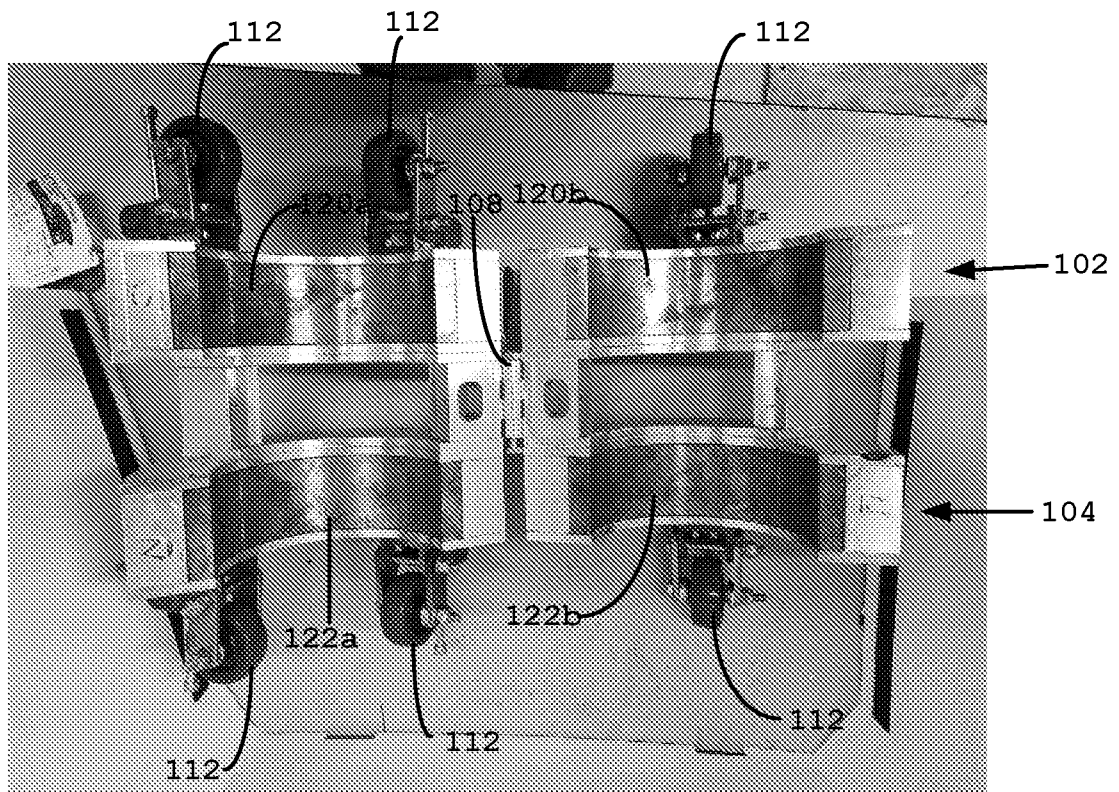
**[0010]** FIG. 4 is an elevational side view of the sensing device in an open position;

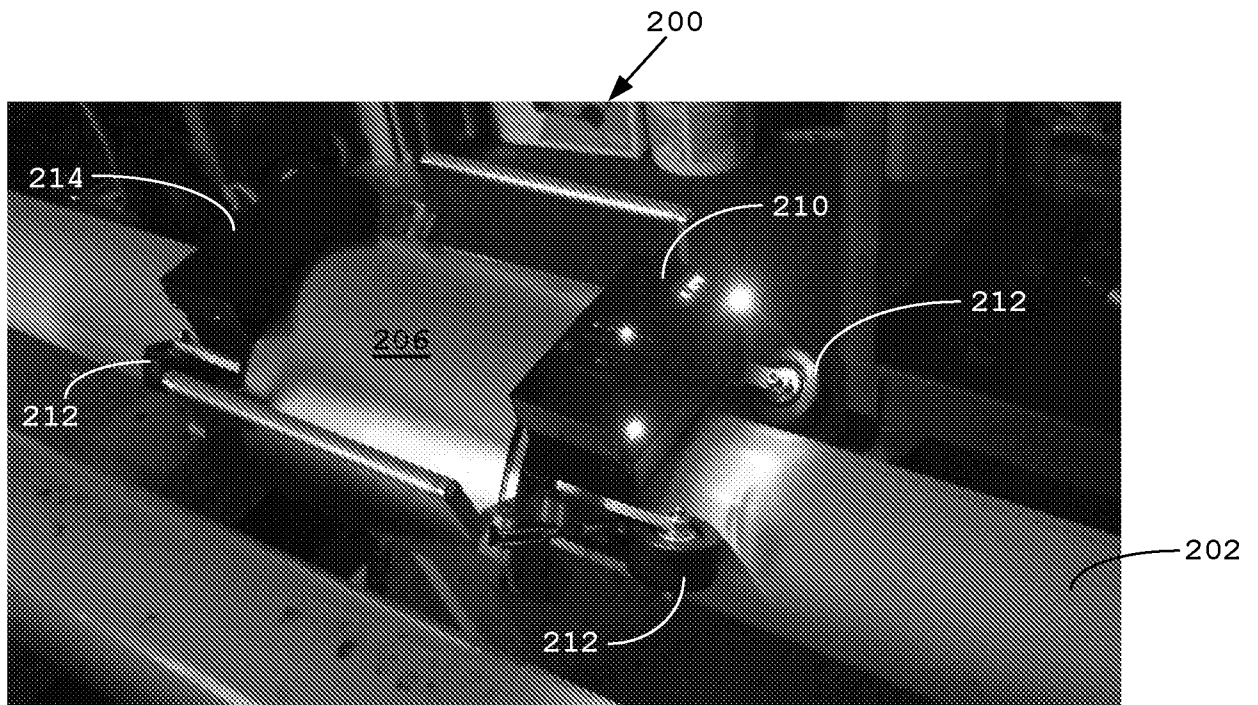
**[0011]** FIG. 5 is a perspective view of a second embodiment of the sensing device secured around a tendon;

**[0025]** The second embodiment of the sensing device 200 is shown in FIGs. 5-8. In contrast to the first embodiment described above, the sensing device 200 is configured to surround about 240 degrees around the bridge tendon 202 (with 360 degrees being completely around). As shown in FIG. 6, the sensing device 200 includes a housing 206 and grab rails 208 that can be used by the inspector to roll the sensing device 200 along the bridge tendon 202 using the wheels 212. A sensor display 210 having a processor and coupled to a sensor 218 is proximate a first end of the sensing device 200 and a battery pack 214 is proximate to a second end of the sensing device 200. In addition, the sensing device 200 may include a location device 215 to determine the location of the sensing device 200 on the bridge tendon 202.

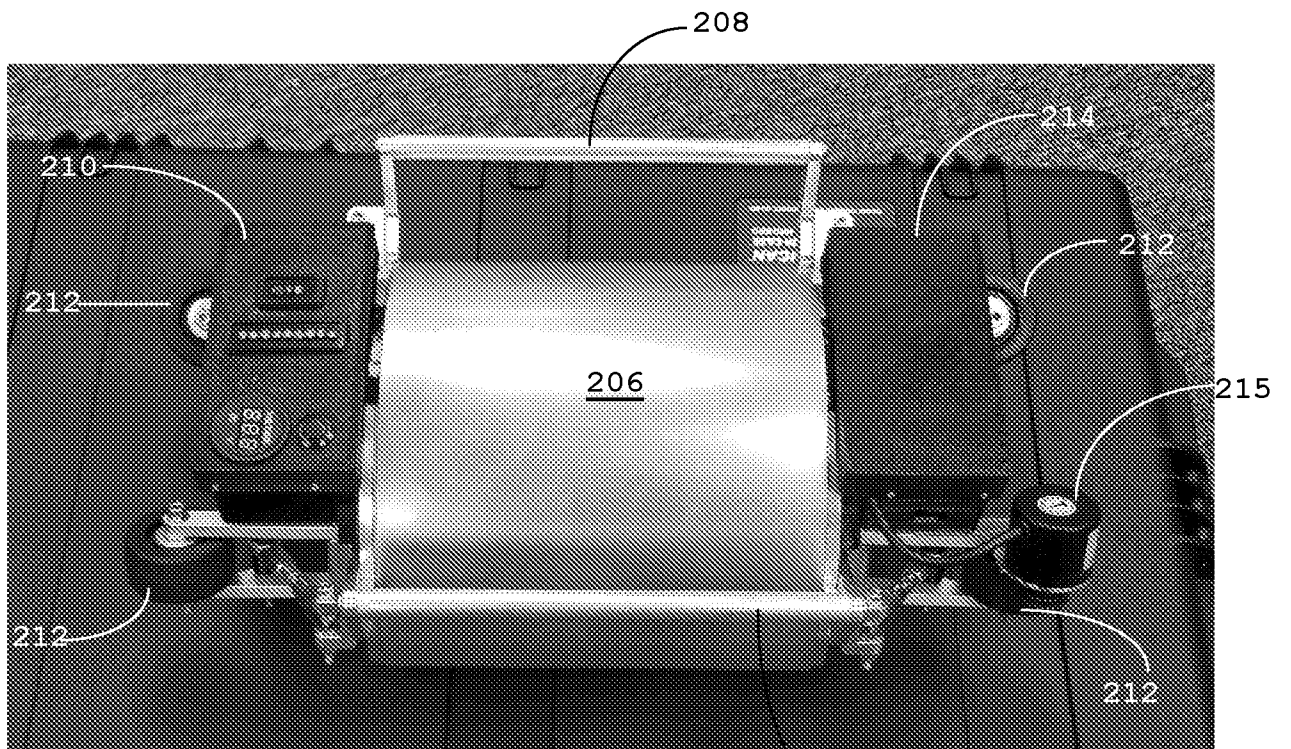
**[0012]** FIG. 6 is an elevational side view of a closed side of the sensing device;
