**United States Patent** [19]  
**Madjerec**

[11] **Patent Number:** **5,549,925**  
[45] **Date of Patent:** **Aug. 27, 1996**

[54] **HYBRID MICROCIRCUIT  
GLASS-TO-METAL SEAL REPAIR PROCESS**

[73] Assignee: **Hughes Missile Systems Company**,  
Los Angeles, Calif.

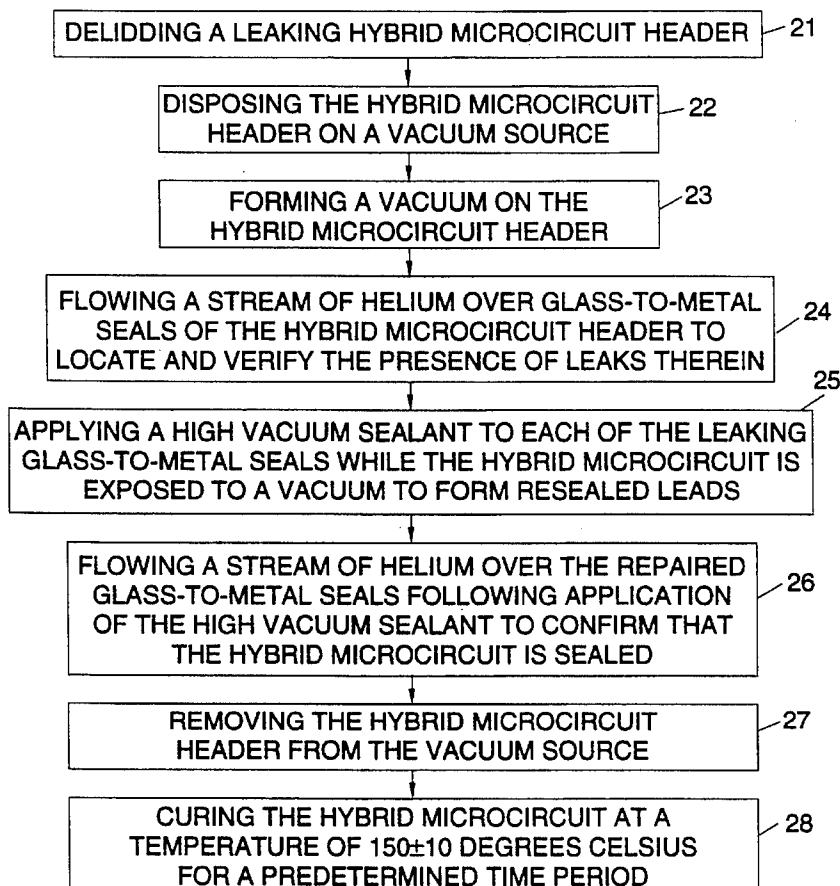
Fig. 1

FIGS. 1 and 2 illustrate a hybrid microcircuit header repair process in accordance with the principles of the present invention;

Referring to the drawing figure, FIGS. 1 and 2 illustrate top and side views of a hybrid microcircuit header 10 having leaking glass-to-metal seals 13 that are to be repaired using a repair or sealing process 20 or procedure 20 in accordance with the principles of the present invention. The hybrid microcircuit header 10 contains leaking glass-to-metal seals 13 that are repaired by the process 20.

As is shown in FIG. 1, the hybrid microcircuit header 10 contains electrical leads 12 that extend from the surface thereof and which permit electrical connections to be made to the hybrid microcircuit header 10. Each of the leads 12 is surrounded and sealed at the surface of the hybrid microcircuit header 10 by means of a glass-to-metal seal 13 that is comprised of glass material, which is deposited and fired during the fabrication process. For the purposes of clarity, FIG. 1a illustrates an enlarged view of one glass-to-metal seal 13 of the hybrid microcircuit header 10.

The present sealing process 20 is designed to repair leaking glass-to-metal seals 13 that are uncovered during leak testing of the complete hybrid microcircuit package of which the hybrid microcircuit header 10 of FIG. 1 forms a

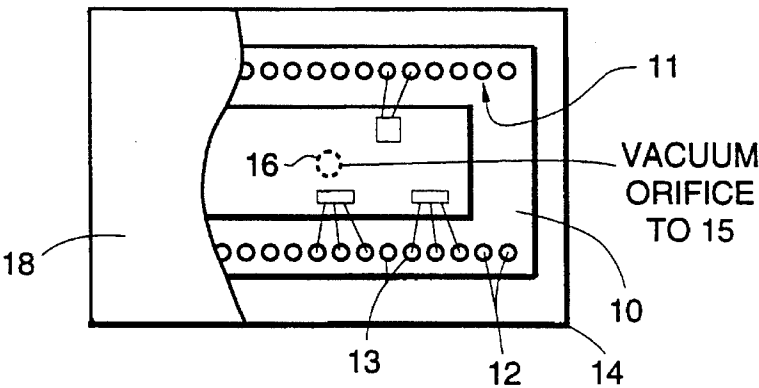
Fig. 1a

FIG. 1a illustrates an enlarged view of a glass-to-metal seal of the hybrid microcircuit header of FIGS. 1 and 2;

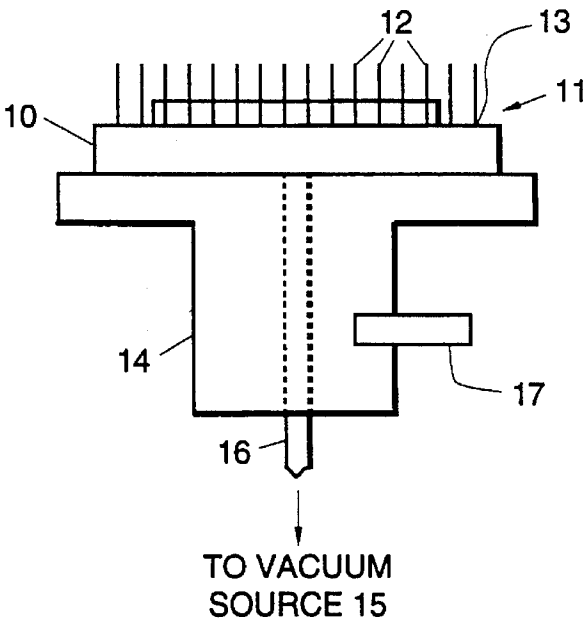
Fig. 2

part. As is shown in FIG. 2, in order to implement the present repair process 20, the hybrid microcircuit header 10, with its lid 18 removed, is attached to a platen 14 of a vacuum source 15, such as is provided by a Helium leak detector 17, for example. The platen 14 has one or more orifices 16 that permit a vacuum to be applied to the delidded hybrid microcircuit header 10.

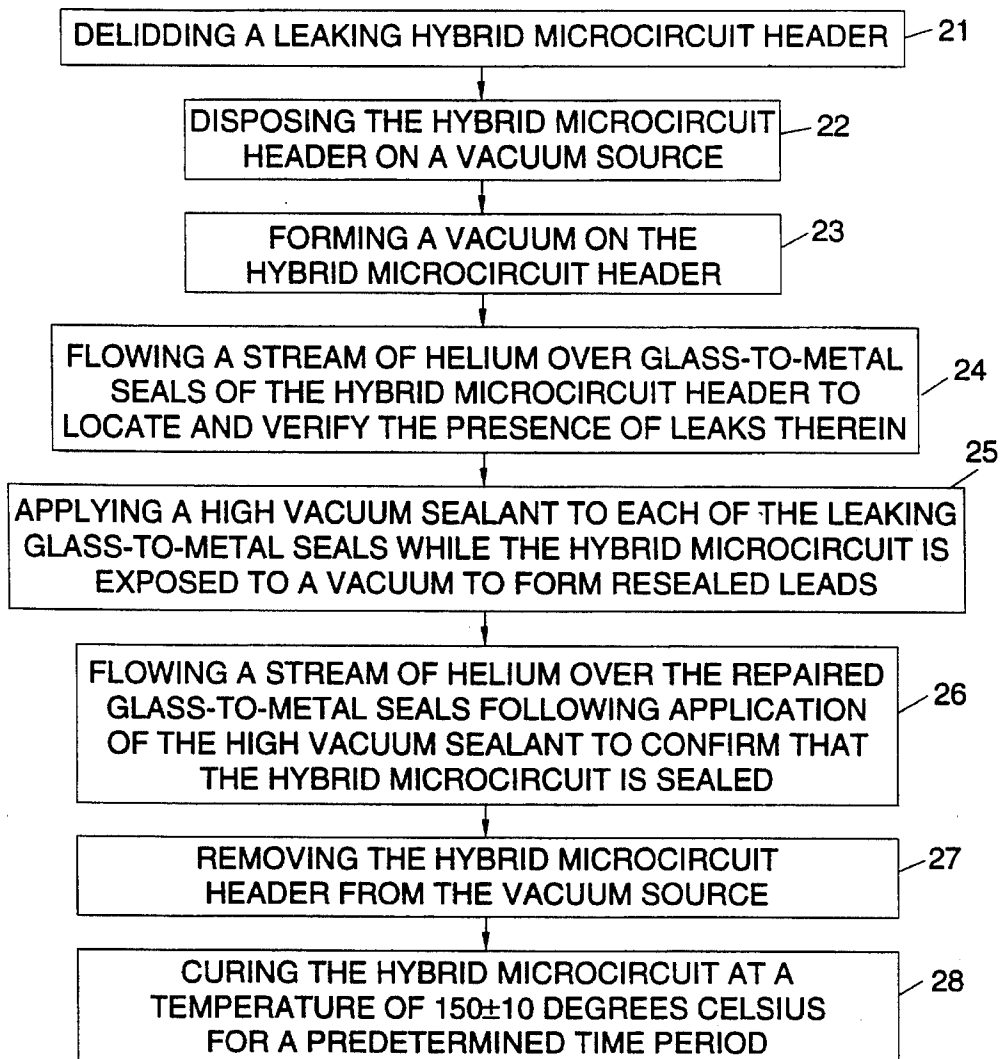
Fig. 3

FIG. 3 is a detailed flow diagram illustrating the hybrid microcircuit header repair process in accordance with the principles of the present invention; and

FIG. 3 is a flow diagram illustrating the repair process 20 in accordance with the principles of the present invention for repairing leaking glass-to-metal seal 13 of a hybrid microcircuit header 10. With reference to FIG. 3, the glass-to-metal seal 13 repair process 20 for repairing leaking hybrid microcircuit headers 10 comprises the following steps.

The failed hybrid microcircuit header 10 is first delidded 21 (its lid 18 or cover is removed) before performing the repair procedure. After delidding 21, the hybrid microcircuit header 10 is disposed 22, typically with its leads 12 pointing vertically, on a vacuum source 15. Then a vacuum is formed 23 on the hybrid microcircuit header 10 using the vacuum source 15, in the manner shown in FIG. 2. An open face helium leak detection system may be used as the vacuum source 15. A fine stream of helium is flowed 24 over the seals 13 to verify leaks in the seals 13 of the hybrid microcircuit header 10.

A small amount of high vacuum sealant 11 is then applied 25 to each leaking seal 13 while the hybrid microcircuit header 10 is exposed to the vacuum. The high vacuum sealant 11 may be applied 25 to each of the glass-to-metal seals 13 using a hypodermic syringe, for example. Following application of the high vacuum sealant 11, a stream of helium is flowed 26 over the leads 12 to confirm that the hybrid microcircuit header 10 is sealed.

The hybrid microcircuit header 10 is removed 27 from the vacuum source 15 and cured 28 in an oven at a temperature of  $150 \pm 10$  degrees C. (302 degrees Fahrenheit) for 2 hours minimum. Following curing 28, the hybrid microcircuit header 10 is retested 29 for leaks using the Helium and vacuum source 15. Once the resealed hybrid microcircuit header 10 has passed the open face leak tests, the hybrid microcircuit header 10 is processed and tested through the remaining assembly processes beginning with the seam seal process (reattachment of the lid 18 or cover).

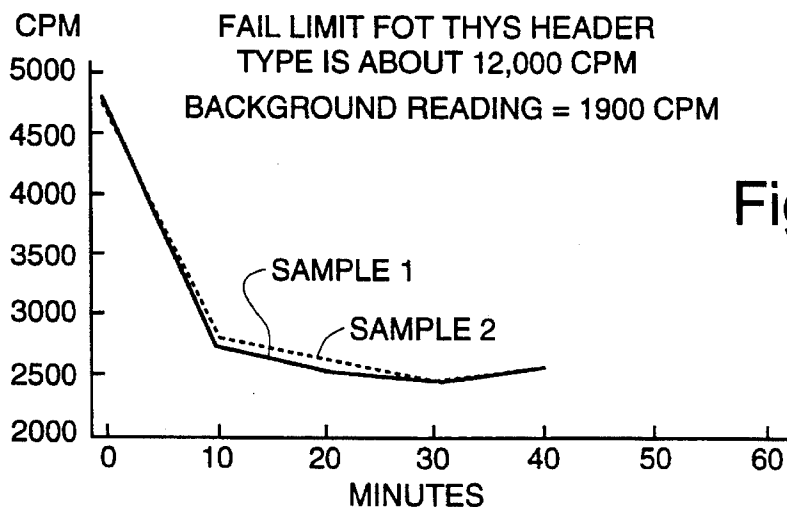
Fig. 4

FIG. 4 illustrates a radioactive decay test plot for hybrid microcircuit headers repaired using the present repair process.

Leak detection using Krypton gas was performed on one of the hybrid microcircuit headers 10 to determine the absorption rate of the radioactive gas into the sealant 11. Results of the test indicate that the counts per minute are well below desired limits, as is indicated in the radioactive decay test plot of FIG. 4.
