(10) **Patent No.:** **US 8,384,837 B2**
(45) **Date of Patent:** **Feb. 26, 2013**

(54) **ARRAY SUBSTRATE OF LIQUID CRYSTAL DISPLAY DEVICE AND REPAIR METHOD THEREOF**

(73) Assignee: **Century Display(ShenZhen)Co., Ltd.**, Loghua, Baoan, Shen-zhen, Guangdong (CN)

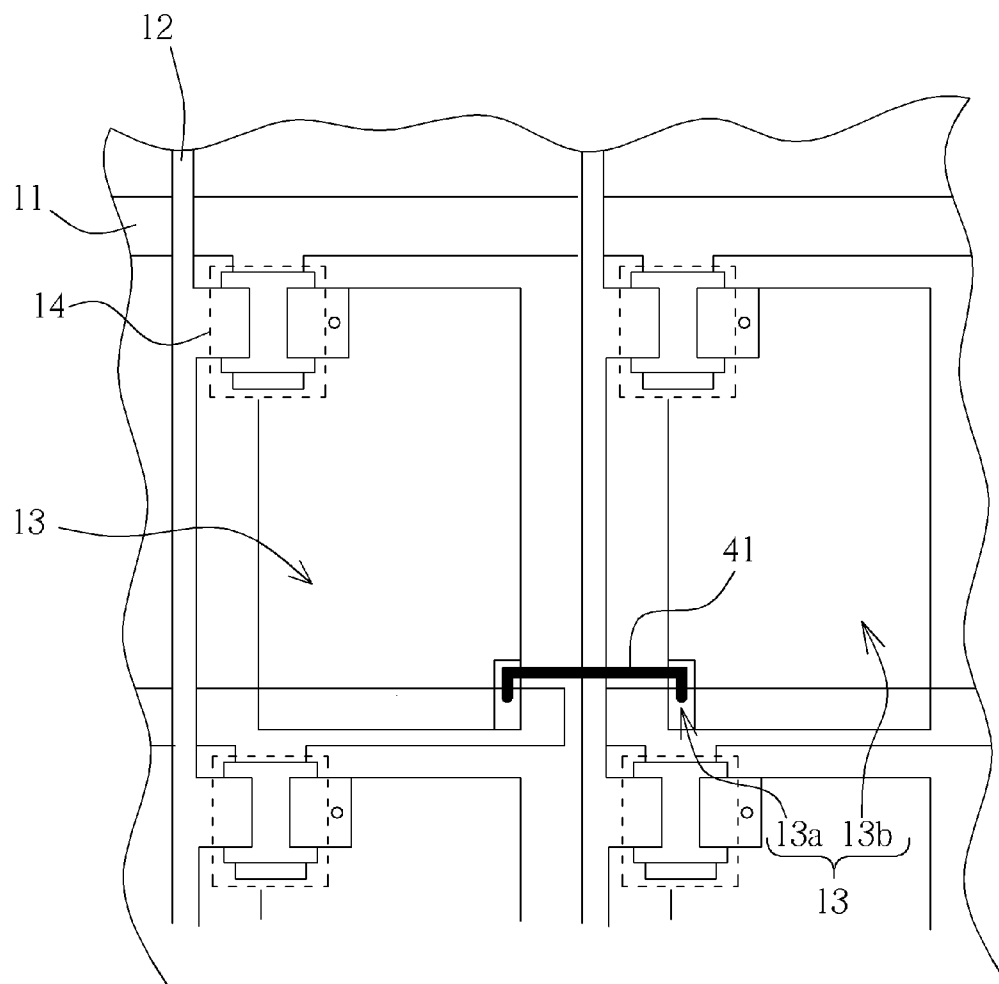
FIG. 3B PRIOR ART

FIG. 3B is a schematic diagram illustrating a repair of a scan line in accordance with another conventional laser repair method.

FIG. 3B is a schematic diagram illustrating a repair of a scan line in accordance with another conventional laser repair method. As illustrated in FIG. 3B, a scan line 11 and a data line 12 are perpendicularly intersected to define a pixel region. A pixel electrode 13, which is made of ITO, is disposed in the pixel region, and the pixel electrode 13 is electrically connected to the scan line 11 and the data line 12 respectively via a thin film transistor 14. When a line defect occurs at the scan line 11 below the data line 12, the repair method includes: first, dividing the pixel electrodes 13 adjacent to the line defect into a display portion 13b and a repair portion 13a, which are electrically insulated with each other; and then depositing a metal film 41 on the repair portions 13a between the two adjacent pixel electrodes 13 so that two ends of the broken scan line 11 are electrically connected via the metal film 41. Although such method can repair the line defects, the procedures of the repair are more complicated.

Also, when depositing the metal film 41, the deposition could be very time consuming and the results of the deposition cannot be guaranteed. Furthermore, the pixel electrode may be contaminated during the deposition process, which adversely affects the display quality.

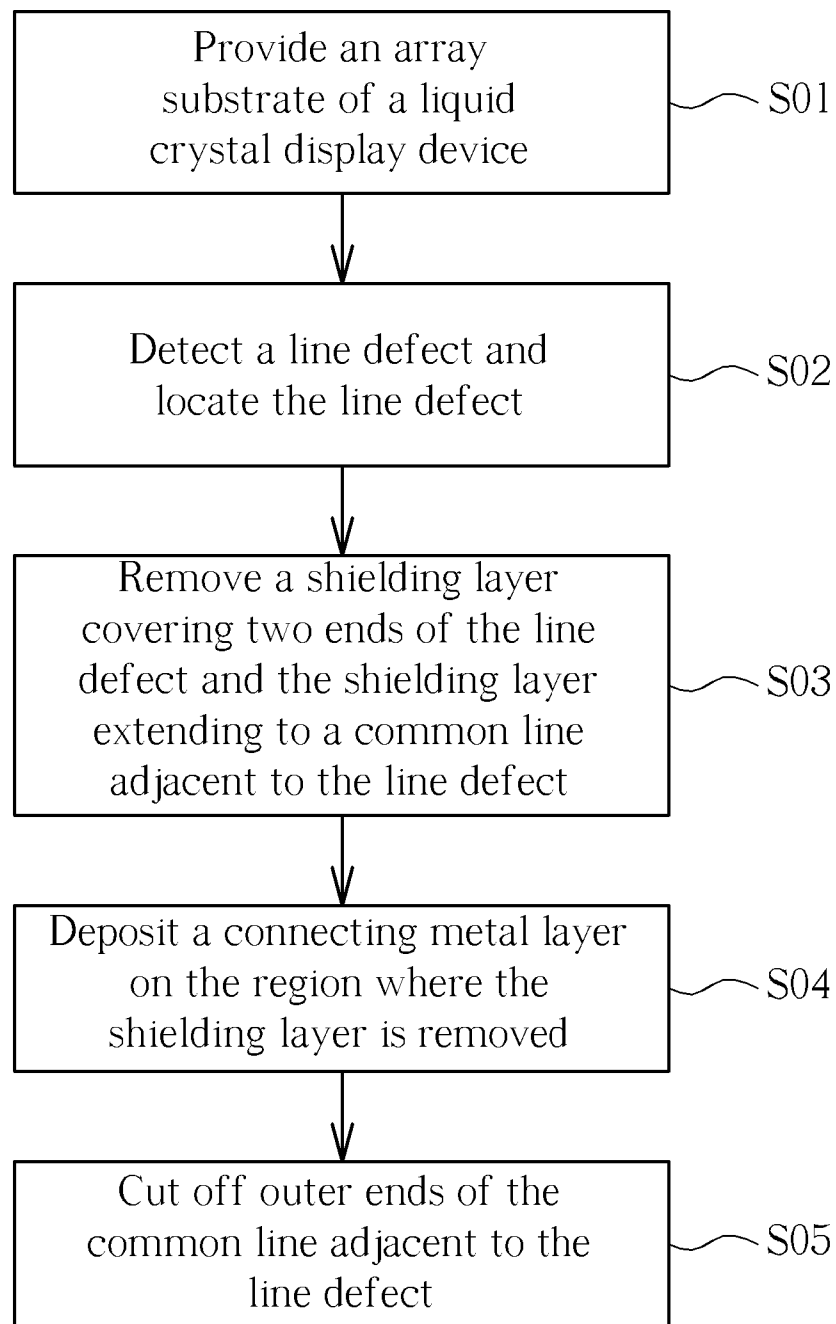
FIG. 4 is a schematic line defect repair process flow diagram in accordance with the present invention.

FIG. 4 is a schematic line defect repair process flow diagram in accordance with the present invention. As illustrated in FIG. 4, the repair process includes the following steps. First, provide an array substrate of a liquid crystal display device (S01); then, detect a line defect and locate the line defect (S02). The detections may be executed by AOI machine or other methods/machines, e.g. a TESTER machine could detect, for detecting any line defect of the signal transmitting wires. The signal transmitting wires described above include a data line and a scan line. Then, locate the positions of the line defects at the data line or the scan line and remove a shielding layer covering two ends of the line defect and the shielding layer extending to a common line adjacent to the line defect (S03). The shielding layer located on the two ends of the signal transmitting wire adjacent to the line defect, and the shielding layer extending horizontally from the two ends to the space (line section) of the common line is removed by a laser light beam.

When the shielding layer described above includes only a shielding layer for metal (i.e. the third process without the deposition of the transparent electrode layer of the five processes in fabricating a TFT-LCD, and the line defect is detected and repaired), the shielding layer for metal is disposed above a first metal layer. The first metal layer includes scan lines and common lines. Meanwhile, the shielding layer described above may be removed using an IR (far-infrared

Then a connecting metal layer is deposited on the regions where the shielding layer is removed (S04). A laser chemical vapor deposition (L-CVD) repairing apparatus is used using a tungsten-carbon compound as its target material to deposit the connecting metal layer on the regions where the data line and the common line are exposed in order to repair the line defect of the data line. Or, the connecting metal layer may also be formed on regions where the scan line and the common line are exposed in order to repair the line defect of the scan line. Typically, the thickness of the connecting metal layer is between 2000 Å and 4000 Å, wherein the exposed regions of the scan line or the data line and the common line are the regions where the shielding layer is removed. When the shielding layer includes only the shielding layer for metal, the connecting metal layer would be slightly larger than the exposed regions of the data line and the common line, so that the electrical connection can be further improved. When the shielding layer includes the insulation layer and the transparent electrode layer, two different methods can be employed. In method 1, the connecting metal layer is slightly smaller than the regions where the data line and common line are exposed, so that the transparent electrode layer is not electrically connected to the connecting metal layer. In method 2, in order to improve the electrical connection of the connecting metal layer, the connecting metal layer is slightly larger than the regions where the data line and the common line are exposed. The process of disconnecting the electrical connection between the connecting metal layer and the transparent electrode layer will be performed after all of the repair processes have completed. Method 2 will be discussed in more details in the following passages.

Then the repair process includes performing a cutting process to disconnect outer ends of the common line adjacent to the line defect to form a common line section (S05). The laser light beam is used to cut off the electrical connection of the common line adjacent to the outer ends of the connecting metal layer, so that the common line is by passed without being affected by the signal of the data line or the signal of the scan line. Also, the signal transmission of the data line or the scan line is completed via the common line section between the connecting metal layers. When the shielding layer mentioned above includes the insulation layer and the transparent electrode layer, method 2 is employed to form a thin channel in the pixel electrode around the common line after the common line disposed in the external ends of the shielding layer is cut off, so that the pixel electrode is not electrically connected to the common line between the connecting metal layers. Typically a width of the thin channel is between 2 micrometers (um) and 6 um.

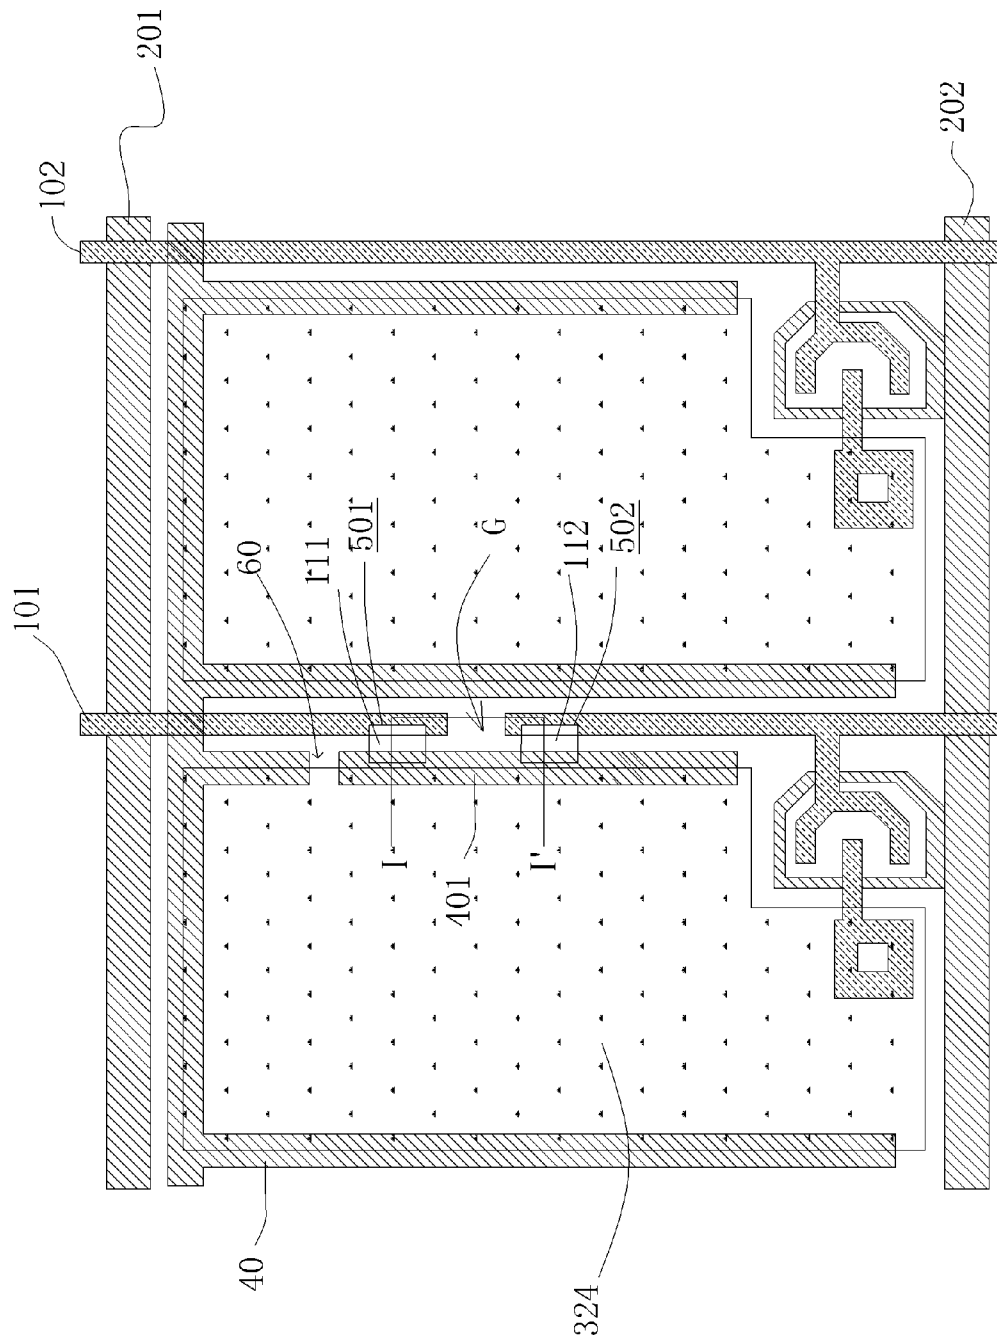
FIG. 5 is a schematic diagram illustrating a line defect in a "C" shaped common line in accordance with the present invention.

Referring to FIG. 5, FIG. 5 is a schematic diagram illustrating a line defect in a "C" shaped common line in accordance with the present invention. A first data line 101 is

disposed perpendicular to a first scan line **201**, the first data line **101** is disposed parallel to a second data line **102**, the first scan line **201** is disposed parallel to a second scan line **202**, the second scan line **202** is disposed perpendicular to the first data line **101**, the second scan line **202** is disposed perpendicular to the second data line **102**, and the second data line **102** is disposed perpendicular to the first scan line **201**. The intersected data lines and the scan lines define a plurality of pixel units, wherein a common line **40** serving as a bottom electrode of a storage capacitor is disposed on top of the data lines and the scan lines, and the common line **40** forms the storage capacitor with the pixel electrode **324** in the pixel unit. The shape of the common line **40** in the pixel unit affects the magnitude of the storage capacitor directly. In the present embodiment, the common line **40** serving as the bottom electrode of the storage capacitor has a "C" shape, wherein a "C" shaped common line section **401** is the line section of the common line **40** after the cutting process and is not electrically connected to the original common line **40**, i.e. the common line section **401** above the connecting metal layer **111** is cut off. The previously described cut off region is the opening **60**, and the "C" shaped common line section **401** is partially coupled with the pixel electrode **324** and partially contacts the connecting metal layers **111** and **112**. In addition, the connecting metal layers **111** and **112** are also partially connected to the first data line **101** having the line defect G. The connecting metal layers **111** and **112** are disposed adjacent to the two ends of the line defect G, but do not overlap the line defect G. Therefore, the repaired circuit described above allows the first data line **101** having the line defect G to complete the transmission via the common line section **401**.

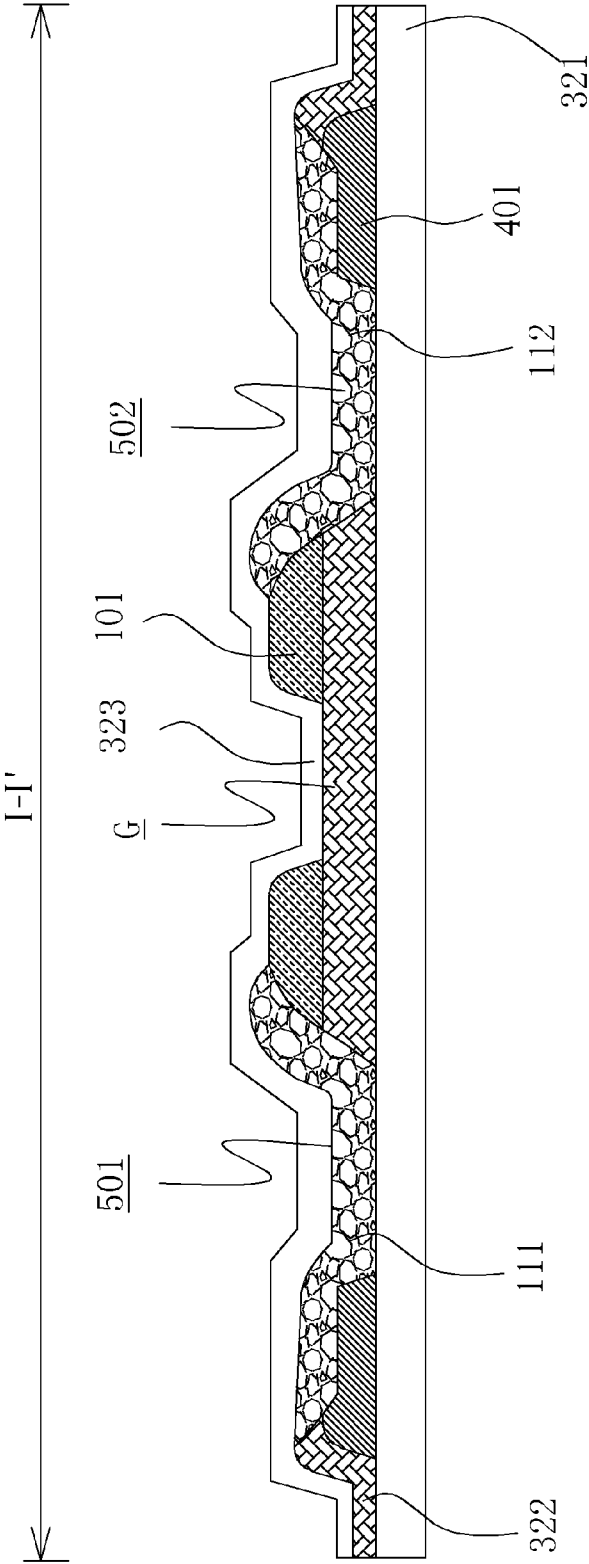
FIG. 6A and FIG. 6B are a schematic cross-sectional diagrams illustrating the line section across line I-I' of FIG. 5.

FIG. 6A is a schematic cross-sectional diagram illustrating the line section across line I-I' of FIG. 5. Referring to FIG. 5 and FIG. 6A, when the shielding layer includes only the shielding layer for metal (i.e. the third process without the deposition of the transparent electrode layer of the five processes in fabricating a TFT-LCD, and the line defect is detected and repaired), the common line section **401**, the shielding layer for metal **322** and the connecting metal layers **111** and **112** are disposed on a glass substrate **321**. A portion of the shielding layer for metal **322** previously described is disposed on a portion of the common line section **401**, and the first data line section **401** is disposed on the other portion of the shielding layer for metal **322**. During the third process without the deposition of a passivation layer **323** of the five processes in fabricating a TFT-LCD, the detection detects the line defects and proceeds to the repairing immediately. The IR with a wavelength between 1000 nm and 1500 nm or the green light with a wavelength between 450 nm and 600 nm removes the shielding layer for metal **322**, and the regions of removal are positions of connection holes **501** and **502** as illustrated in the figure (the regions of removal also includes the shielding layer described above located adjacent to the two ends of the line defect, and the space (line sections) extending horizontally from these two ends to the common line section). Also, the positions of the connection holes **501** and **502** are covered by the connecting metal layers **111** and **112**. Therefore, the laser chemical vapor deposition (L-CVD) repairing apparatus is used using a tungsten-carbon compound as its target material to deposit the connecting metal layer **111** and **112** on the regions where the first data line **101** and the common line section **401** are exposed, i.e. to deposit the connecting metal layers **111** and **112** on the connection holes **501** and **502** in order to repair the line defect G of the first data line **101**. Typically, the connecting metal layers **111** and **112** are slightly larger than the exposed regions of the first data line **101** and the common line section **401**, i.e. the con-

nection holes **501** and **502**, so that the connecting metal layers **111** and **112** cover a portion of the first data line **101** and a portion of the common line section **401**. Then the laser light beam is used to disconnect the common line section **401** located above the connecting metal layer **111**, so that the common line **40** is not affected by the signal of the first data line **101** having the line defect G, and the signal of the first data line **101** may also complete the transmission via the common line section **401** between the connecting metal layers **111** and **112** in order to complete the signal transmission. Then the following manufacturing process of the array substrate is continued to form the passivation layer **323** and the transparent electrode layer (not illustrated in the figure).

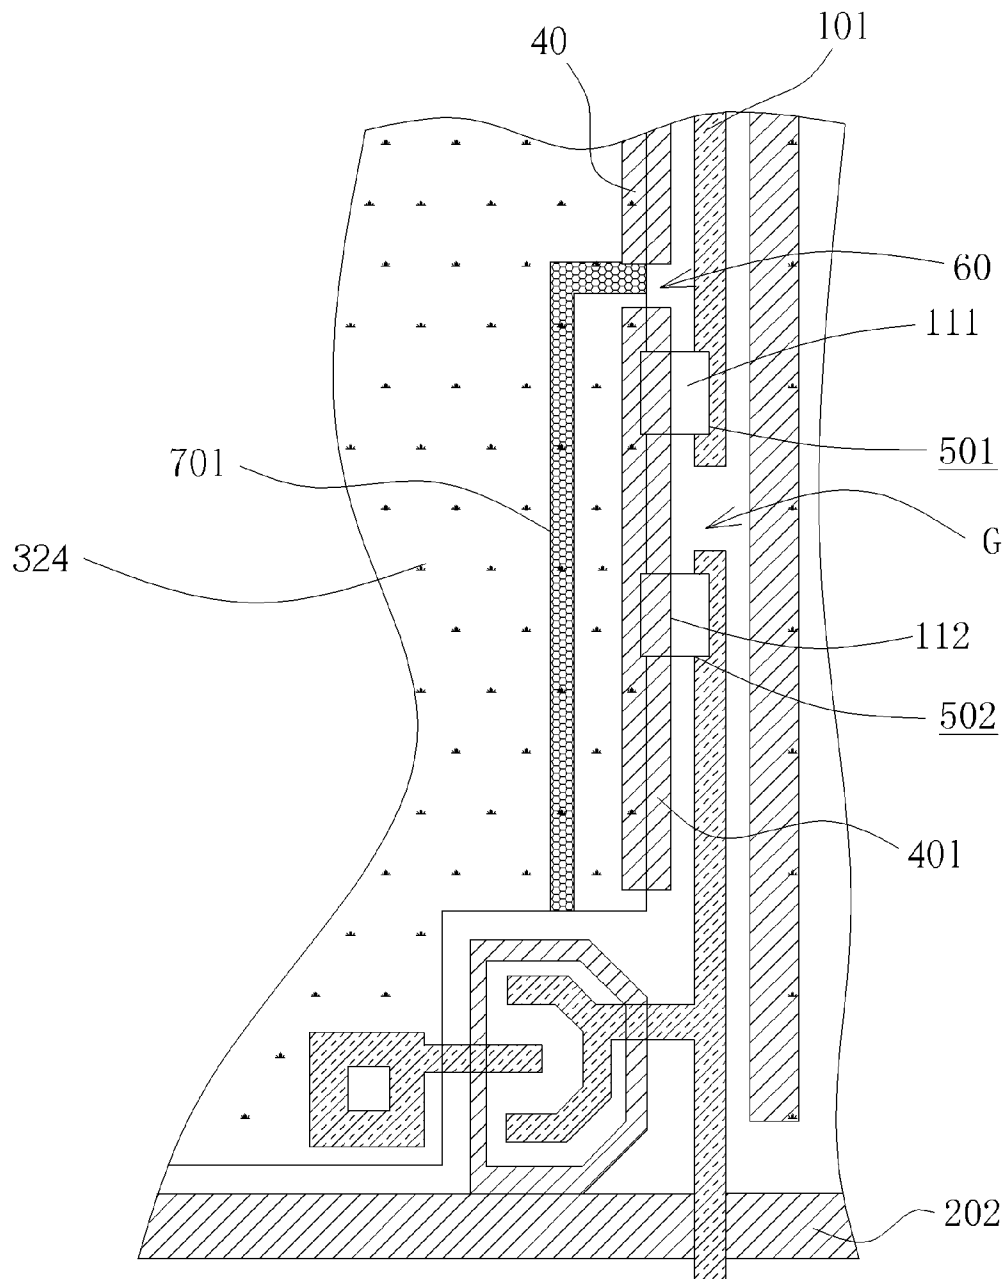
FIG. 8 is another sectional zoomed-in diagram of FIG. 5.

FIG. 8 is another sectional zoomed-in diagram of FIG. 5. Referring to FIG. 5 and FIG. 8, when the shielding layer includes the shielding layer for metal, the passivation layer and the pixel electrode, method 2 is employed. First the shielding layer for metal, the passivation layer and the pixel electrode are removed as mentioned above, to form the connection holes 501 and 502; then the laser chemical vapor deposition (L-CVD) repairing apparatus is used using a tungsten-carbon compound as its target material to deposit the connecting metal layer 111 and 112 on the regions where the first data line 101 and the common line section 401 are exposed, i.e. the connection holes 501 and 502, to repair the line defect G of the first data line 101. Typically, the connecting metal layers 111 and 112 are slightly larger than the exposed regions of the first data line 101 and the common line section 401, i.e. the connection holes 501 and 502, so that the connecting metal layers 111 and 112 cover a portion of the first data line 101 and a portion of the common line section 401. Then the laser light beam is used to disconnect the common line section 401 located above the connecting metal layer 111, to form the opening 60. Finally, a thin channel 701 is formed in the pixel electrode 324 around the common line section 401 by the laser light beam, so that the common line section 401 between the connecting metal layers 111 and 112 is not electrically connected to the pixel electrode 324. Meanwhile, the signal of the first data line 101 passes through the common line section 401 between the connecting metal layers 111 and 112 to complete the signal transmission.

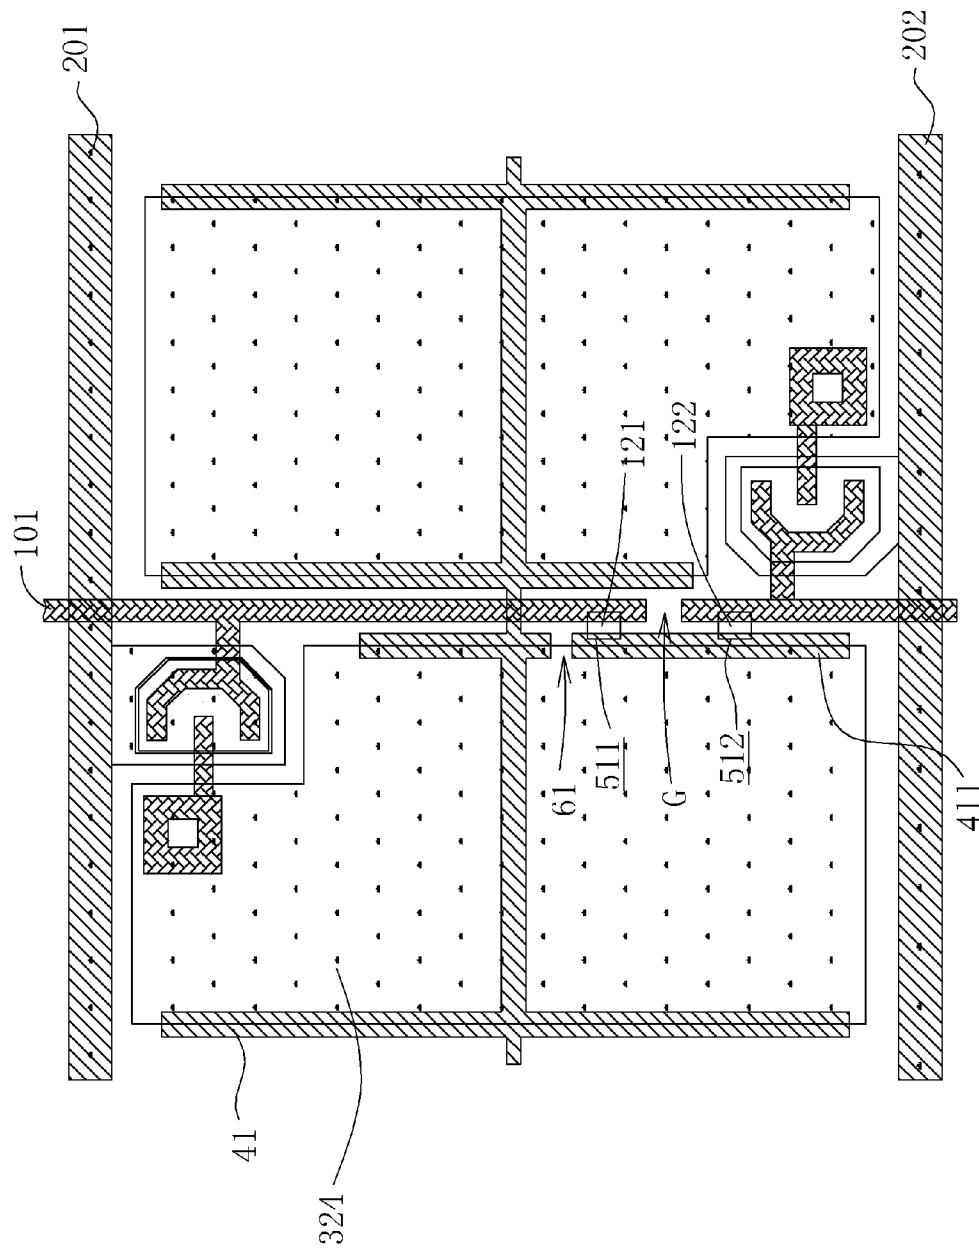
FIG. 9 is a schematic diagram illustrating a line defect in an "H" shaped common line in accordance with the present invention.

FIG. 9 is a schematic diagram illustrating a line defect in an "H" shaped common line in accordance with the present invention. In the present embodiment, the common line serving as the bottom electrode of the storage capacitor, has an "H" shape. A first data line 101 and a first scan line 201 are disposed perpendicularly, the first scan line 201 is disposed parallel to a second scan line 202, and the second scan line 202 is disposed perpendicular to the first data line 101. The intersected data lines and the scan lines define a plurality of pixel units, wherein a common line 41 serving as a bottom electrode of the storage capacitor is disposed on top of the data lines and the scan lines, and the common line 41 forms the storage capacitor with the pixel electrode 324 in the pixel unit. The shape of the common line 41 on the pixel unit affects the magnitude of the storage capacitor directly. In the present embodiment, the common line 41 serving as the bottom electrode of the storage capacitor has an "H" shape, wherein an "H" shaped common line section 411 is the line section of the common line 41 after the cutting process and is not electrically connected to the original common line 41, i.e. the common line section 411 above the connecting metal layer 121 is cut off. The previously described cut off region is an opening 61, and the "H" shaped common line section 411 is partially coupled with the pixel electrode 324 and partially contacts connecting metal layers 121 and 122. In addition, the connecting metal layers 121 and 122 are also partially connected with the first data line 101 having the line defect G. The connecting metal layers 121 and 122 are disposed adjacent to the two ends of the line defect G, but do not overlap with the line defect G. Therefore, the repaired circuit described above allows the first data line 101 having the line defect G to complete the transmission via the common line section 411.

When the shielding layer includes a shielding layer for metal, or a combination of a shielding layer for metal, a passivation and a pixel electrode, a higher energy laser light beam is used to remove the shielding layer for metal, the passivation layer and the pixel electrode. Then the laser chemical vapor deposition (L-CVD) repairing apparatus is used using a tungsten-carbon compound as its target material to deposit the connecting metal layers 121 and 122 on the regions where the first data line 101 and the common line section 411 are exposed, i.e. the connection holes 511 and 512, to repair the line defect G of the first data line 101. Typically, the thickness of the connecting metal layers 121 and 122 is between 2000 Å and 4000 Å, and here the connecting metal layers 121 and 122 are respectively larger than the exposed regions of the first data line 101 and the common line section 411, i.e. the connection holes 511 and 512. Then the laser light beam is used to cut off the common line section 411 above the connecting metal layer 121 to form the opening 61. Meanwhile, the signal of the first data line 101 passes through the common line section 411 between the connecting metal layers 121 and 122 to complete the signal transmission. The laser light beam mentioned above can be IR (far-infrared light), UV (far-ultraviolet light), Green light (Green), or laser light beam and is used for removing the shielding layer above. Typically, the wavelength of the IR is between 1000 nm and 1500 nm, the wavelength of the green light is between 450 nm and 600 nm, and through adjusting the energy of the light beams, the objective of removing the shielding layer can be achieved.

When the shielding layer includes only the shielding layer for metal, the connecting metal layer is slightly larger than the exposed region of the data line and the common line, so that the electrical connection can be improved. When the shielding layer mentioned above includes the insulation layer and the transparent electrode layer, two different methods can be

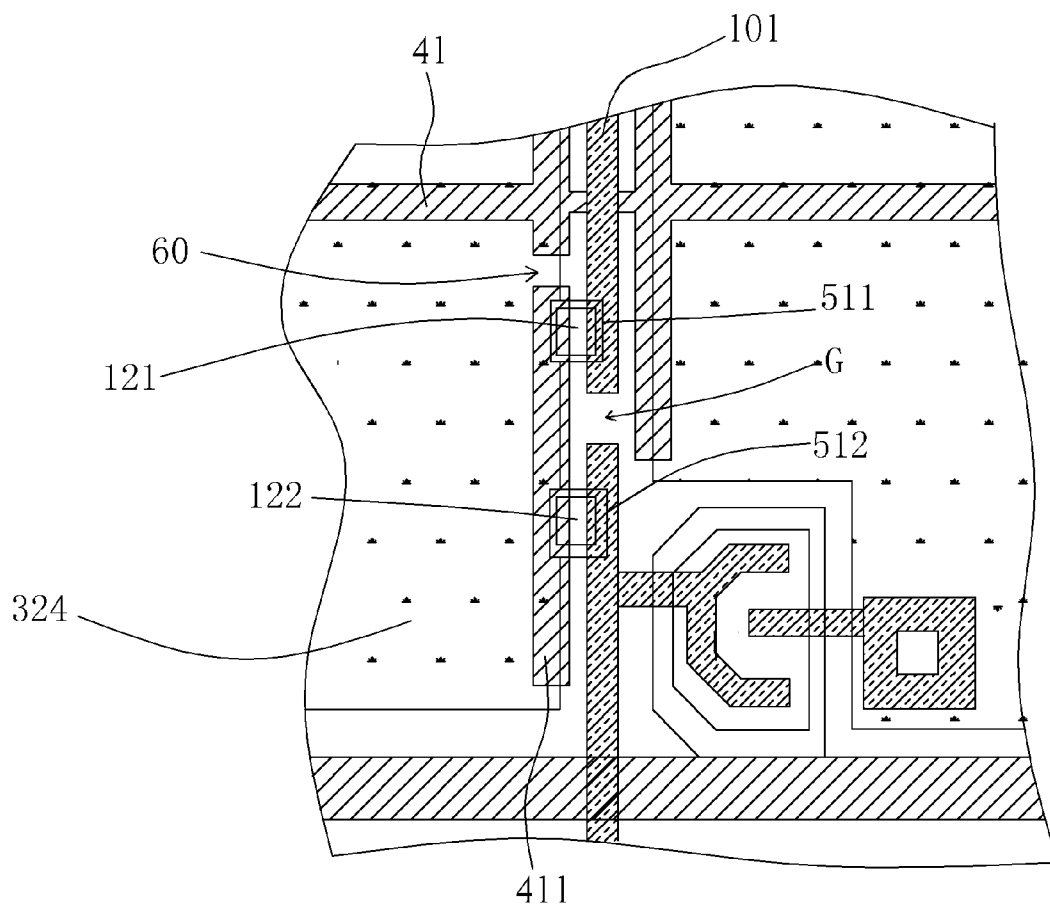
FIG. 10 is a schematic sectional zoomed-in diagram of FIG. 9.

applied. In method 1, the connecting metal layer is slightly smaller than the exposed regions of the data line and common line, so that the transparent electrode layer is not electrically connected to the connecting metal layer, as illustrated in FIG. 10 where FIG. 10 is a schematic sectional zoomed-in diagram of FIG. 9. In the present embodiment, the common line 41 serving as the bottom electrode of the storage capacitor has an "H" shape, wherein an "H" shaped common line section 411 is the line section of the common line 41 after the cutting process and is not electrically connected to the original common line 41, i.e. the common line section 411 above the connecting metal layer 121 is cut off. The previously described cut off region is the opening 61, and the "H" shaped common line section 411 is partially coupled with the pixel electrode 324 and partially contacts the connecting metal layer 121 and 122. The pixel electrode 324 on the overlapping region of the common line section 411 and the connecting metal layers 121 and 122 is removed, and the removed portion is slightly larger than the connecting metal layers 121 and 122, so that the first data line 101 and the pixel electrode 324 are not electrically connected. In addition, the connecting metal layers 121 and 122 also partially overlap the first data line 101 having the line defect G, wherein the connecting metal layers 121 and 122 are disposed adjacent to the two ends of the line defect G, but do not overlap the line defect G. Therefore, the repaired circuit described above allows the first data line 101 having the line defect G to complete the transmission via the common line section 411. However, when the shielding layer includes the insulation layer and the transparent electrode layer, method 1 is employed. When a higher energy laser light beam is used to remove the shielding layer, the laser chemical vapor deposition (L-CVD) repairing apparatus is used using a tungsten-carbon compound as its target material to deposit the connecting metal layers 121 and 122 on the regions where the first data line 101 and the common line section 411 are exposed, i.e. the connection holes 511 and 512, for repairing the line defect G of the first data line 101. Here, the connecting metal layers 121 and 122 are respectively smaller than the exposed regions of the first data line 101 and the common line section 411, i.e. the positions of the connection holes 511 and 512. Then the laser light beam is used to cut off the common line section 411 above the connecting metal layer 121 to form the opening 60. Meanwhile, the signal of the first data line 101 passes through the common line section 411 between the connecting metal layers 121 and 122 to complete the signal transmission.

In method 2, in order to improve the electrical connection of the connecting metal layers, the connecting metal layers are slightly larger than the exposed regions of the data line and the common line. The step that disconnects the electrical connection between the connecting metal layers and the transparent electrode layer will be performed after all of the repair steps are completed. Specifically, a thin channel will be formed in the pixel electrode 324 around the common line after the common line disposed in the external ends of the shielding layer is cut off, so that the pixel electrode is not electrically connected to the common line between the connecting metal layers.

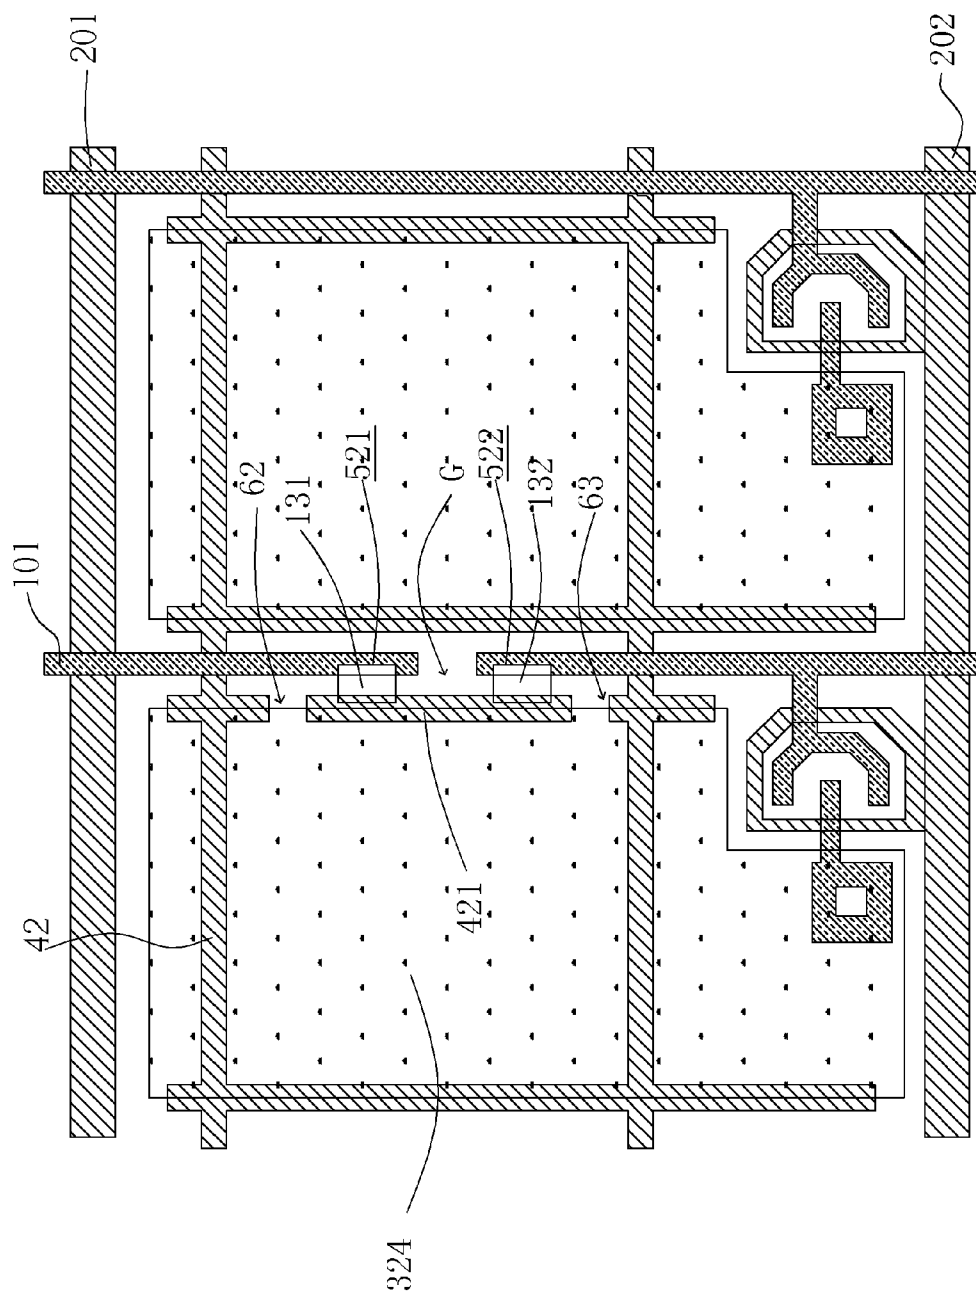
FIG. 11 is a schematic diagram illustrating a line defect in a hollow square shaped common line of the present invention.

FIG. 11 is a schematic diagram illustrating a line defect in a hollow square shaped common line of the present invention. In the present embodiment, the common line 42 serving as the bottom electrode of the storage capacitor has a hollow square

shape. A first data line 101 is disposed perpendicular to a first scan line 201, the first scan line 201 is disposed parallel to a second scan line 202, and the second scan line 202 is disposed perpendicular to the first data line 101. The intersected data lines and the scan lines define a plurality of pixel units, wherein a common line 42 serving as a bottom electrode of the storage capacitor is disposed on top of the data lines and the scan lines, and the common line 42 forms the storage capacitor with the pixel electrode 324 in the pixel unit. The shape of the common line 42 on the pixel unit affects the magnitude of the storage capacitor directly.

In the present embodiment, the common line 42 serving as the bottom electrode of the storage capacitor has a hollow square shape, wherein the common line section 421 is the line section of the common line 42 after the cutting process and is not electrically connected to the original common line 42, i.e. the common line section 421 above the connecting metal layer 131 is cut. The previously described cut off region is the openings 62 and 63, and the common line section 421 is partially coupled with the pixel electrode 324 and partially contacts the connecting metal layers 131 and 132. In addition, the connecting metal layers 131 and 132 are also partially connected to the first data line 101 having the line defect G. The connecting metal layers 131 and 132 are disposed adjacent to the two ends of the line defect G, but do not overlap the line defect G. Therefore, the repaired circuit described above allows the first data line 101 having the line defect G to complete the transmission via the common line section 421.

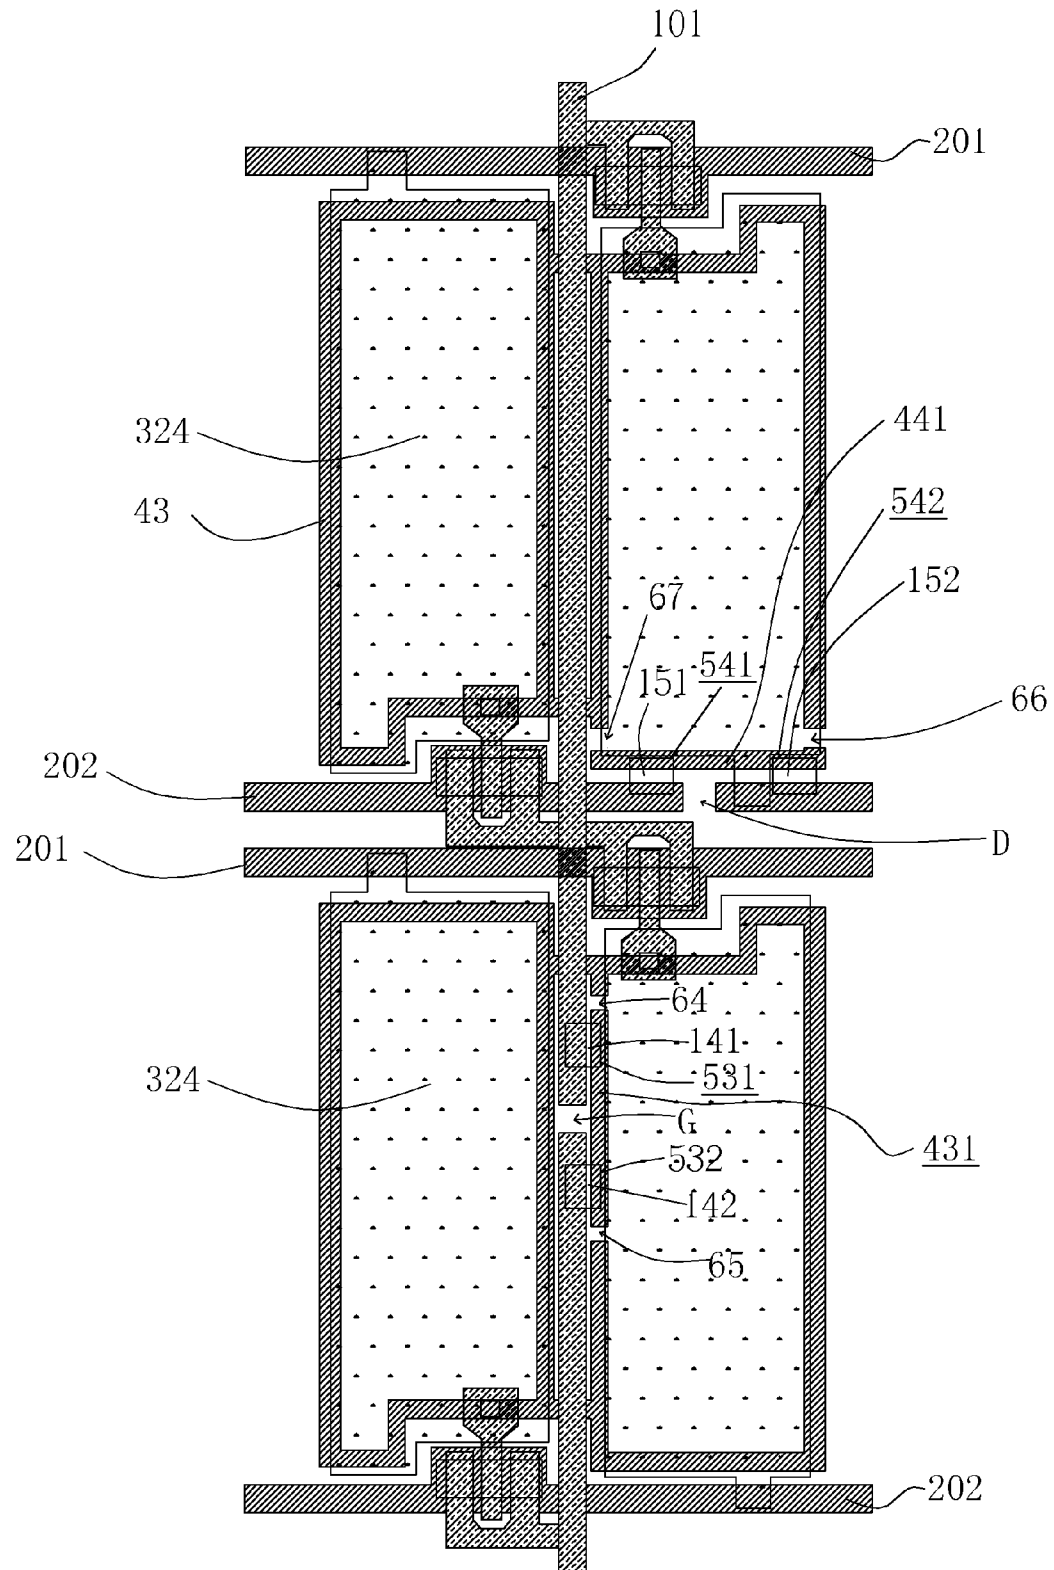
FIG. 12 is a schematic diagram illustrating a line defect in another hollow square shaped common line of the present invention.

FIG. **12** is a schematic diagram illustrating a line defect in another hollow square shaped common line of the present invention. Referring to bottom portion of FIG. **12**, in the present embodiment, the common line serving as the bottom electrode of the storage capacitor has a hollow square shape. A first data line **101** is disposed perpendicular to a first scan line **201**, the first scan line **201** is disposed parallel to a second scan line **202**, and the second scan line **202** is disposed perpendicular to the first data line **101**. The intersected data lines and the scan lines define a plurality of pixel units, wherein a common line **43** serving as a bottom electrode of the storage capacitor is disposed on top of the data lines and the scan lines, and the common line **43** forms the storage capacitor with a pixel electrode **324** in the pixel unit. The shape of the common line **43** on the pixel unit affects the magnitude of the storage capacitor directly. In the present embodiment, the common line **43** serving as the bottom electrode of the storage capacitor has the hollow square shape, wherein the common line section **431** is the line section of the common line **43** after the cutting process and is not electrically connected to the original common line **43**, i.e. the common line section **431** above the connecting metal layers **141** and **142** is cut. The previously described cut off region is the openings **64** and **65**, and the common line section **431** is partially coupled with the pixel electrode **324** and partially contacts the connecting metal layers **141** and **142**. In addition, the connecting metal layers **141** and **142** are also partially connected with the first data line **101** having the line defect G. The connecting metal layers **141** and **142** are disposed adjacent to the two ends of the line defect G, but do not overlap the line defect G. Therefore, the repaired circuit described above allows the first data line **101** having the line defect G to complete the transmission via the common line section **431**.

repaired circuit described above allows the second scan line **202** having the line defect D to complete the transmission via the common line section **441**.

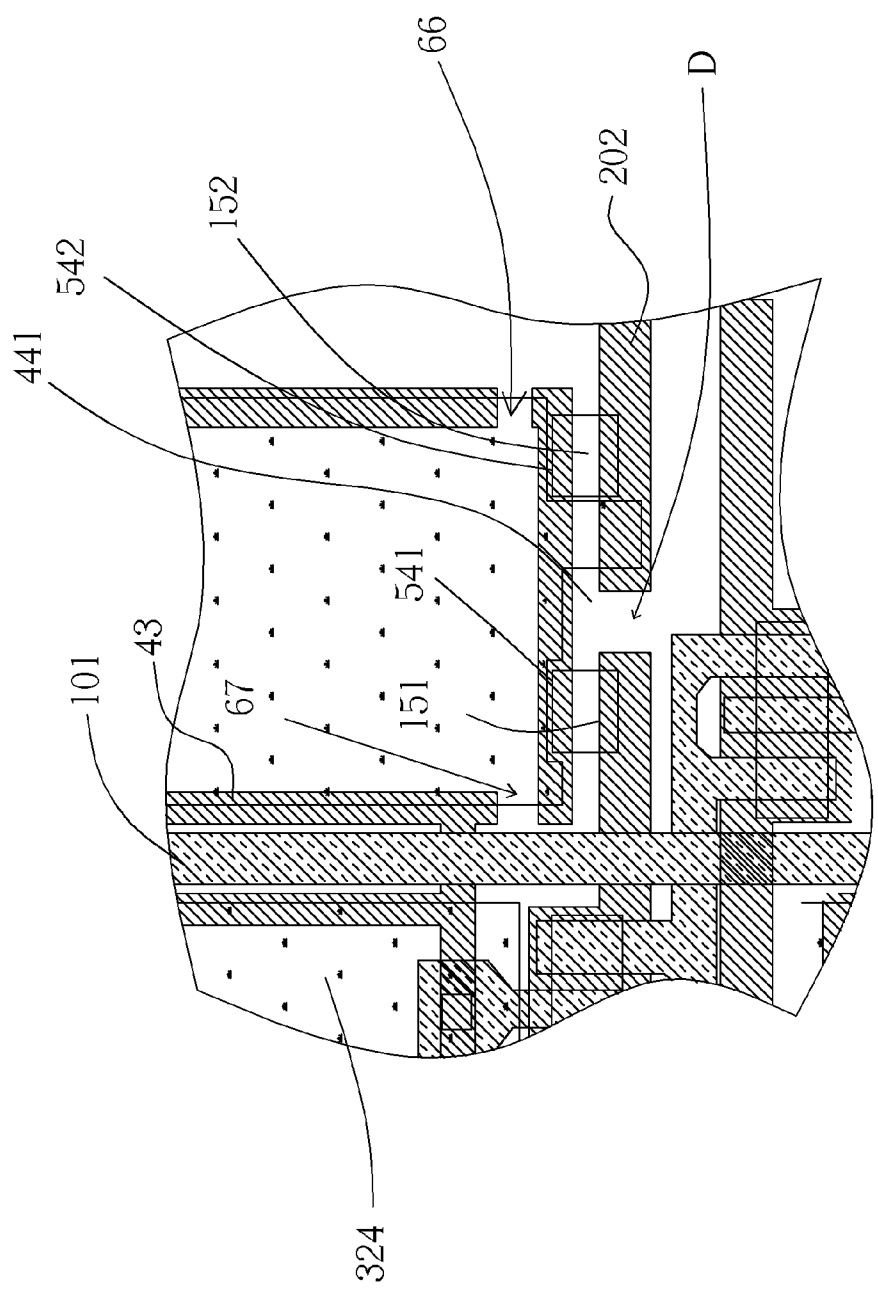
FIG. 13 is a sectional zoomed-in diagram of FIG. 12.
