# United States Patent [19]

[11] Patent Number: **4,576,400**

[54] **RISER REPAIR ASSEMBLY FOR UNDERGROUND IRRIGATION SYSTEMS**

A repair assembly for broken or leaking risers in underground irrigation systems is provided. The repair assembly is adapted to be inserted into a hole through the wall of a buried water distribution line and is held in place by locking tangs engaging the interior surface of the distribution line and by a locking ring flange disposed about the exterior of the assembly and bearing on the exterior wall of the distribution line.

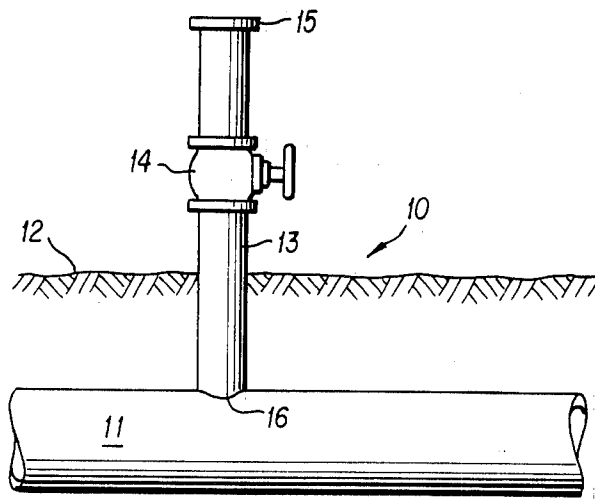
FIG. 1 is a schematic view illustrating a conventional arrangement of a buried irrigation water distribution line and riser;

Referring now to FIG. 1, there is shown at 10 the customary arrangement of an underground irrigation system. A water distribution line 11 is buried below the ground surface 12 at a depth which does not interfere with normal cultivation. Spaced along the distribution line 11 are risers 13 which communicate with the interior of the water mains or laterals. An above-ground valve 14 controls the flow of water through the riser. Riser 13 may terminate in a connection flange or similar means 15 for attachment to a sprinkler system or other conventional water distribution system.

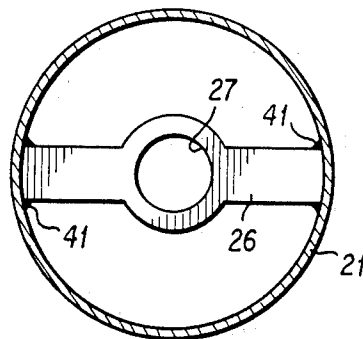
FIG. 4 is a detail view of the cross bar assembly;

Disposed within housing 21 at an upper portion thereof is cross bar 26 shown in a more detailed view in FIG. 4. Cross bar 26 is fixedly attached within housing 21 as by welds 41 securing its ends to the housing interior. A threaded hole 27 is provided in the center of cross bar 26 to accept an upper, matingly threaded, portion of wedge activating rod 28. The lower end of rod 28 rotatably engages wedge bar 29 which is fixedly disposed across the open interior of cylindrical wedge member 30. Wedge member 30 by means of welds 42 comprises a relatively thick walled metal cylinder having an inwardly tapered lower end 31. The external diameter of wedge member 30 is sized just slightly smaller than the internal diameter of housing 21 so as to allow free movement of the wedge relative to the hous-

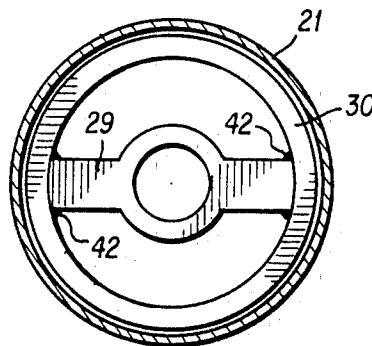
FIG. 5 details the arrangement of the wedge member, wedge bar and housing; and

ing. Rod 28 is fixed to, but free to rotate within, wedge bar 29 by means of thrust washer 32 and retaining means 33. FIG. 5 shows in plan view the arrangement of the wedge member, wedge bar and housing.

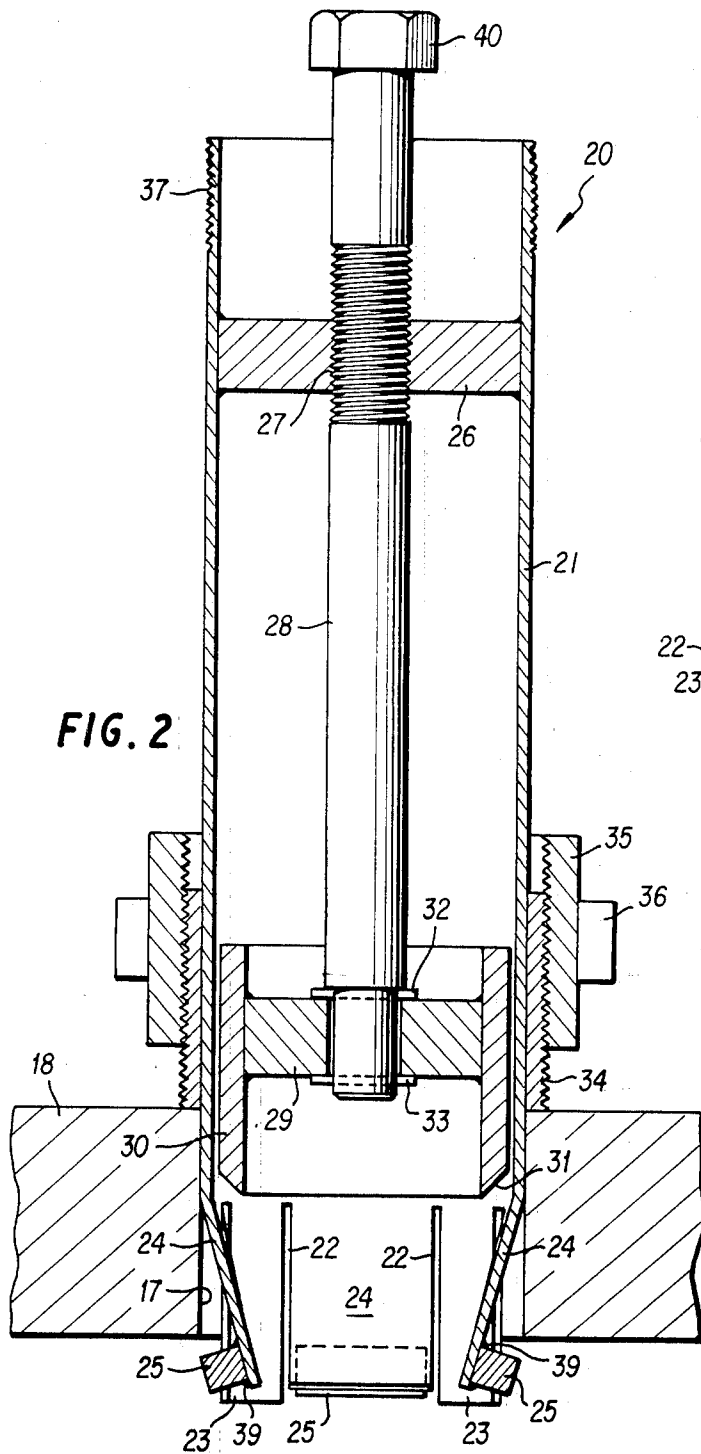
FIG. 2 is a partial sectional view in elevation of the repair assembly of this invention;

After removal of the riser and reaming of the hole through the pipe wall, the repair assembly of this invention, illustrated in FIG. 2, is inserted into the pipe wall. Turning now to FIG. 2, repair assembly 20 comprises a cylindrical housing 21 having a lower end adapted for insertion into the reamed hole 17 in the pipe wall 18. Housing 21 is preferably formed from a section of relatively thin-walled steel pipe having a diameter equal to that of the original riser. A series of eight slots 22 are cut into the lower end of housing 21 for a distance somewhat shorter than the wall thickness of pipe 11. Slots 22 are all of equal depth and extend parallel to the housing axis to form eight tang members. These eight tang members comprise four guide tangs 23 alternating with four locking tangs 24. Each locking tang 24 is provided with an outwardly extending lug 25 attached, suitably by weld 39, adjacent its free end and perpendicular to the axis of housing 21. The top side of each lug 25 preferably forms a right angle with its companion tang 24 so as to provide a secure lock with the interior surface of the pipe wall in a manner which will be later described.

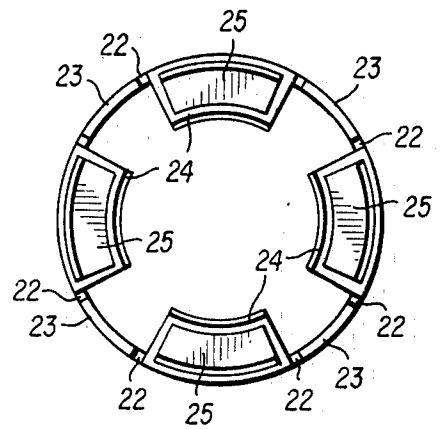
FIG. 3 is a bottom view of the repair assembly showing the attitude of guide and locking tangs;

All four locking tangs 24 are then bent inwardly a sufficient amount so that the projection of lugs 25 does not extend beyond the diameter of housing 21. Guide lugs 23 remain unbent as extensions of the housing wall. The resulting attitude of the guide tangs and locking tangs, each with its companion lug, is shown in FIG. 3. As is shown in FIG. 3, it is preferred but not required, that each locking tang include about twice the arc length of each guide tang. It is necessary for proper functioning of the repair assembly that opposing pairs of locking tangs be of equal arc length and that the midpoint of opposing lug pairs be disposed at essentially 180° one from the other. In a preferred embodiment, each guide tang and adjacent locking tang encompasses 90° of arc with the arc length of the locking tang being about twice that of the guide tang.

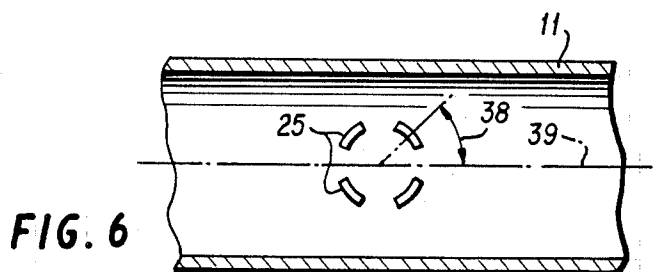
FIG. 6 shows the arrangement of the repair assembly on a water distribution line.

The sealant-coated tang end of the repair assembly is then inserted into the hole in the pipe wall. The assembly is then rotated so as to position the centers of each of locking tangs 24 and lugs 25 at an equal angle 38 (FIG. 6) from the axis 39 of line 11. In the case of equally spaced tang members, angle 38 will be 45°. This rotational positioning of the repair assembly relative to the pipe axis is critical to successful use of the repair assembly. As may be appreciated, the interior surface of pipe 11 is curved. Positioning opposite lugs 25 at an equal angle relative to the pipe axis ensures that all of the lugs will grippingly contact the internal surface of the pipe wall.
