(10) **Patent No.:** **US 10,173,291 B2**

(54) **LOW AND EXTRA LOW SULFUR ALLOYS FOR REPAIR**

(71) Applicant: **UNITED TECHNOLOGIES CORPORATION**, Farmington, CT (US)

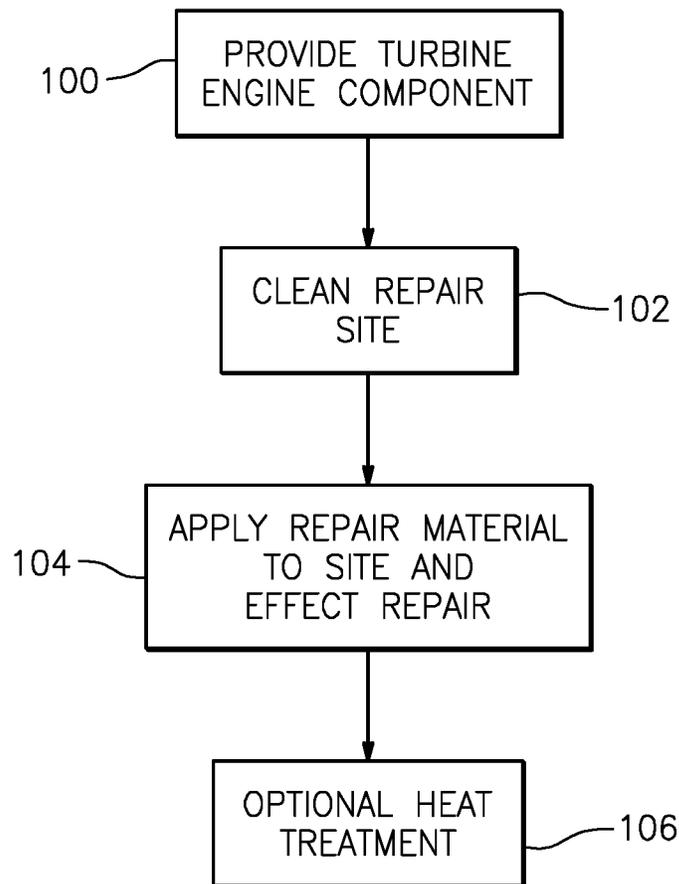
FIG. 1 is a flow chart showing a method for effecting a repair;

In accordance with the method of the present invention, and as shown in FIG. 1, a turbine engine component/sub-component to be repaired/replaced may be provided in step 100. Each site to be repaired/refurbished/replaced may be cleaned in step 102. Any suitable cleaning technique known in the art may be used to remove deleterious material from the site(s) to be repaired and/or clean the site(s).

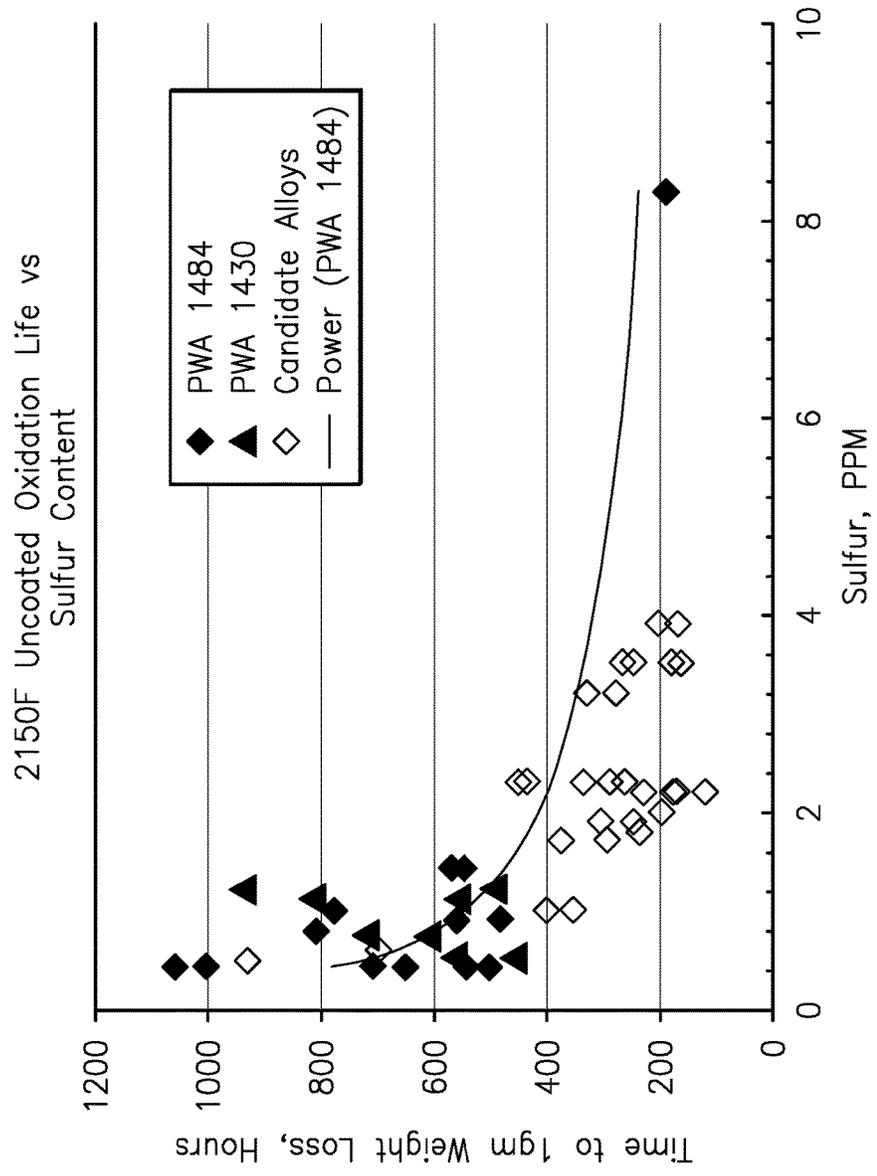
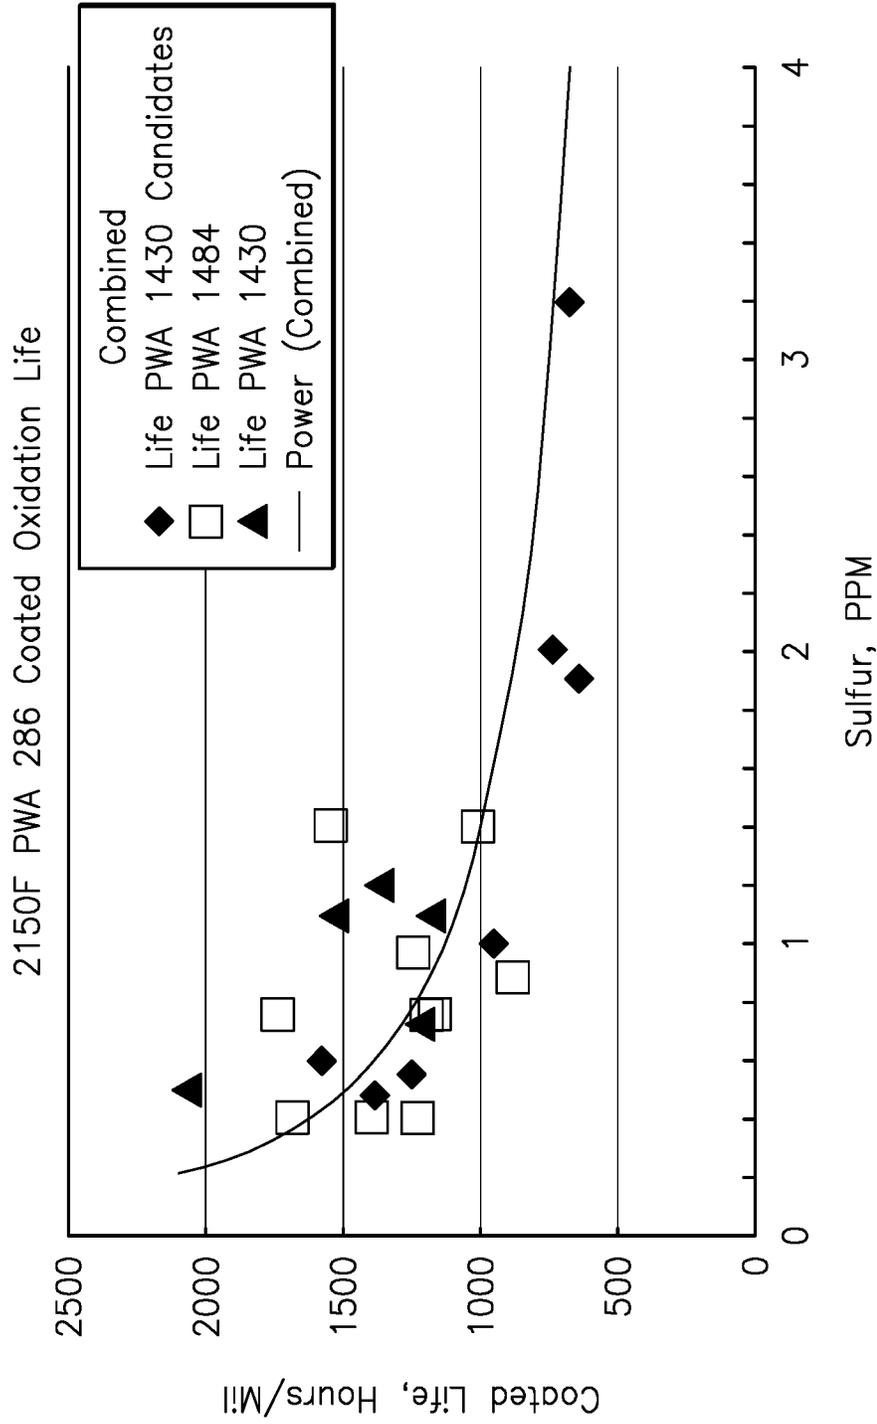
FIG. 2

FIGS. 2 and 3 are graphs showing a direct comparison of coated oxidation life of low sulfur PWA 1430 and PWA

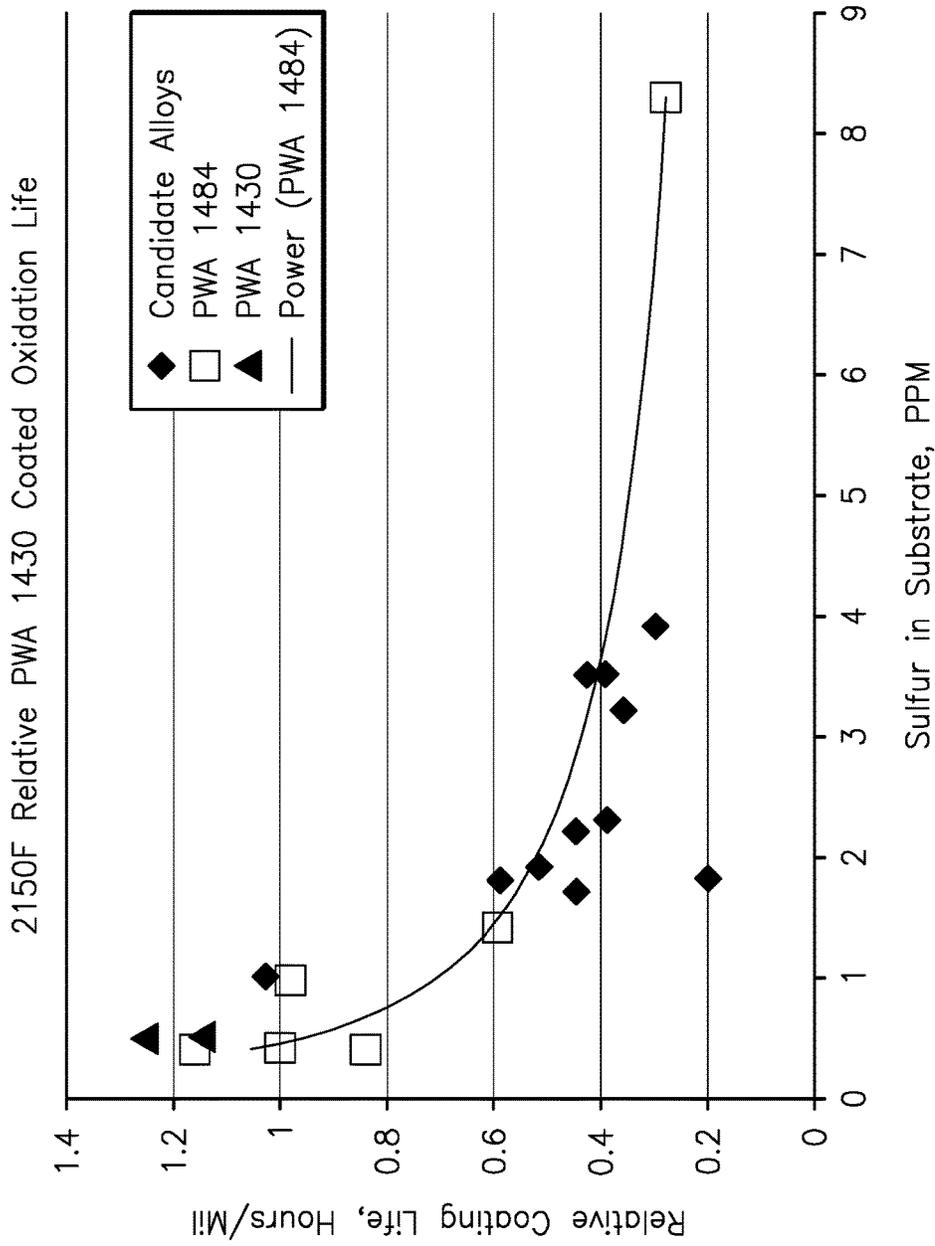
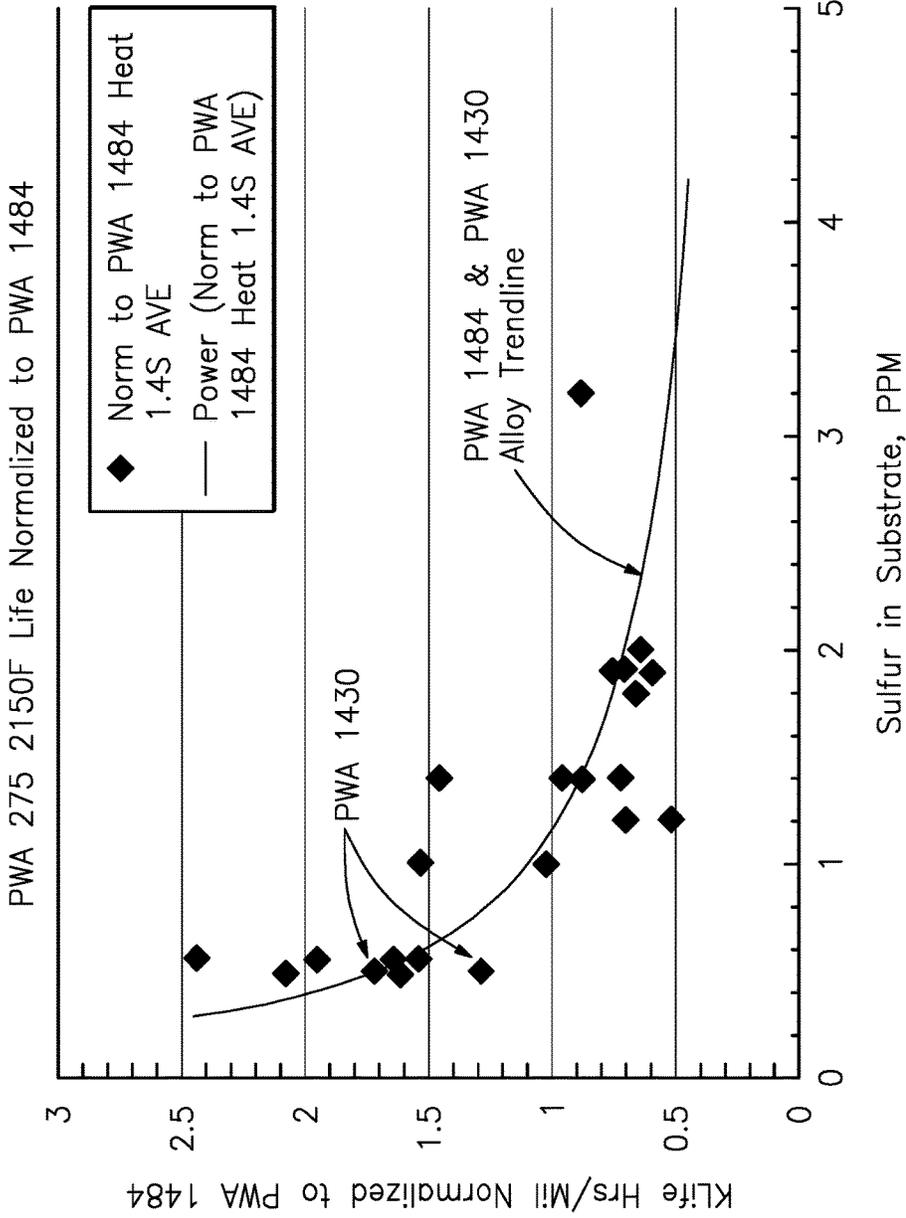
FIG. 4

FIGS. 4 and 5 are graphs showing a direct comparison of coated oxidation life of low sulfur PWA 1430 and PWA 1484; and
