(10) **Patent No.:** **US 11,209,113 B2**  
(45) **Date of Patent:** **\*Dec. 28, 2021**

(54) **FIBER COMPOSITE SYSTEM AND METHOD FOR PIPE REINFORCEMENT**

(71) Applicant: **CSC Operating Company, LLC**,  
Houston, TX (US)

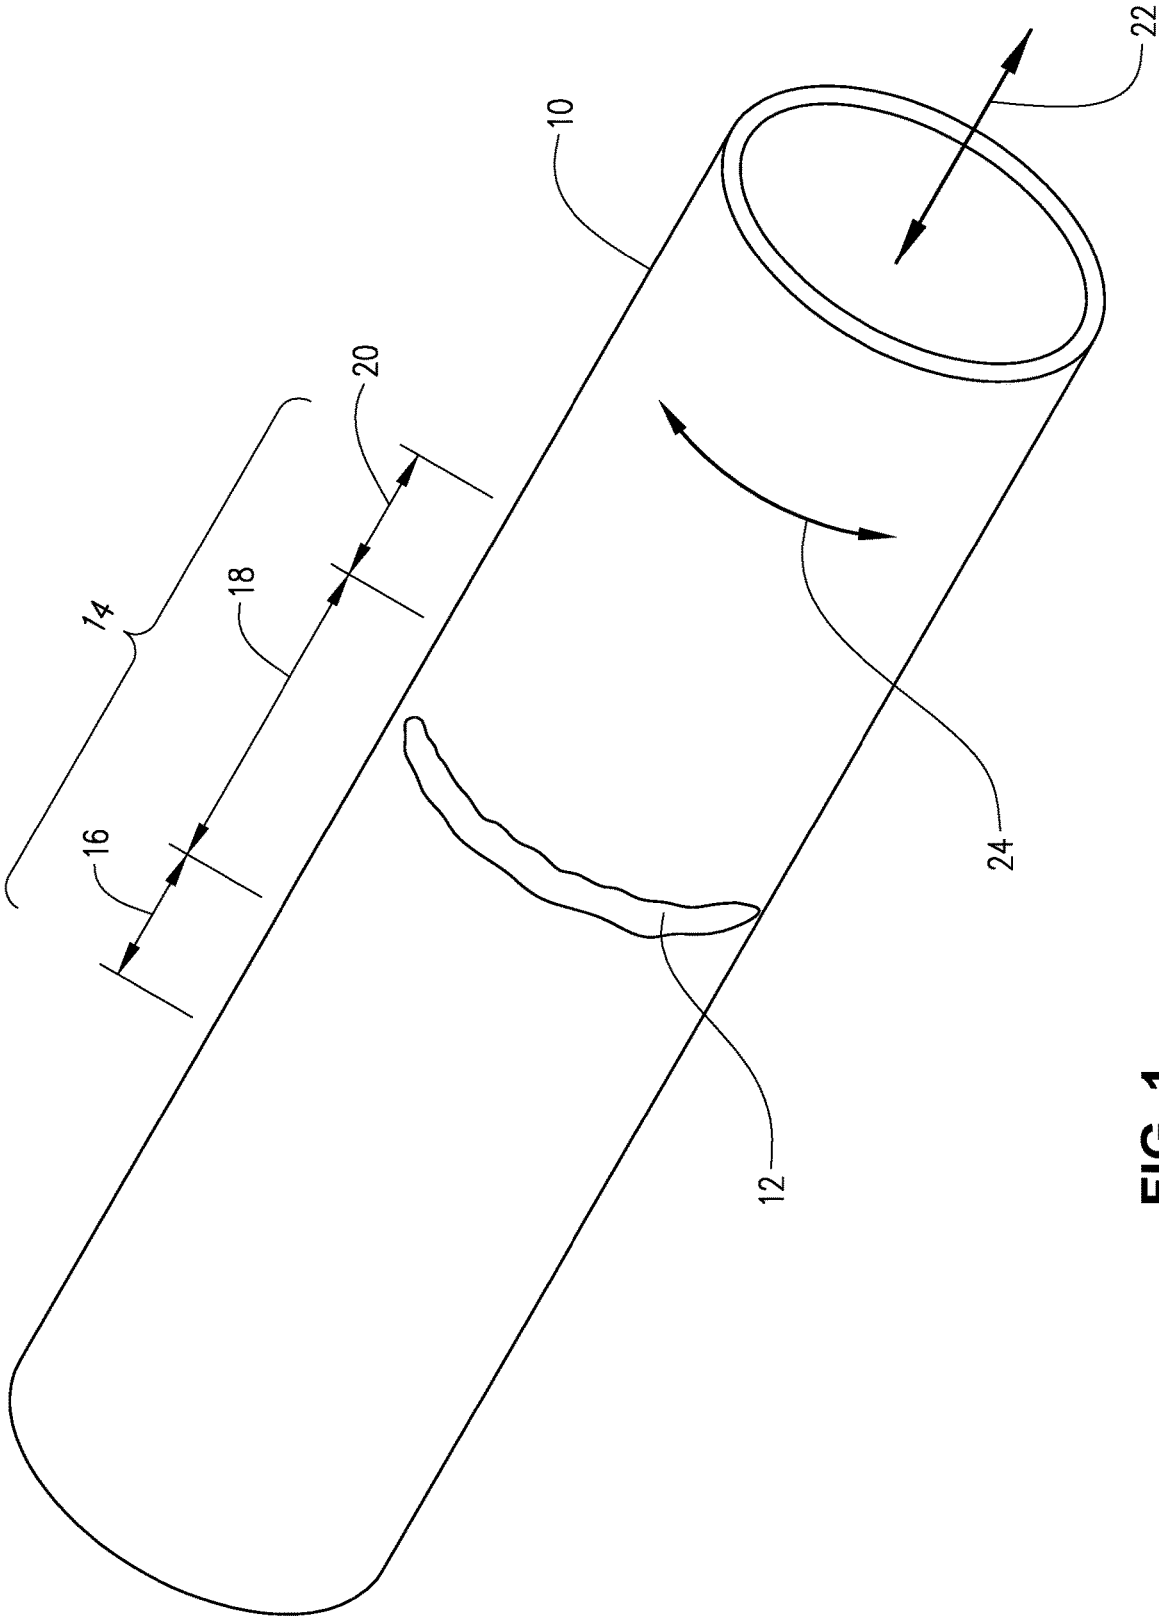
FIG. 1 is a perspective view illustrating a pipe having a circumferential defect.

Referring now to FIG. 1, a pipe 10 is illustrated. Pipe 10 is a pipe having at least one circumferential defect 12 such as a wrinkle bend. Typically, pipe 10 will be a metal pipe, such as steel, aluminum, etc. More typically, pipe 10 is a steel pipe. Circumferential defect 12 such as a wrinkle bend is the type that is introduced in a pipe during construction during alignment of the pipe by bending. Circumferential defect 12 runs circumferentially along pipe 10. A repair area 14 is defined around circumferential defect 12. The repair area has a left section 16, a center section 18 and a right section 20. Center section 18 is between left section 16 and right section 20, and center section 18 contains circumferential defect 12. Pipe 10 has an axial direction (or longitudinal direction) 22 and a circumferential direction 24. As previously indicated, circumferential defect 12 is oriented in the circumferential direction.

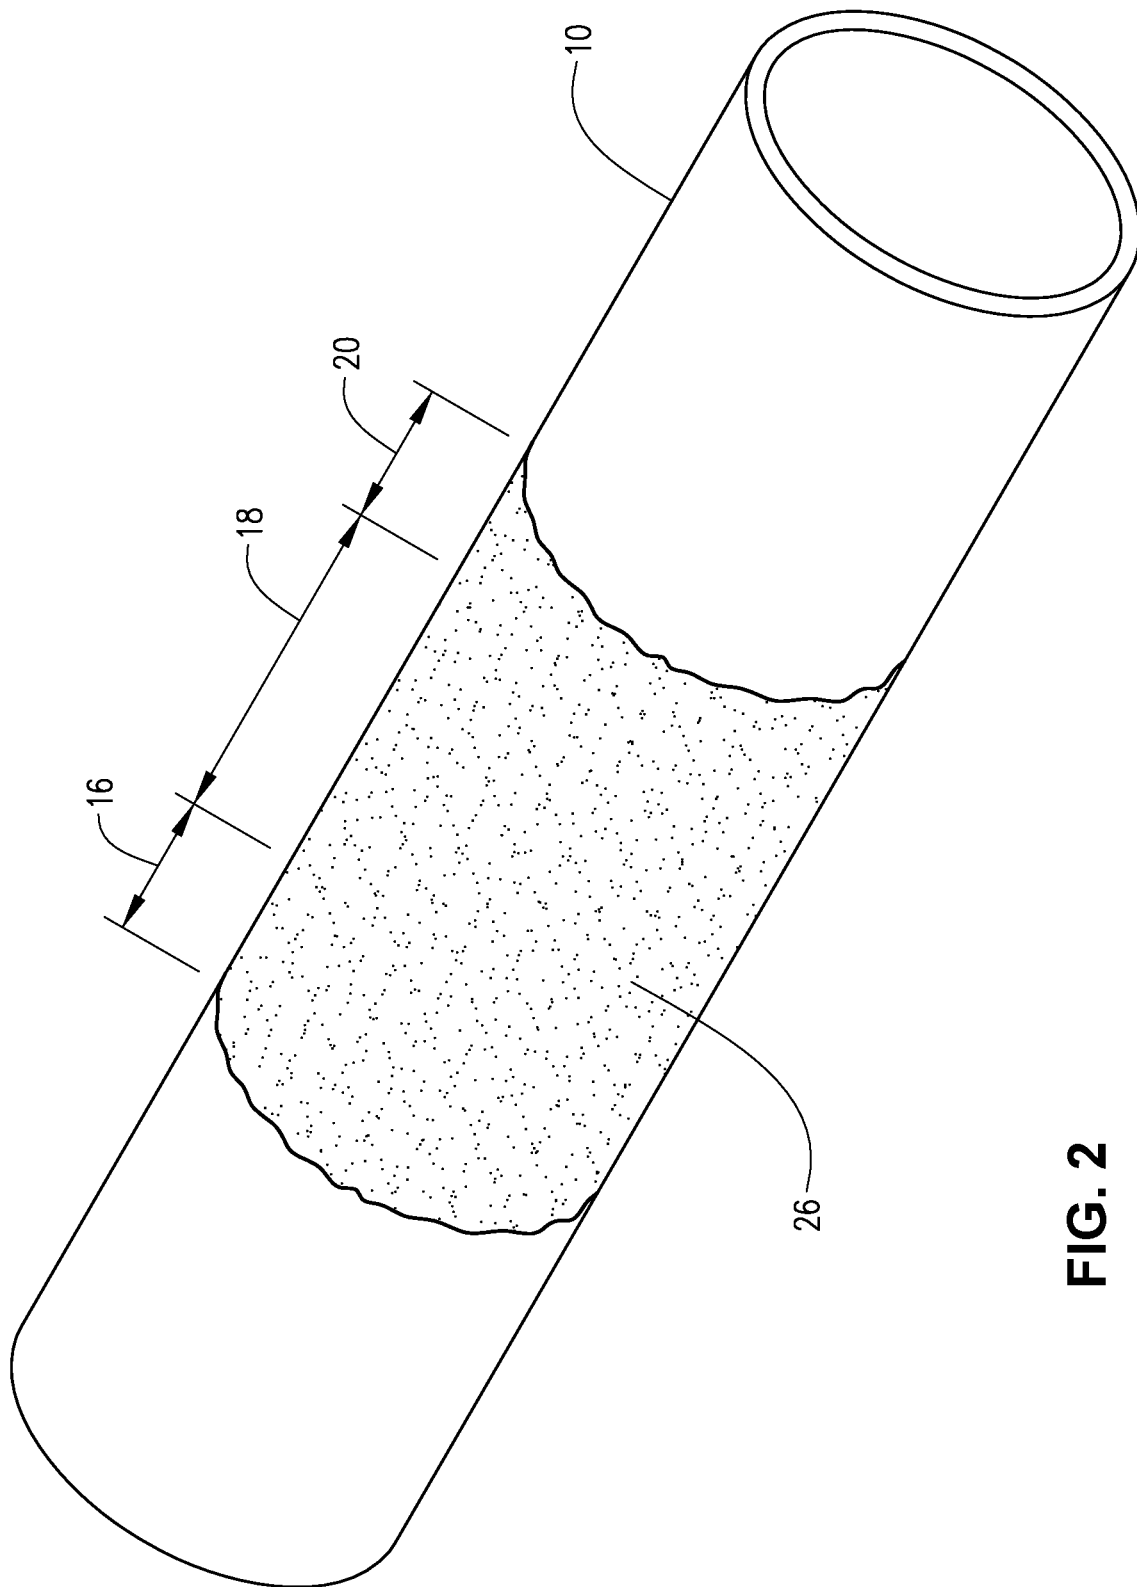
FIG. 2 is a perspective view of the pipe of FIG. 1 with a resin coating on the repair area.

Turning now to FIG. 2, the first layer to be deposited on pipe 10 typically will be a load transfer material 26 to even out the surface of the repair area and fill in any gaps or voids in the surface, such as dents, gouges and/or cracks. The load transfer material typically is tested for compressive strength and modulus, and additionally for compatibility with the composite system being applied to the pipe 10. While generic load transfer materials are often unsuitable for use in this application, the load transfer material generally can be any suitable putty such as epoxy putties designed for making fast and curable repairs to metals, or ceramic load transfer fillers. Load transfer material 26 is applied to center section 18, in the location of the wrinkle bend, and in localized areas within repair section 14 where any other defects may exist.

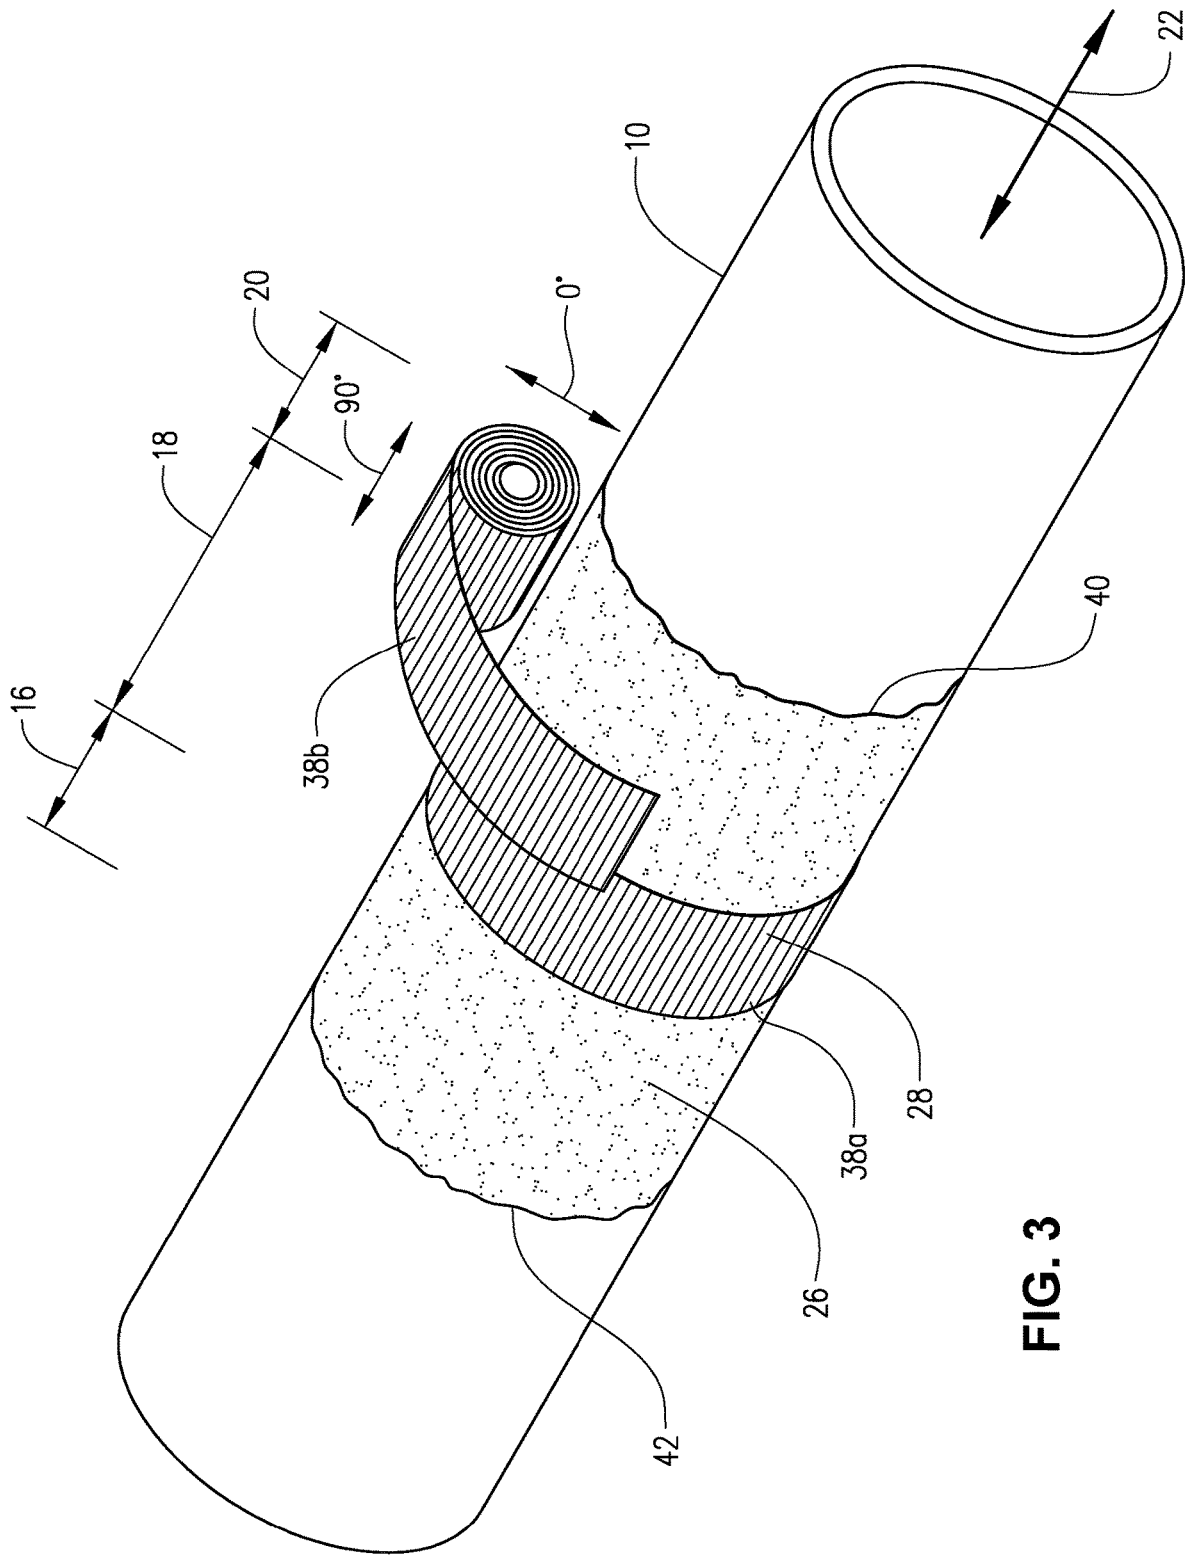
FIG. 3 is a perspective view of the pipe of FIG. 2 illustrating the application of a unidirectional fabric to the repair area.

As illustrated in FIGS. 3 and 4, a unidirectional fabric **28** is placed on top of load transfer material **26** and resin, if applied. Unidirectional fabric **28** is circumferentially wrapped around repair area **14** of the pipe so as to result in multiple layers of the unidirectional fabric around repair area **14**.

As illustrated in FIG. 3, the unidirectional fabric is wrapped around pipe **10** such that the 90° direction of the fabric runs parallel to axial direction **22** of pipe **10**. Accordingly, when the unidirectional fabric is applied to pipe **10**, the high-performance fibers run in the axial direction.

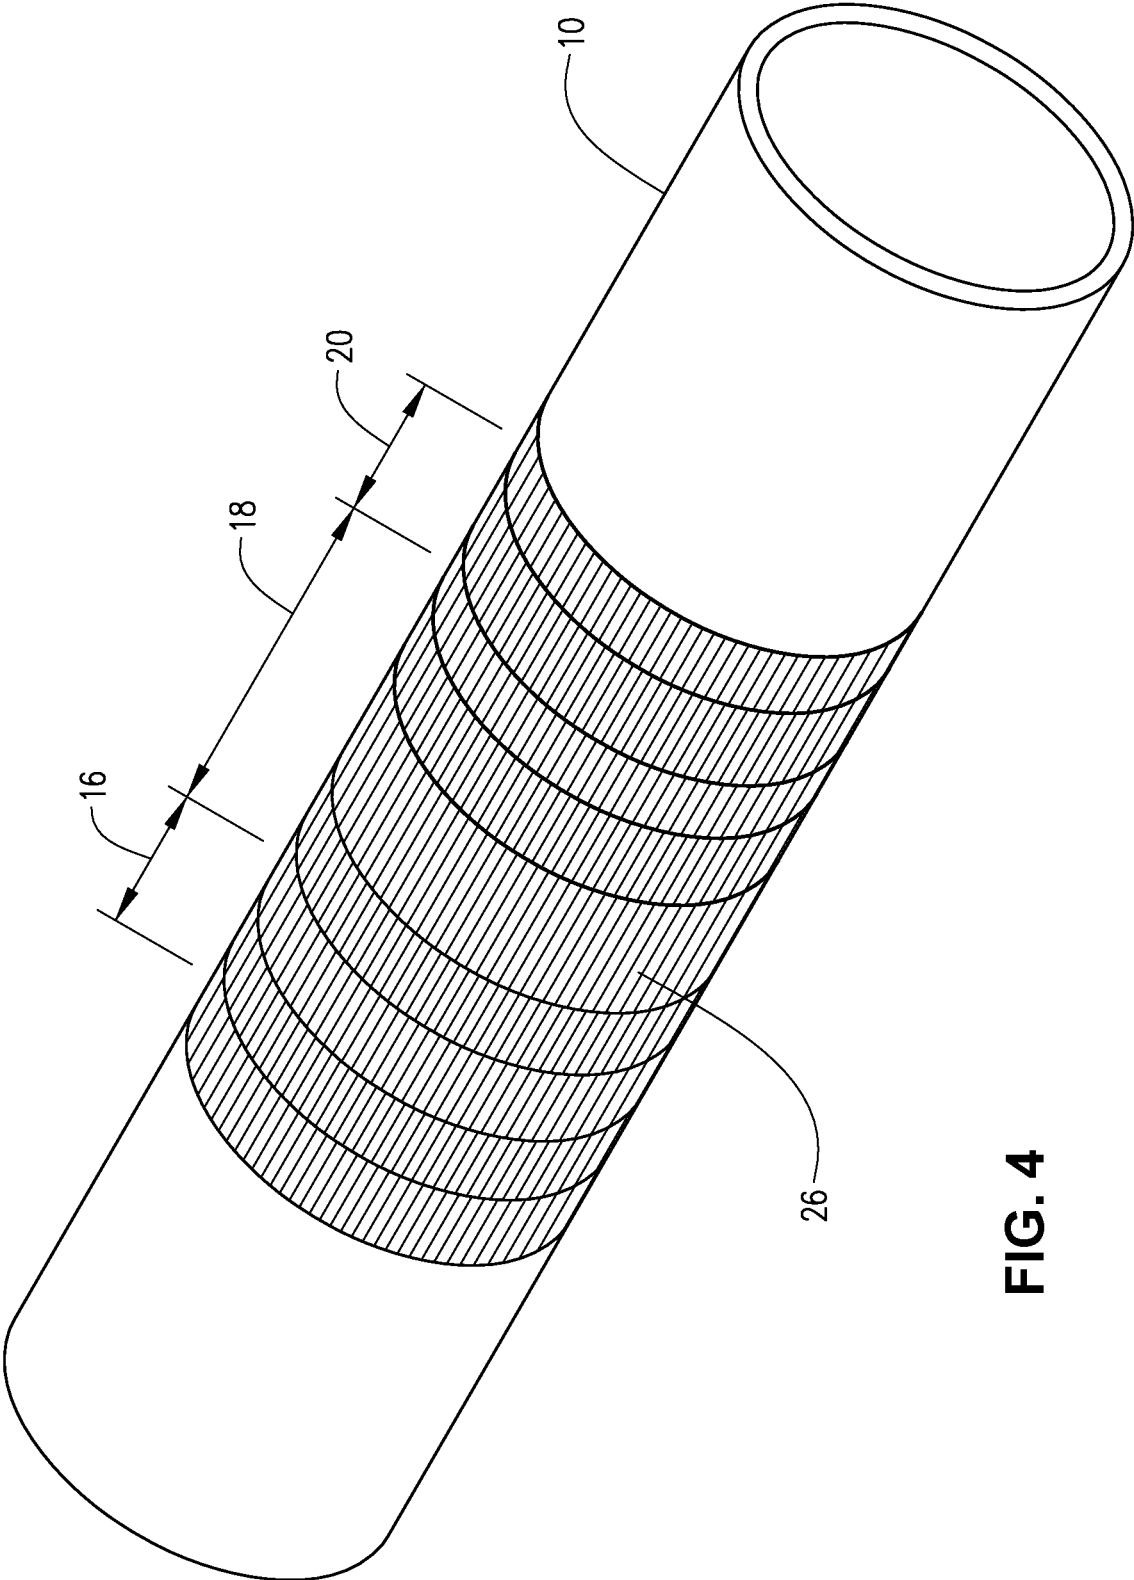
FIG. 4 is a perspective view of the pipe of FIG. 3 illustrating the completed application of the unidirectional fabric.

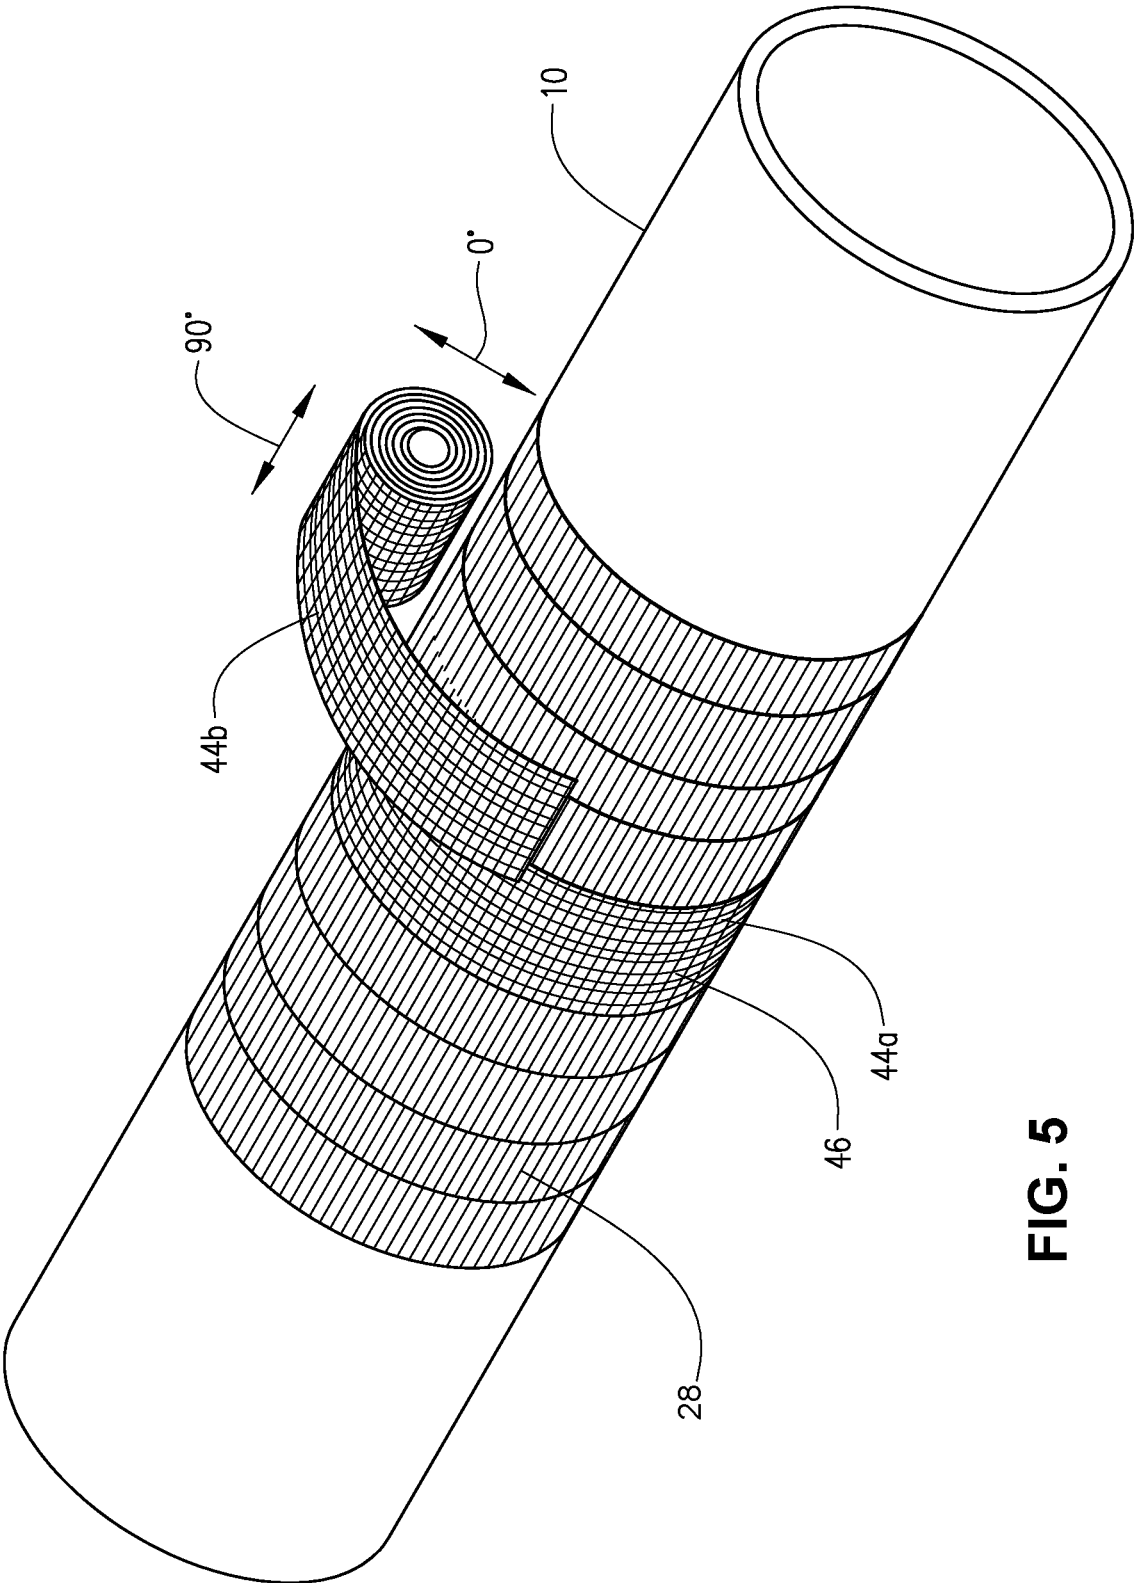
FIG. 5 is a perspective view of the pipe of FIG. 4 illustrating the application of a bidirectional fabric to the repair area.

In accordance with this disclosure, there is provided a reinforced pipe wherein the pipe 10 has circumferential defect 12, and repair area 14 around the circumferential defect 12 has been reinforced by several distinct layers. The reinforced pipe is described below in relation to FIGS. 2 to 6, which illustrate the distinct layers.

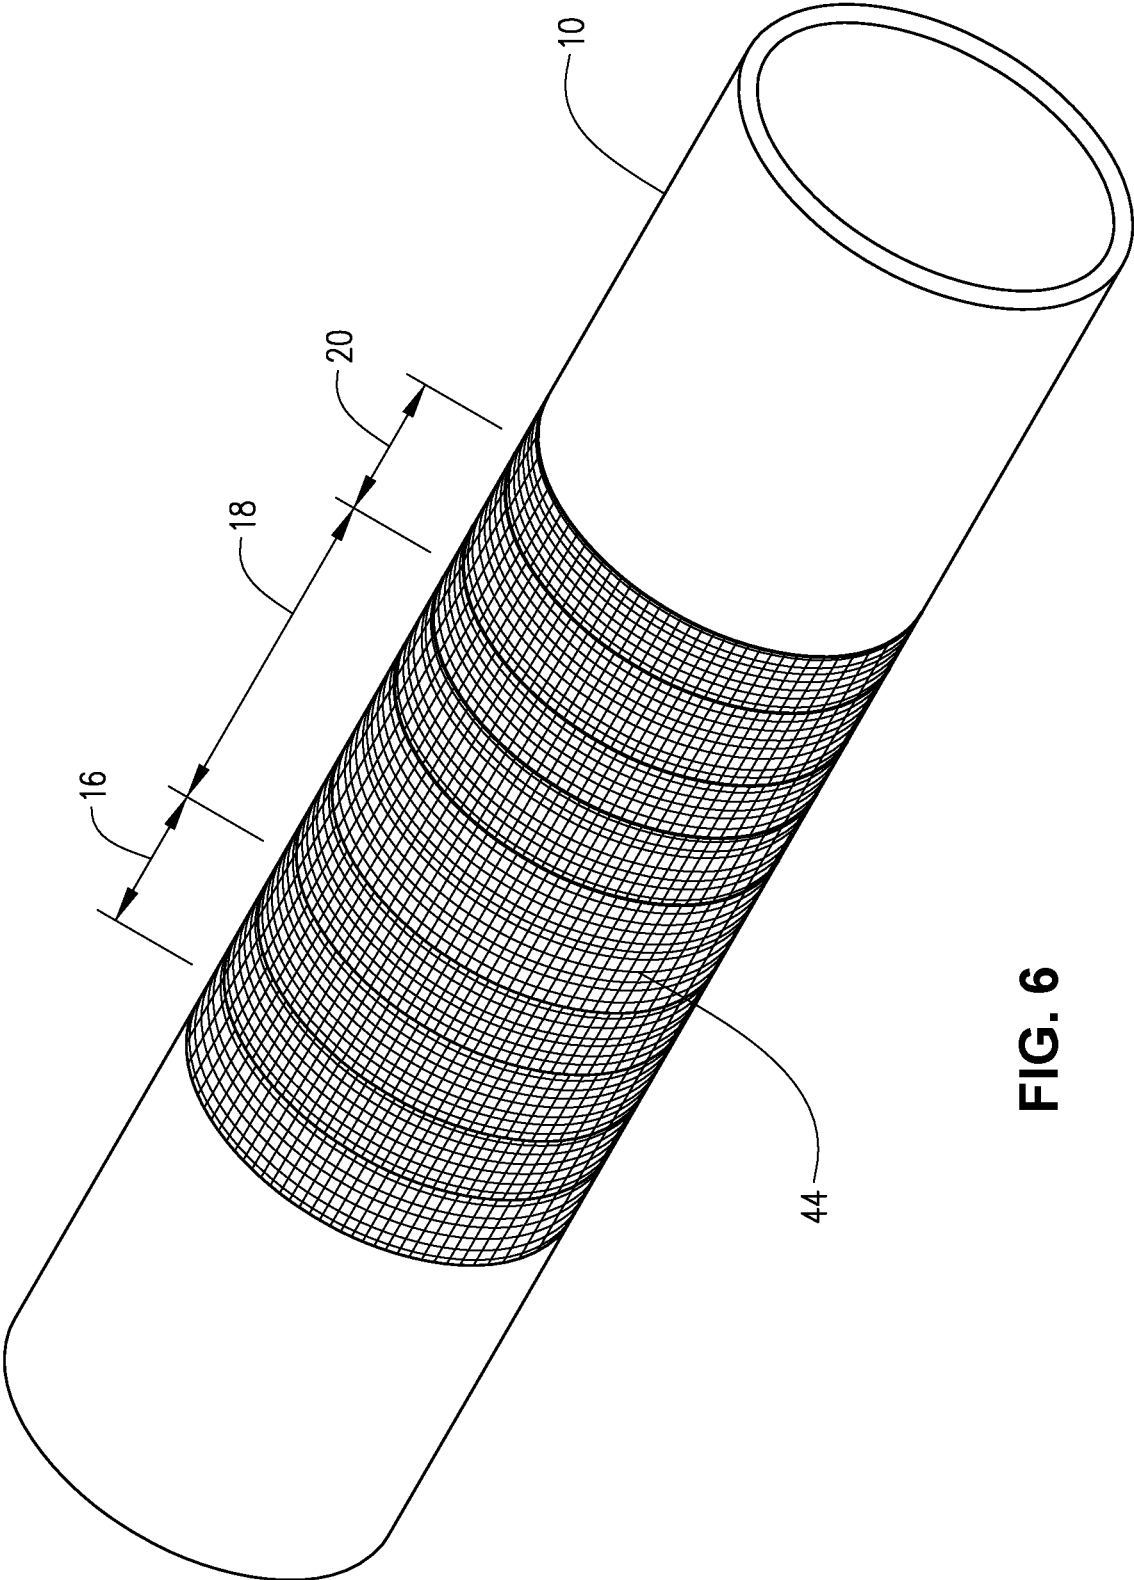
FIG. 6 is a perspective view of the pipe of FIG. 5 illustrating the completed application of the bidirectional fabric.

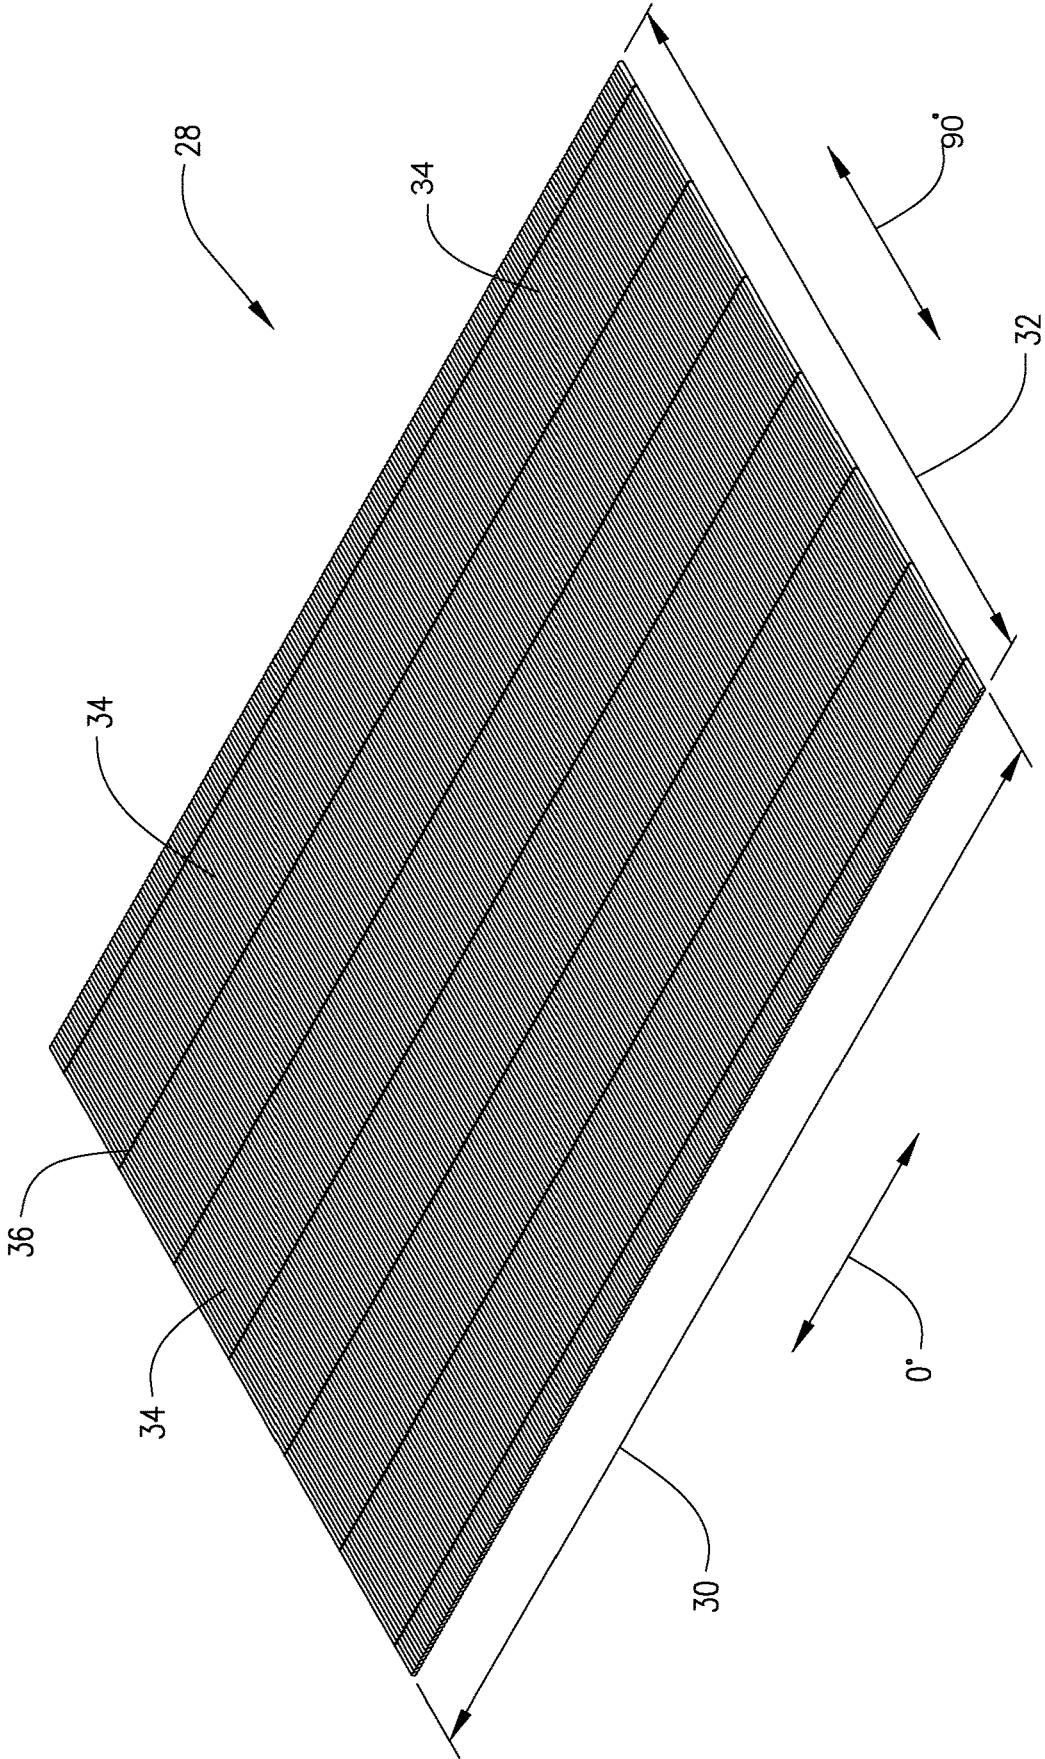
FIG. 7 is an illustration of a unidirectional fabric for use in the reinforcement of a pipe in accordance with this disclosure.

Referring to FIG. 7, unidirectional fabric **28** has a length **30** and width **32**, with length **30** typically being greater than width **32**. Often, width **32** will be less than the pipe circumference, and length **30** will be greater than the pipe circumference and even greater than two pipe circumferences. The length corresponds to the 0° direction for the fabric and the width corresponds to the 90° direction of the fabric. Unidirectional fabric **28** will have substantially all of its high-performance fibers **34** oriented in the 90° direction. Generally, this will mean that at least 90% of high-performance fibers **34** are oriented in the 90° direction. Typically, at least 95% or at least 98% of high-performance fibers **34** are oriented in the 90° direction. More typically, at least 99%, at least 99.5%, at least 99.9% or 100% of high-performance fibers **34** are oriented in the 90° direction.

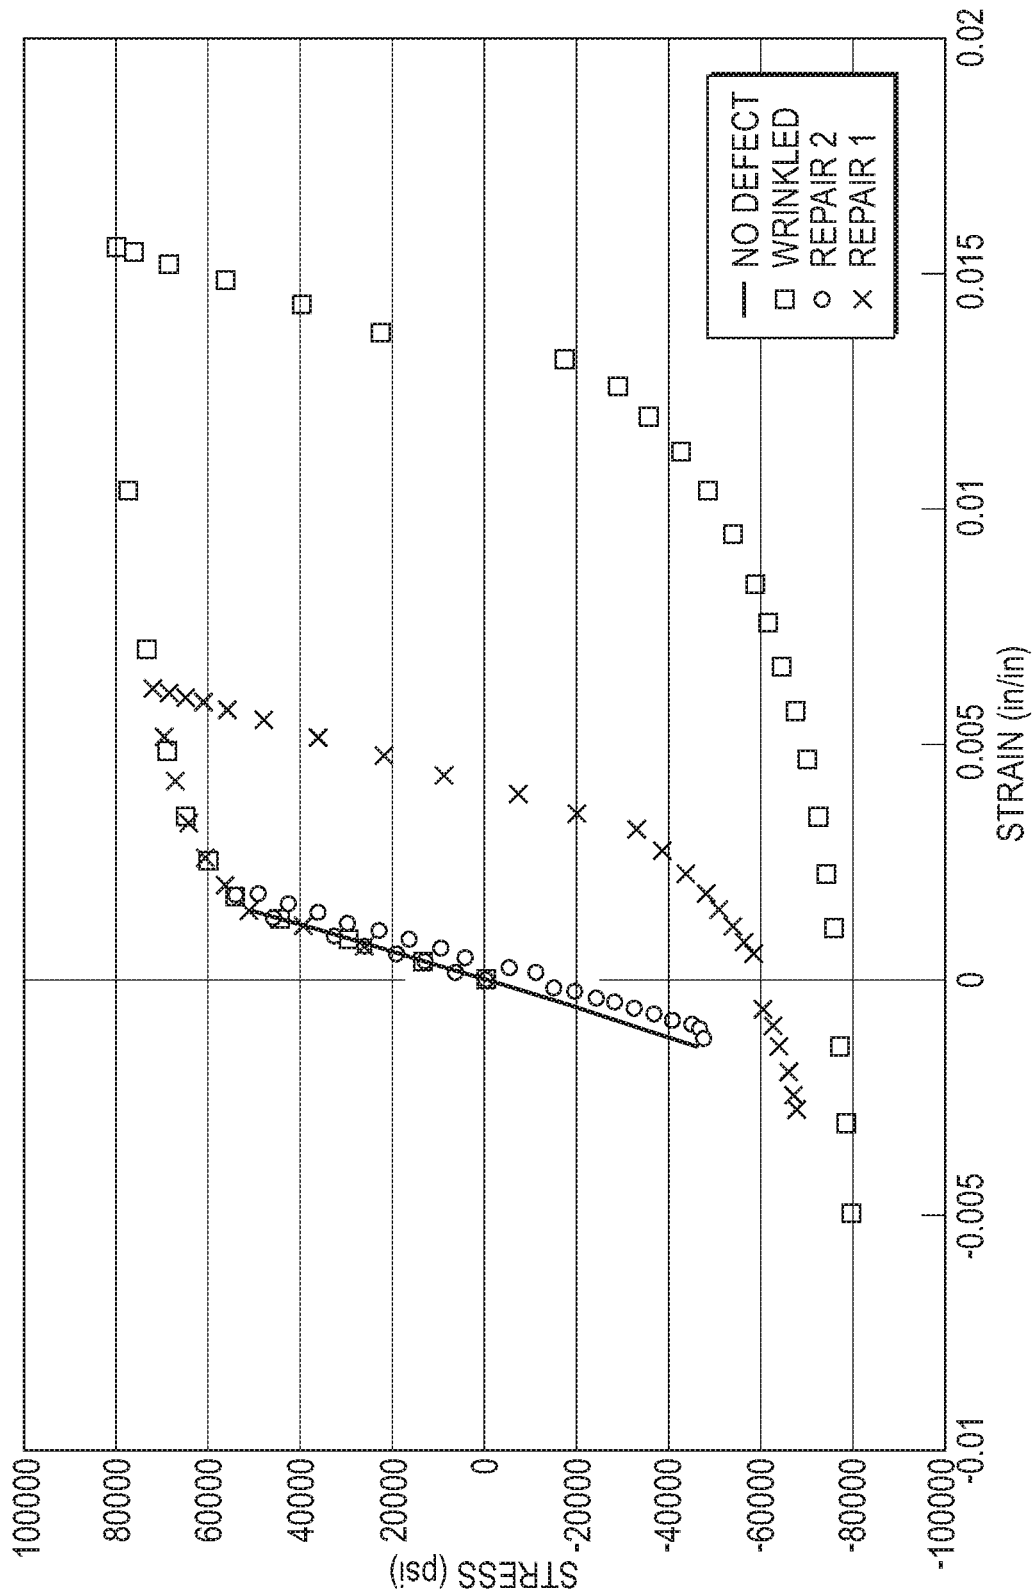
FIG. 8 is a graph of stress v. strain that illustrates the stress and strain ranges for a typical bending cycle for Control I, Control II, Control III and Example I.
