(10) **Patent No.:** **US 8,083,465 B2**

(54) **REPAIRED TURBINE EXHAUST STRUT
HEAT SHIELD VANES AND REPAIR
METHODS**

A method of repairing a turbine exhaust case strut heat shield vane includes removing a damaged portion of the vane, solution heat treating the vane, attaching a replacement section to the vane, and relieving local stresses in an attachment area between the replacement section and the vane.

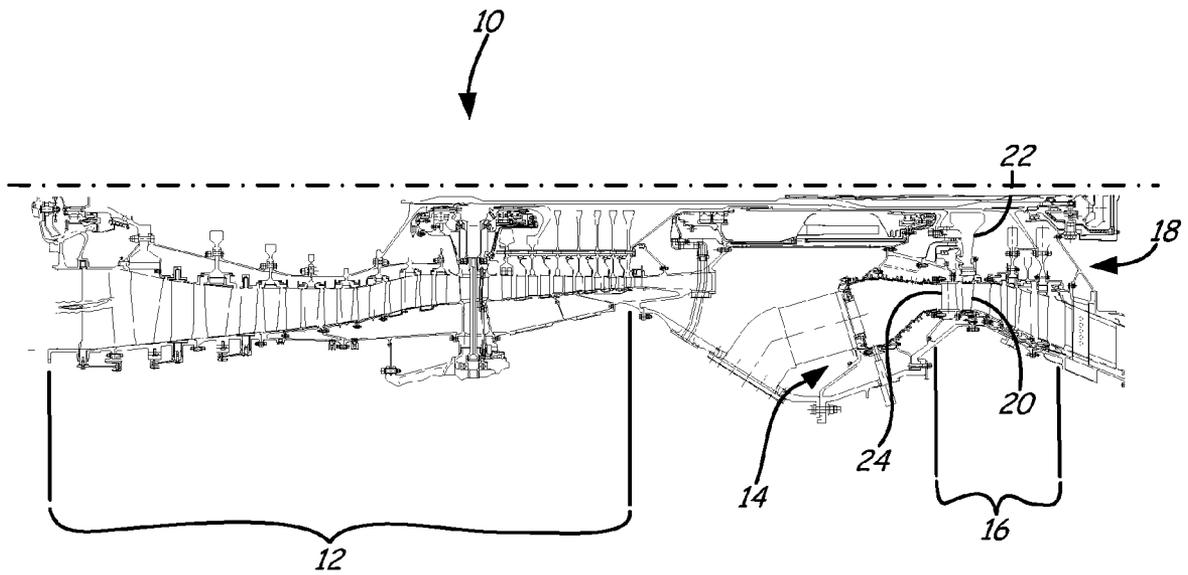
FIG. 1 is an axial section view of an industrial gas turbine including a turbine exhaust case.

FIG. 1 is a partial axial section view of industrial gas turbine 10 including compressor 12, combustor 14, turbine section 16, and exhaust case 18. Although the section view of FIG. 1 shows only one combustor 14, turbine 10 will generally include multiple combustors 14 circumferentially distributed around a turbine main shaft (not shown). Turbine section 16 includes a plurality of rotating blades 20 secured to a rotatable rotor disk 22. A plurality of stationary vanes 24 are each alternately positioned upstream of each of the rotating blades 20. The vanes 24 are dimensioned and configured to guide the working gas over the blades 20.

Vanes 40 shown in FIGS. 1 and 2 may experience a loss of material due to a combination of abrasion, exfoliation, oxidation, hot corrosion and some mode of metallurgical attack during engine operation. Although the damage observed on vanes 40 may not have structural repercussions, the damage may compromise, to an increasing degree over time, the heat shielding function of vanes 40. Vanes 40 may therefore be repaired by embodiments of the exemplary method, such as method 50 illustrated by the flow chart of FIG. 3. In FIG. 3, method 50 of repairing a strut heat shield vane includes removing a damaged portion of the vane (step 52), solution heat treating the vane (step 54), cooling an exhaust case strut around which the vane is arranged (step 56), attaching a replacement section to the vane (step 58), relieving local stresses in an attachment area between the replacement section and the vane (step 60), and removing material from the attachment area between the replacement section and the vane (step 62).

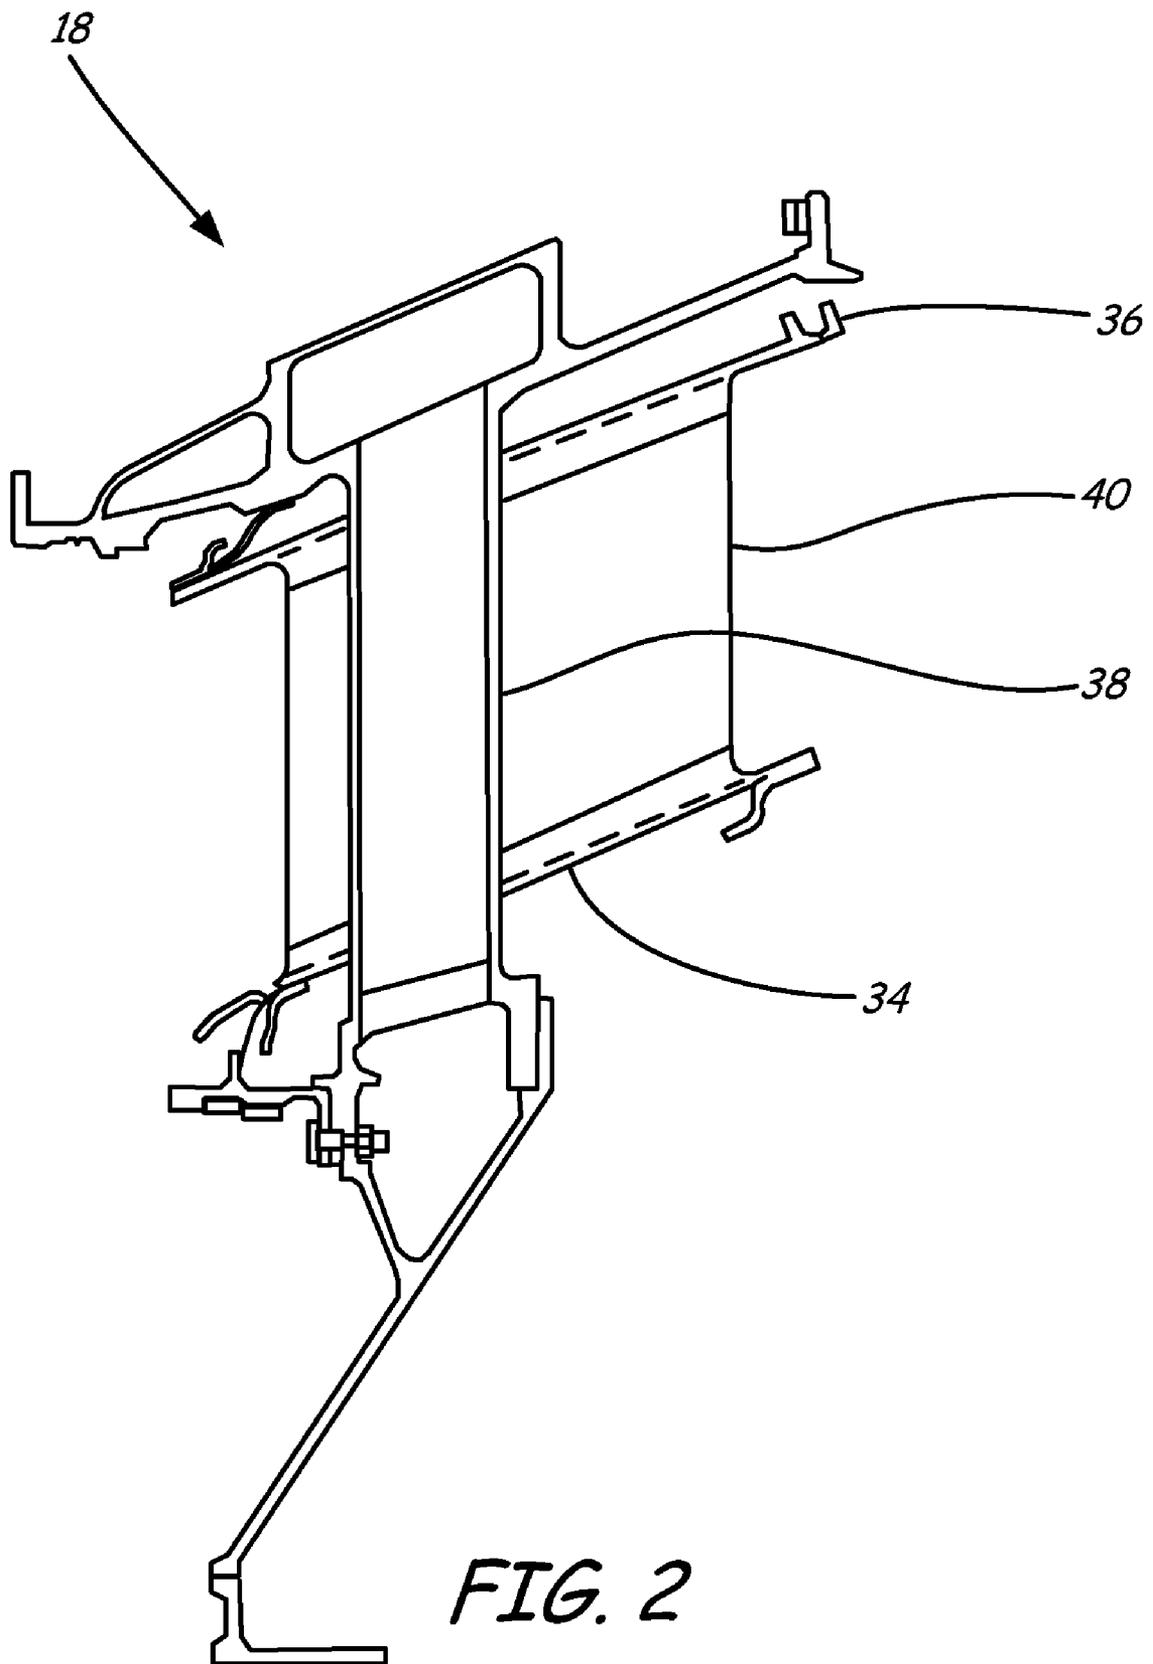
FIG. 2 is a detail view of the turbine exhaust case including a strut heat shield vane from the turbine of FIG. 1.

Exhaust case 18 is positioned downstream of the last row of turbine blades 20 shown in FIG. 1. FIG. 2 is a detail view of exhaust case 18 including a pair of annular rings, such as diffusers 34 and 36, struts 38, and heat shield vanes 40. Diffuser 34 forms the inner wall of the working gas path and diffuser 36 forms the outer wall of the working gas path. Radially extending struts 38 are circumferentially distributed about the engine axis and span the gas path between diffusers 34, 36. Each radially extending strut 38 is surrounded by vane 40. Vanes 40 act both to direct working gas flow through exhaust case 18 and to shield load bearing struts 38 from heat.

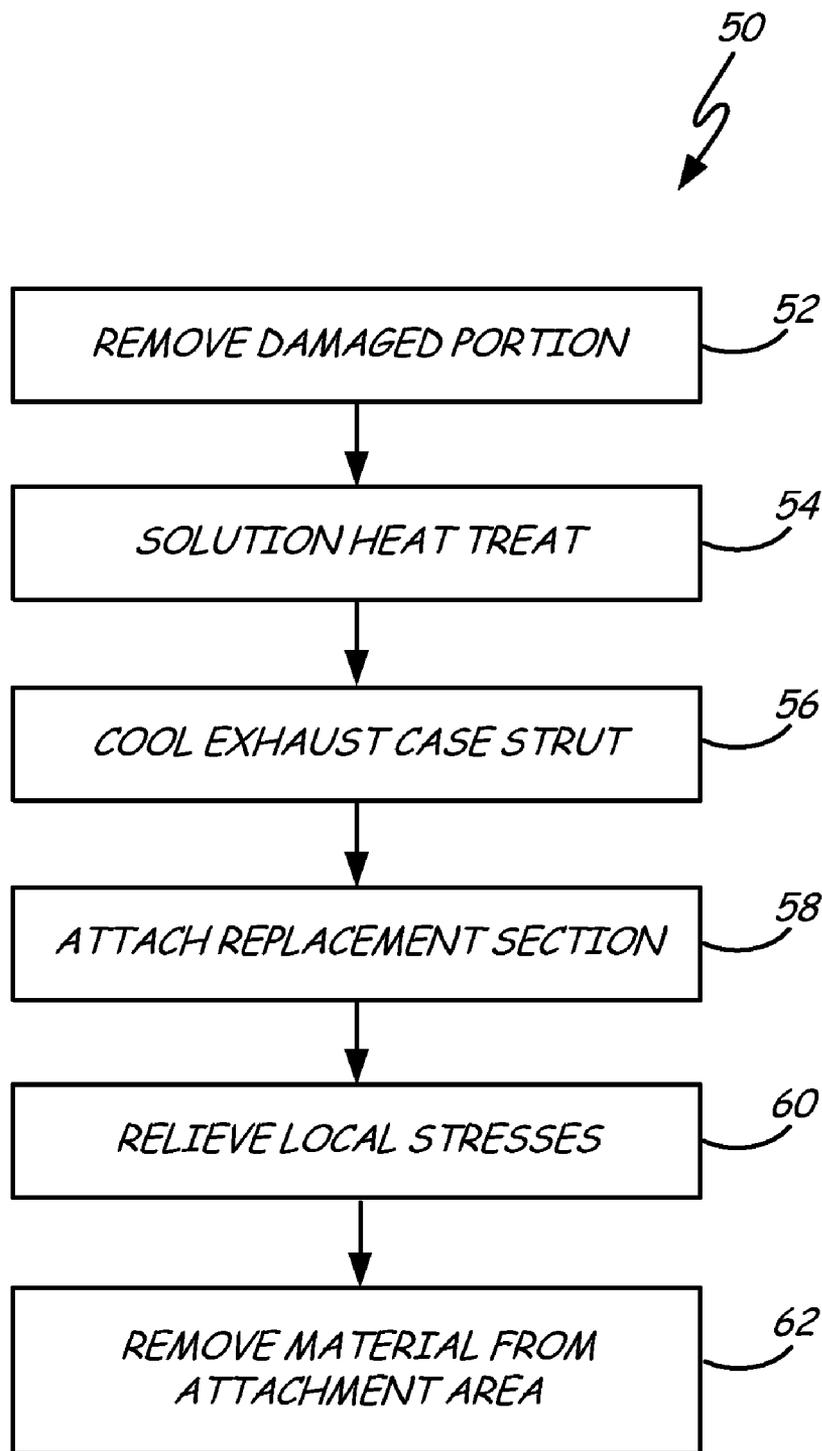
FIG. 3 is a flow chart of an exemplary embodiment of a method for repairing the turbine exhaust strut heat shield vane shown in FIG. 2.

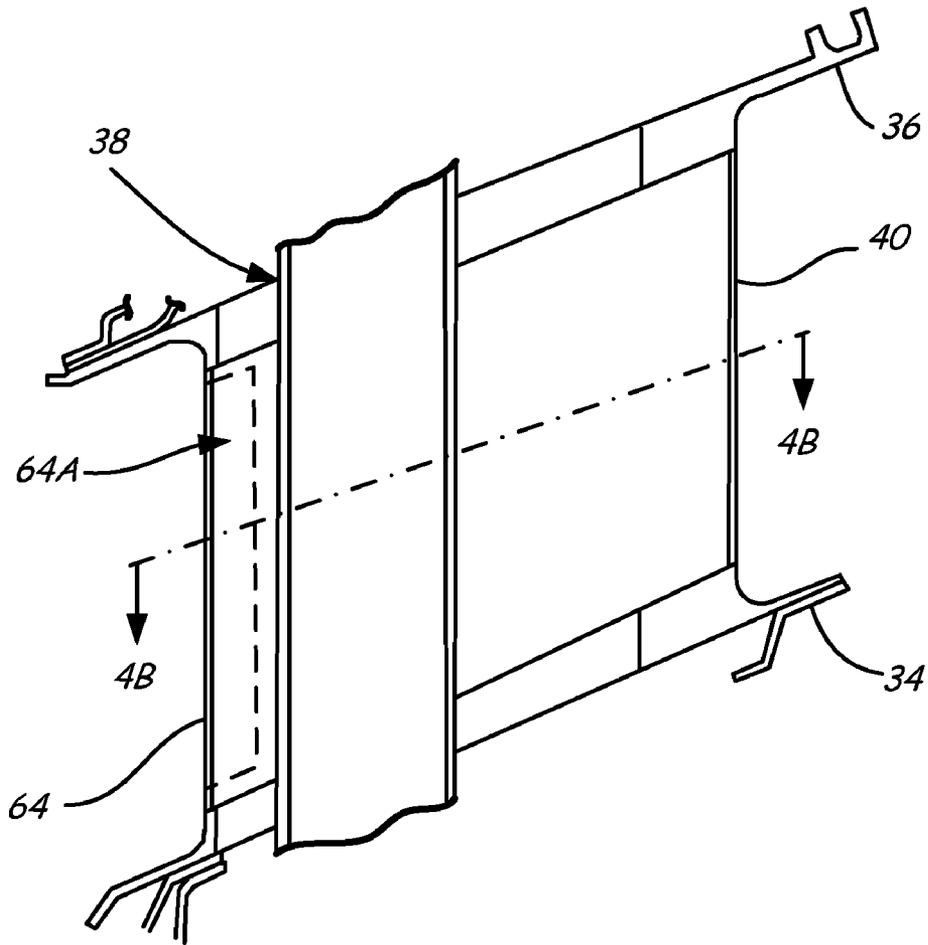
FIG. 4A

FIGS. 4A and 4B are detail views of a strut heat shield vane repaired by the exemplary method of FIG. 3.

FIGS. 4A and 4B are detail views of strut heat shield vane 40 repaired by method 50 illustrated in FIG. 3. Heat shield vane 40 surrounds strut 38 between diffusers 34 and 36. Vane 40 includes leading edge 64 and replacement section 64a. In the repaired heat shield vane 40 of FIGS. 4A and 4B, leading edge 64 may have experienced a loss of material due to a combination of abrasion, oxidation and some mode of metallurgical attack during engine operation. The damaged portion of vane 40 has therefore been removed in the region of leading edge 64. Replacement section 64a has then been attached to vane 40 by, for example, welding replacement section 64a to vane 40.
