**REPAIRED TURBINE NOZZLE**

The present invention relates to a repair of the trailing edge of an airfoil and particularly relates to a coupon having a trailing edge cooling configuration for replacement of a damaged trailing edge portion of a nozzle airfoil for a gas turbine. The present invention also relates to methods for repairing the trailing edge portion of the airfoil.

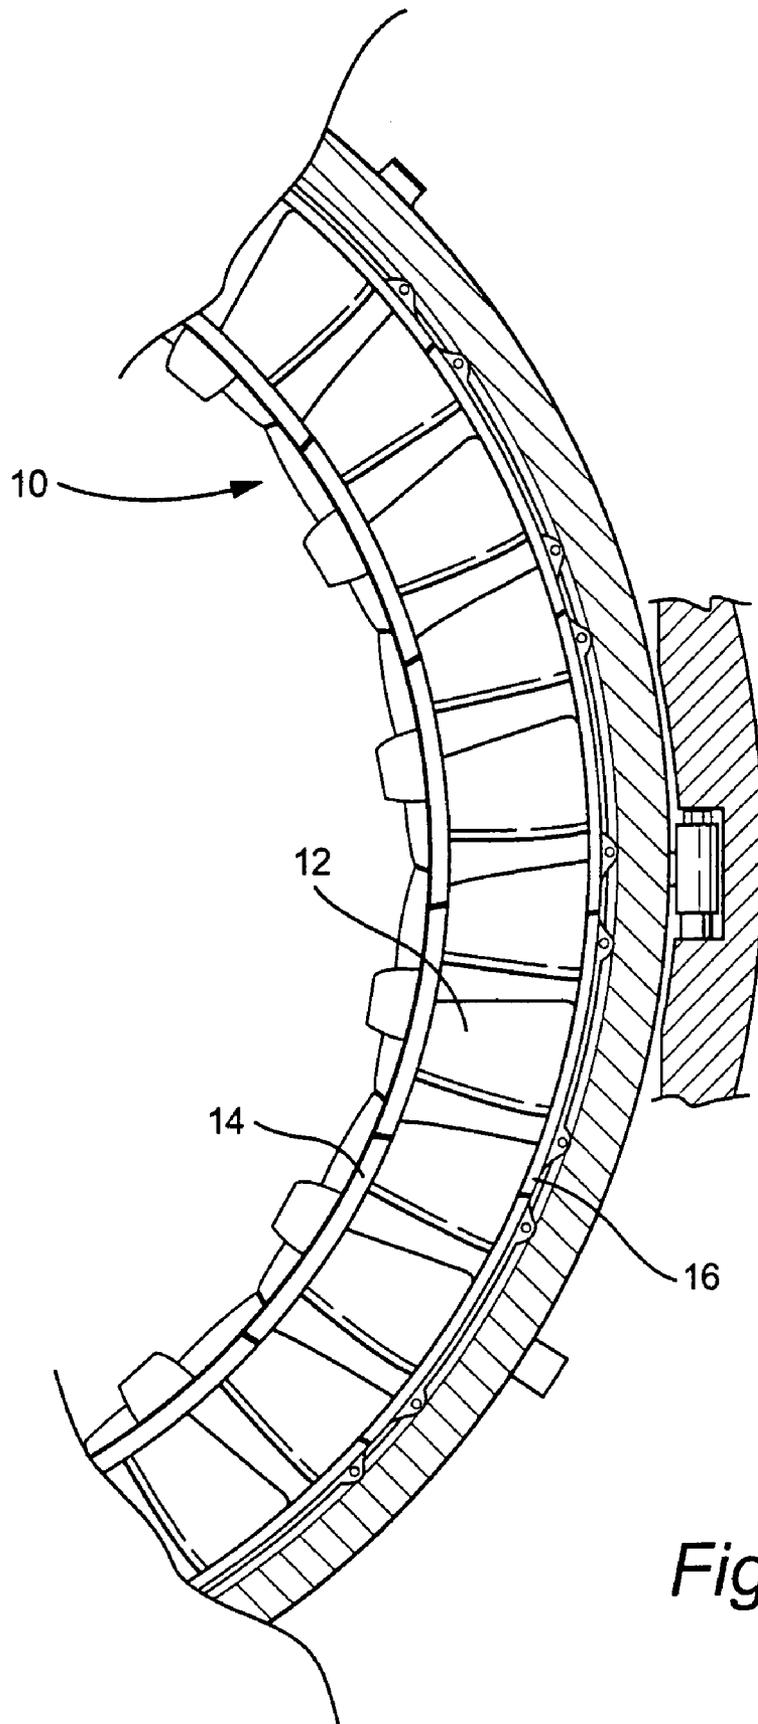
Fig. 1

FIG. 1 is a fragmentary axial view of a plurality of nozzle segments forming part of an annular array of nozzles for a turbine stage;

Referring now to FIG. 1, there is illustrated a plurality of circumferentially spaced nozzle segments, generally designated 10, forming part of a gas turbine and arranged in an annular array about a turbine axis. It will be appreciated that each of the segments 10 includes one or more nozzle vanes or airfoils 12 which extend between an inner platform 14 and outer platform 16. The nozzle airfoils 12 as well as the platforms 14 and 16 define in part a generally axially extending hot gas path through the turbine as well as defining a portion of a turbine stage. In FIGS. 2 and 3, the nozzle segments 10 are illustrated in greater particularity. In this embodiment, a pair of airfoils 12 form part of each segment 10 and extend between the inner and outer platforms 14 and 16, respectively. It will be appreciated that each segment may include one or more airfoils between the platforms. Also illustrated in FIG. 2 is an retaining ring 20 to which the nozzle segment is secured and an inner support ring 22 having a slot 24 for receiving a radially inwardly extending rail 26 of the inner platform 14 for securing the nozzle segment against axial movement in an aft direction.

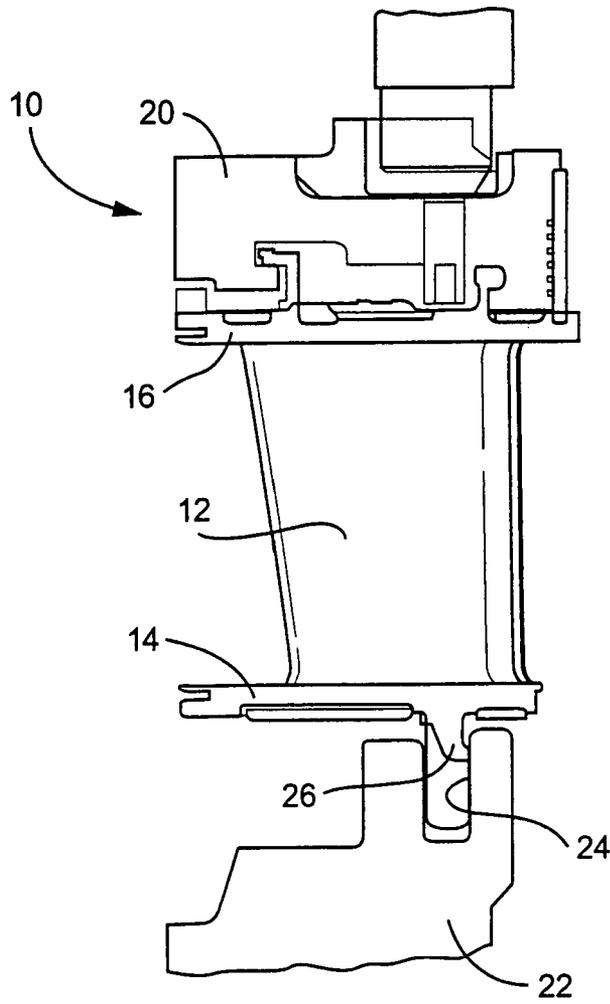
Fig. 2

FIG. 2 is a side elevational view of a nozzle segment installed between portions of an inner and outer casing;

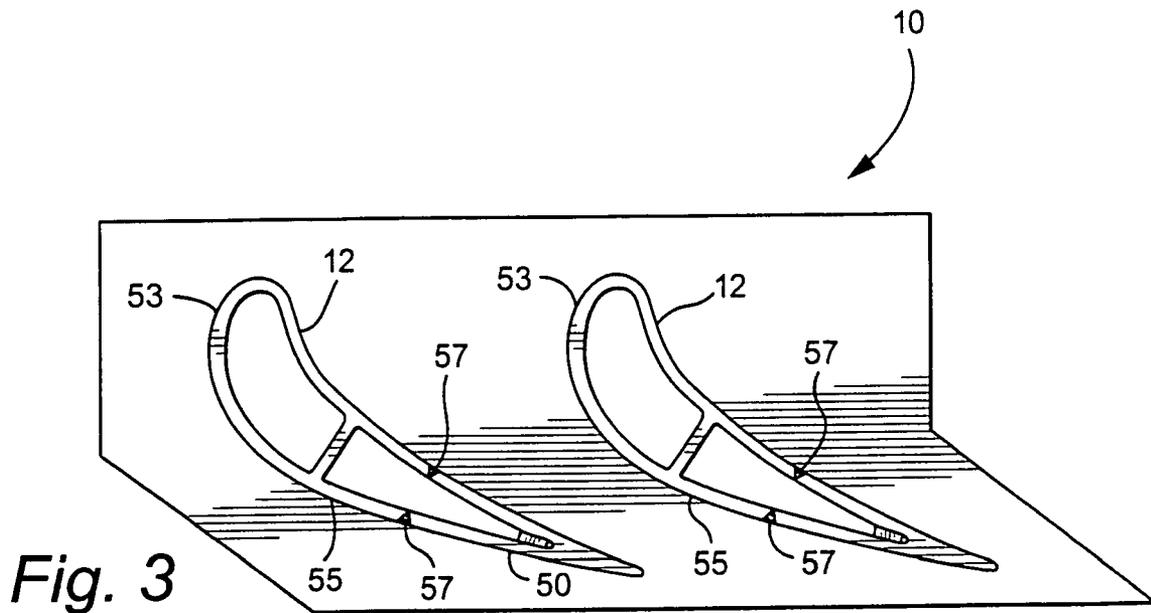
Fig. 3

FIG. 3 is an enlarged cross-sectional view through the airfoils of a nozzle segment illustrating a coupon welded to a reusable portion of the original airfoil;

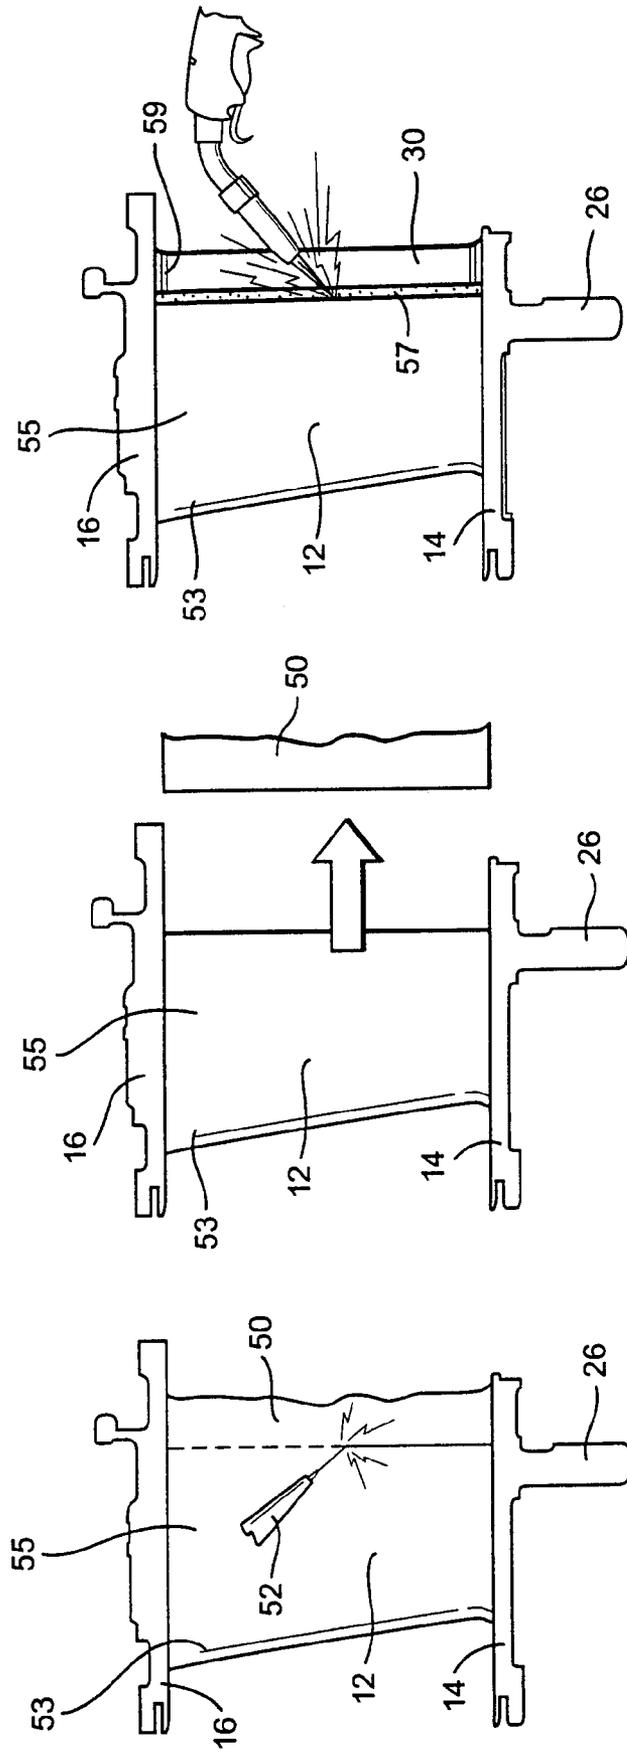
Fig. 9

Particularly, as illustrated in FIG. 9, the coupon **30** is disposed between the inner and outer platforms and the pressure and suction side edges **54** and **56** are welded to the pressure and suction side edges of the remaining portion of the airfoil to form a repaired airfoil having the same aerodynamic configuration as the original airfoil. Additionally, however, it will be appreciated that the cooling configuration of the trailing edge of the repaired airfoil has been changed by the removal of the damaged trailing edge region **50** and the addition of the coupon **30** with the aforedescribed cooling configuration.

The weld-up of the coupon **30** to the remaining portion of the airfoil may be accomplished for example by a TIG welding process. The welds **57** proceed along the opposite sides of the airfoil between the inner and outer platforms and also between the radial outer and inner edges of the coupon and the outer and inner platforms. The welds are cleaned to provide a smooth surface and fillets **59** (FIG. 9) are applied as necessary and blended with the repaired airfoils having the advanced cooling configuration in each of these segments.
