(12) **United States Patent**  
**Gluskin et al.**

(54) **INFRASTRUCTURE CORROSION ANALYSIS**

(71) Applicant: **Quanta Associates, L.P.**, Houston, TX (US)

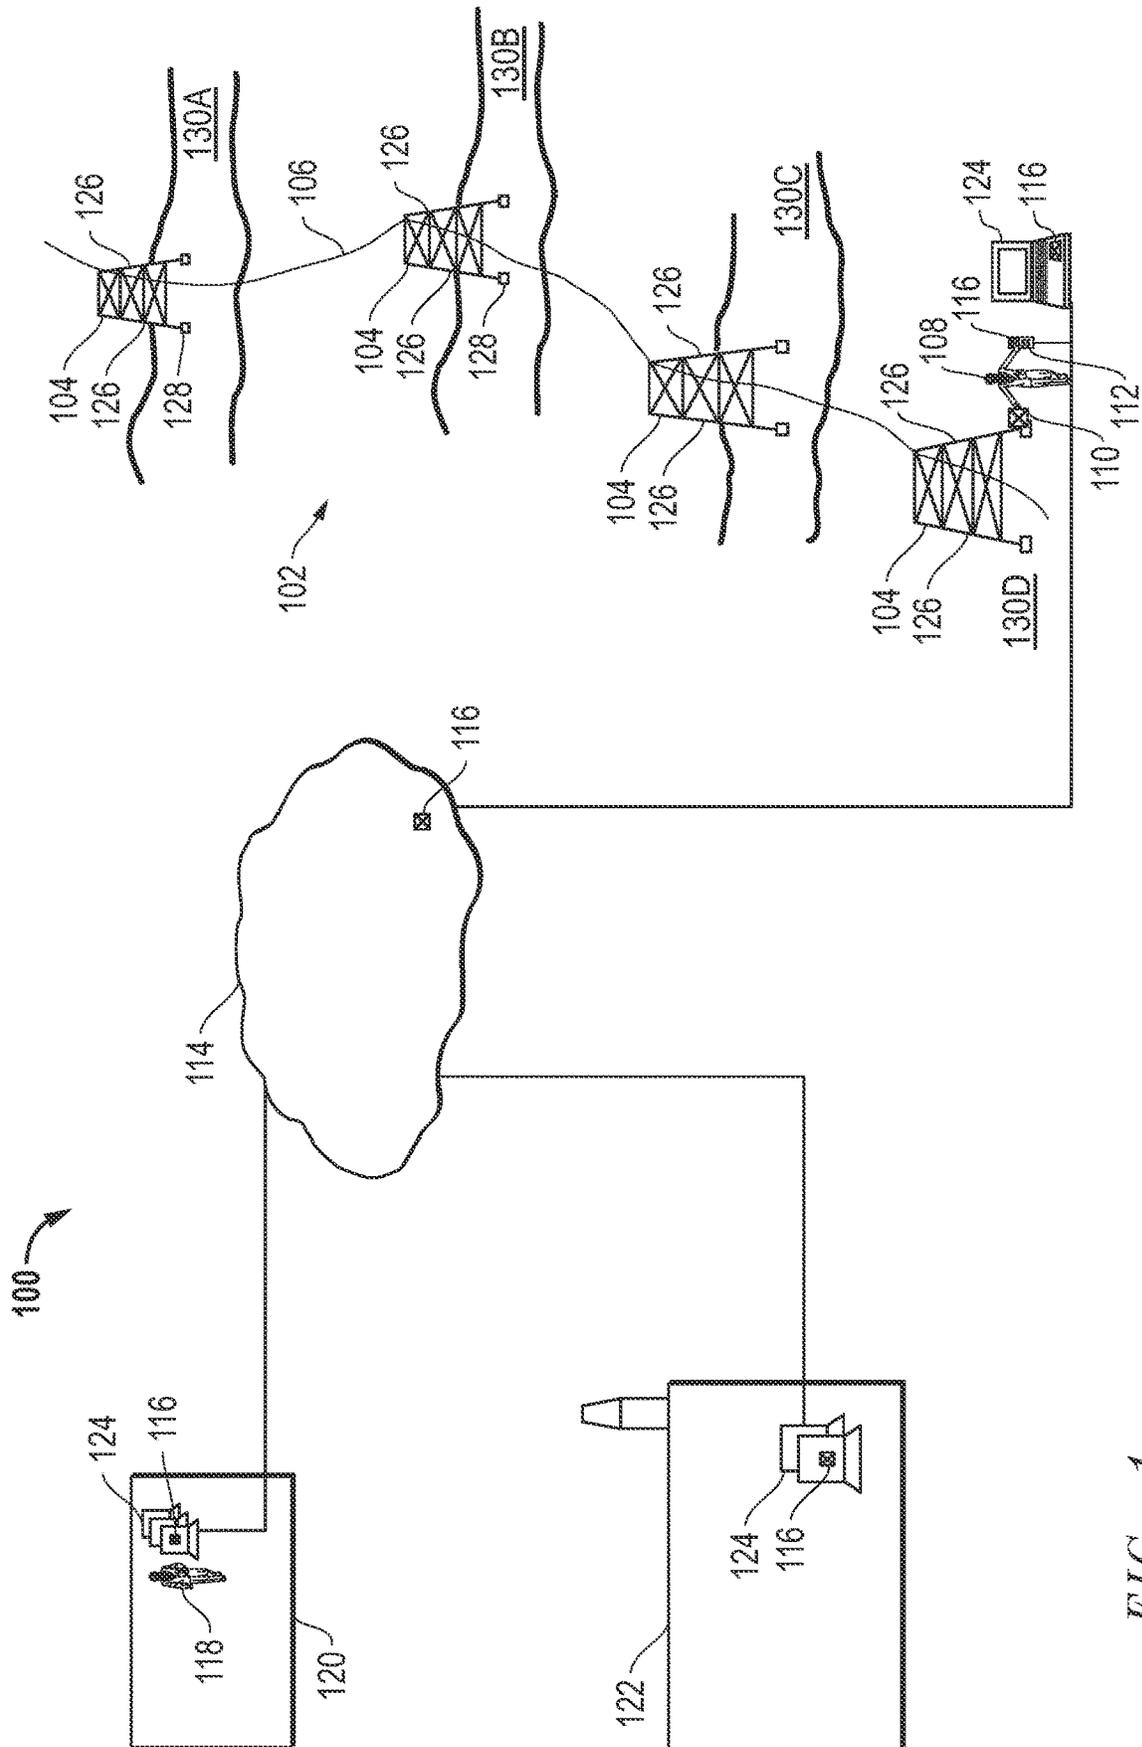
FIG. 1 depicts a schematic view of an infrastructure analysis system.

FIG. 1 depicts a schematic view of an infrastructure analysis system 100. The infrastructure analysis system 100 may be for analyzing conditions and/or damage to a power infrastructure 102. As shown the infrastructure analysis system 100 is a plurality of transmission towers 104 for supporting a transmission line 106. The infrastructure analysis system 100 may have the power infrastructure 102, one or more field workers 108, one or more data collection tools 110, one or more data input devices 112, a communication network 114 and an infrastructure unit 116. In addition the infrastructure analysis system 100 may have one or more analysis workers 118 at a service company 120. The service company 120 may be hired to perform analysis, maintenance, remediation, and/or construction on the power infrastructure 102. Further, the infrastructure analysis system 100 may communicate with a client company 122. The service company 120 and/or the client company 122 may have any number of computers 124 which may have the infrastructure unit 116 therein. In addition to, or as an alternative to, the one or more data input devices 112, the field worker may have a computer 124.

The transmission towers 104 may be any suitable transmission towers or transmission line supports. The transmission towers 104 may have one or more legs 126 and one or more tower footings 128. The tower footings 128 may secure into a soil 130(A-D) for securing the transmission tower 104 in place. The tower footings 128 may secure to the legs 126 or be integral therewith. The tower footing 128 may be steel member foundations having multiple components as shown in FIGS. 2A and 2B. The soil 130A-D at each of the transmission towers 104 may be similar or may vary at each transmission tower 104 or at each leg 126.

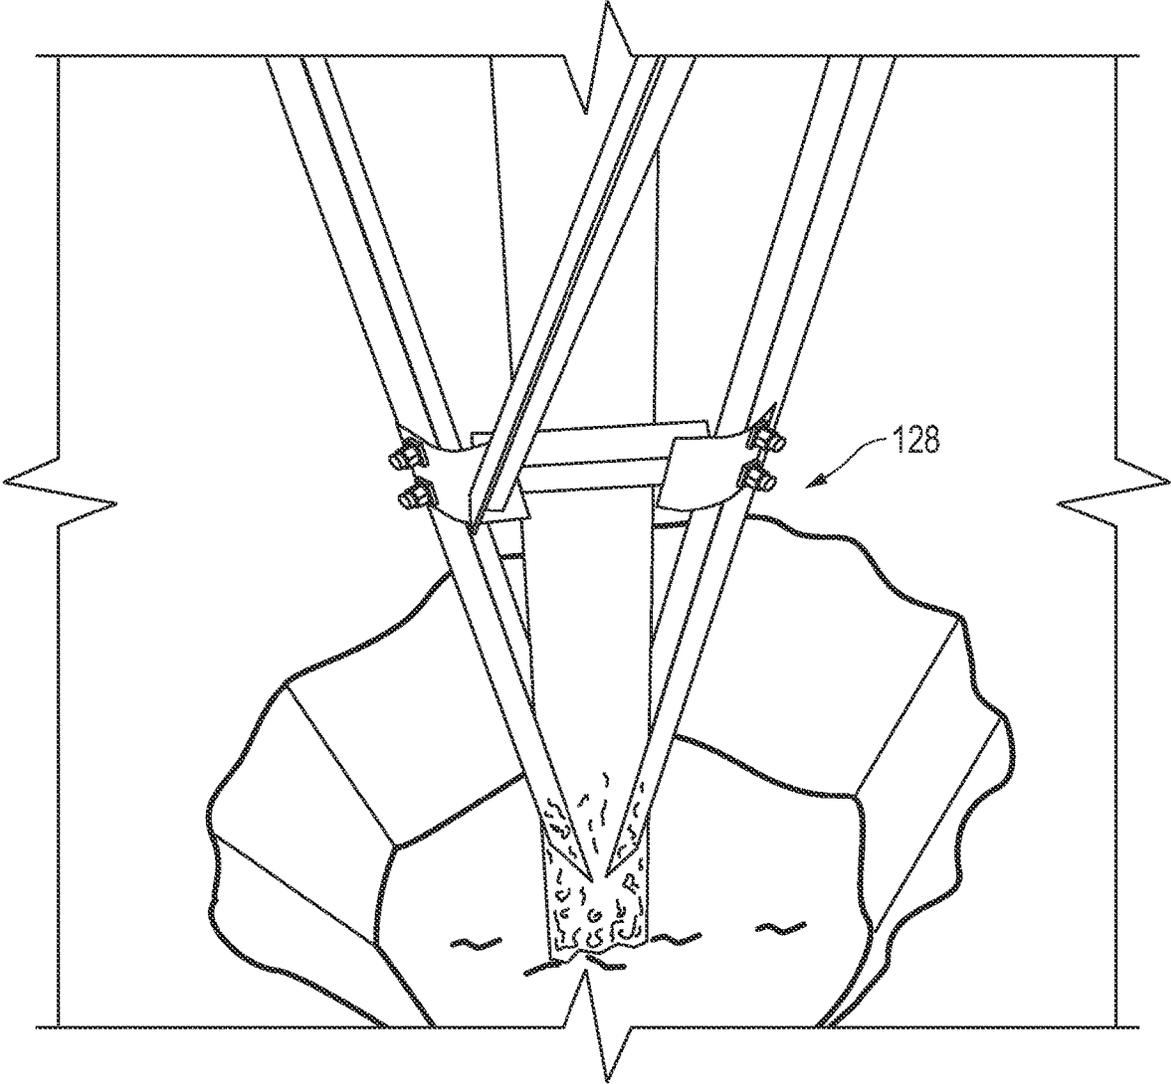
FIG. 2A

FIGS. 2A and 2B depict a view of a tower footing according to one embodiment.

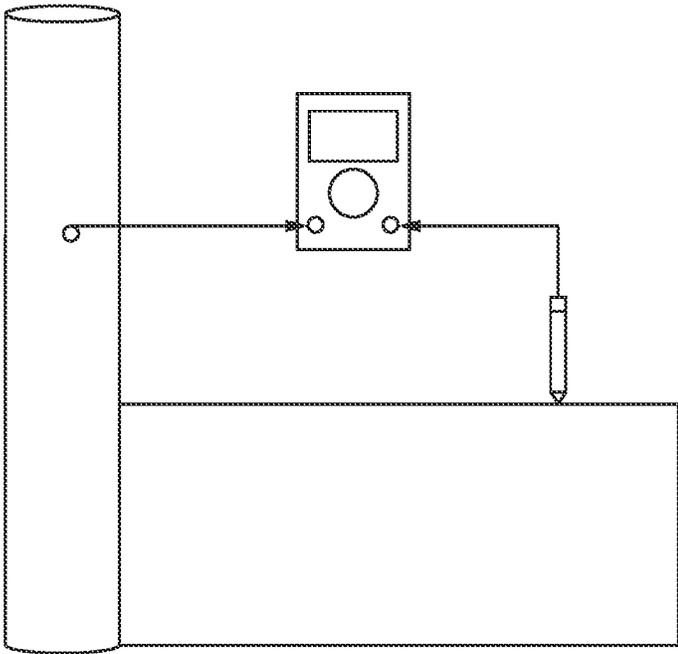
FIG. 3A

FIGS. 3A and 3B depict a schematic view of data collection systems or methods.

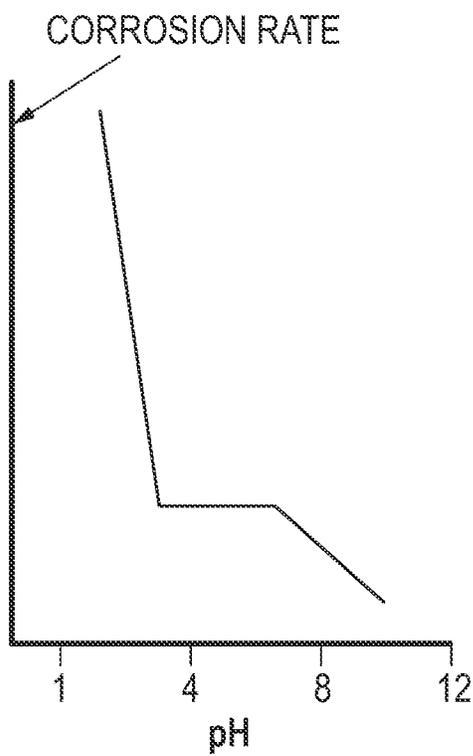
FIG. 4B

5 FIGS. 4B and 4C depict pH versus corrosion rate graphs for steel and zinc respectively.

A pH of 7 is considered neutral and indicates that the number of hydrogen ions in solution is equal to the number of hydroxyl ions in solution. The relationship of pH to the impact of corrosion for steel and zinc is shown in FIGS. 4B and 4C.

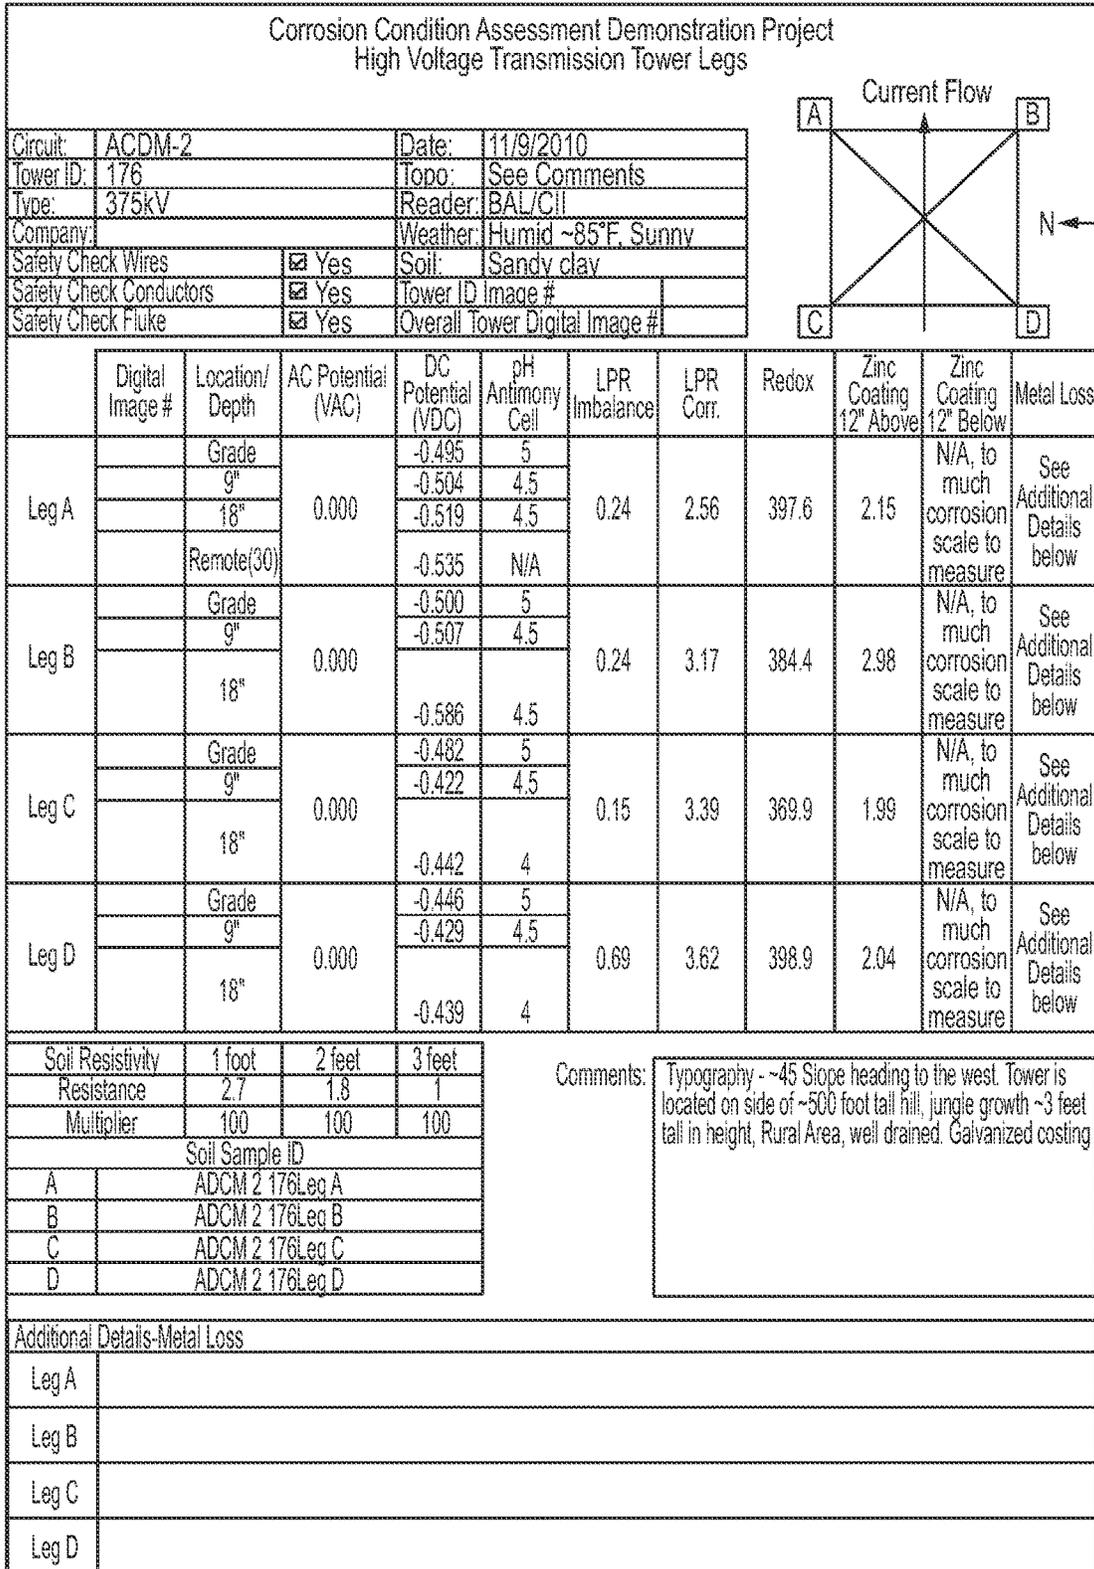
10 FIG. 6 depicts an example of a data collection sheet.

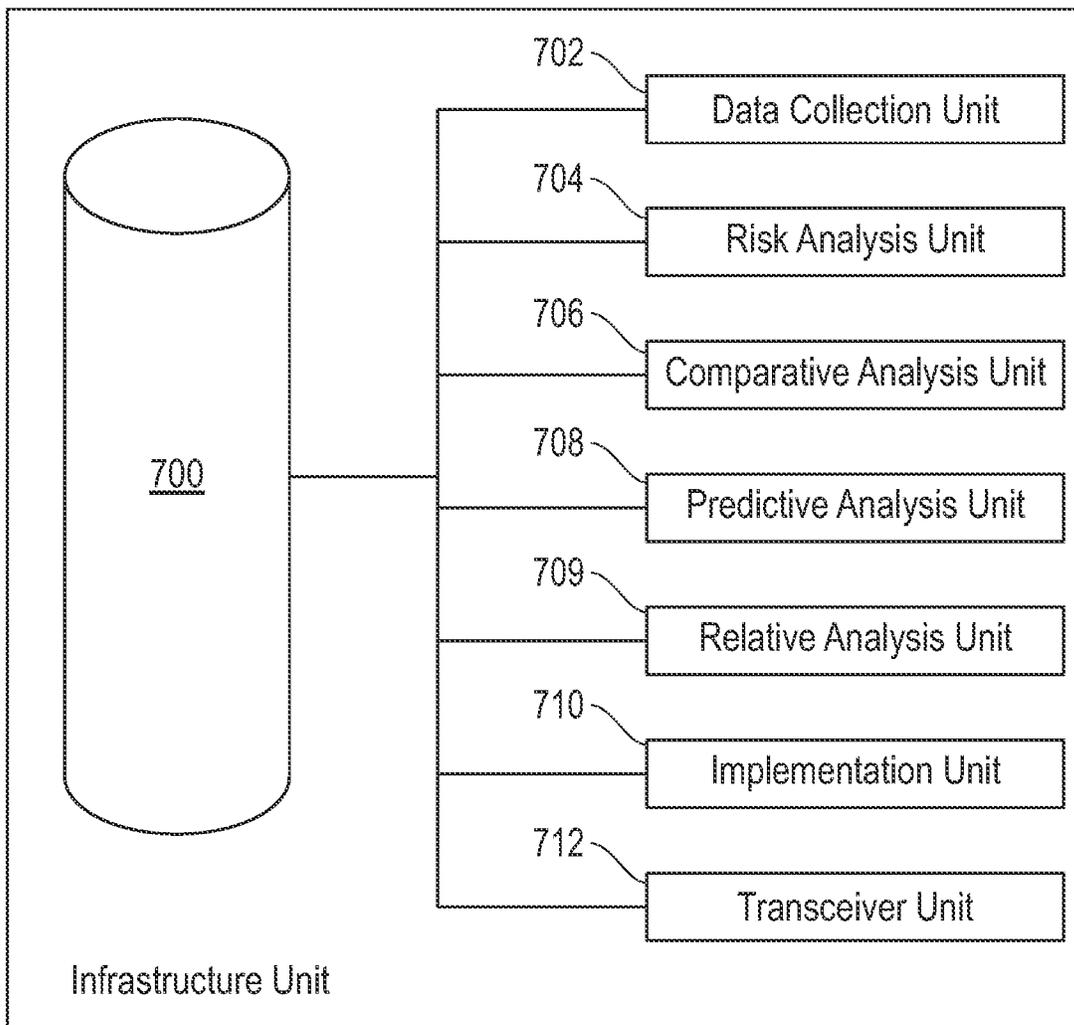
FIG. 7 depicts a block diagram of an infrastructure unit of the infrastructure analysis system.

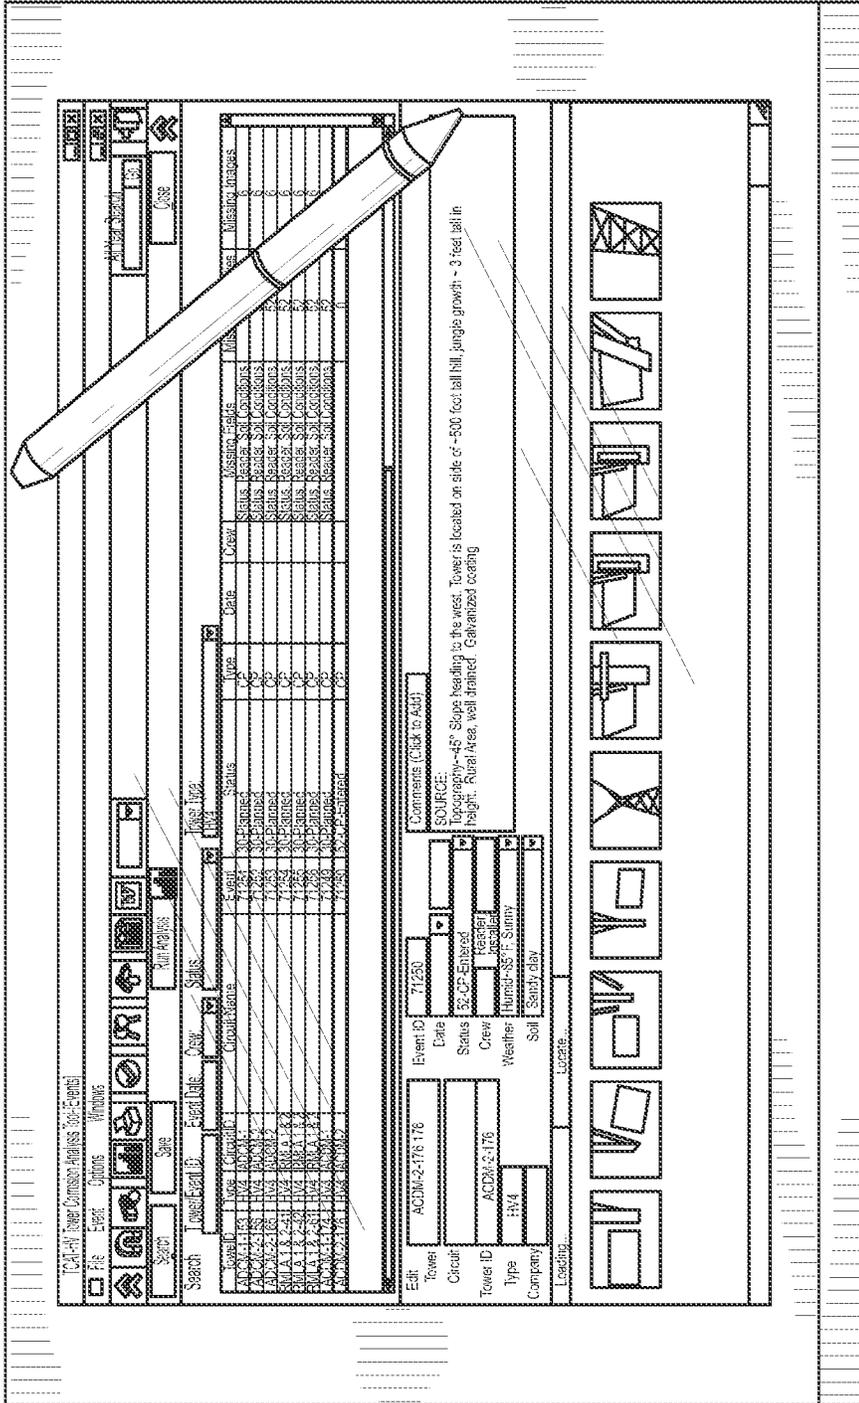
FIG. 8A

FIGS. 8A and 8B depict a portion of a visual display from the infrastructure unit.

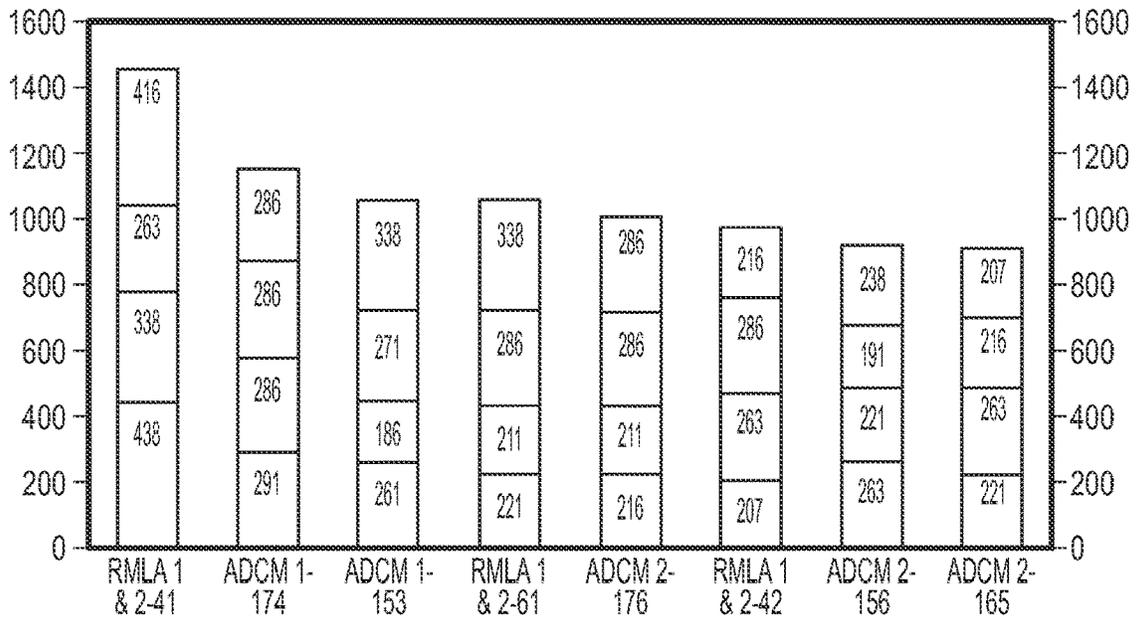
FIG. 10A

FIGS. 10A-10C show displays of various risk scores created by the infrastructure unit.

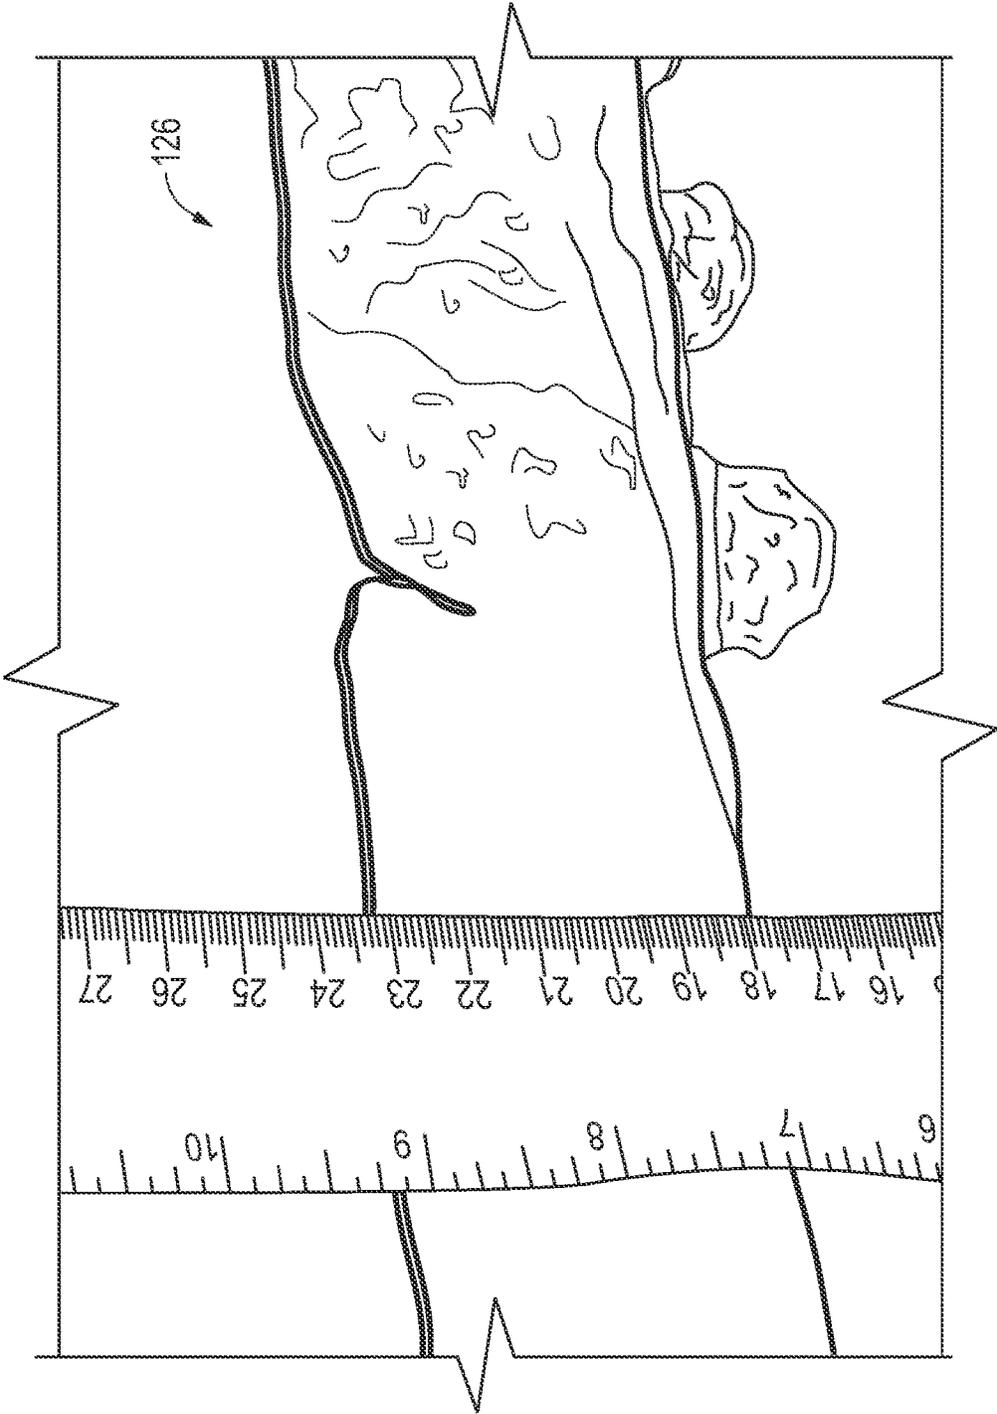
FIG. 13A

FIGS. 13A-13D depict photos of portions of the energy infrastructure.

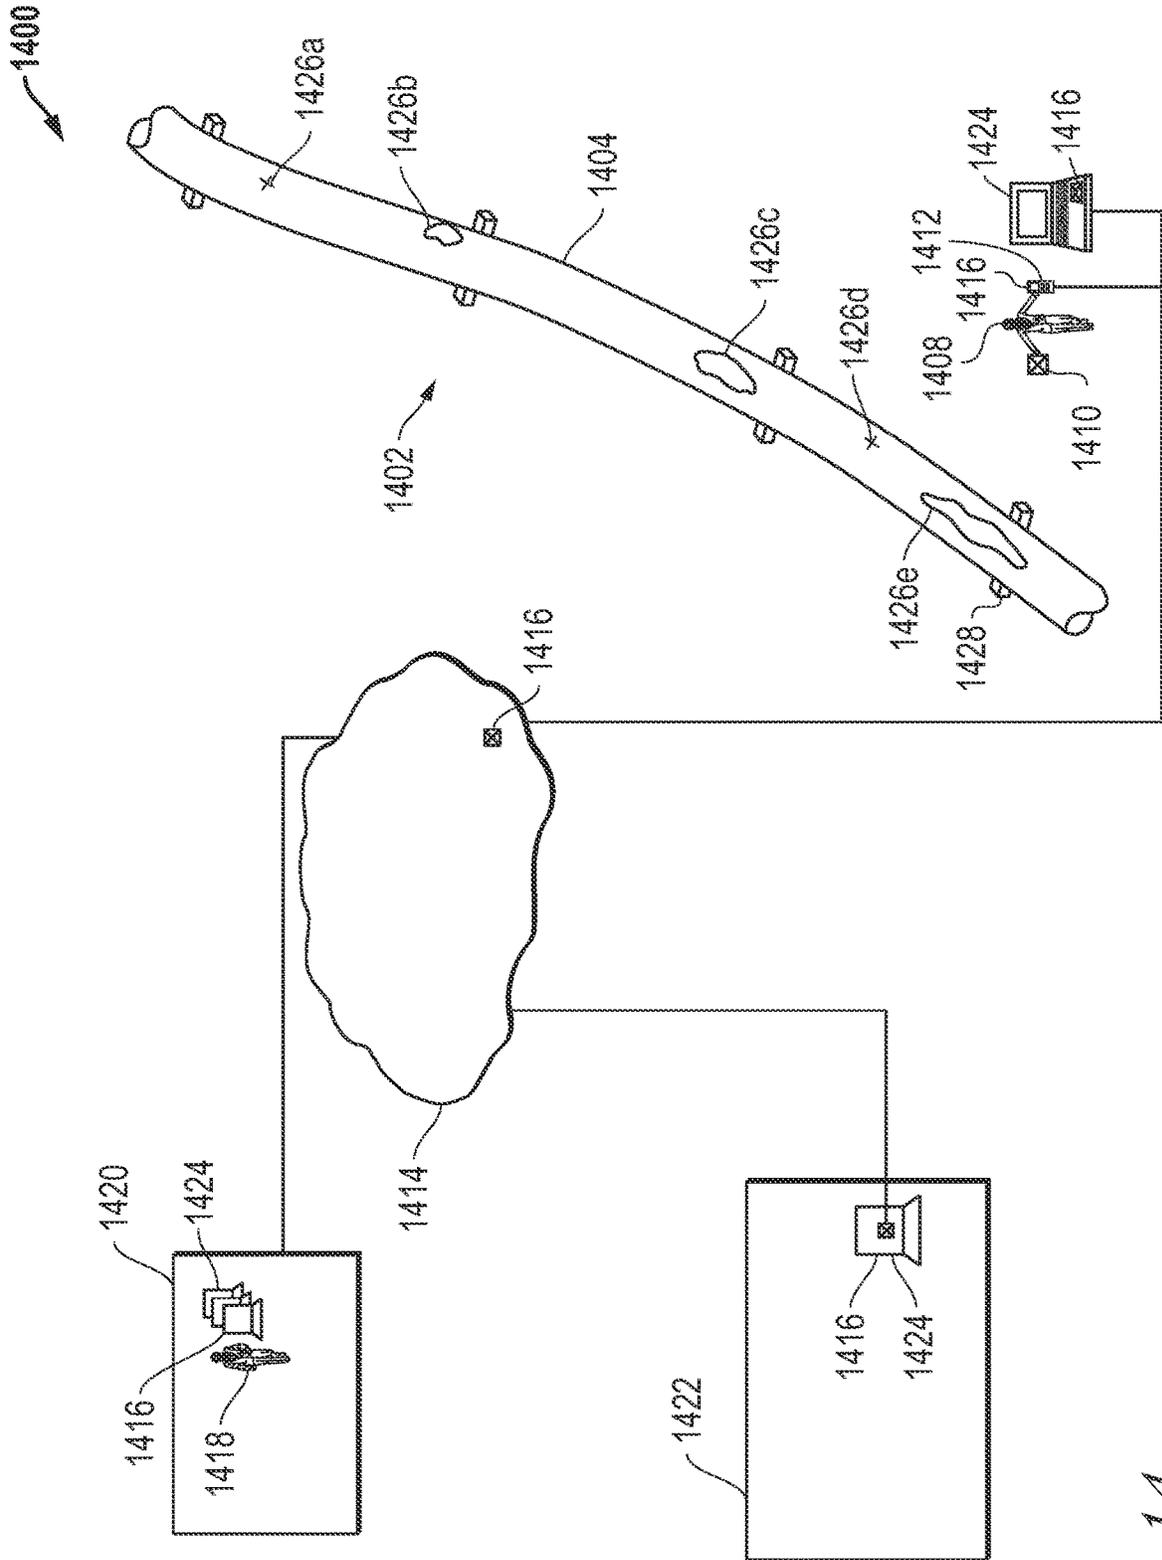
30 FIG. 14 depicts a schematic view of a pipeline analysis system.

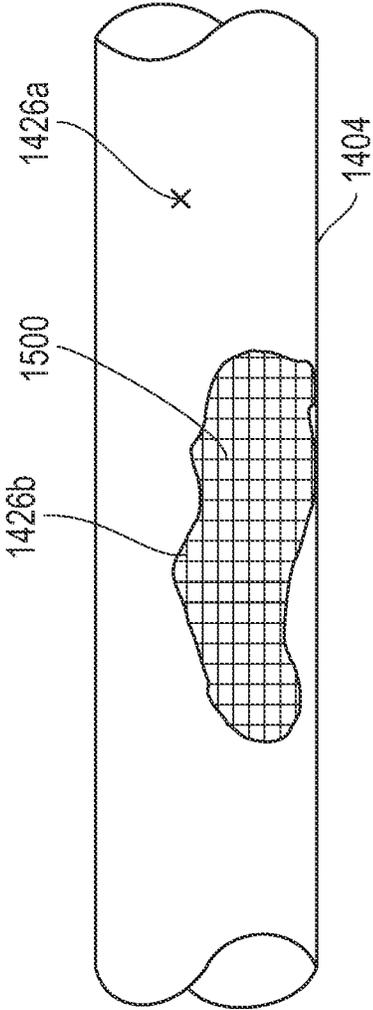
FIG. 15 depicts portion of a pipeline with one or more damaged sections.

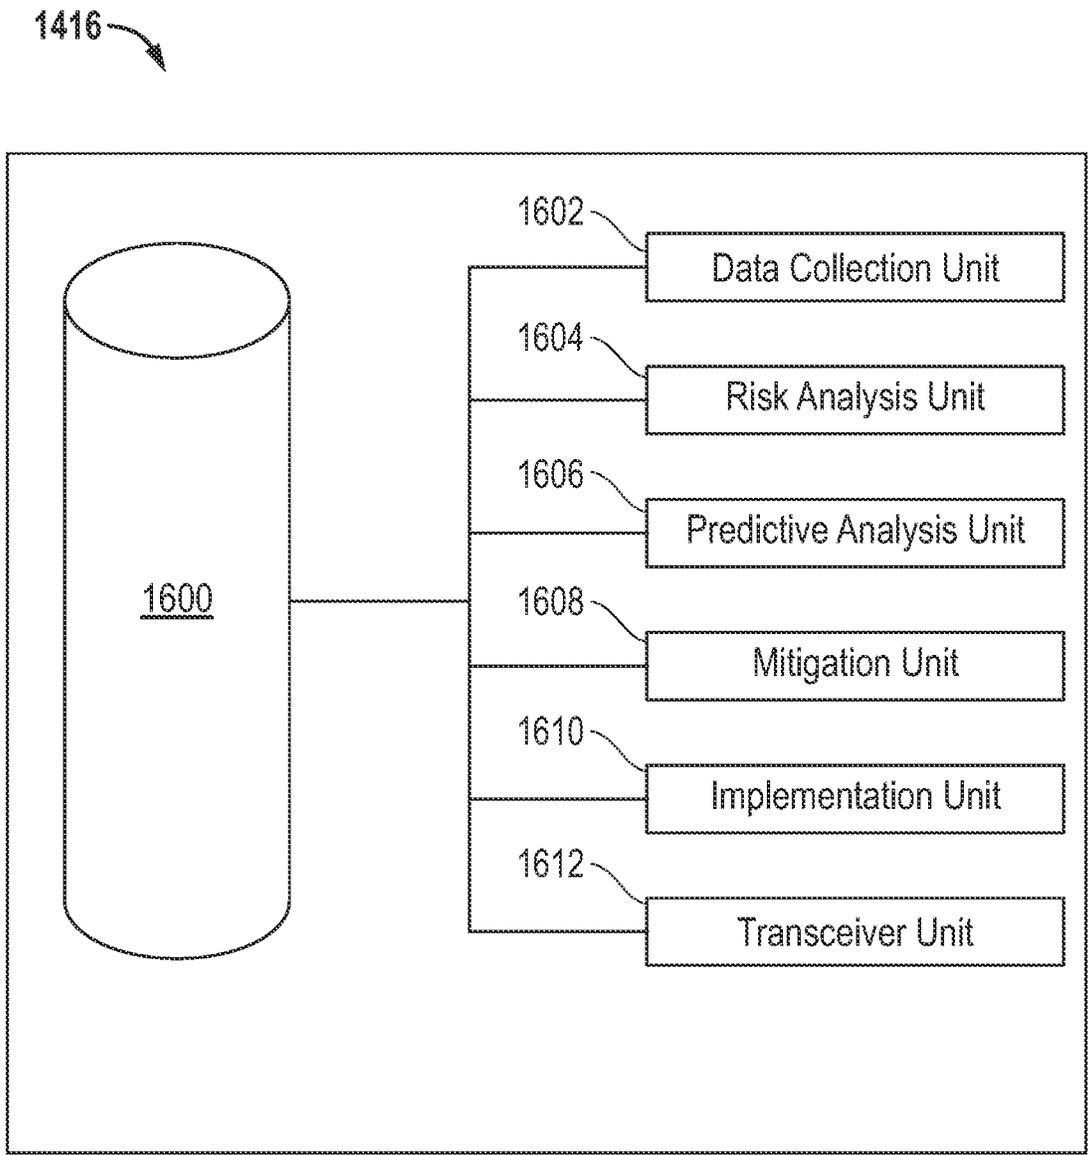
35 FIG. 16 depicts a pipeline infrastructure unit according to an embodiment.

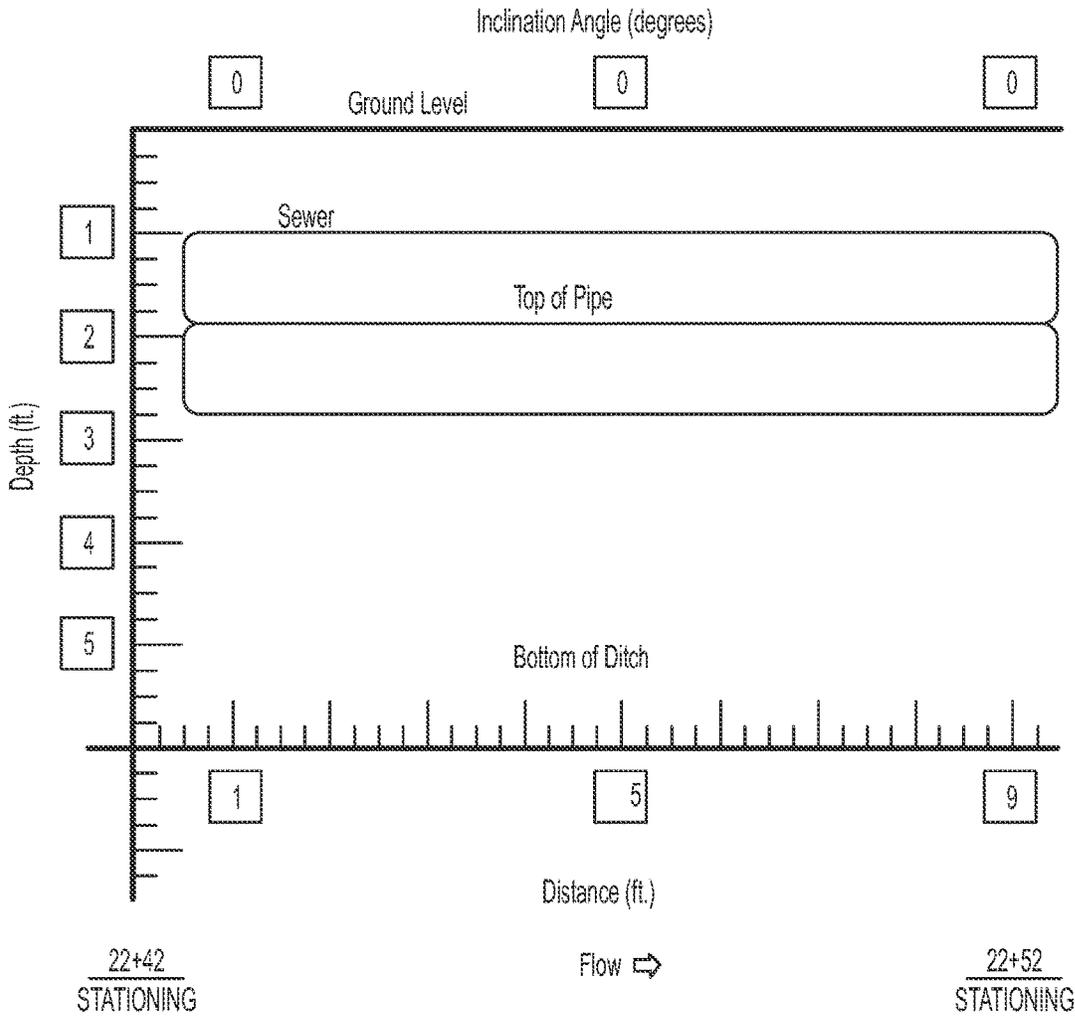
FIG. 17G

Excavation Diagram

FIGS. 17A-17H depict an example of a report used in conjunction with the pipeline analysis system according to an embodiment.

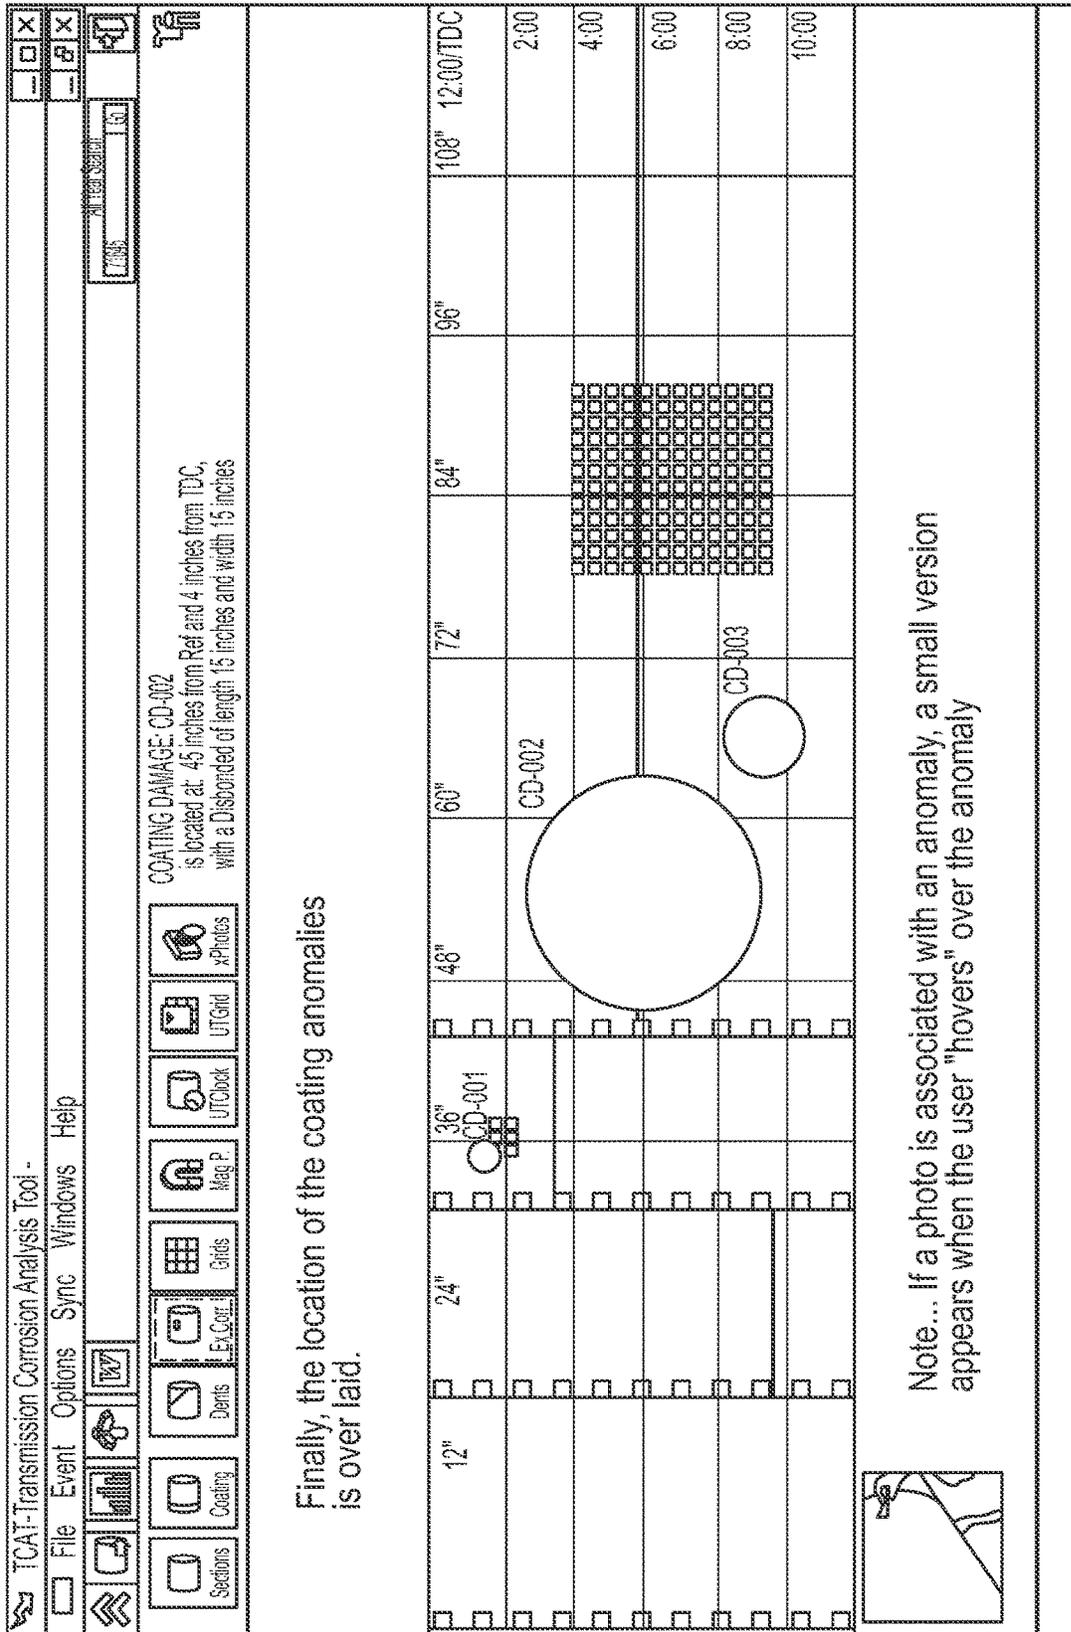
FIG. 18G

40 FIGS. 18A-18H depict screenshots of a visual display from the infrastructure unit.
