(54) **CESSNA TAIL-CONE REINFORCEMENT ANGLE SPLICE, INSTALLATION KIT, AND METHOD FOR INSTALLATION THEREOF**

A tail-cone reinforcement angle of a Cessna 180-185 series aircraft is repaired by the removal of an aft most section of that tail-cone reinforcement angle and its replacement with an elongated splice body. The elongated splice body is attached to the remainder of the tail-cone reinforcement angle and to the tail-cone portion of the fuselage of the aircraft. The aft section of the original tail-cone reinforcement angle is subject to the development and propagation of cracks in the area of the rear pivot shaft receiving bore, which cracks render the aircraft unfit for use. The invention includes the provision of a suitable elongated splice body, a method for its installation, and a tool kit which is usable in accomplishing the removal and replacement of the aft section of the tail-cone reinforcement angle.

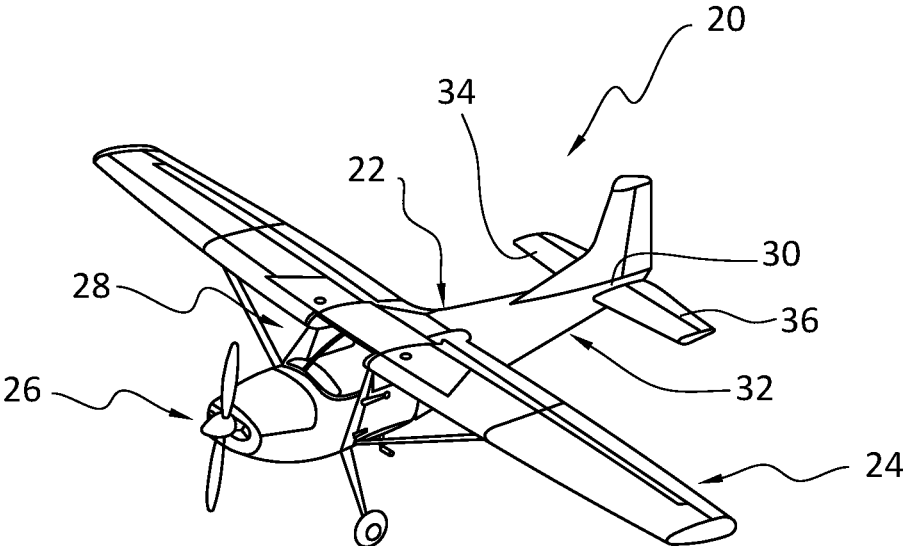
FIG. 1 is a schematic depiction of a Cessna series 180-185 series aircraft with which the pertinent invention is intended for use;

Referring initially to FIG. 1 of the patent drawings filed in the subject U.S. patent application, there may be seen, generally at **20**, a typical Cessna 180-185 series aircraft with which the tail-cone reinforcement angle splice, in accordance with the present invention, finds particular usage. Aircraft **20**, as is well known to one familiar with such aircraft, includes a fuselage, generally at **22**, forward upper mounted wings **24**, an engine and propeller assembly **26**, a cockpit **28** and a rear elevator and stabilizer assembly generally at **30**. The rear elevator and stabilizer assembly generally at **30**, is attached to a rear portion of the fuselage **22**, in an area that fuselage known as the tail-cone **32**, which tail-cone area **32** is seen somewhat schematically in FIG. 2. The rear stabilizer and elevator assembly, generally at **30**, includes a pivotally mounted horizontal stabilizer **34** and a pair of elevators **36**. The horizontal stabilizer **34** is attached to the tail-cone, generally at **32**, in an aft portion **38** of the tail cone **32**. The attachment of the horizontal stabilizer **34** is accomplished by providing pivot shafts which are located in the trailing portion of the horizontal stabilizer **34**, which pivot shafts are well known, are not illustrated, and which form no part of the present invention. The horizontal stabilizer is attached to the tail-cone aft portion **38**, of the aircraft's fuselage **22**, through the provision of horizontal stabilizer pivot shaft receiving apertures or bores **40** which

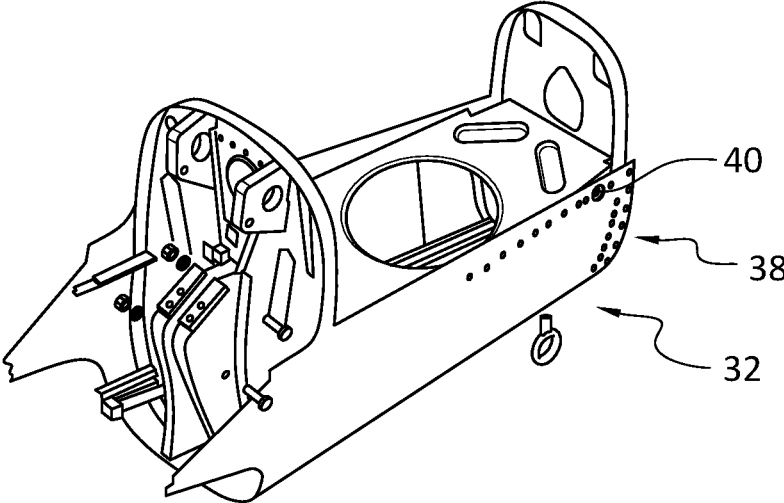
FIG. 2 is a schematic depiction of a tail-cone area of the Cessna 180-185 series aircraft depicted in FIG. 1, and with the horizontal stabilizer, elevator, tail, tail wheel and stinger removed;

Once the tail of the Cessna 180-185 series aircraft has been disassembled, to render the tail-cone assembly as it is depicted in FIG. 2, the installation process may commence. The initial step is to use a suitable reamer, which is supplied in a kit that is provided by the manufacturer of the subject invention, and which is supplied together with, and including the subject tail-cone reinforcement angle splice, as will be discussed subsequently, to ream out both the horizontal stabilizer rear pivot aperture 40 in the tail cone of the fuselage and the underlying bore 44 in the original far aft portion of the now defective tail-cone reinforcement angle. Once this has been accomplished, four aft flush rivets 82, in the tail cone portion 32 of the fuselage 22 and in the underlying blade portion 42 of the tail-cone reinforcement angle, are drilled out. This is depicted in FIG. 9 of the drawings accompanying the application. The holes in the web of the blade portion of the tail-cone reinforcement angle, which result from the drilling out of these four flush rivets 82, will align with the rivet receiving holes 68 in the forward or overlap section 62 of the splice 54.

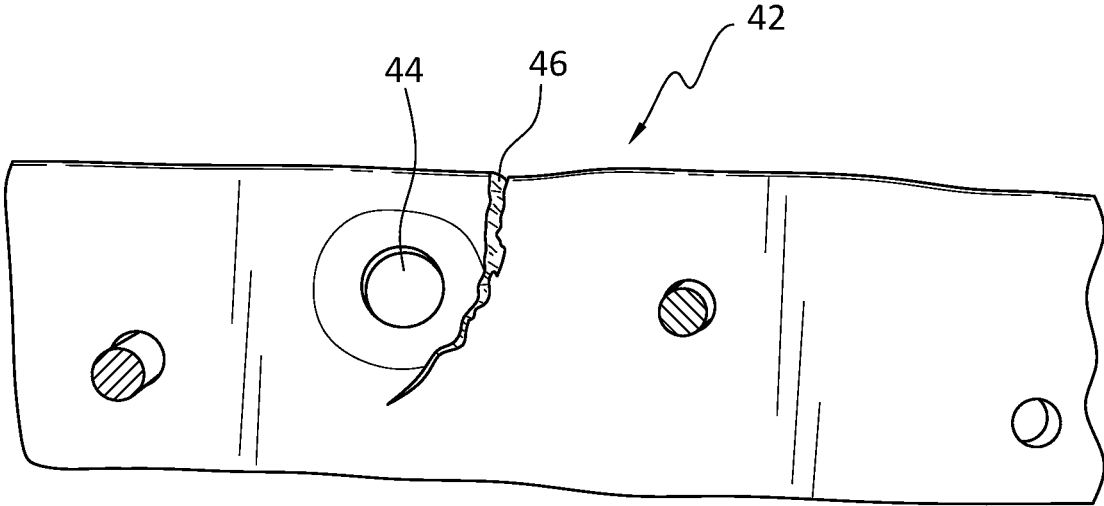
FIG. 3 is a photograph of an aft portion of a tail-cone reinforcement angle showing a typical failure in the horizontal stabilizer pivot shaft receiving bore of tail-cone reinforcement angle;

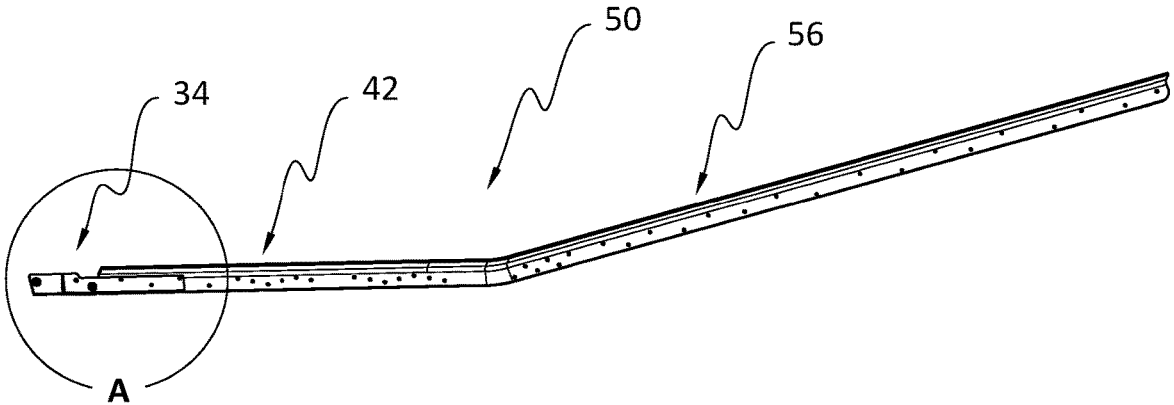
FIG. 4 is a perspective view of a left side tail-cone reinforcement angle including a left side tail-cone reinforcement angle splice, in accordance with the present invention;

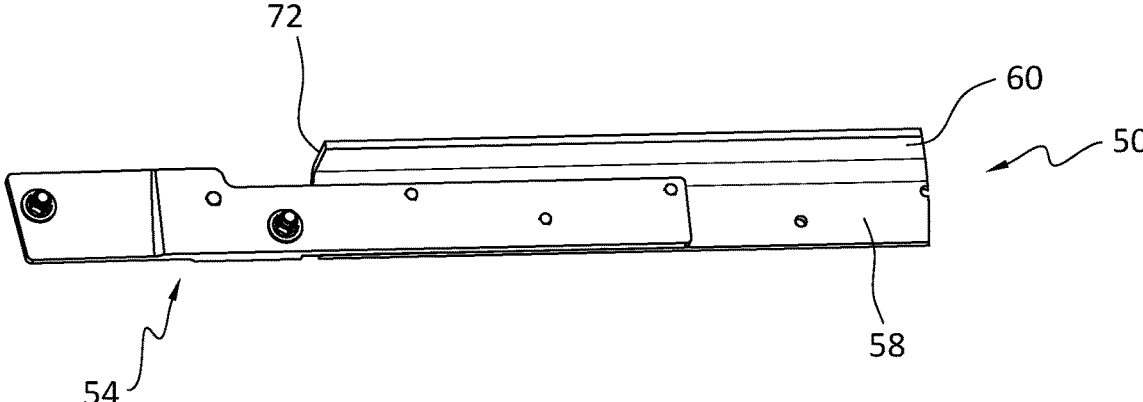
FIG. 5 is a side elevation view of an aft portion of the left side tail-cone reinforcement angle, encircled at A in FIG. 4, with the tail-cone reinforcement angle splice, in accordance with the present invention, in place;

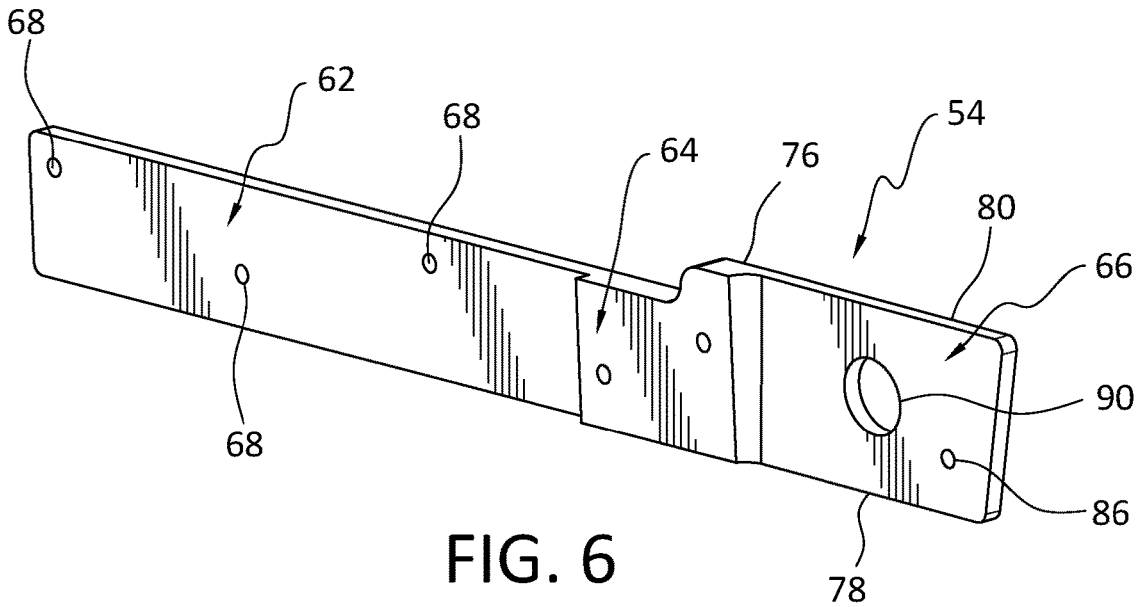
FIG. 6 is a perspective view of a left side tail-cone reinforcement angle splice prior to installation;

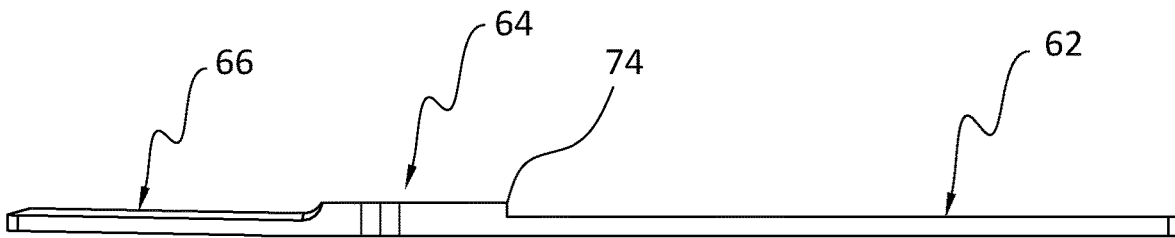
FIG. 7 is a top-plan view of the reinforcement angle splice depicted in FIG. 6;

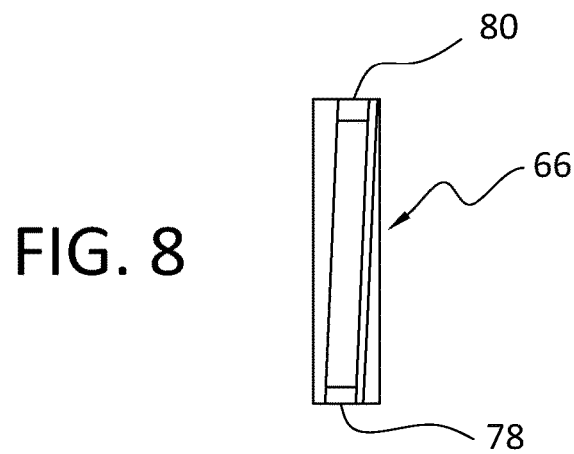
FIG. 8 is an aft end view of the reinforcement angle splice depicted in FIGS. 6 and 7 and taken from the right as seen in FIG. 6 and from the left as seen in FIG. 7;

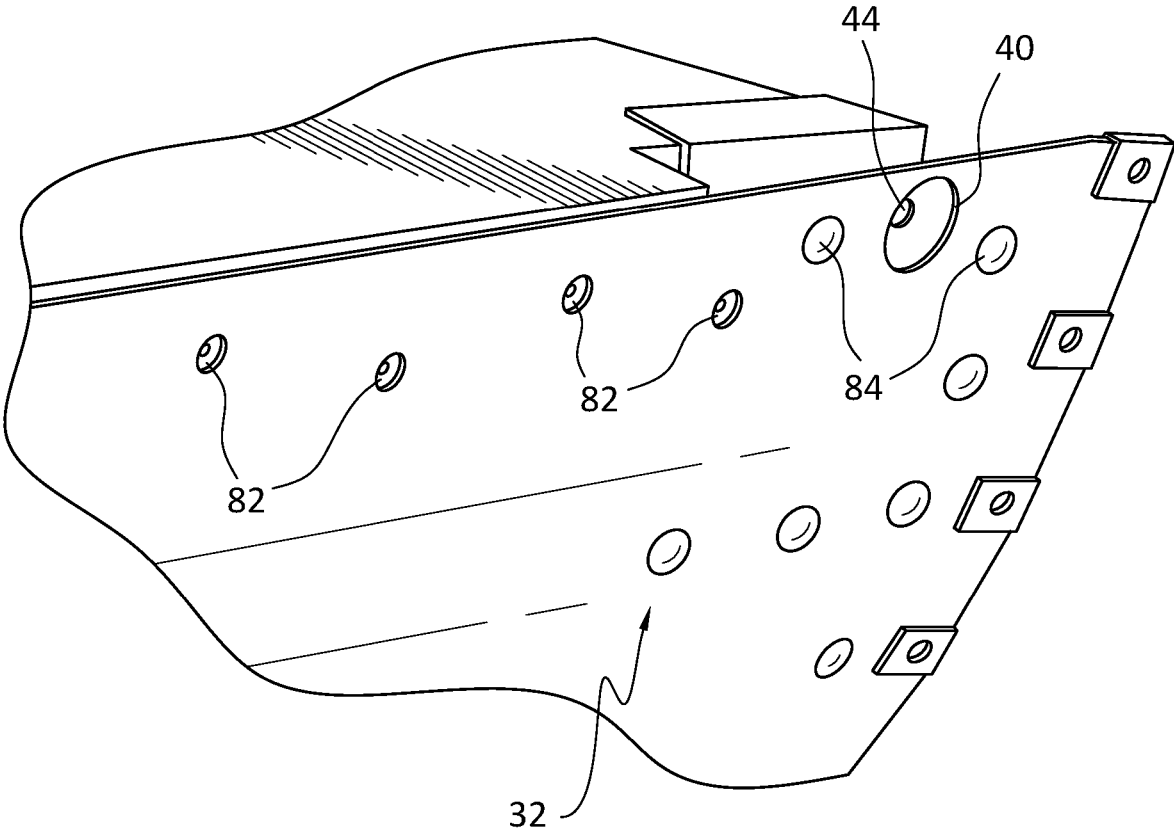
FIG. 9 is a view of an aft portion of the tail cone and showing the removal of four rivets;

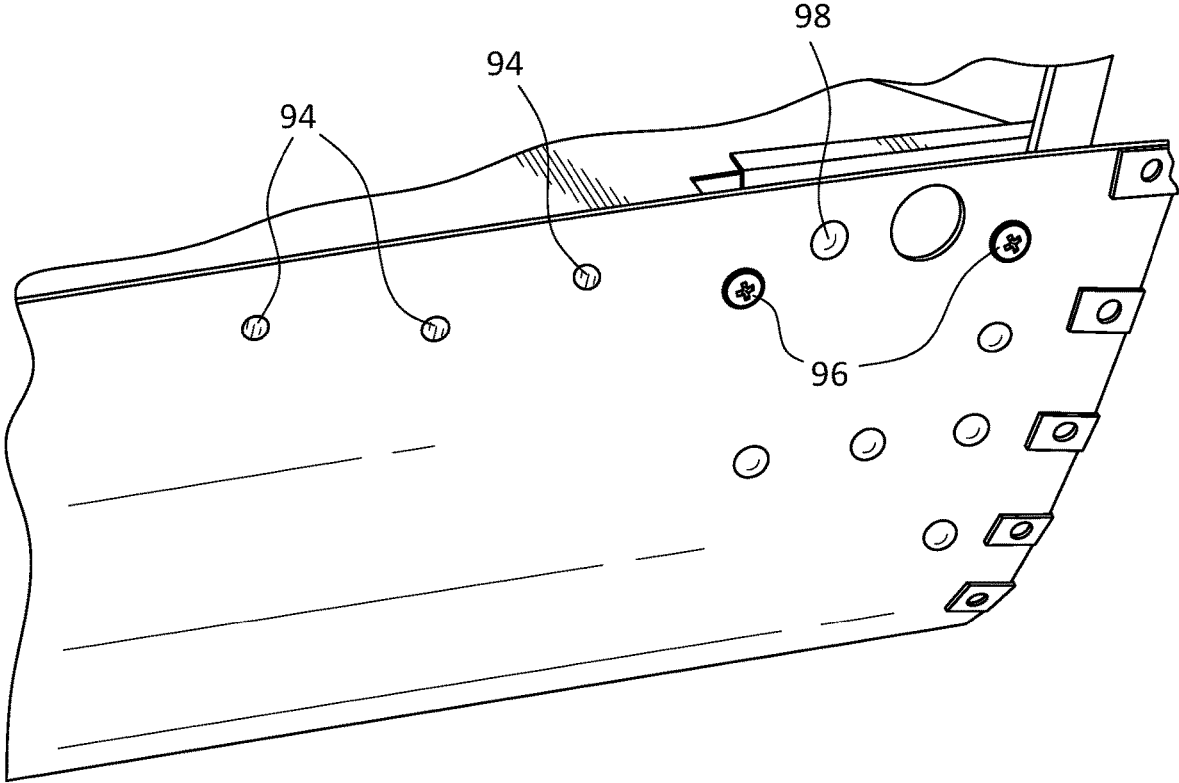
FIG. 10 is a view similar to FIG. 9 with the tail-cone reinforcement angle splice installed and secured in place;

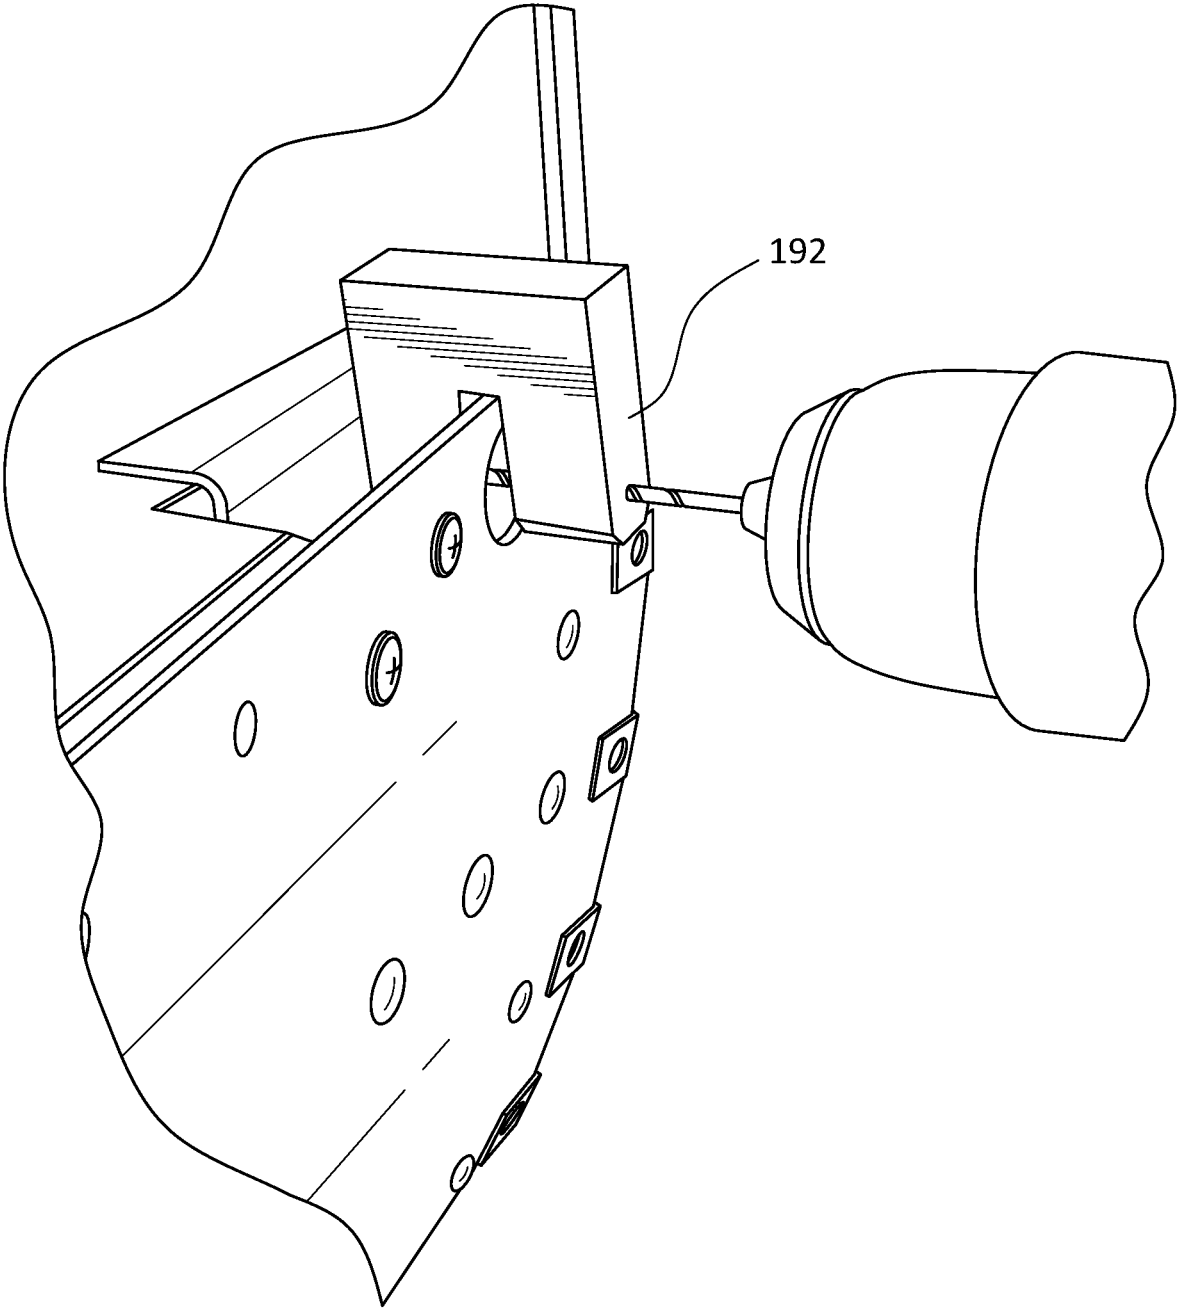
FIG. 11 is a view of the aft section of the tail cone and showing the forming of the horizontal stabilizer shaft receiving bore in the tail-cone reinforcement angle splice;

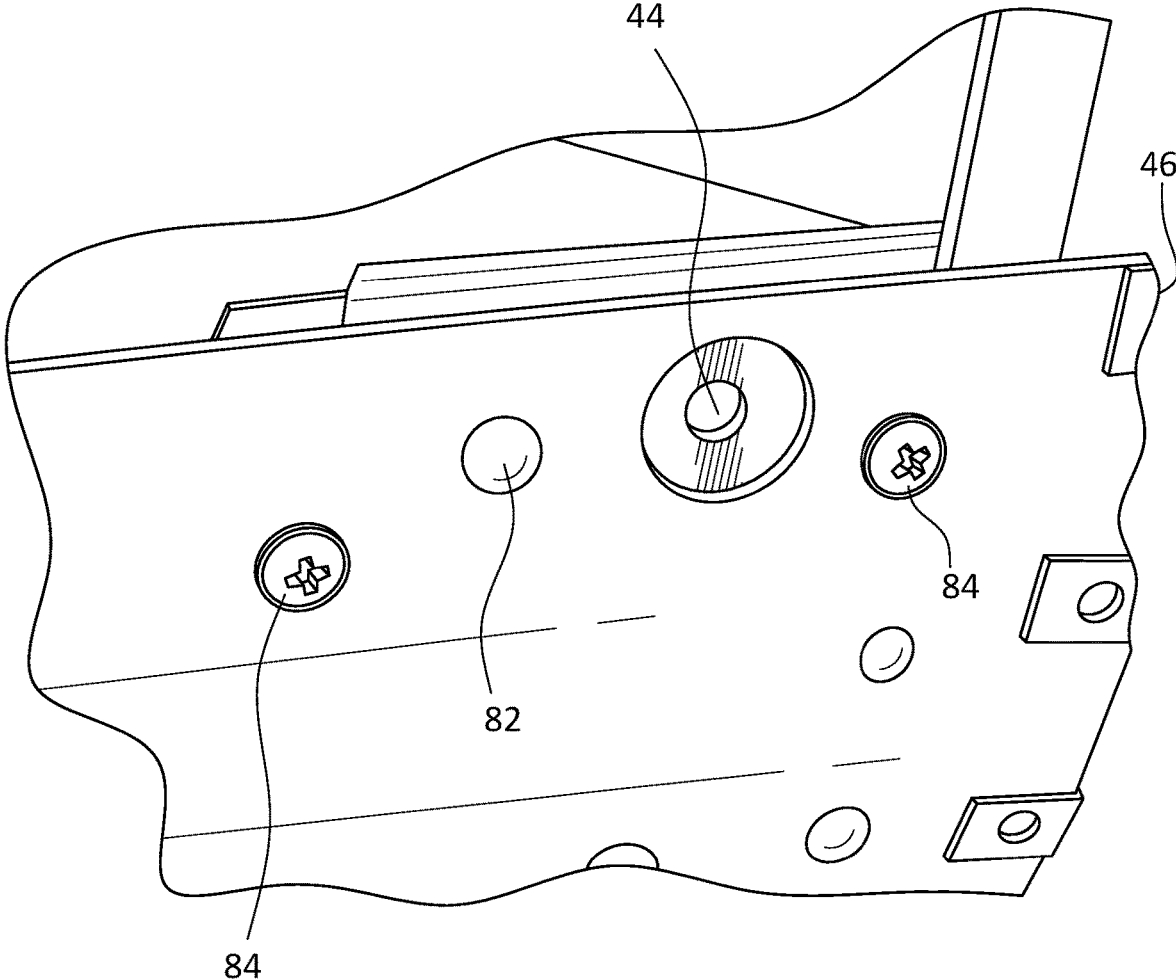
FIG. 12 is a view of the aft section of the tail cone and showing the completed horizontal stabilizer pivot shaft receiving bore formed in the tail-cone reinforcement angle splice; and
