(19) **United States**(12) **Patent Application Publication**  
**Pagano**(10) **Pub. No.: US 2013/0111997 A1**(43) **Pub. Date: May 9, 2013**(54) **METHOD AND APPARATUS FOR  
DETECTING INTERNAL RAIL DEFECTS**(52) **U.S. Cl.**CPC ..... *G01N 29/04* (2013.01)USPC ..... *73/636*(76) Inventor: **Dominick A. Pagano**, Weston, CT (US)(21) Appl. No.: **13/462,971**

An ultrasonic rail inspection system designed to detect defects in a rail which result from longitudinal cracks that propagate in the horizontal and transverse plane of the rail. Detection of this type of defect is possible by directing an ultrasonic beam into the rail at a predetermined angle from the perpendicular to the surface of the rail. The predetermined angle must be sufficient to detect these normally undetectable defects and can be in the range of 8° to 14° from the perpendicular.

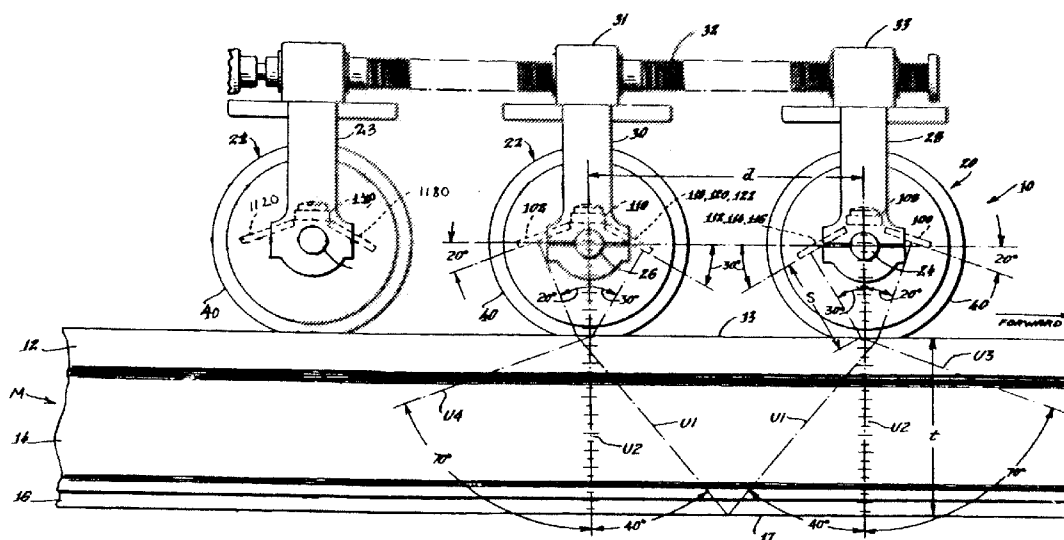
Fig. 1A

[0017] 1. FIG. 1A illustrates a prior art ultrasonic rail detection system;

[0022] FIG. 1 illustrates a prior art two wheel ultrasonic inspection system 10 described in U.S. Pat. No. 4,165,648, which is arranged to detect flaws and defects in a length of test material M, illustrated as a rail having a substantially rectangular head 12 with an upper surface 13, a vertical web 14, and a base 16 with a bottom surface 17 typically resting on ties (not shown.)

[0024] As illustrated in FIG. 1 the leading and trailing wheels 20 and 22 have zero degree transducers 108 and 110 which are oriented to emit beams U2 of ultrasonic energy downward perpendicularly through Teflon (polytetrafluoroethylene) waveguides to surface 13 into the test material. The downward-looking (zero degree) transducers 108 and 110, used in a pulse echo mode, can indicate whether there is a head and web separation, and can indicate the presence of bolt holes, bolt hole cracks, and some vertical split heads that occur in the web region. These zero degree transducers can also detect the horizontal component of detail fractures as described below. It is to be noted that these zero degree transducers 108 and 110 are mounted high up within the wheel. This location advantageously provides a long travel path of at least two inches within the wheel, which avoids problems of undesired echoes interfering with the reflected energy U2 returning from the bottom 17 of the test material M. The Teflon waveguides serve to reduce beam divergence and thus also eliminate false echoes.

[0028] The prior art system shown in FIG. 1A shows the use of both a leading 20 and trailing 22 wheel. For purposes of the present invention a third single wheel 21 is shown in FIG. 1B and FIG. 1C and is used with the leading 20 and trailing 22 wheel. In one embodiment, the single wheel 21 has one zero degree transducer 1100 and two 70 degree transducers 1180, 1120. In other embodiments the single wheel 21 will have one or more than two of each zero degree transducer 1100 and 70 degree transducers. Operation of the zero degree transducer 1100 and the 70 degree transducers 1180, 1120 in the third wheel 21 will be in accordance with the teachings in U.S. Pat. No. 4,165,648.

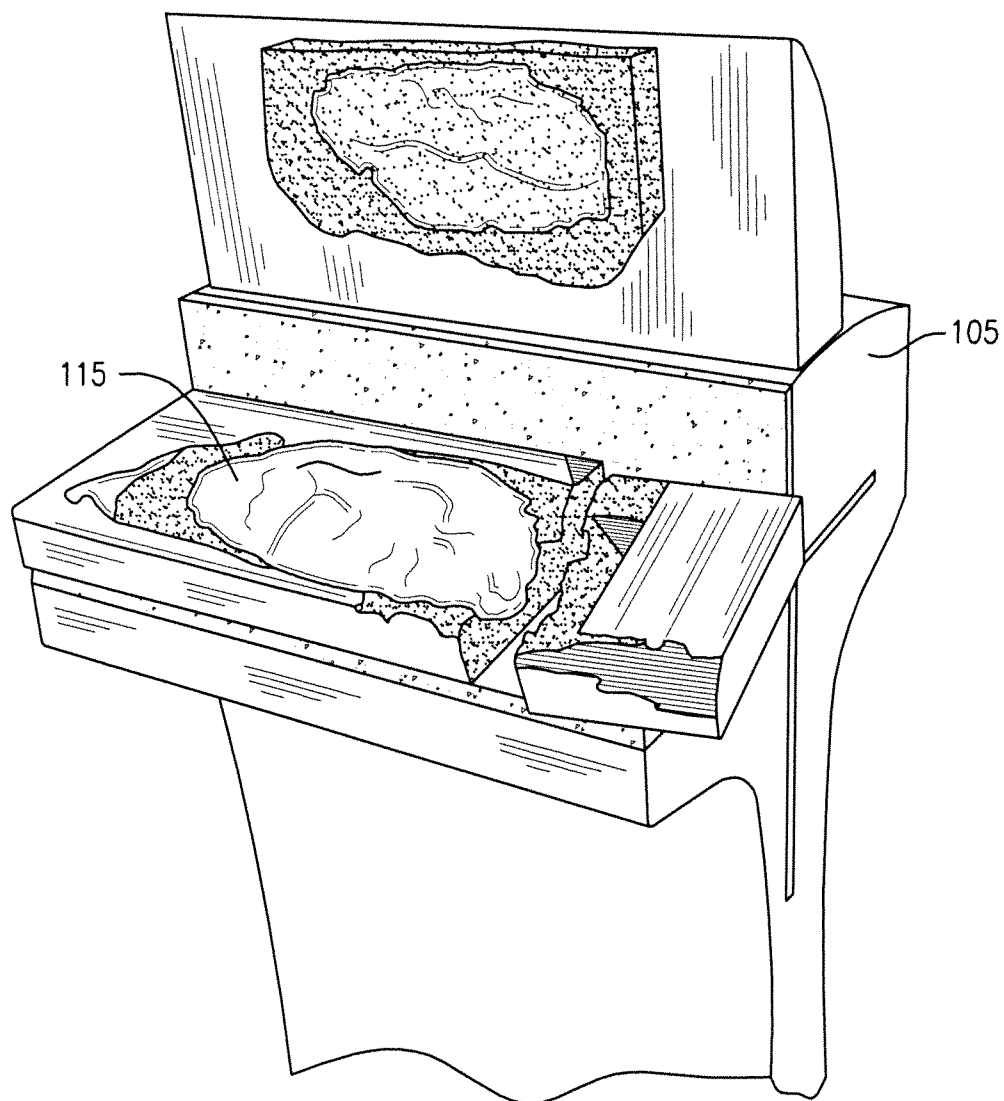
FIG. 2

[0020] 4. FIGS. 2-5 illustrate detailed fractures which can be detected with the invention; and

[0026] Referring now to FIG. 2, there is shown a portion 105 of a railroad rail which has been cut into sections to reveal the existence of internal defect 115. Based on the analysis of samples such as rail portion 105 it has been determined that the genesis of this class of internal defects, such as defect 115 defined herein as a detail fracture, is that the defect starts out as a longitudinal seam that propagates in the horizontal plane to become a deep shell or horizontal split head as illustrated in FIG. 2.

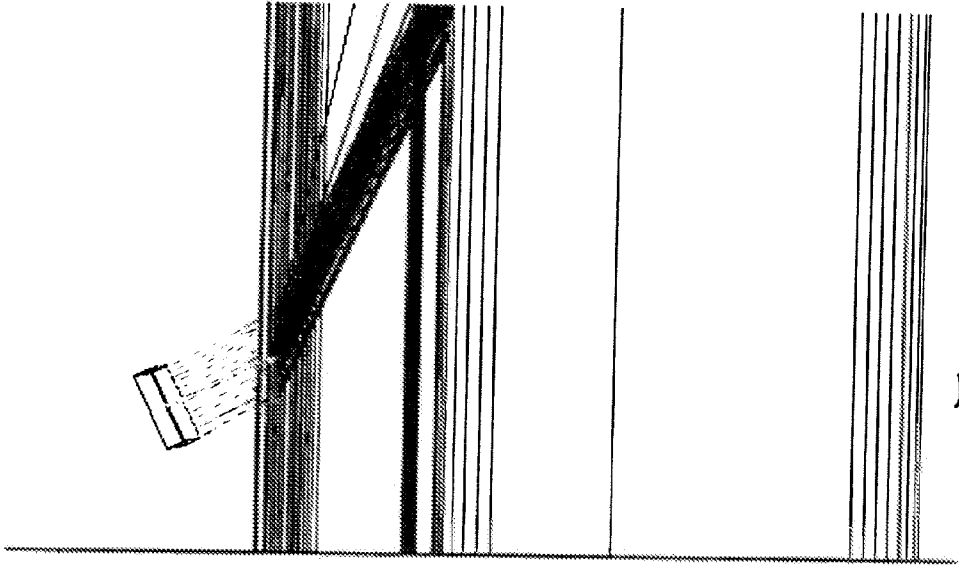
Fig 9B

Normal 70 Degree with  
Defect and Without Tilting

[0032] The teaching of the present invention with respect to the third single (or sensing) wheel **21** on the rail **12** is shown using end schematic section views of FIGS. 7, 9A, 9B, and 10A, 10B. Here, when looking at the end view of the rail **12**, the third single wheel **21** is shown angled to the left or right of the rail or, stated a different way, the wheel **21** is tilted perpendicular to the vertical plane and out of vertical alignment with the rail **12**.

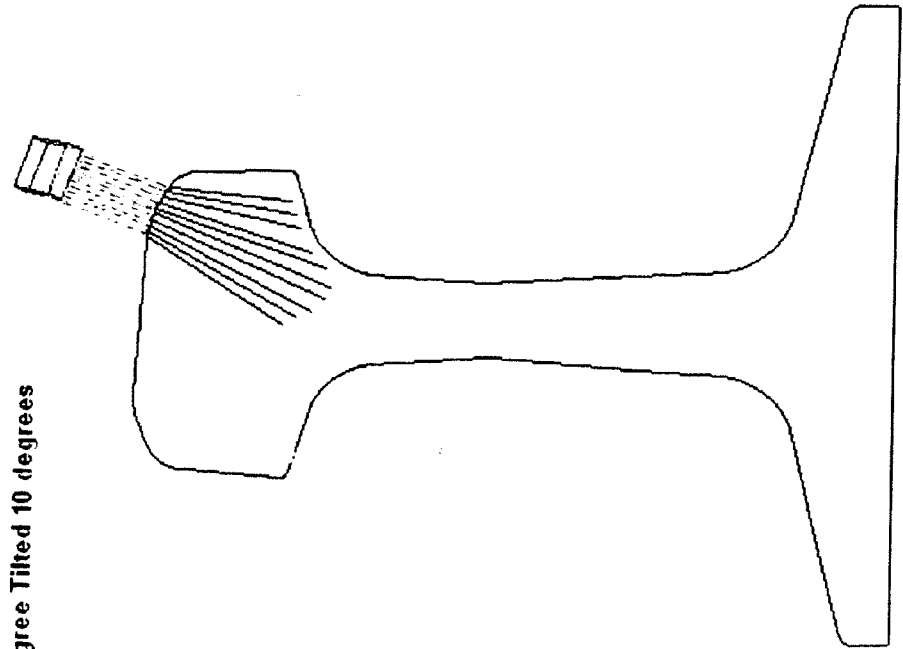
Fig 9A

70 Degree Tilted 10 degrees

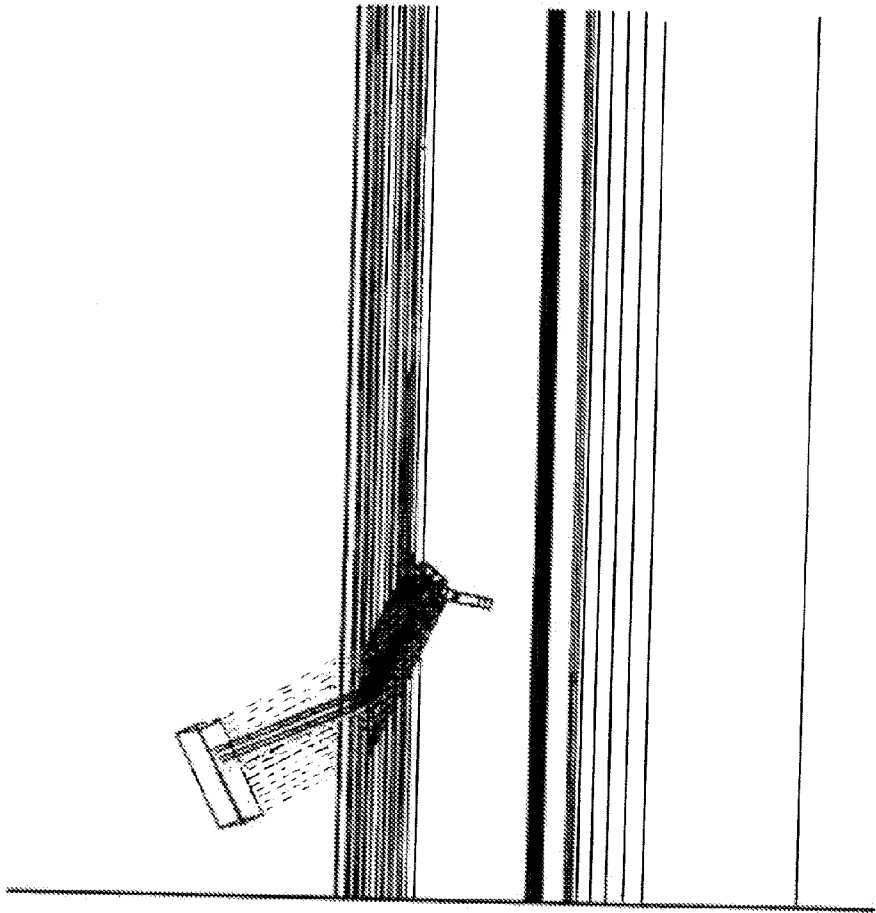
Fig 10B

70 Degree Tilted 10 Degrees  
with defect
