(54) **METHOD FOR REPAIRING AN AIRCRAFT FUSELAGE**

(73) Assignee: **AIRBUS OPERATIONS S.A.S.**,
Toulouse (FR)

A method for repairing damage to the coating of an aircraft fuselage, the coating being made of fiber-reinforced composite material. This method comprising making a cut-out in the fuselage with a substantially parallelepipedal outline around the damage and drilling a circular hole substantially centered on the intersection of the sides of the outline of the parallelepiped of the cut-out at each of the corners of the outline before the cutting out operation.

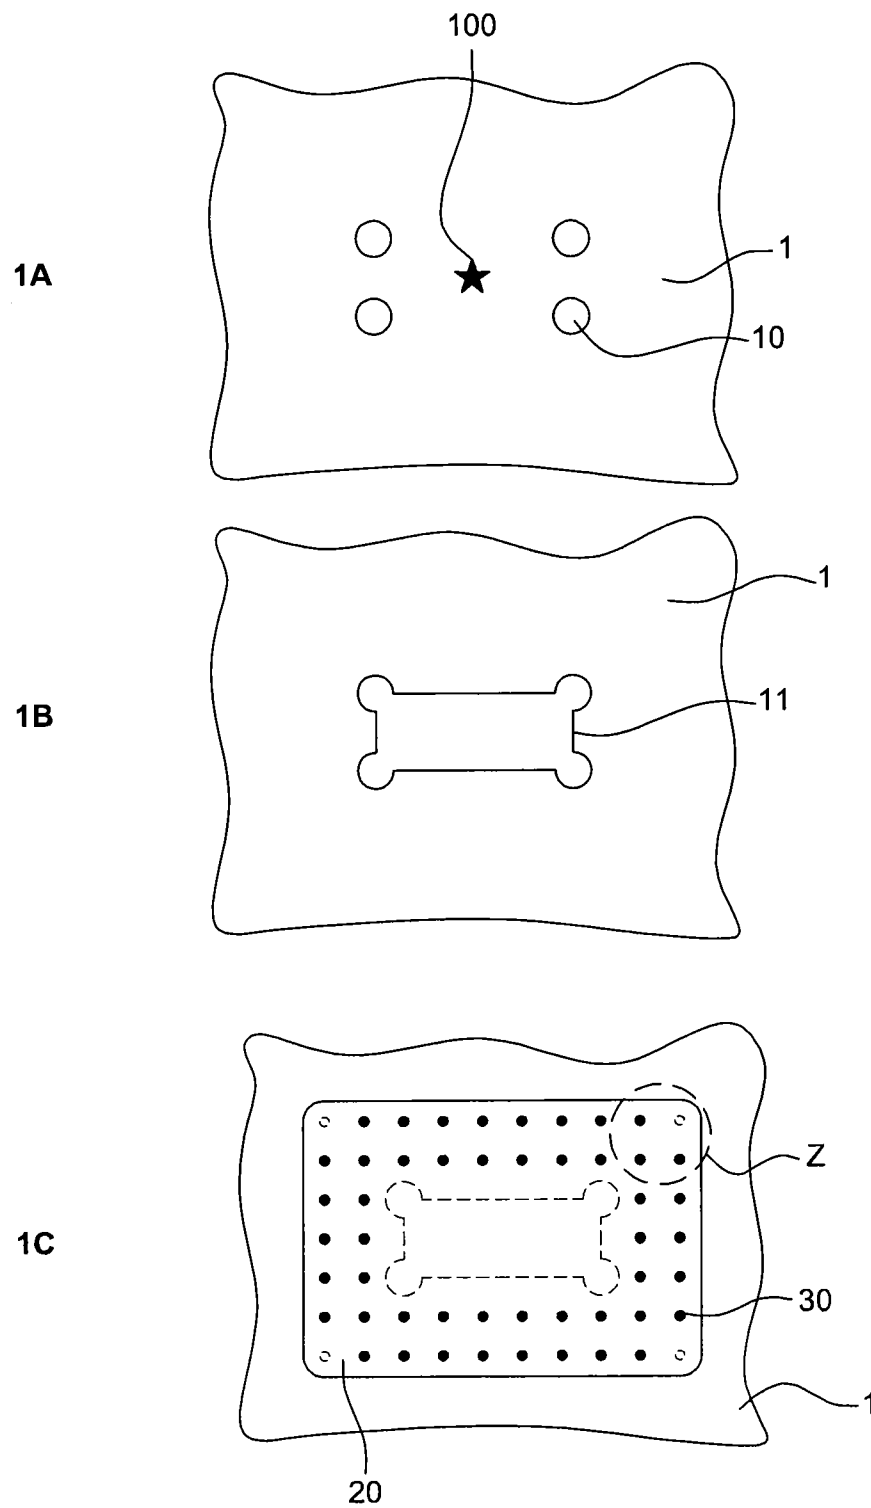
Fig. 1

FIG. 1 represents a synopsis of the repair principle which is the subject of the invention, with the drilling of the end holes in FIG. 1A, the cutting out in FIG. 1B and the fitting of the liner in FIG. 1C;

FIG. 1A: the coating of a composite fuselage (1) has been subjected to an impact (100). To perform the repair, the operator starts by drilling four holes (10) using an axial machining

FIG. 1B: from these holes, the operator realizes the cut-out lines (11) to extract the recommended rectangular area from the coating. This cut-out is realized with a radial advance movement tool, to which the advance movement is communicated manually by the operator. As an example, for a fiber reinforced composite coating, this tool can consist of an angle grinder, a jig-saw or a router such as a portable milling machine available under the brand name ONSRUD® manufactured by LMT Tools.

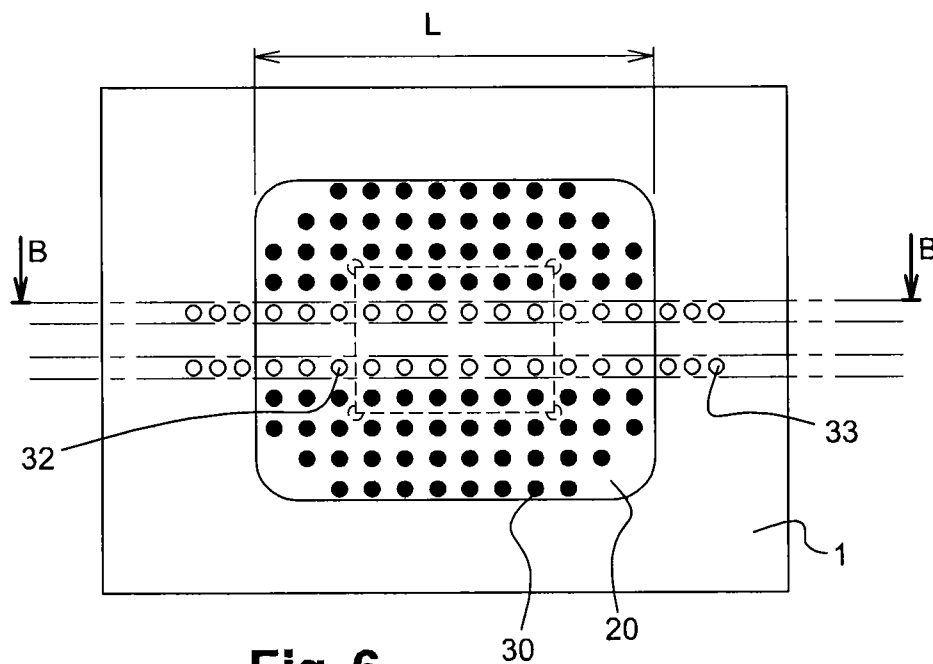
Fig. 6

FIG. 6 is an example of repair in a general case that requires cutting out a longitudinal stiffener in front view;

FIG. 6 represents the general case of a fuselage repair, in particular where the area to be cut-out goes through a longitudinal stiffener or stringer (40). In the case of a composite fuselage, such stiffeners are linked to the skin by bonding, cocuring or other techniques of assembly without fasteners. In this case, the stringer is cut out over a width L, greater than the width of the cut-out. The width L is equal to the width of the liner (20) and will therefore vary as a function of the number of rows of fasteners required to fasten it to the sound part of the fuselage and to transmit the flow of forces.

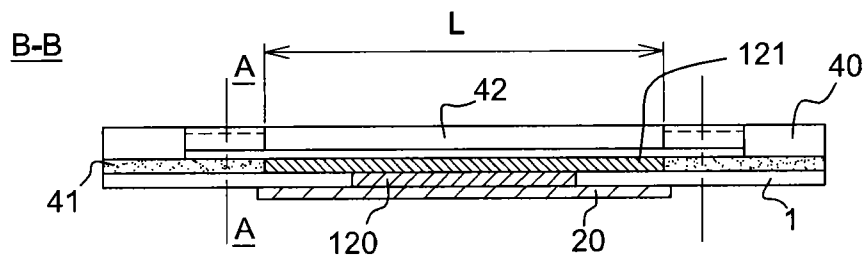
Fig. 7

FIG. 7 is a B-B cross-section view along the thickness of the repair shown in FIG. 6;

FIG. 7: a shim (120) whose thickness is equal to the thickness of the skin is placed in the cut-out. An inner liner (121) whose thickness is designed to compensate the thickness of the stringer's flange (41) and whose dimensions are substantially equal to those of the outer liner (20) is placed inside the

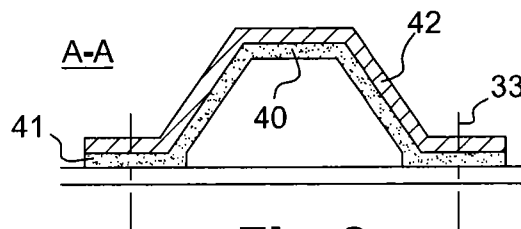
Fig. 8

FIG. 8 is a transversal A-A cross-section view of this same view in the immediate vicinity of the repair.

Lastly, FIG. 8: beyond the outer liner, a third type of fastener (33) assembles and goes through the outer skin, the flange (41) of the original stringer and the flange of the stringer splice plate.
