(54) **AUTOMATIC DETECTION OF DEFECTS IN
COMPOSITE STRUCTURES USING NDT
METHODS**

A method and an apparatus for automatically collecting and processing nondestructive test (NDT) data to determine the presence, type, location, size, and strength of defects in composite, honeycomb, and grid structures like those found in aircraft, wind blades, boats, cars, building structures. The preferred embodiment is comprised of an uncooled IR mounted on a frame, a conductive heating mat, an IR Ruler with fiducials in a recognizable pattern, a computer, a processor, and output displays. The data collection, processing, and display output can be controlled or reviewed remotely via the internet. The processing, location, and output displays can be applied to any NDT system that collects and processes a two-dimensional amplitude image (e.g., x-ray systems).

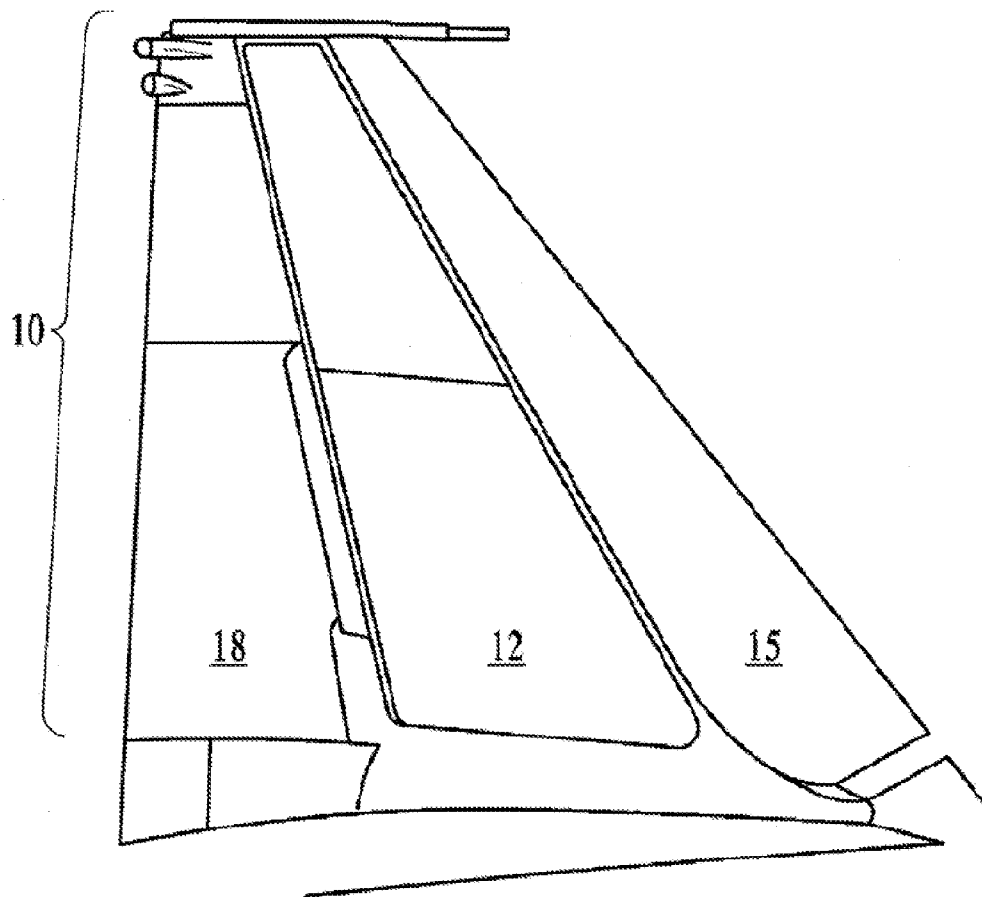
FIG. 1 illustrates the F-15 vertical stabilizer showing the boron composite area and the leading and trailing edge.

FIG. 9 illustrates the output of a raw IR image obtained 30 s after heating the surface of an aircraft honeycomb boron composite used in the vertical stabilizer of the US Air Force (USAF) F-15 jet aircraft shown in FIG. 1. An illustration of a section of the honeycomb boron composite 20 is shown in FIG. 2. The boron composite 26 over the honeycomb 28 and the aluminum skin 24 over the honeycomb is shown. Distinct white spots in the IR image can indicate the presence of a disbond (separation of the boron composite from the aluminum honeycomb) or a delamination (separation between one or more layers of the boron composite). Visual inspection of the IR image indicates many such areas and significant ambiguity. FIG. 10 illustrates the results of the same IR image processed with a computer using a noise cancellation background removal method. One can easily see the disbond along the right edge of the aircraft structure and not be confused by the large area of ambiguous white spots along the left edge and center sections of the composite structure. This simple illustration shows the benefit of signal processing methods over visual interpretation in terms of accuracy and reliability. It minimizes the number of false detections (i.e., false alarms). It is also significant that the computer analysis is done automatically and can be done remotely without having to output the IR image.

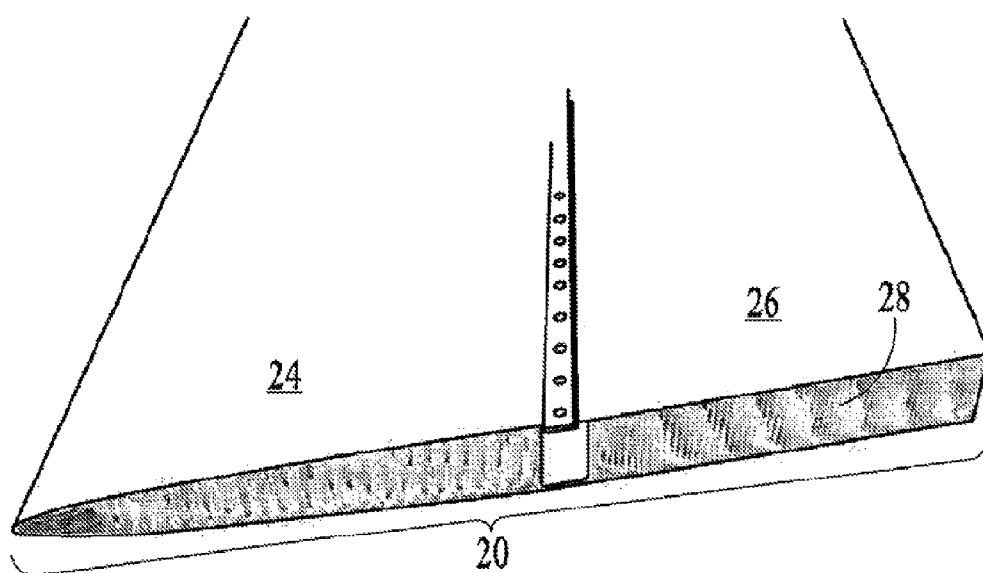
FIG. 2 illustrates the internal structure of an article with a boron composite skin over an internal aluminum honeycomb.

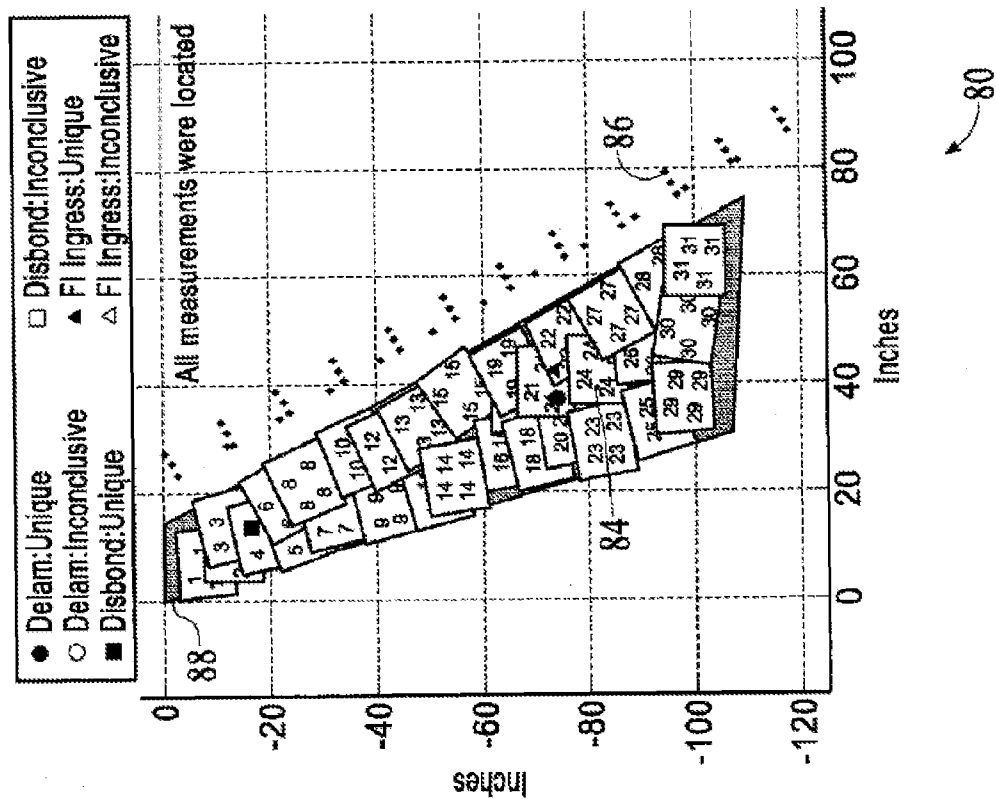
FIG. 3 illustrates the IRIS system in used on an actual F-15 with a defect and image coverage map shown on the right.

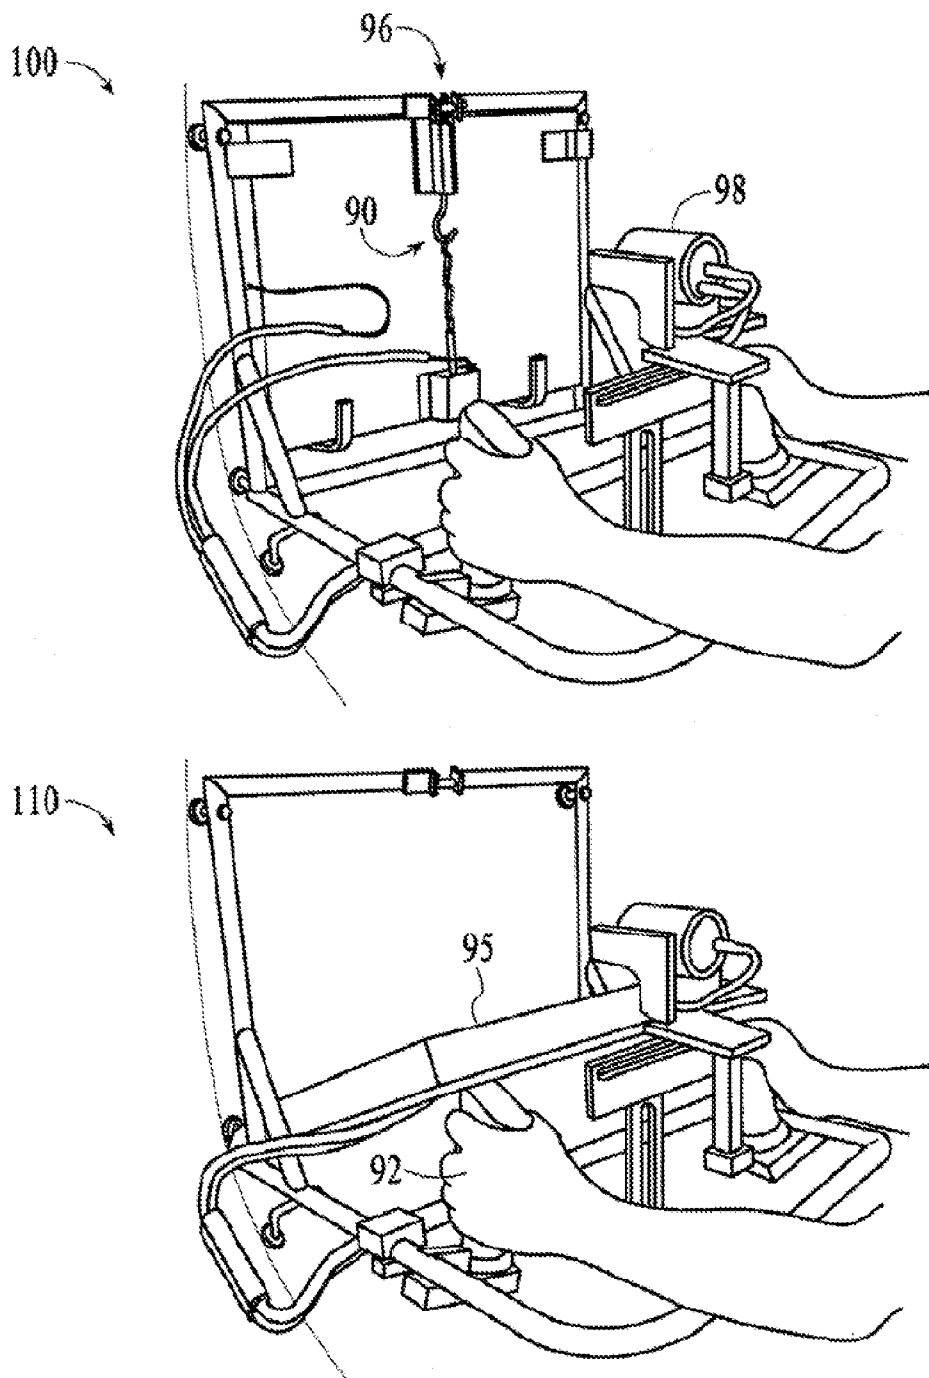
FIG. 4 illustrates the IR inspection method with heat being applied to the surface of the boron honeycomb composite on an F-15 vertical stabilizer in the lab and after the latch was released so that the heating mat fell out of the way of the IR camera and IR measurements of the composite surface could take place.

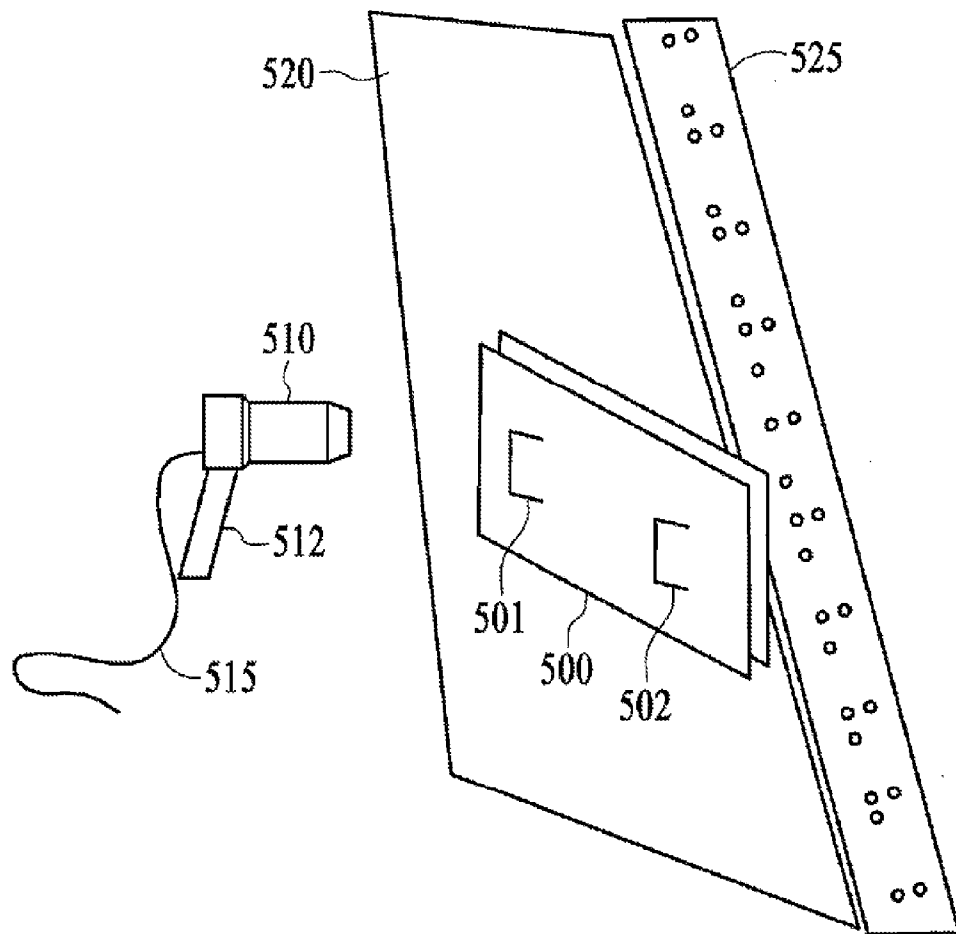
FIG. 5 illustrates a conceptual sketch of a handheld IR inspection system consisting of a handheld camera and manually operated heating mat.

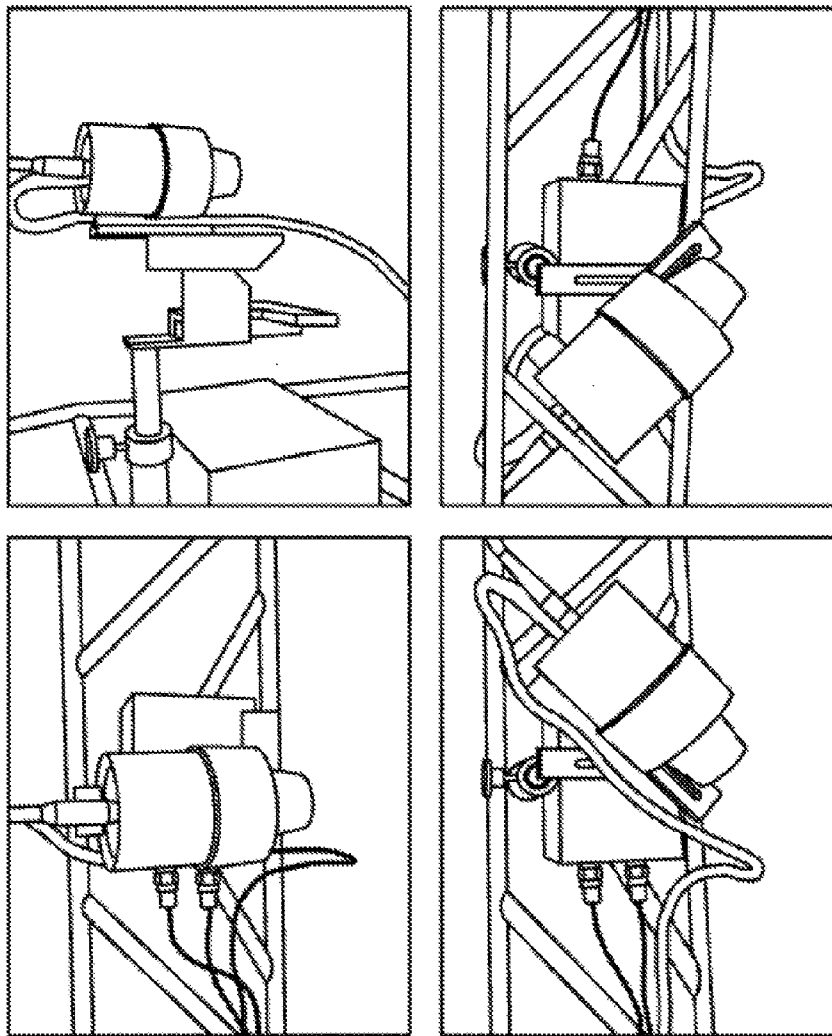
FIG. 6 illustrates the IR camera mount which allows the IR camera to be rotated to the correct position for viewing the IR Ruler. Stops designed in the mount set the rotation without the operator having to measure or align the rotation.

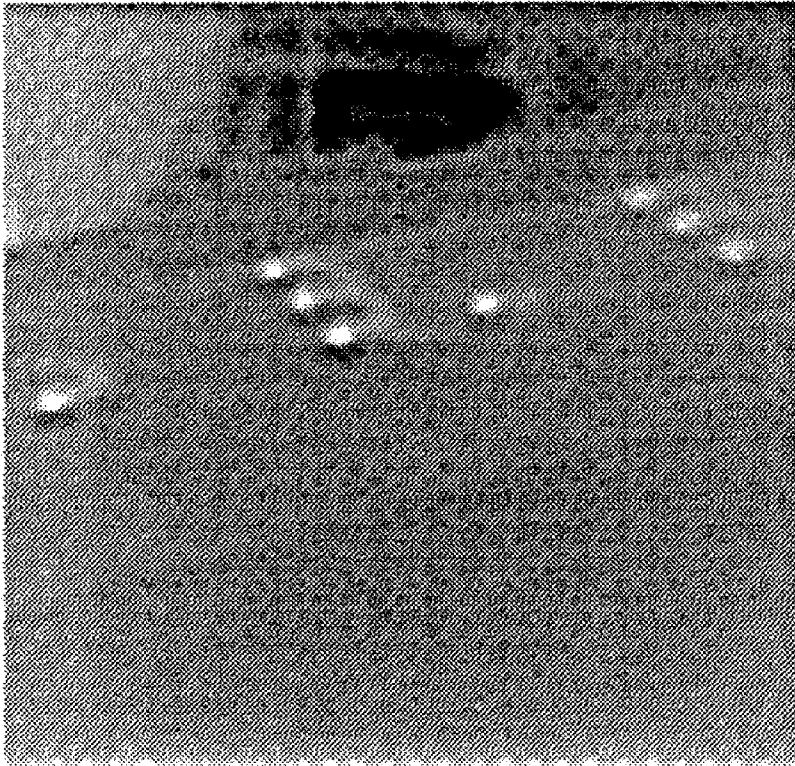
FIG. 7 illustrates the IR Ruler positioned on the vertical stabilizer and the IR image of the IR Ruler recorded during the heating step of a measurement.

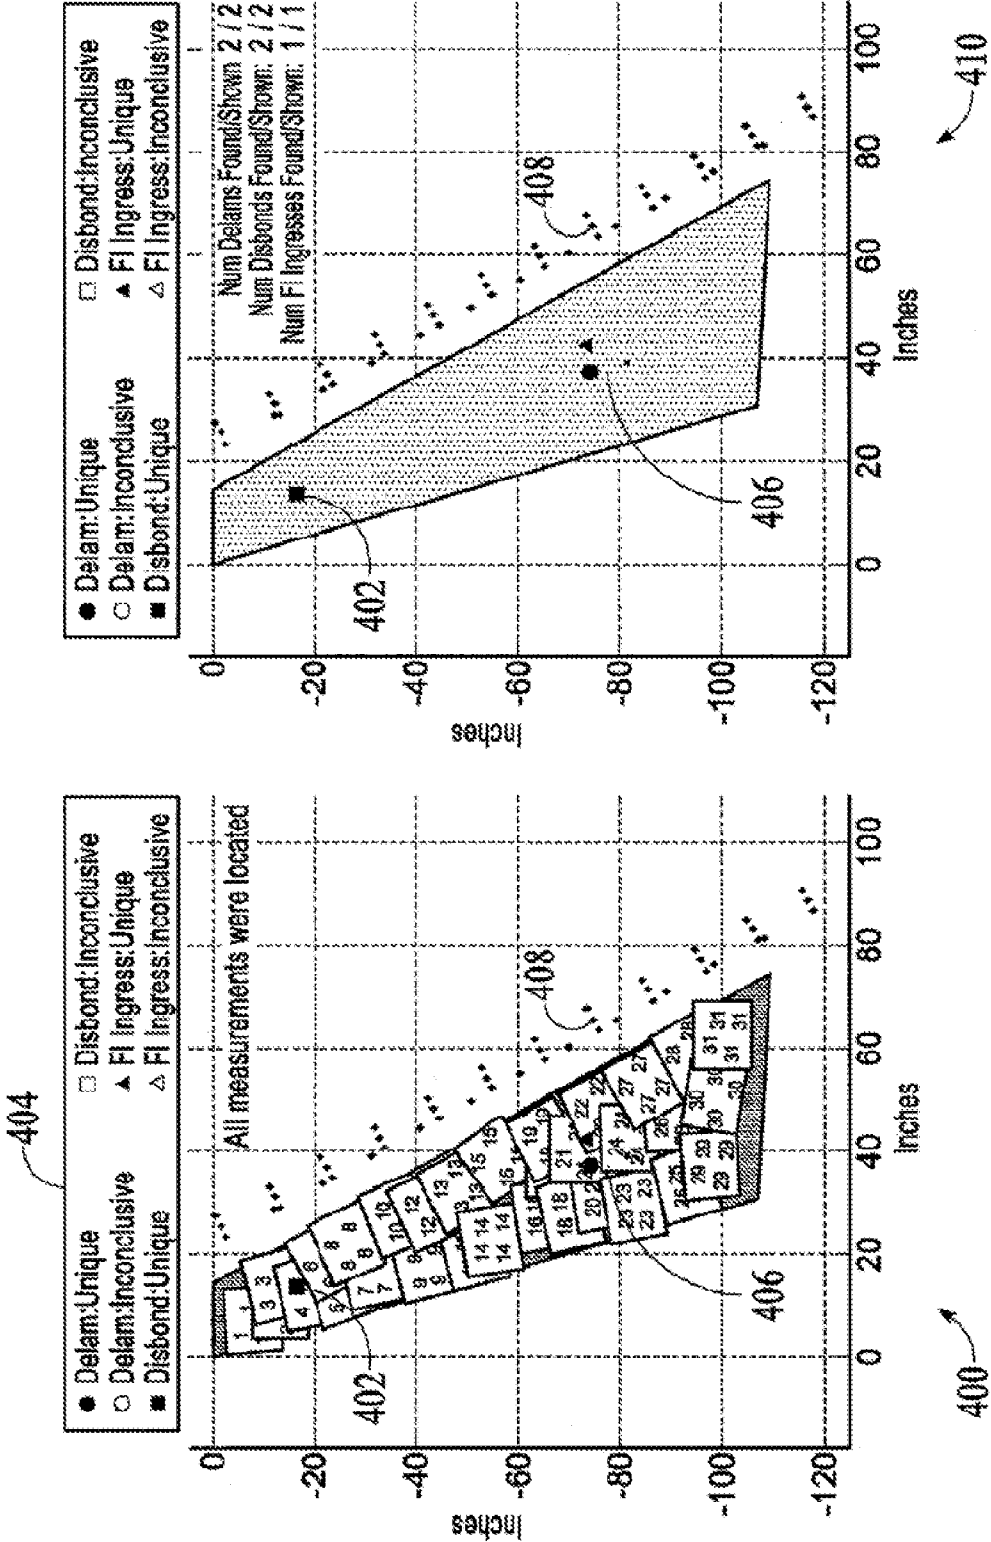
FIG. 8 illustrates the coverage map with measurement numbers and the flaw map that the IRIS creates at the end of an inspection.

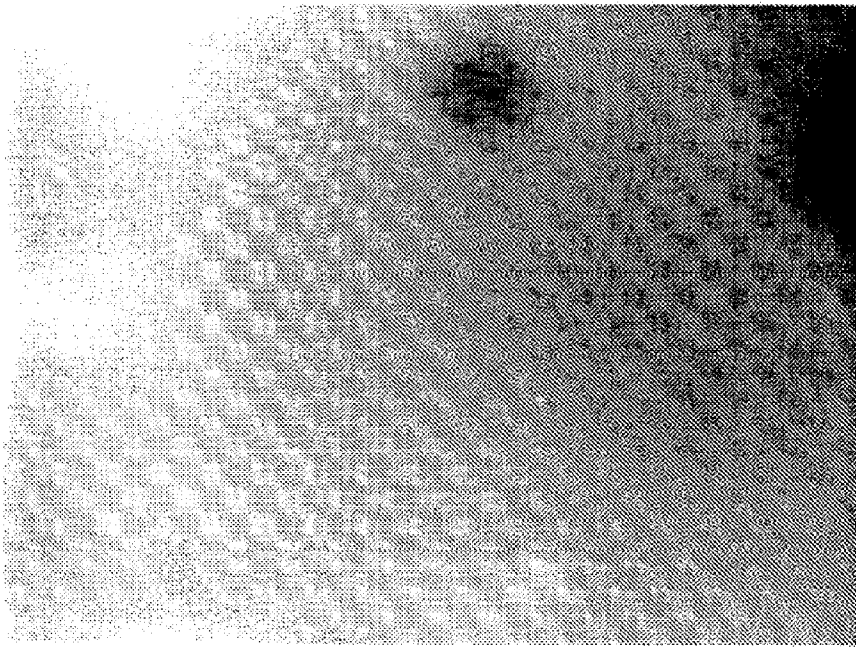
FIG. 9 illustrates a raw IR image collected 30 seconds after removing the heater showing a fluid ingress (darker area) and a disbond (lighter area).

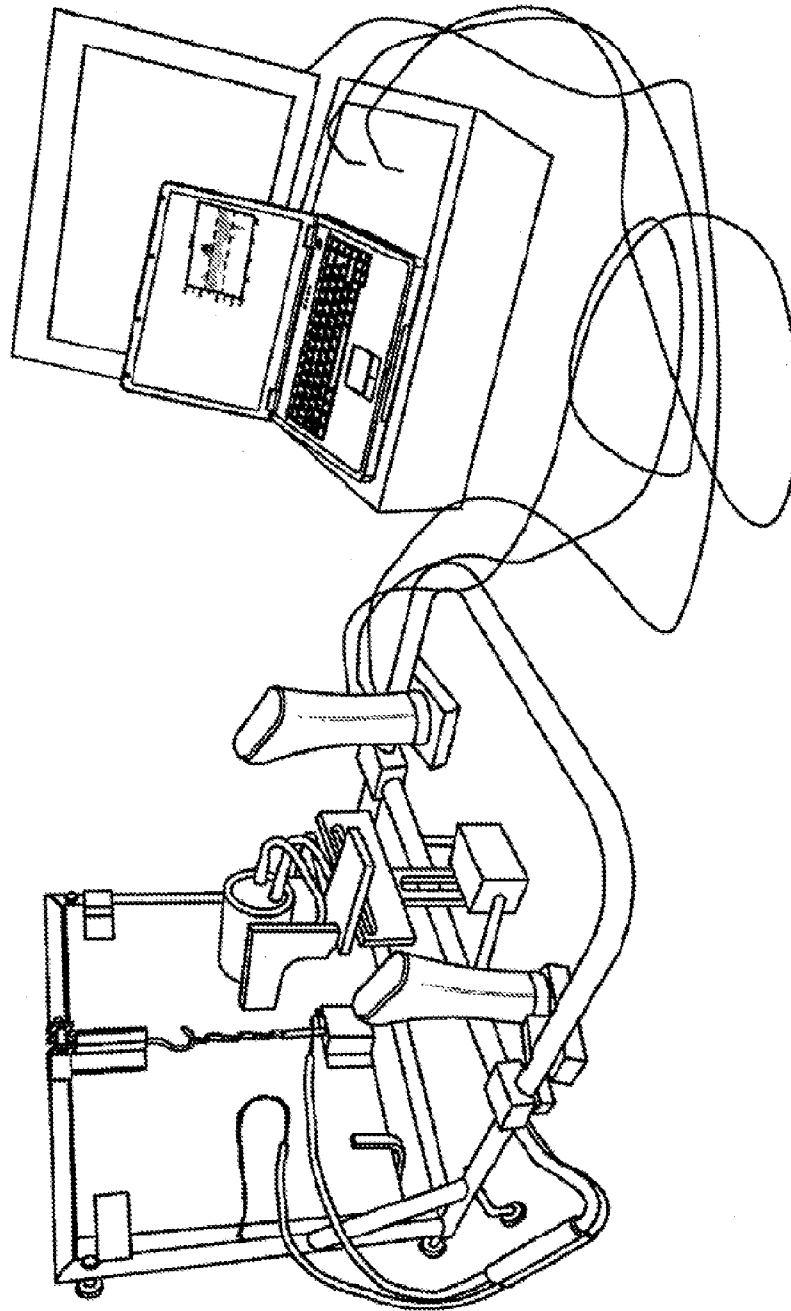
FIG. 13 illustrates the complete IRIS system including the frame with heater and IR camera, control box with notebook computer, and cabling.

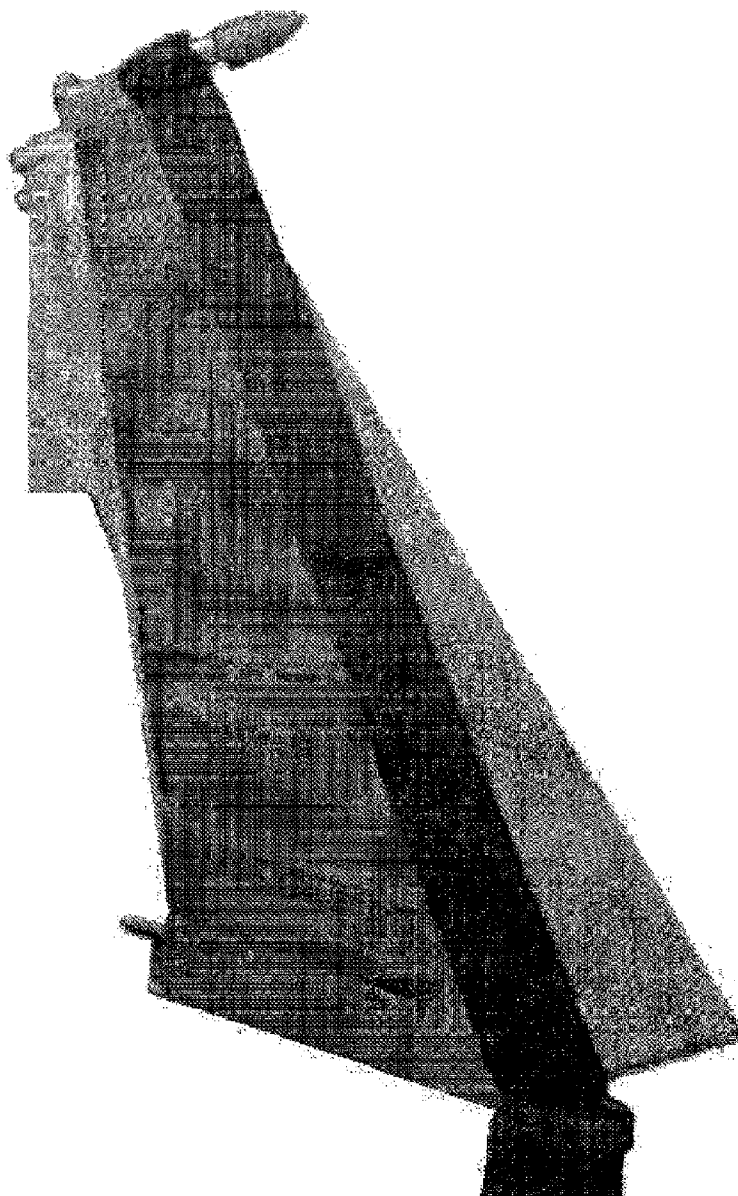
FIG. 14 illustrates an F-15 vertical stabilizer with the IR Ruler placed along the leading edge.

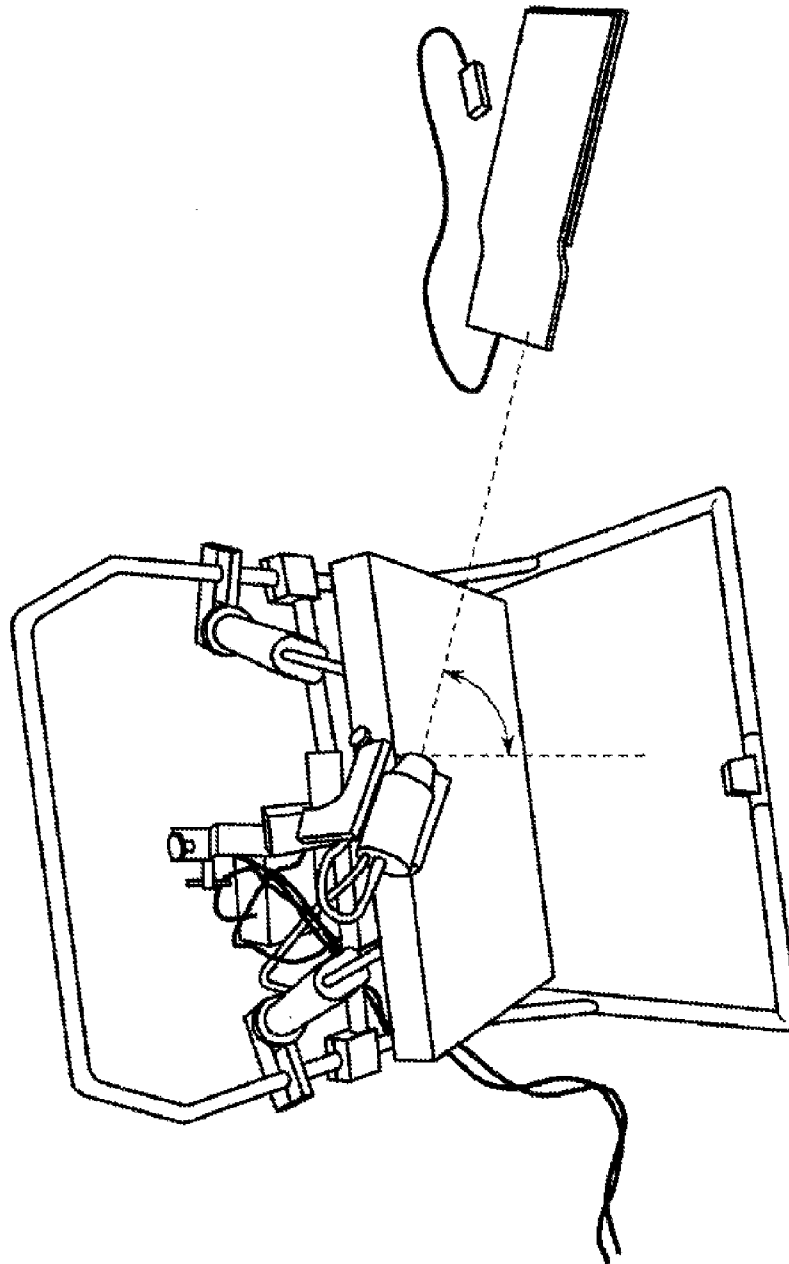
FIG. 15 illustrates the IRIS frame placed in the calibration jig which is used to confirm the placement of the camera and determine the calibration factors for the location algorithms.

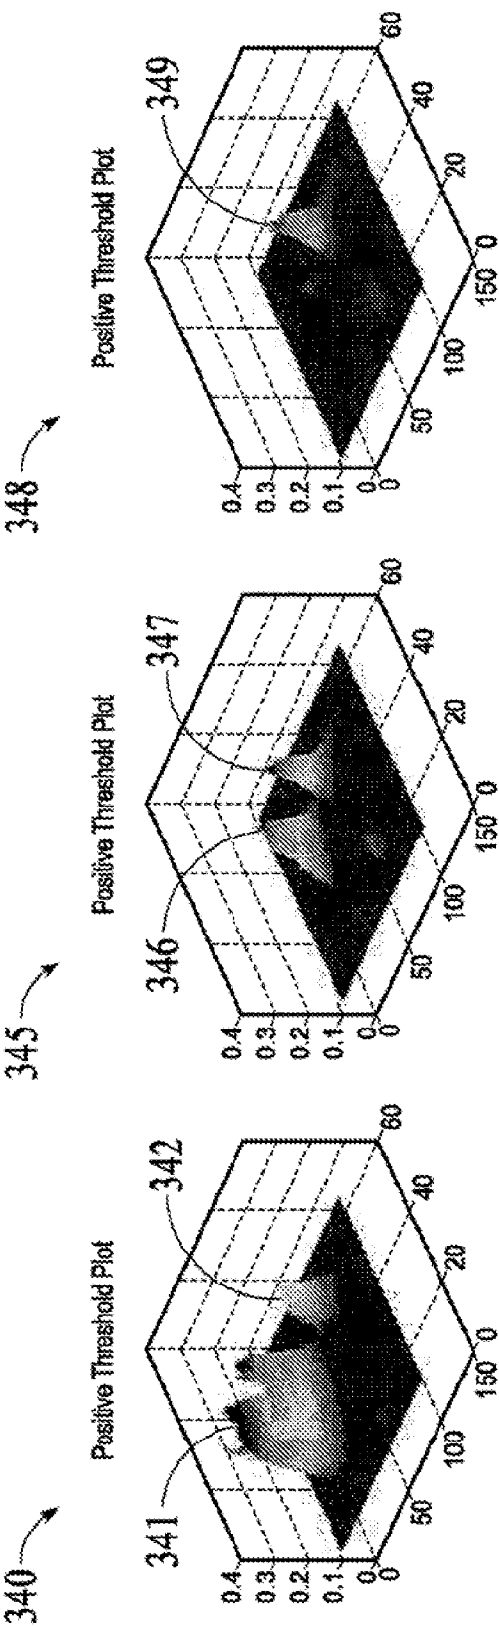
FIG. 40A illustrates the detection of both a delamination and a disbond in a single measurement.

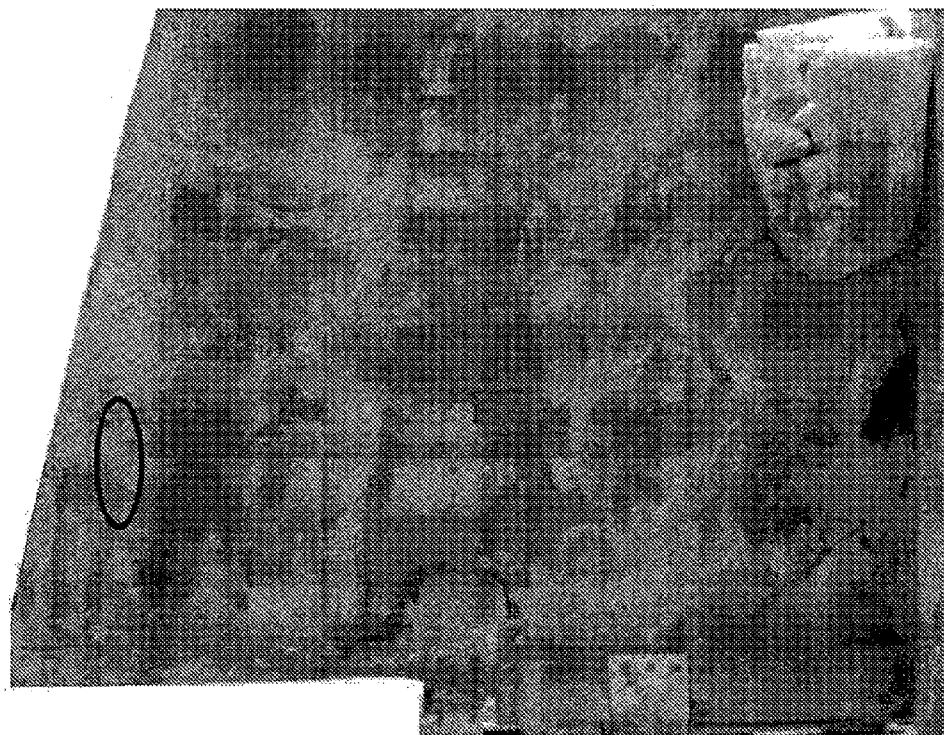
FIG. 45 illustrates the IRIS measurement locations on both sides of the rudder. IRIS measurements were conducted at locations of suspected damage.

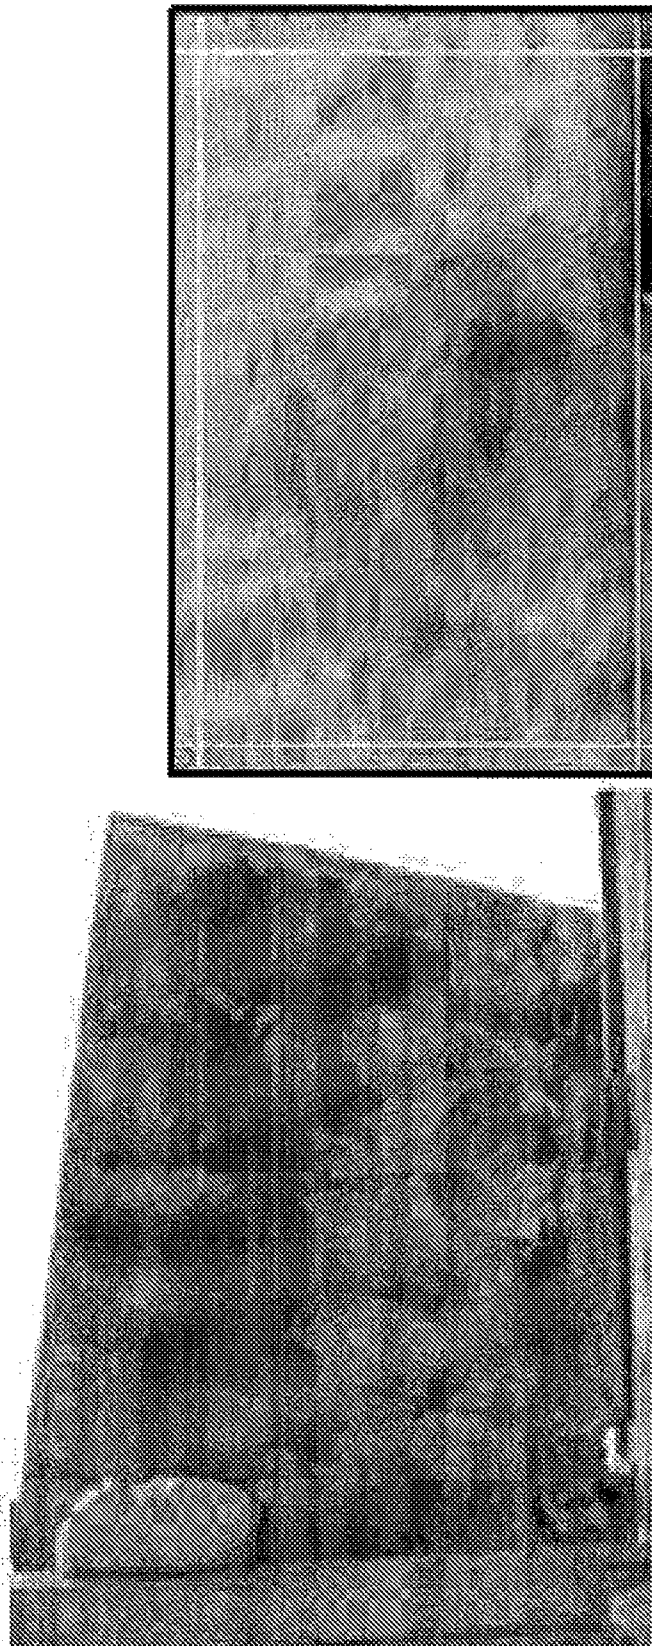
FIG. 48 illustrates the results of IRIS measurement taken of a region of suspected fluid ingress with the rudder tilted away from the surface being inspected. The region within the white cursors was analyzed and the results are shown on the right.

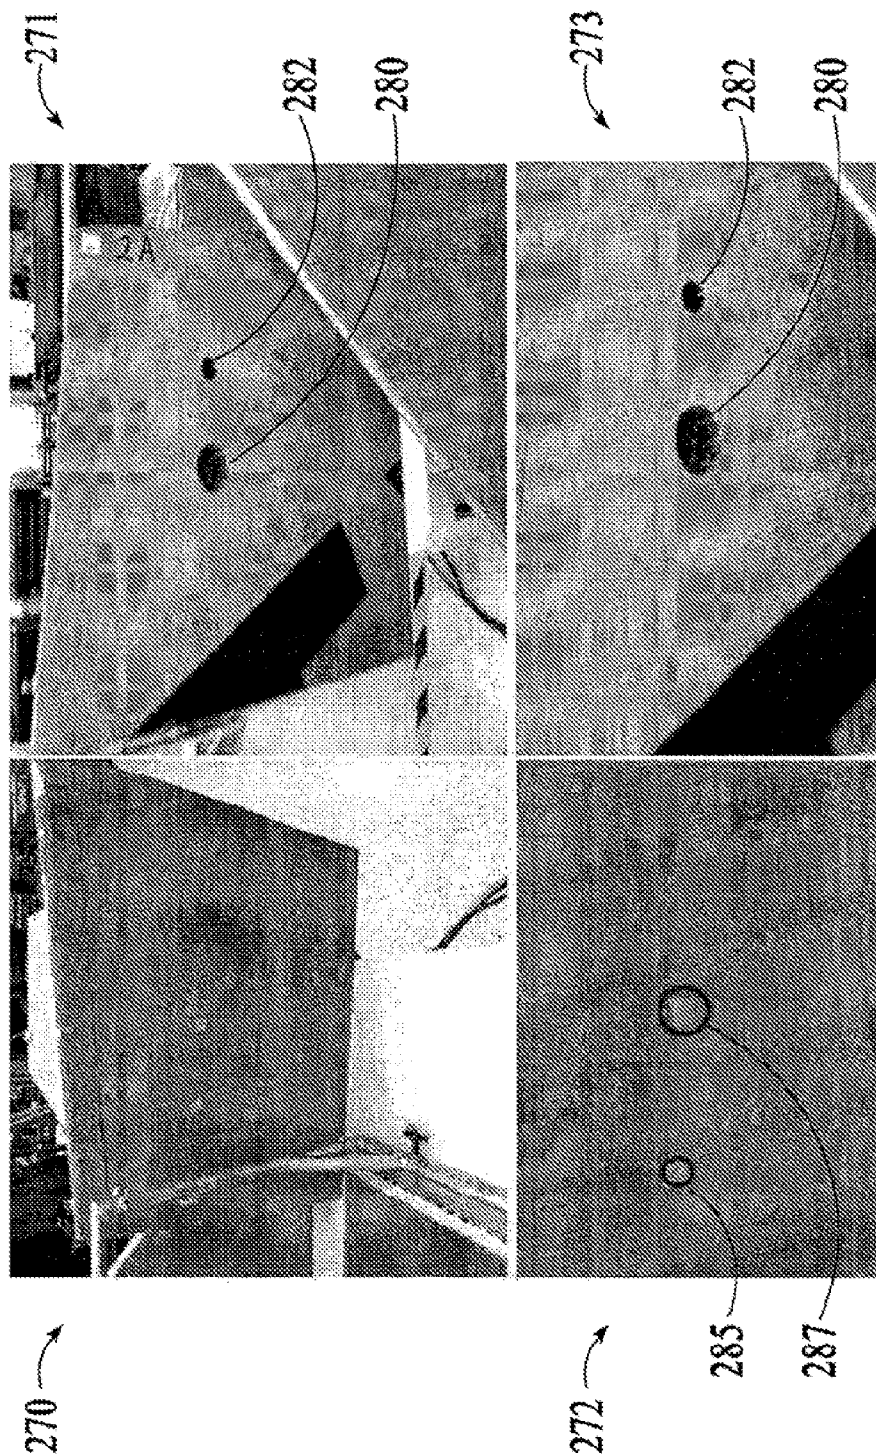
FIG. 49 illustrates an IRIS measurement on a repair of an F-15 Rudder.
