(54) **ROTOR SEAL WIRE GROOVE REPAIR**

A method of repairing a seal wire groove is disclosed, the groove forming an annular structure having an outer surface and an inner surface and defining an original profile when new, comprising the steps of: removing a less-than-annular portion of the original profile of the groove to remove damaged portions of at least one of the inner and outer surfaces thereby forming a void; adding new material to the void; and shaping the new material to form a new profile of the groove.

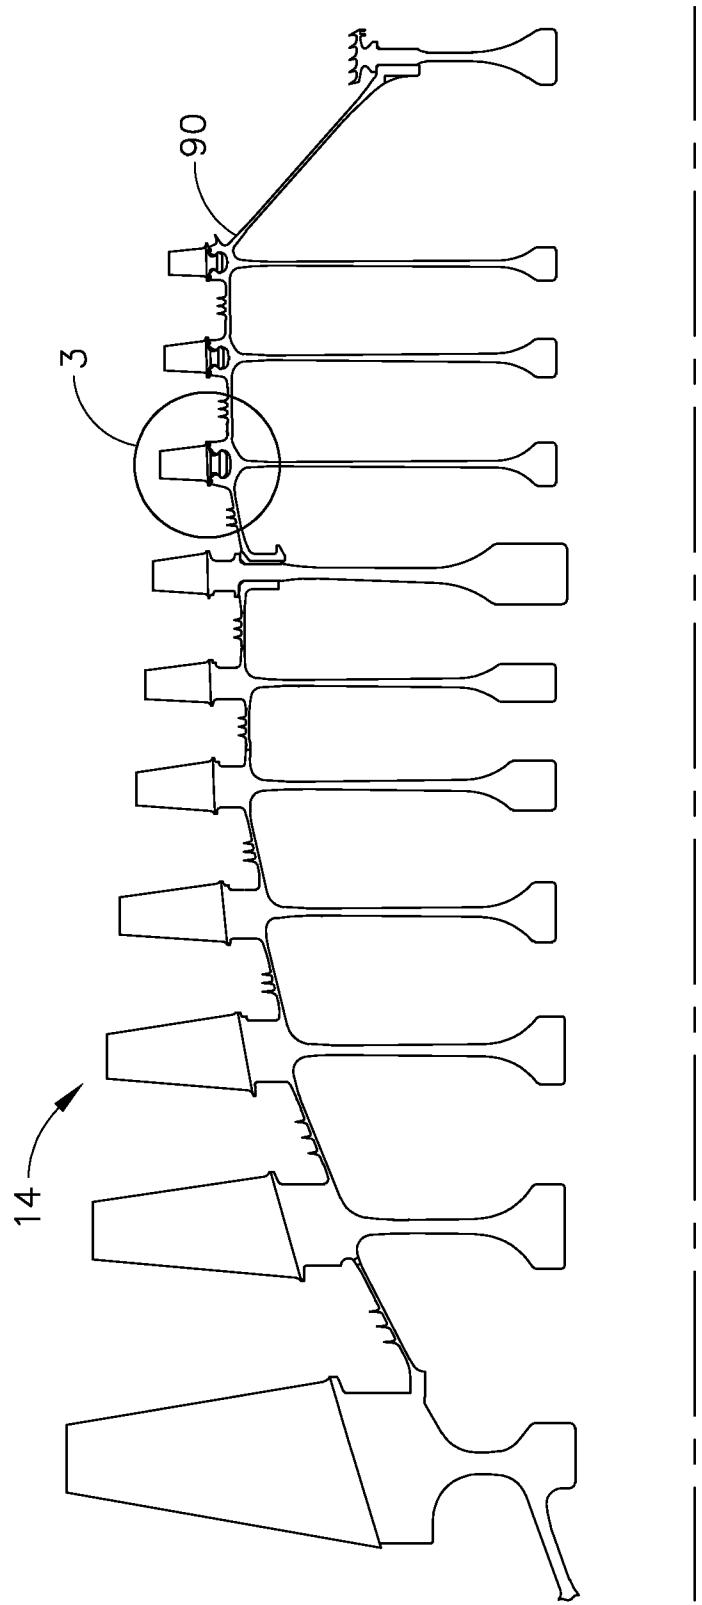
FIG. 2 is a cross-sectional elevational illustration of an exemplary compressor spool depicting a representative location for remaining illustrations;

FIG. 2 is a cross-sectional elevational illustration of an exemplary compressor spool 90 forming a part of the compressor 14 of FIG. 1, depicting a representative location identified with the circle and numeral 3 for the more detailed illustrations which follow.

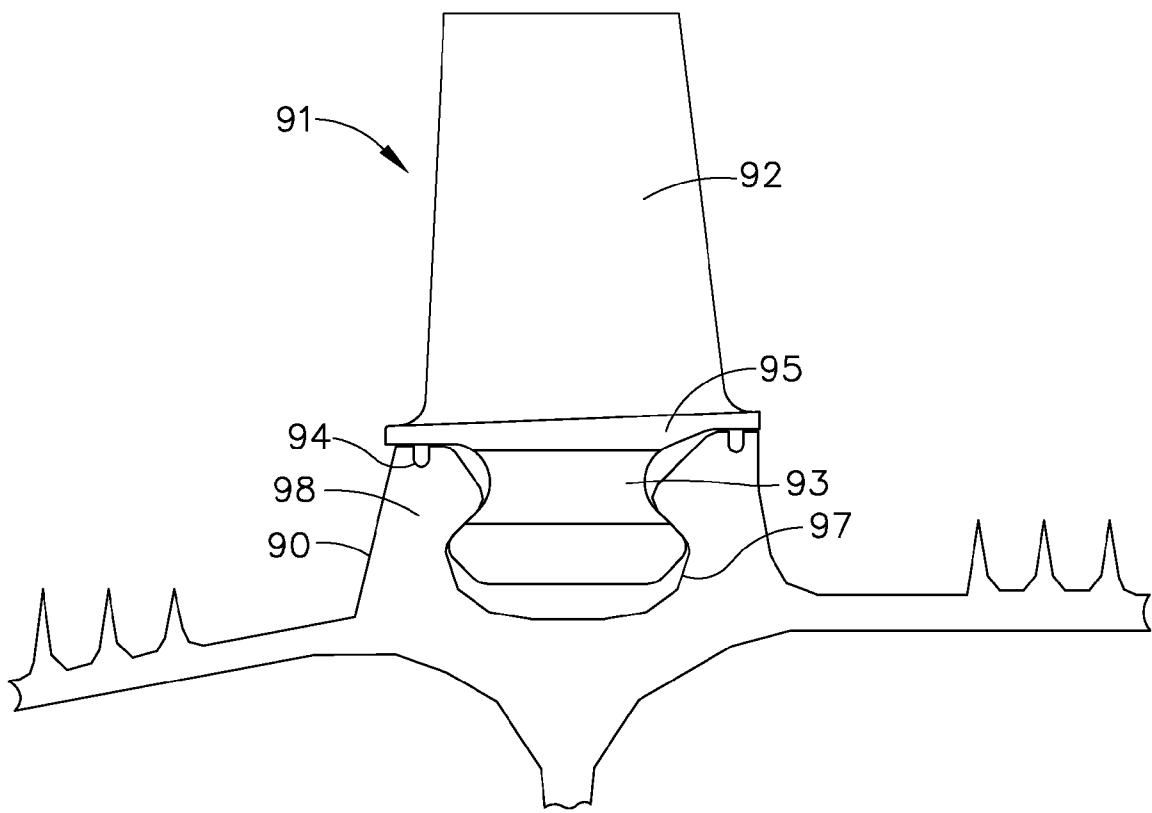
FIG. 3 is an enlarged partial elevational sectional illustration of a compressor blade mounted on a compressor spool;

FIG. 3 is an enlarged partial elevational sectional illustration of a compressor blade 91 mounted on a compressor spool 90. As shown in FIG. 3, the compressor blade 91 includes several elements such as an airfoil 92, a dovetail 93, and a platform 95 between the airfoil 92 and the dovetail 93. The dovetail 93 is sized and shaped to fit in dovetail slot 97 of compressor spool 90 to secure the blade 91 to the spool 90. The spool 90 and dovetail slot 97 are annular structures and a plurality of blades 91 are secured to the spool 90 around their circumference, though only a single blade 91 is illustrated for clarity. Also shown in FIG. 3 is a seal wire groove 94 for containing a seal wire 96 to form a seal between the platform 95 and the spool 90 to enhance efficiency of the compressor 14 in operation and thereby improve fuel consumption of the gas turbine engine assembly 10.

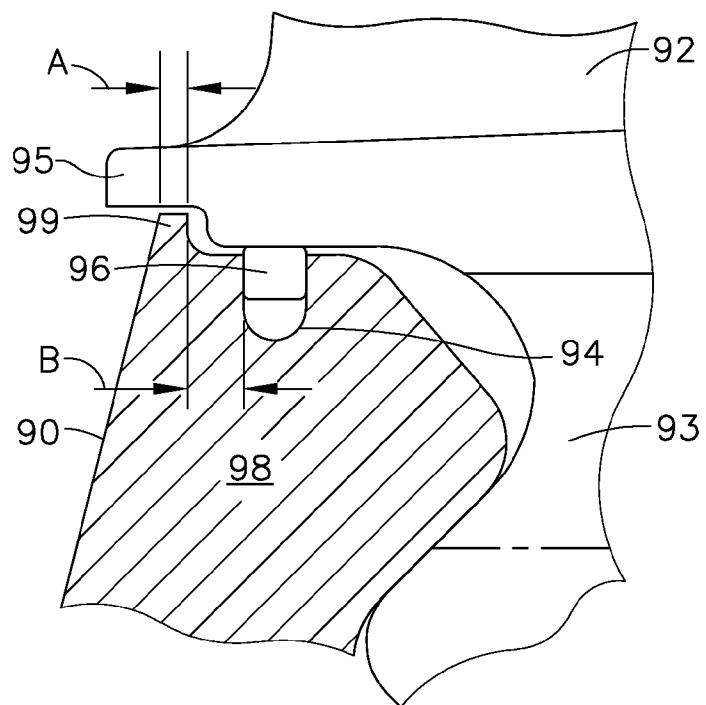
FIG. 4 is a more enlarged partial elevational sectional illustration depicting and defining relevant dimensions;

FIG. 4 is a more enlarged partial elevational sectional illustration of the elements of FIG. 3. As shown in FIG. 4, the seal wire groove 94 is spaced inwardly from the edge of the disk portion 98 of the compressor spool 90 by a dimension A which forms a shoulder 99 and a dimension B which forms a horizontal surface on the outer side of the groove 94. These shapes and dimensions are sized, shaped, and configured for the specific gas turbine engine assembly 10 for which they are intended, so the illustrations herein are intended to be illustrative and not limiting in terms of geometry. The platform 94 typically has a complementary shape to the radially-outer surfaces of the disk portion 98. As shown in FIG. 4, the seal wire 96 is located in the seal wire groove 94 and typically biased radially outwardly against the underside of the platform 94. The disk portion 98 may be formed from a metallic material, in which case the inner and outer surfaces of the groove 94 are formed of a metallic material. The seal wire 96 may also be formed of a metallic material and may be generally rectangular in cross section.

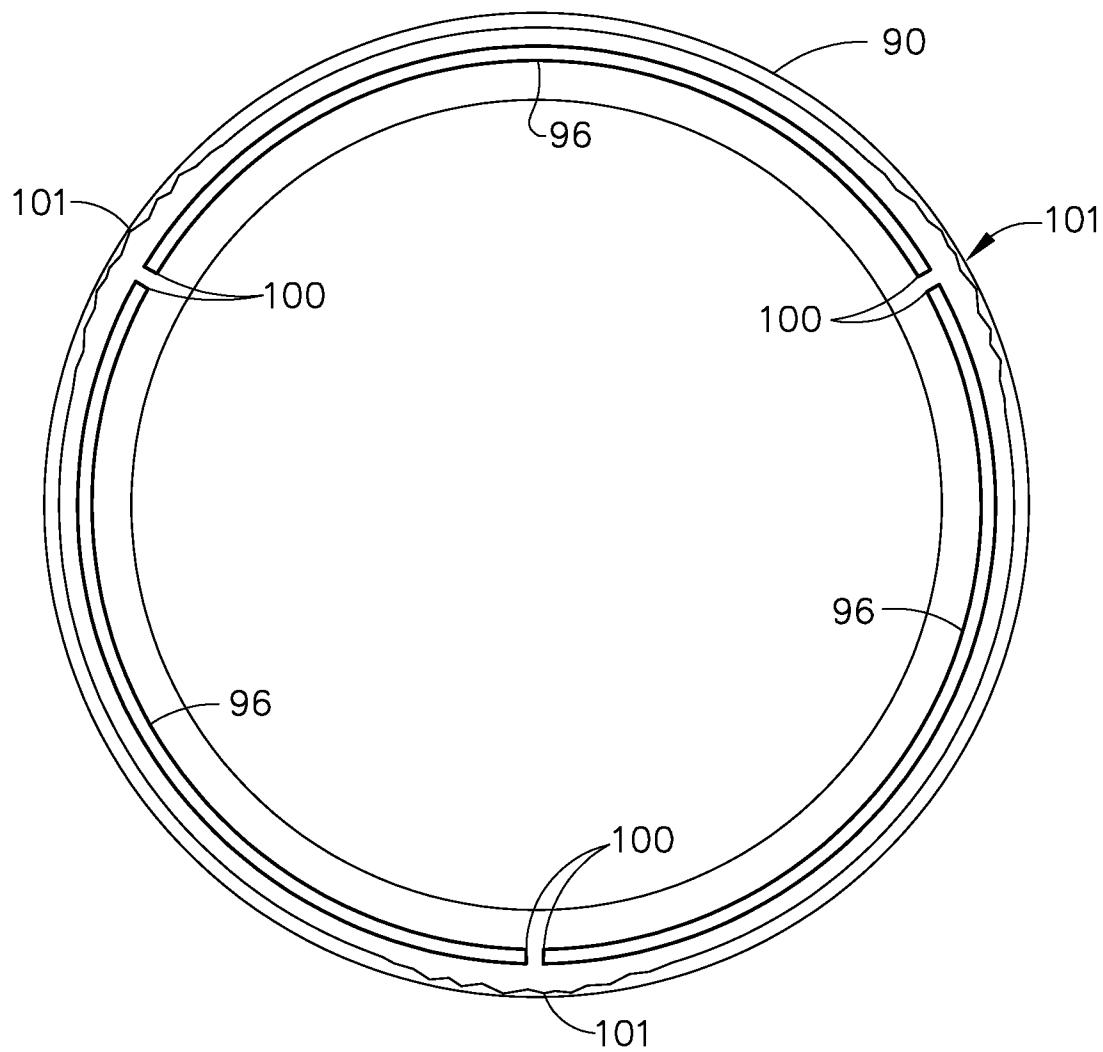
FIG. 5 is a cross-sectional illustration of a complete revolution of the compressor spool including seal wire sections installed;

FIG. 5 is a cross-sectional illustration of a complete revolution of the compressor spool 90 including sections of seal wire 96 installed in groove 94. The seal wire 96 will typically comprise multiple (more than one) pieces of material and thus have at least two ends 100. In the exemplary embodiment shown in FIG. 5, the seal wire 96 is formed in three (3) sections having six (6) ends labeled 100. Each of the ends 100 is a potential source for wear of the seal wire groove 94.

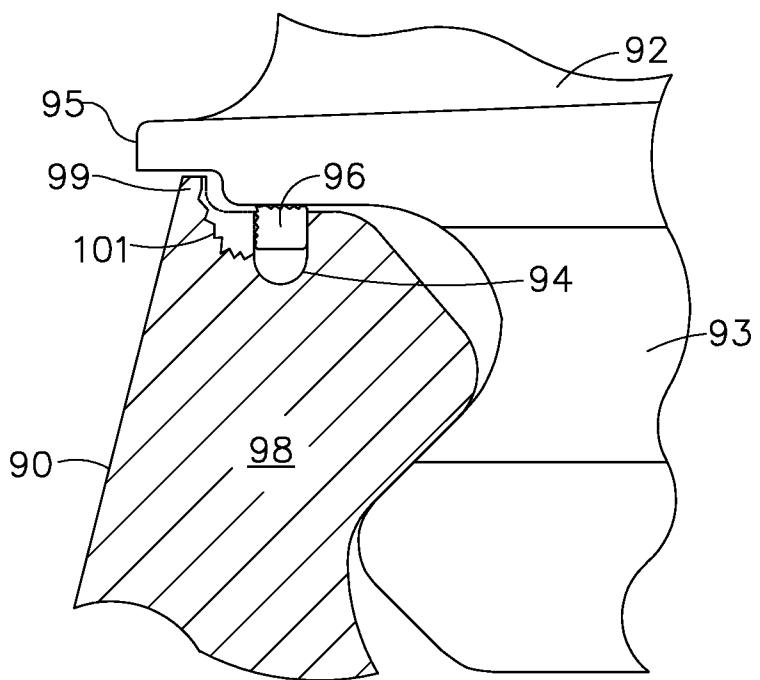
FIG. 6 is a view similar to FIG. 4 depicting fretting wear due to motion of the seal wire in service;

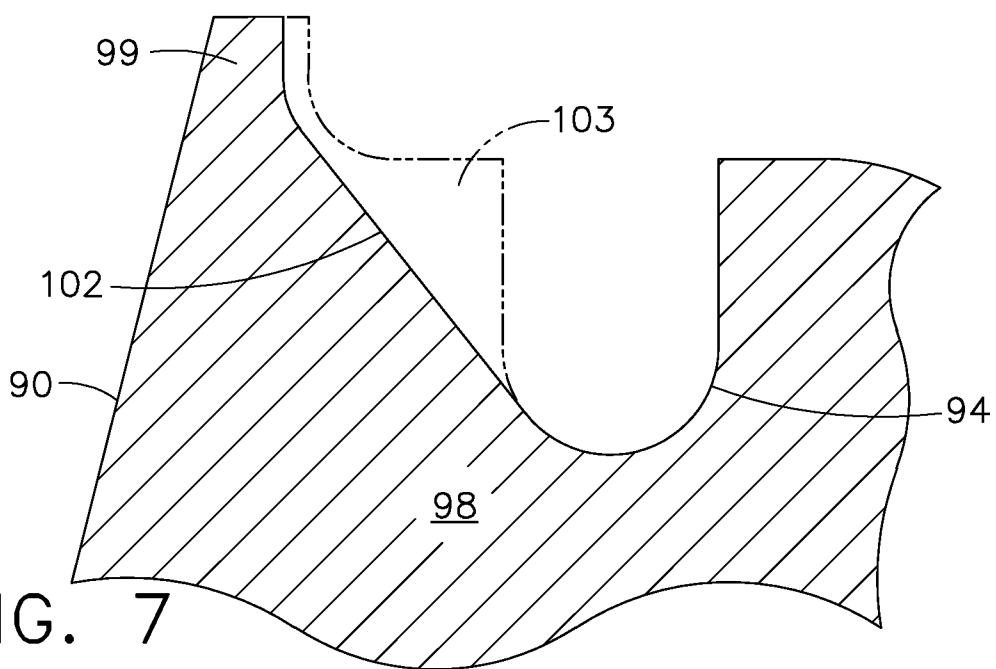
FIG. 7 is a view similar to FIG. 6 depicting a portion of the compressor spool after material removal of the damaged portion;

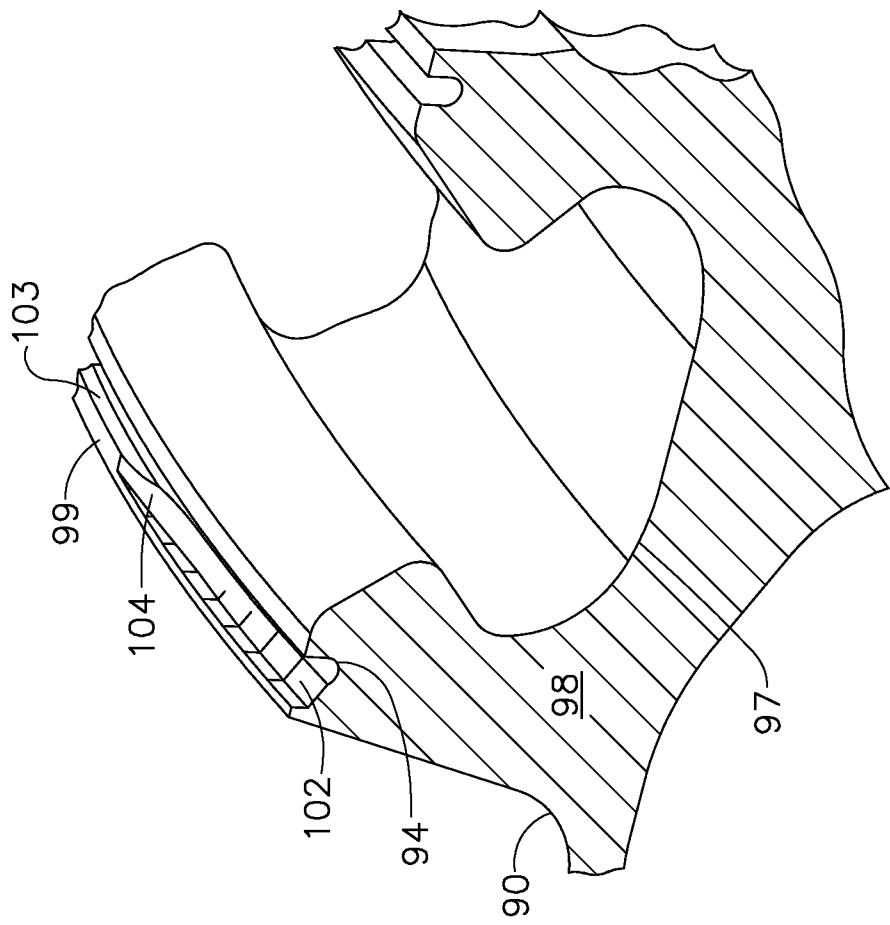
FIG. 8 is a perspective view of the portion of the compressor spool of FIG. 7 taken through an intermediate station of the material removal to illustrate the end of the removal;

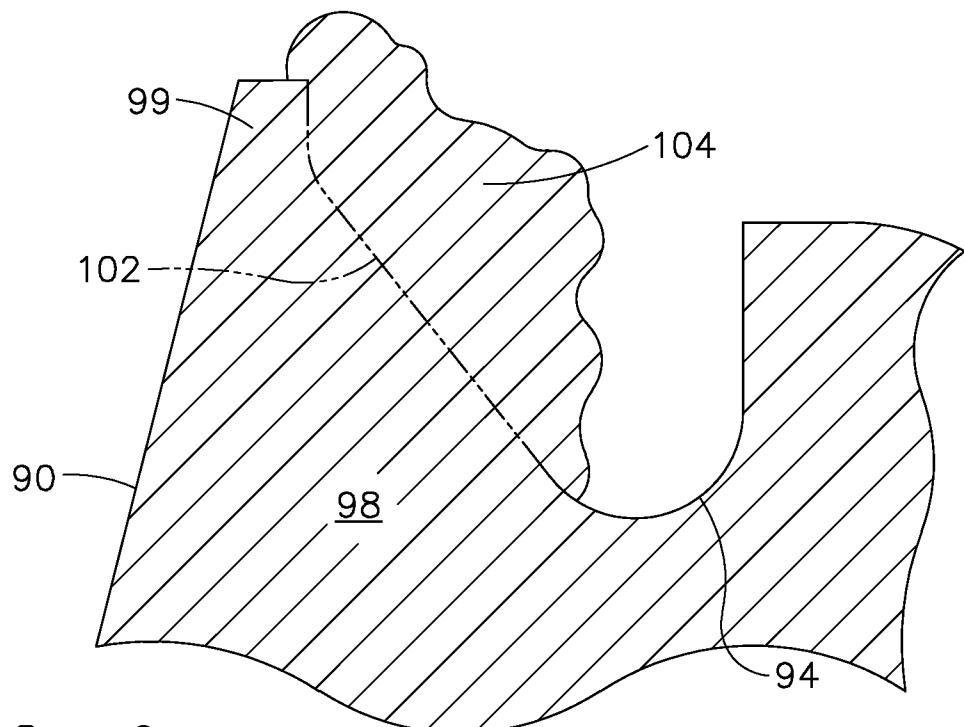
FIG. 9 is a view similar to FIG. 7 after new repair material has been added; and

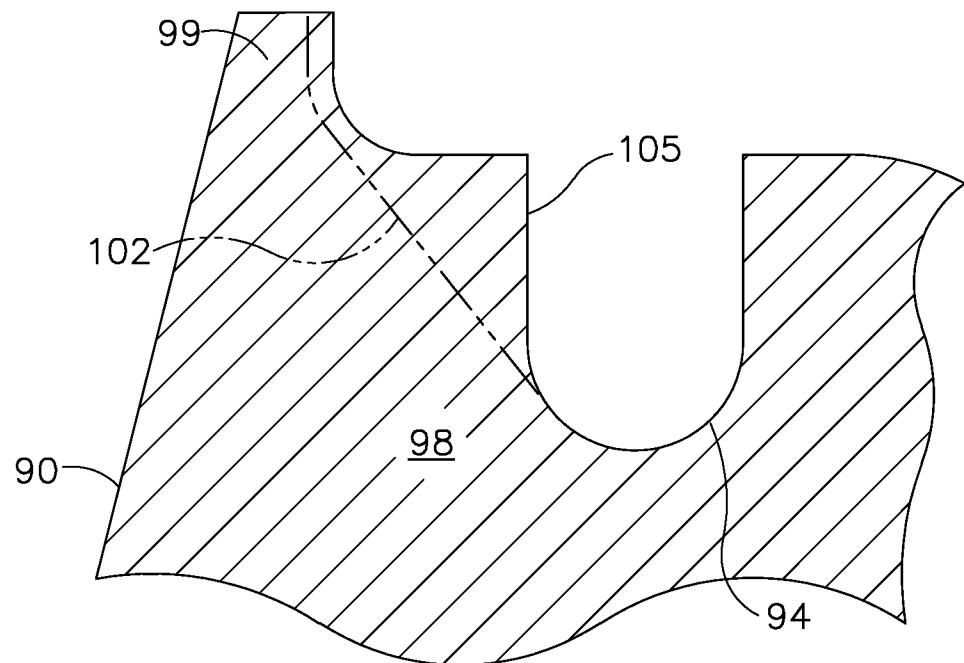
FIG. 10 is a view similar to FIG. 9 after the new repair material of FIG. 9 has been machined to the correct profile.
