(10) **Patent No.:** **US 9,885,240 B2**
(45) **Date of Patent:** **Feb. 6, 2018**

(54) **REPAIR ARTICLE OF A GAS TURBINE ENGINE**

This disclosure relates to a repair method and a repaired article. More particularly, the disclosure relates to a repair method for providing a repaired article having properties that are substantially equal to or better than properties of the original article.

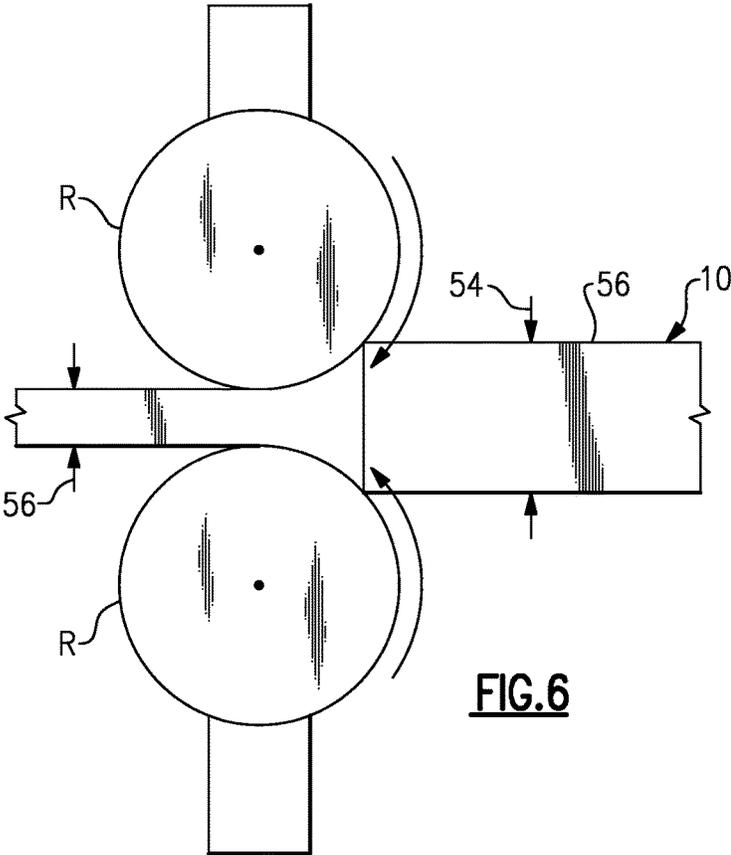
FIG. 6 illustrates an example mechanical working step that includes roll planishing.

As an alternative to forging, or in addition to forging, the mechanical working step 46 may include planishing. As illustrated in FIG. 6, the planishing may be roll planishing where the repair section 50 is rolled between rollers R to reduce the cross-sectional area 54 down to no less than the cross-sectional area 56 of the original geometry of the article 10. As illustrated in FIG. 7, the planishing may be hammer planishing where the repair section 50 is hammered between a reciprocating hammer 57a and a planish stake 57b to reduce the cross-sectional area 54 down to no less than the cross-sectional area 56 of the original geometry of the article 10. The planishing may be conducted manually or using an automated or semi-automated planishing machine.

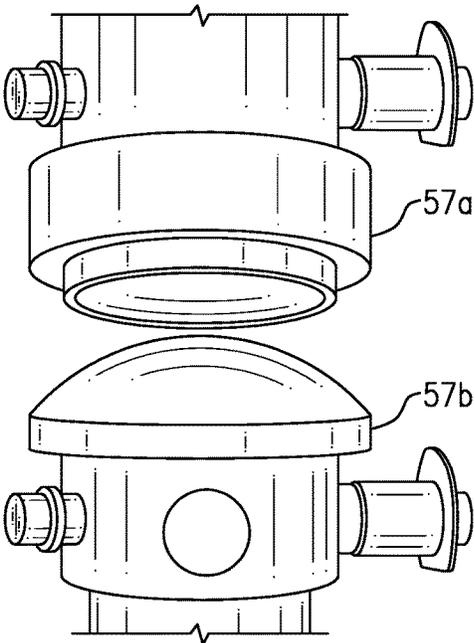
FIG. 7 illustrates an example mechanical working step that includes hammer planishing.

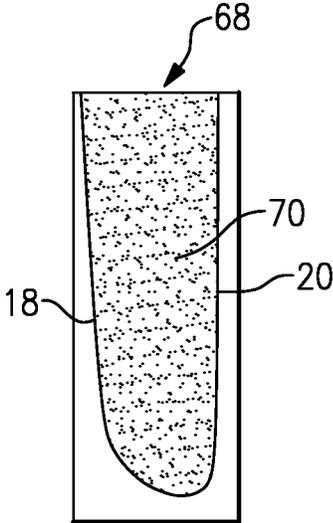
FIG. 8 schematically illustrates an image of a repair section having regions of plastic deformation.

FIG. 8 illustrates an example schematic image 68 using scanning electron microscope electron back-scatter diffraction patterns (Orientation Imaging Microscopy). In this

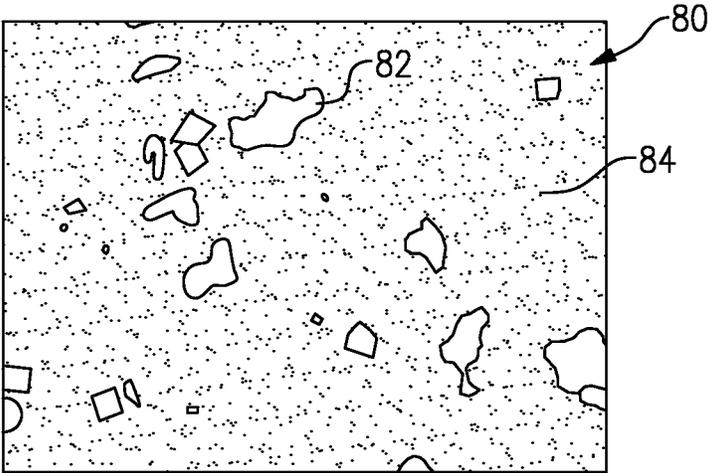
FIG. 9 illustrates an example microstructure that is substantially free of a delta phase.

Referring to FIG. 9, the method 40 may also be used to achieve a desirable microstructure 80. For example, the microstructure 80 includes regions of Laves phase 82 distributed within a matrix 84 of the alloy composition. In this example, the microstructure 80 is substantially free from, and in some examples entirely free of, orthorhombic delta phase regions of Ni₃Cb, which is a needle-shaped phase that is known to degrade physical properties (e.g., fatigue strength). For instance, the disclosed method 40 may be used to avoid a solution heat treating step that typically results in the formation of the delta phase. In some repair processes, an article having a repair section may be heat treated at 1750° F. or higher to homogeneously solutionize elements within the alloy, and then be aged at approximately 1150-1350° F. (621-732° C.) to precipitation strengthen the alloy. The heat treating typically contributes to the formation of the delta phase. However, using the disclosed method 40, the solution heat treating step can be eliminated because the plastic deformation and dislocations from the mechanical working contribute to improving fatigue strength and thereby lessen the need for heat treating. Therefore, at least the heat treating step may be eliminated, although it still may be desirable to utilize the aging process to achieve a degree of precipitation strengthening.
