(54) **CESSNA TAIL-CONE REINFORCEMENT ANGLE SPLICE, INSTALLATION KIT, AND METHOD FOR INSTALLATION THEREOF**

A tail-cone reinforcement angle of a Cessna 180-185 series aircraft is repaired by the removal of an aft most section of that tail-cone reinforcement angle and its replacement with an elongated splice body. The elongated splice body is attached to the remainder of the tail-cone reinforcement angle and to the tail-cone portion of the fuselage of the aircraft. The aft section of the original tail-cone reinforcement angle is subject to the development and propagation of cracks in the area of the rear pivot shaft receiving bore, which cracks render the aircraft unfit for use. The invention includes the provision of a suitable elongated splice body, a method for its installation, and a tool kit which is usable in accomplishing the removal and replacement of the aft section of the tail-cone reinforcement angle.

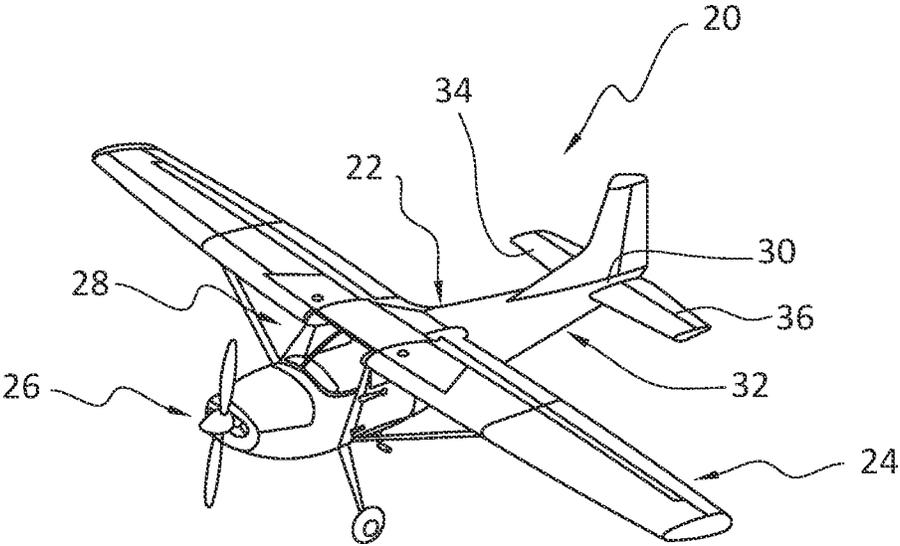
FIG. 1 is a schematic depiction of a Cessna series 180-185 series aircraft with which the pertinent invention is intended for use;

Referring initially to FIG. 1 of the patent drawings filed in the subject U.S. patent application, there may be seen, generally at 20, a typical Cessna 180-185 series aircraft with which the tail-cone reinforcement angle splice, in accordance with the present invention, finds particular usage. Aircraft 20, as is well known to one familiar with such aircraft, includes a fuselage, generally at 22, forward upper mounted wings 24, an engine and propeller assembly 26, a cockpit 28 and a rear elevator and stabilizer assembly generally at 30. The rear elevator and stabilizer assembly generally at 30, is attached to a rear portion of the fuselage 22, in an area that fuselage known as the tail-cone 32, which tail-cone area 32 is seen somewhat schematically in FIG. 2. The rear stabilizer and elevator assembly, generally at 30, includes a pivotally mounted horizontal stabilizer 34 and a pair of elevators 36. The horizontal stabilizer 34 is attached to the tail-cone, generally at 32, in an aft portion 38 of the tail cone 32. The attachment of the horizontal stabilizer 34 is accomplished by providing pivot shafts which are located in the trailing portion of the horizontal stabilizer 34, which pivot shafts are well known, are not illustrated, and which form no part of the present invention. The horizontal stabi-

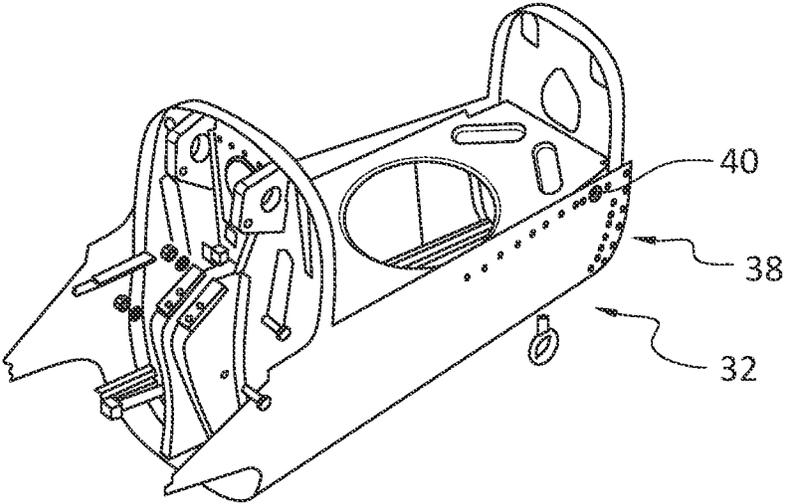
FIG. 2 is a schematic depiction of a tail-cone area of the Cessna 180-185 series aircraft depicted in FIG. 1, and with the horizontal stabilizer, elevator, tail, tail wheel and stinger removed;

Once the tail of the Cessna 180-185 series aircraft has been disassembled, to render the tail-cone assembly as it is depicted in FIG. 2, the installation process may commence. The initial step is to use a suitable reamer, which is supplied in a kit that is provided by the manufacturer of the subject invention, and which is supplied together with, and including the subject tail-cone reinforcement angle splice, as will be discussed subsequently, to ream out both the horizontal stabilizer rear pivot aperture **40** in the tail cone of the fuselage and the underlying bore **44** in the original far aft portion of the now defective tail-cone reinforcement angle. Once this has been accomplished, four aft flush rivets **82**, in the tail cone portion **32** of the fuselage **22** and in the underlying blade portion **42** of the tail-cone reinforcement angle, are drilled out. This is depicted in FIG. 9 of the drawings accompanying the application. The holes in the web of the blade portion of the tail-cone reinforcement angle, which result from the drilling out of these four flush rivets **82**, will align with the rivet receiving holes **68** in the forward or overlap section **62** of the splice **54**.

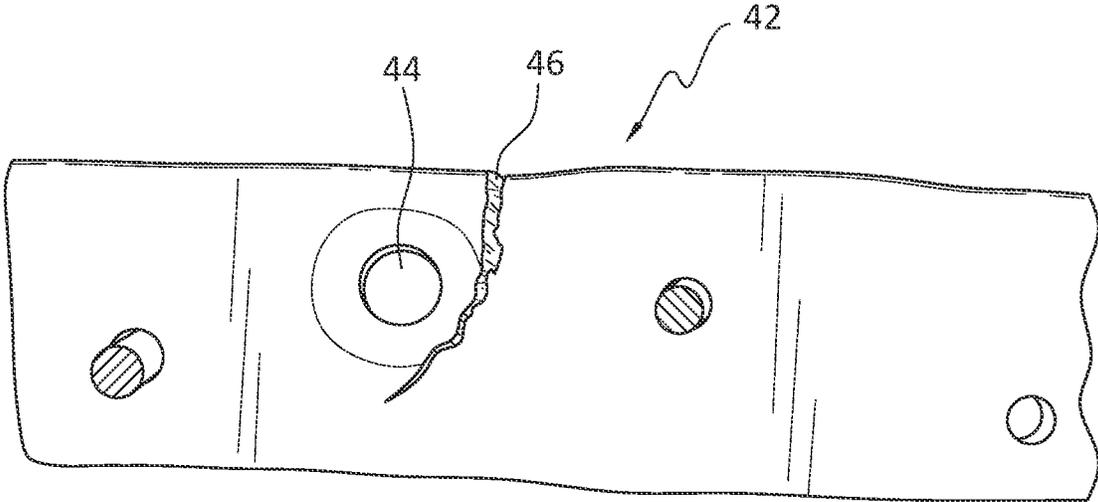
FIG. 3 is a photograph of an aft portion of a tail-cone reinforcement angle showing a typical failure in the horizontal stabilizer pivot shaft receiving bore of tail-cone reinforcement angle;

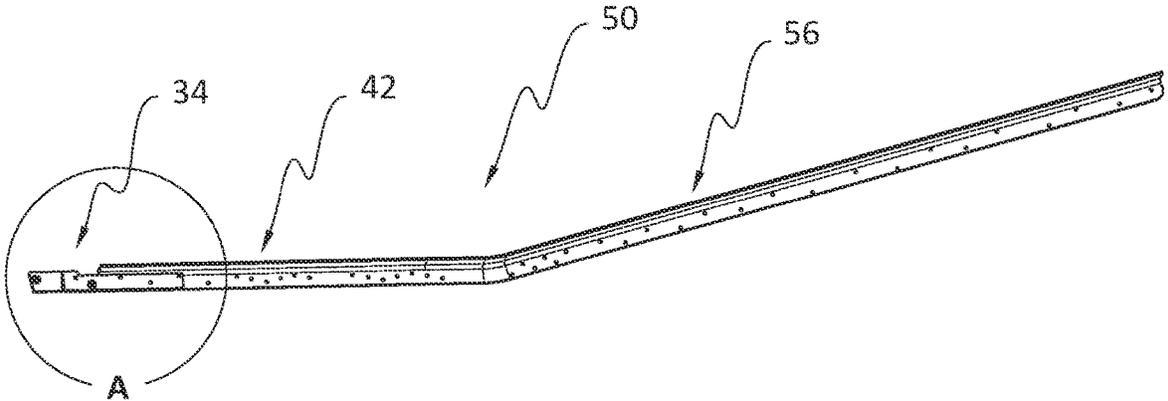
FIG. 4 is a perspective view of a left side tail-cone reinforcement angle including a left side tail-cone reinforcement angle splice, in accordance with the present invention;

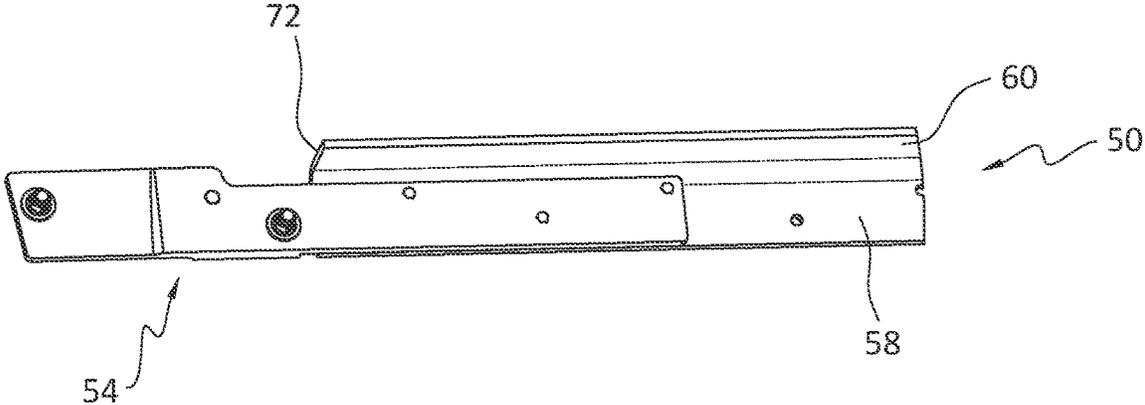
FIG. 5 is a side elevation view of an aft portion of the left side tail-cone reinforcement angle, encircled at A in FIG. 4, with the tail-cone reinforcement angle splice, in accordance with the present invention, in place;

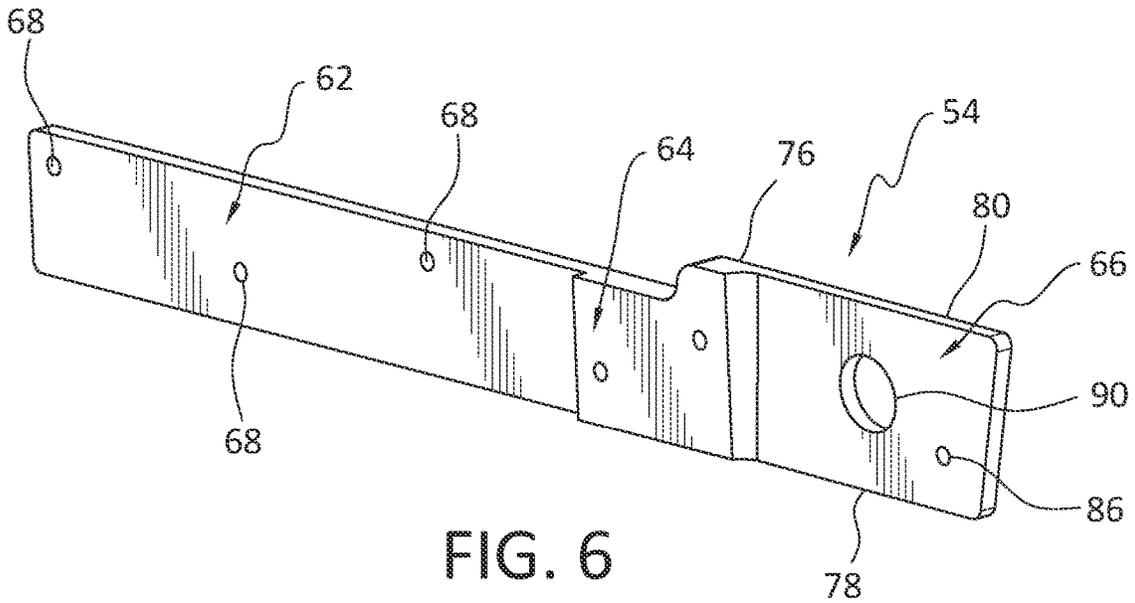
FIG. 6 is a perspective view of a left side tail-cone reinforcement angle splice prior to installation;

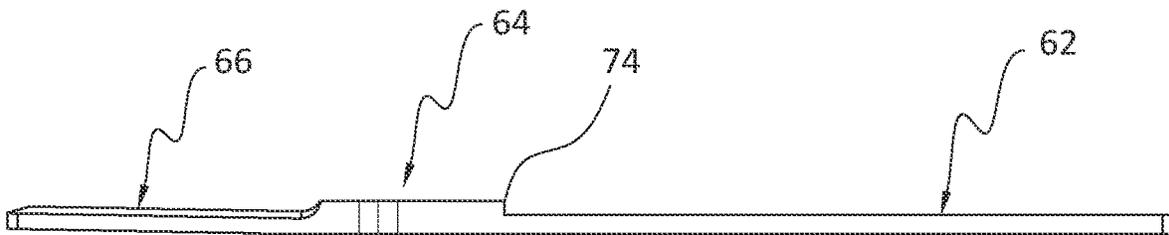
FIG. 7 is a top-plan view of the reinforcement angle splice depicted in FIG. 6;

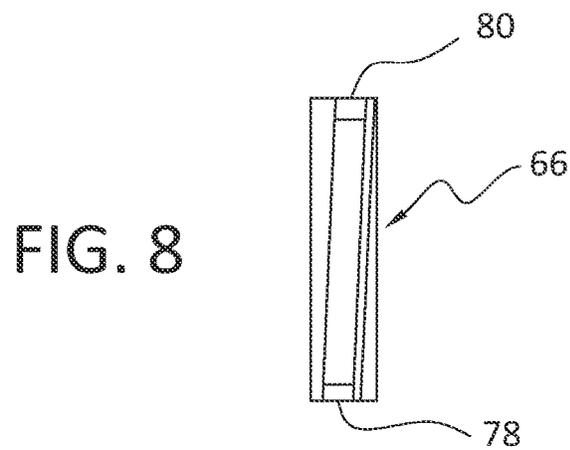
FIG. 8 is an aft end view of the reinforcement angle splice depicted in FIGS. 6 and 7 and taken from the right as seen in FIG. 6 and from the left as seen in FIG. 7;

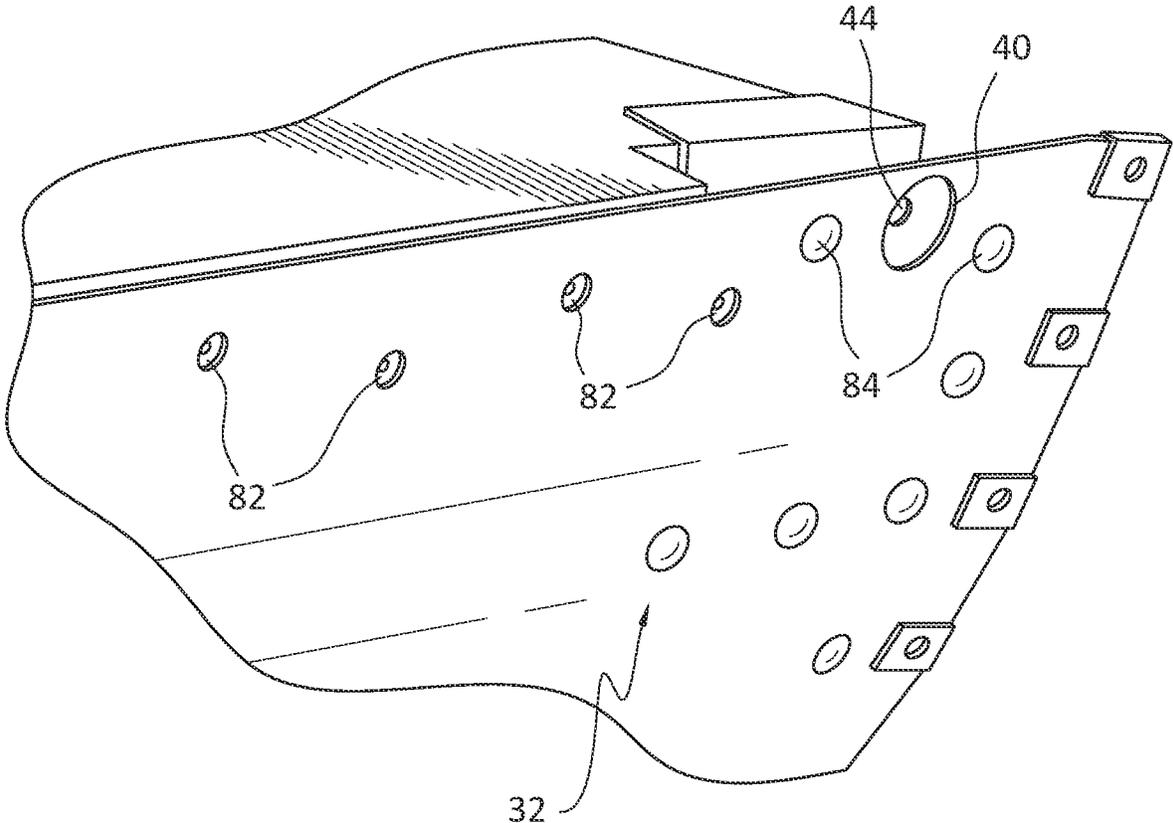
FIG. 9 is a view of an aft portion of the tail cone and showing the removal of four rivets;

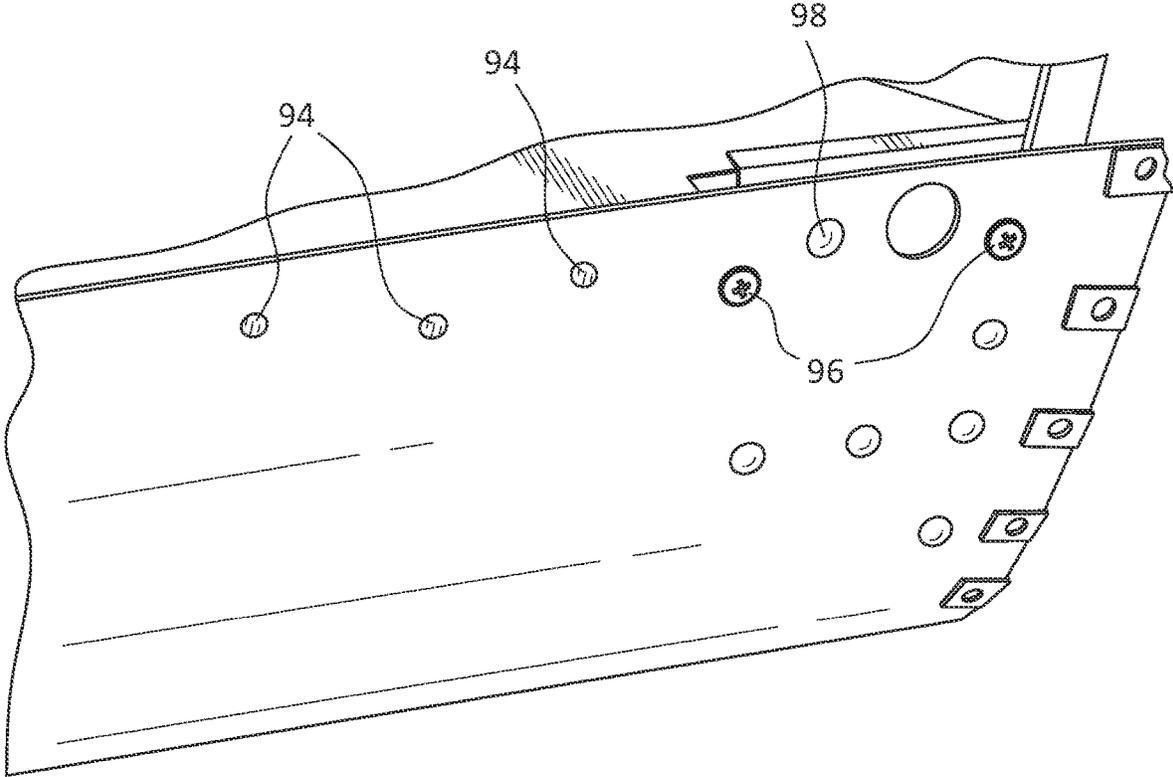
FIG. 10 is a view similar to FIG. 9 with the tail-cone reinforcement angle splice installed and secured in place;

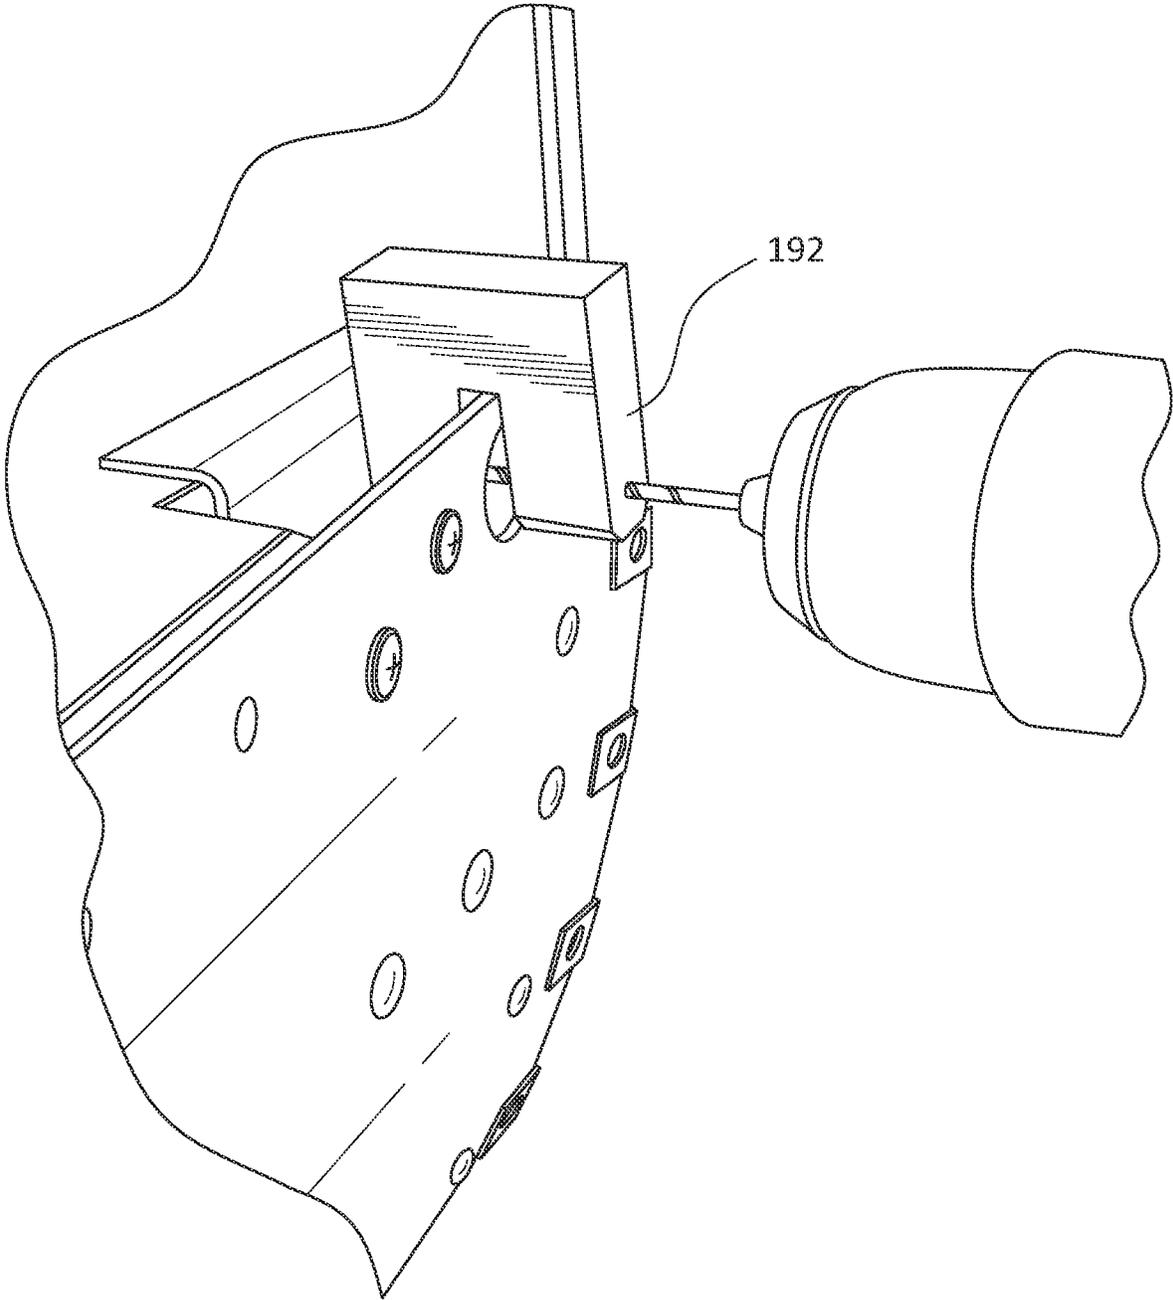
FIG. 11 is a view of the aft section of the tail cone and showing the forming of the horizontal stabilizer shaft receiving bore in the tail-cone reinforcement angle splice;

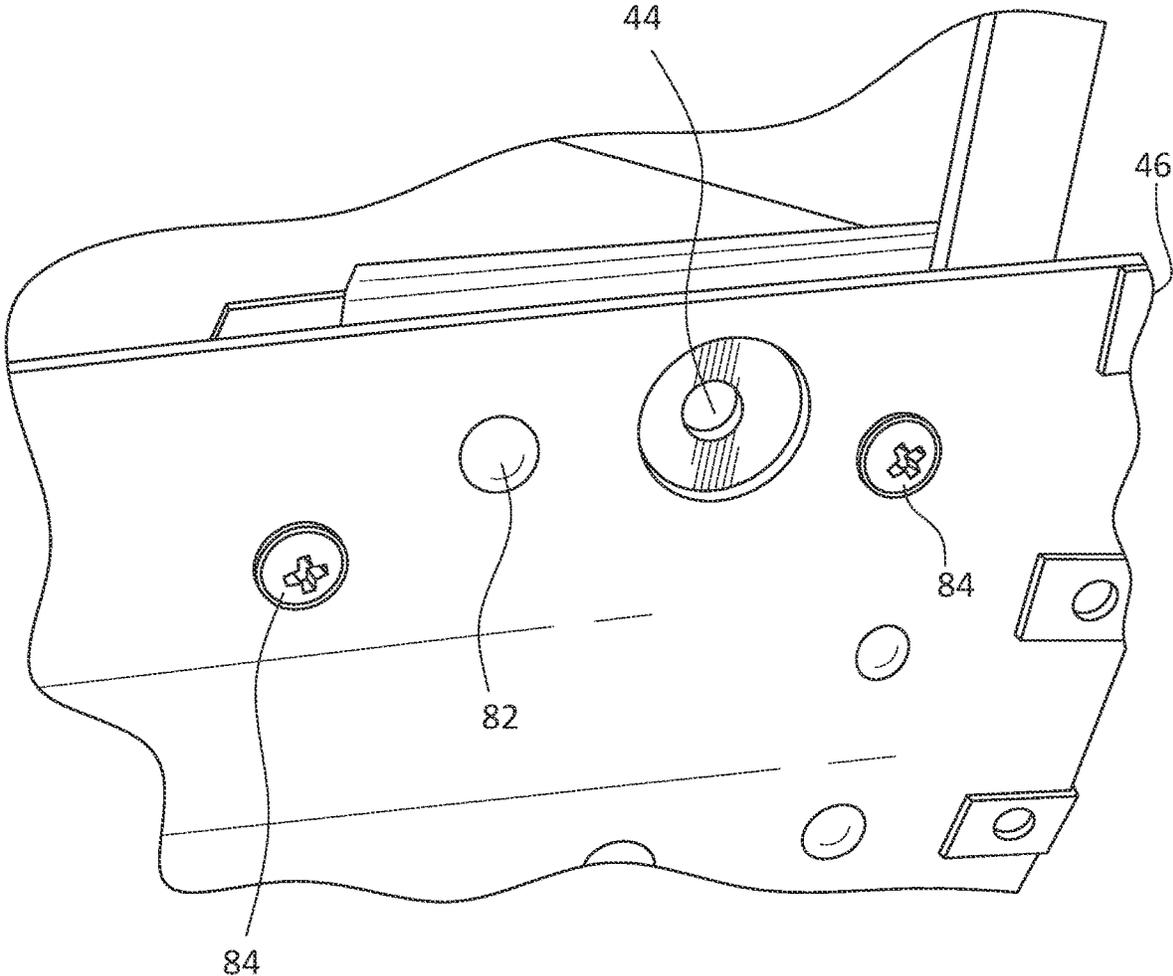
FIG. 12 is a view of the aft section of the tail cone and showing the completed horizontal stabilizer pivot shaft receiving bore formed in the tail-cone reinforcement angle splice; and
