(10) **Patent No.:** **US 10,222,353 B2**  
(45) **Date of Patent:** **Mar. 5, 2019**

(54) **METHOD AND ASSEMBLY FOR INSPECTING A PARTIALLY CURED REPAIR PATCH PRIOR TO INSTALLATION**

(71) Applicant: **The Boeing Company**, Chicago, IL (US)

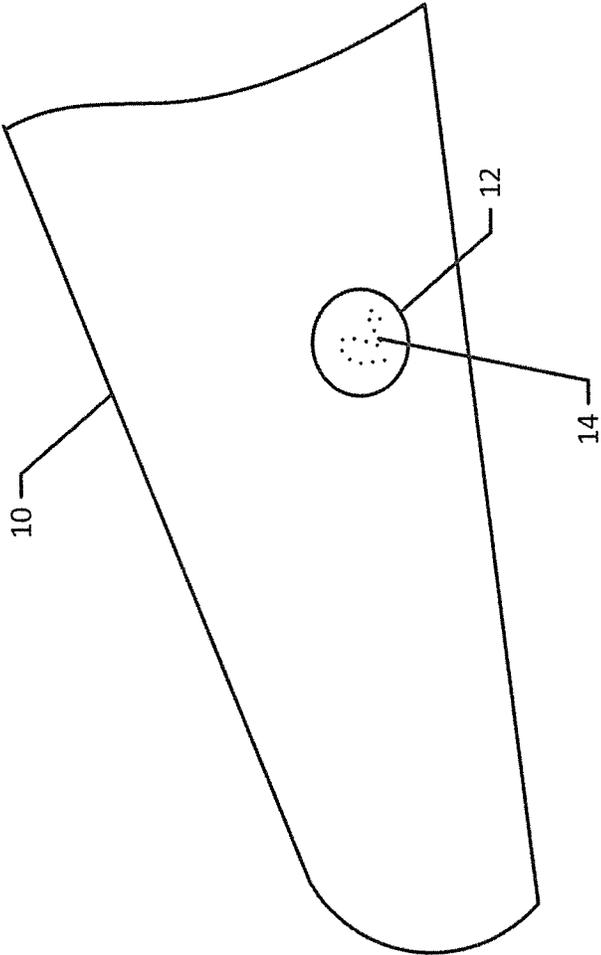
Figure 1

FIG. 1 is a perspective view of a portion of a wing of an aircraft having a repair patch installed thereupon;

An assembly for inspecting a repair patch and the associated method are provided in accordance with an example embodiment of the present disclosure. In this regard, the repair patch may be utilized in order to repair a variety of structures, such as vehicles, including aircraft, watercraft or the like, etc. By way of example, FIG. 1 depicts a portion of a wing 10 of an aircraft to which a repair patch 12 has been affixed, such as with an adhesive, in order to repair a defect 14 shown in dashed lines in the wing. By repairing struc-

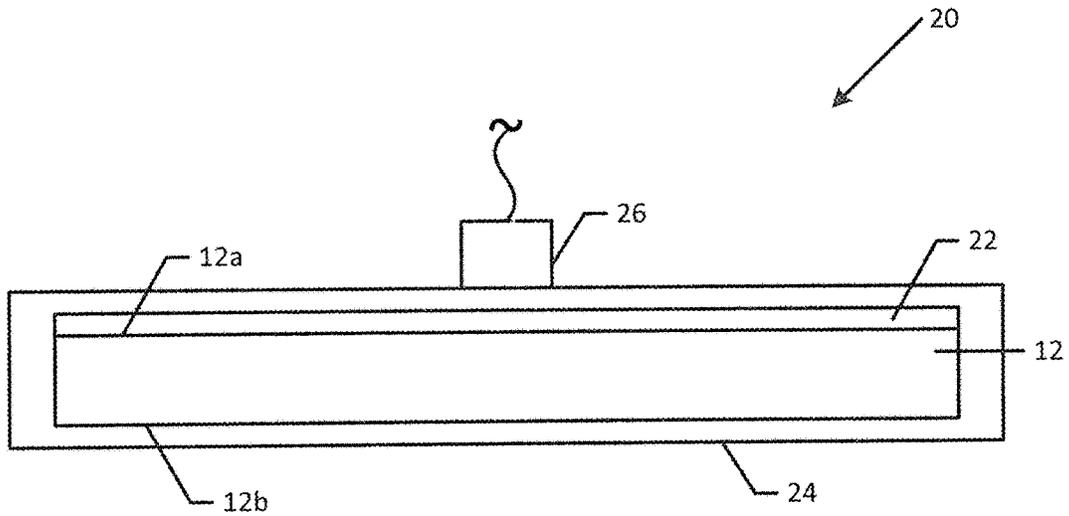
Figure 2

FIG. 2 is a cross-sectional view of a repair patch in accordance with an example embodiment of the present disclosure;

As shown in FIG. 2, the assembly **20** of an example embodiment also includes an ultrasonic transducer **26** configured to introduce ultrasonic signals that propagate through the vacuum bag **24** and the acoustic facilitation layer **22** and then into the repair patch **12**. Although an embodiment that employs through transmission inspection of a repair patch **12** is contemplated as described below, the assembly **20** of FIG. 2 is configured to inspect the repair patch **12** via a single-sided inspection. As such, the ultrasonic transducer **26** is also configured to receive echo signals returning from the repair patch **12**.

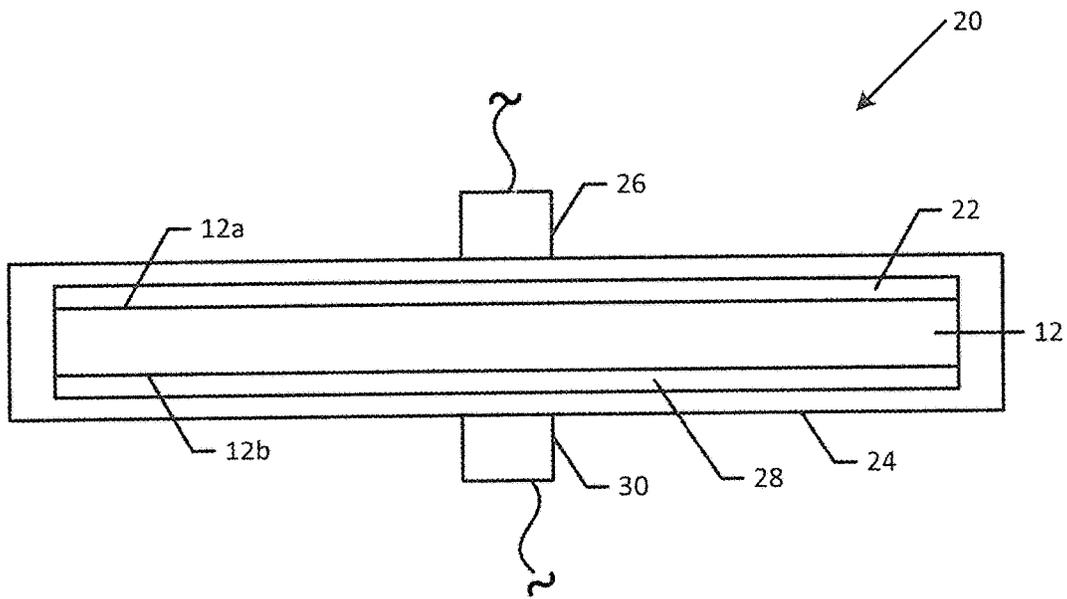
Figure 3

FIG. 3 is a cross-sectional view of a repair patch in accordance with another example embodiment of the present disclosure;

As noted above, and shown in FIG. 3, the assembly 20 of an example embodiment can alternatively provide for through transmission inspection of a repair patch 12 in which ultrasonic signals are introduced through the first side 12a of the repair patch and the signals that exit through the second side 12b of the repair patch are captured and analyzed. In this embodiment, the assembly 20 also includes a second acoustic facilitation layer 28 disposed proximate the second surface 12b of the repair patch 12, opposite the first surface 12a of the repair patch through which the ultrasonic signals will be introduced. The first and second acoustic facilitation layers 22, 28 may be comprised of the same material. Alternatively, the first and second acoustic facilitation layers 22, 28 may be formed of different materials. In this example embodiment, the assembly 20 also include an ultrasonic receiver 30 configured to receive ultrasonic signals that exit the repair path 12 from the second side of the assembly, opposite the first side via which the ultrasonic transducer 26 introduces the ultrasonic signals. In this regard, ultrasonic signals introduced via the first surface 12a of the repair patch 12 by the ultrasonic transducer 26 are received upon exit from the second surface 12b of the repair path with the ultrasonic receiver 30. As such, the repair patch 12 can be subjected to a through transmission inspection, such as while the assembly 20 is held in a rack or submerged in a tank.

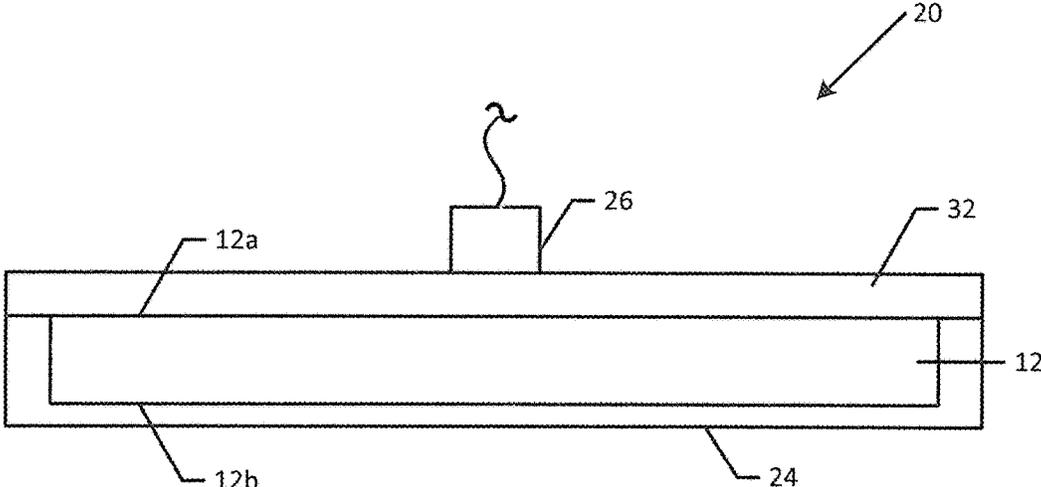
Figure 4

FIG. 4 is a cross-sectional view of a repair patch in accordance with a further example embodiment of the present disclosure;

In a further example embodiment, and as shown in FIG. 4, the assembly 20 need not include a discrete acoustic facilitation layer, but, instead, the vacuum bag 24 may be at least partially comprised of an acoustic facilitation material, such as the rubber-like material described above. In an example embodiment, such as in an instance in which the repair patch 12 is to be subjected to a single-sided inspection, only the portion of the vacuum bag 24 proximate the first surface 12a of the repair patch need be comprised of the

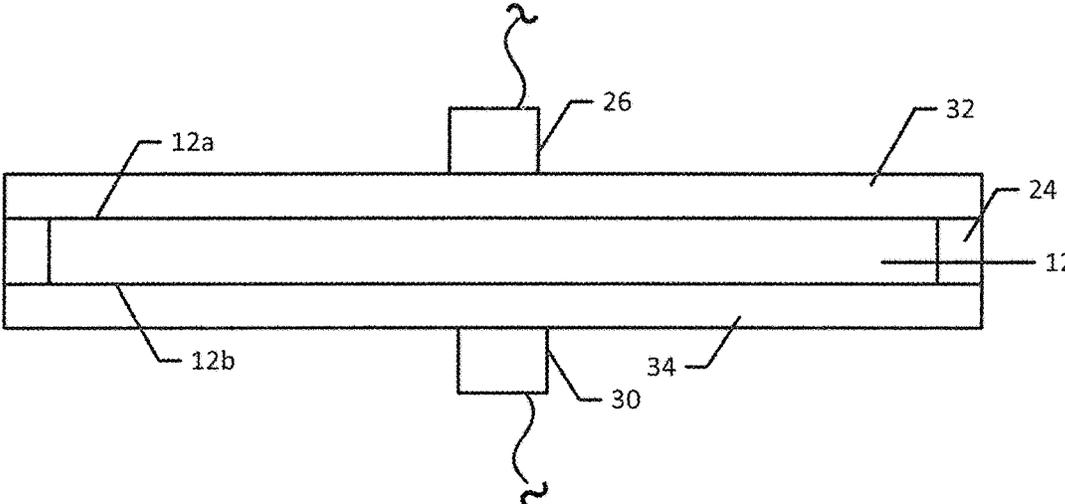
Figure 5

FIG. 5 is a cross-sectional view of a repair patch in accordance with yet another example embodiment of the present disclosure; and

acoustic facilitation material 32 with the remainder of the vacuum bag comprised of another material, such as nylon. Alternatively, in an instance depicted in FIG. 5 in which the repair patch 12 is to be subjected to through transmission inspection, the entire vacuum bag 24 or at least those portions of the vacuum bag proximate the first and second opposed surfaces 12a, 12b of the repair patch 12 may be comprised of the acoustic facilitation material 32, 34. In either embodiment, however, intimate and direct contact is advantageously established between the vacuum bag 24 and the repair patch 12.

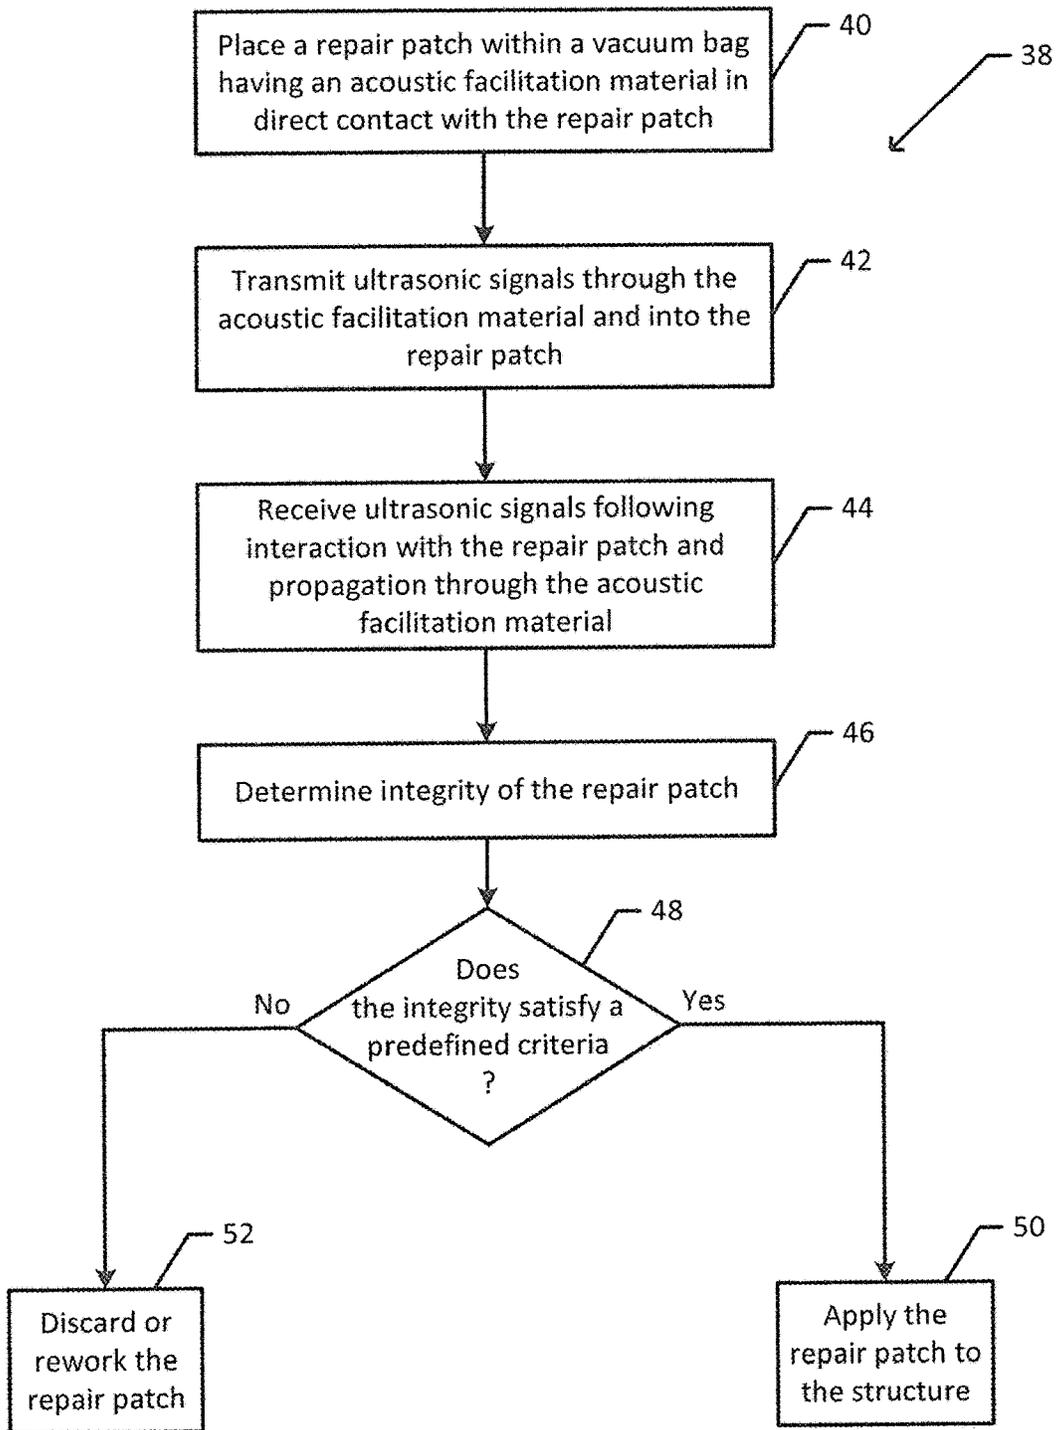
Figure 6

FIG. 6 is a flowchart illustrating operations performed in accordance with an example embodiment of the present disclosure.
