(54) **ACOUSTIC PANEL REPAIR WITH
RETENTION OF ACOUSTIC PROPERTIES**

An acoustic panel (200) for an aircraft nacelle (100) may comprise a perforated first skin (220), a second skin (230), and a core (210) sandwiched between them. A damaged portion of the perforated first skin may be removed. A fiberglass ply (510) may be coupled to the acoustic panel. A pressure differential may cause the fiberglass ply to form dimples (515) within the perforations (325) of the first skin. The fiberglass ply may be used as a template to drill holes in a replacement patch (400).

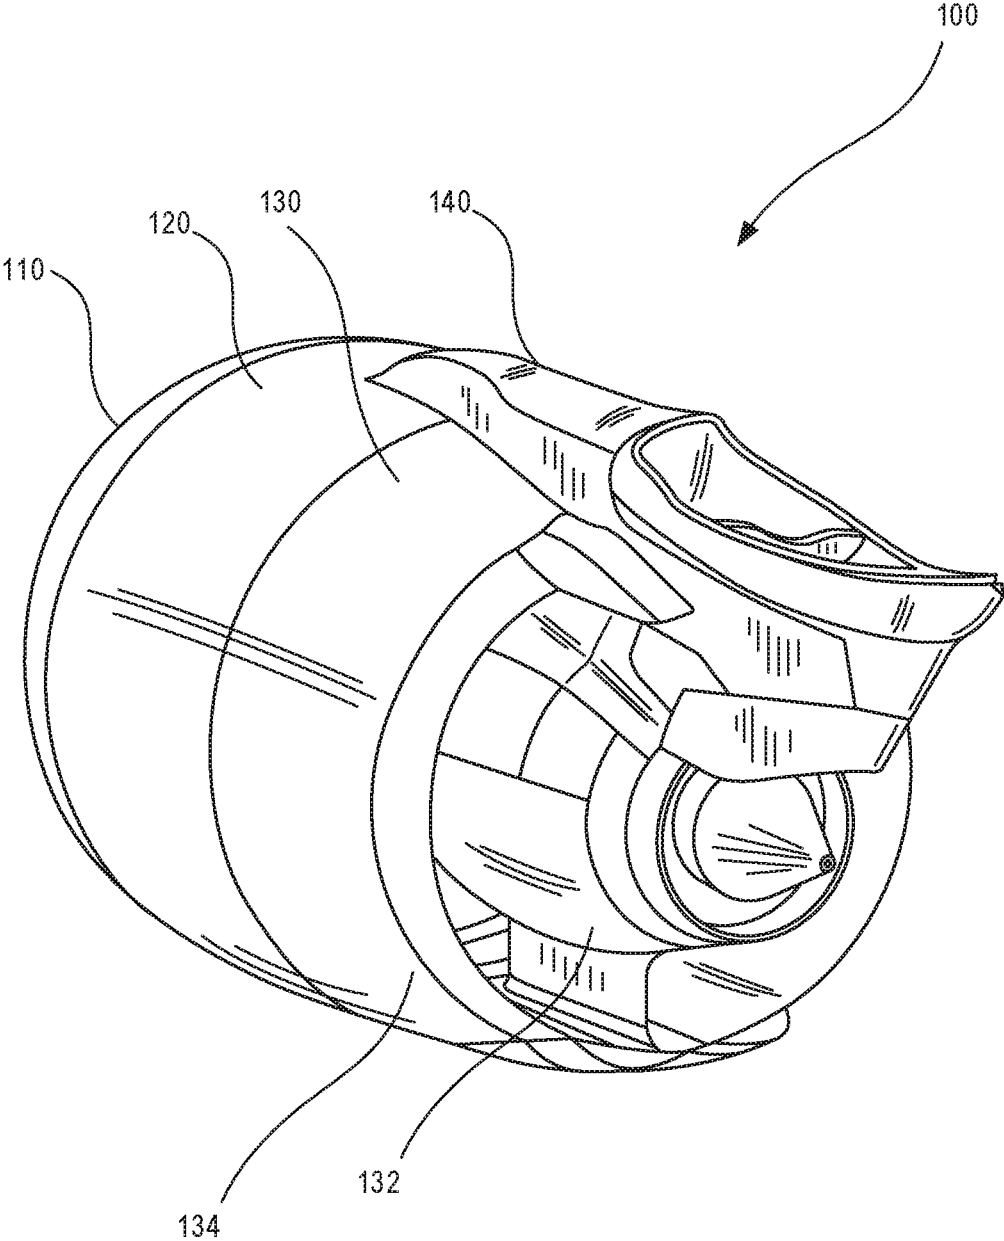
FIG. 1 illustrates a perspective view of a nacelle for an aircraft in accordance with various embodiments;

Referring to FIG. 1, a nacelle 100 for a gas turbine engine is illustrated according to various embodiments. Nacelle 100 may comprise an inlet 110, a fan cowl 120, and a thrust reverser 130. Nacelle 100 may be coupled to a pylon 140, which may mount the nacelle 100 to an aircraft wing or aircraft body. Thrust reverser 130 may comprise an inner fixed structure (“IFS”) 132, an outer fixed structure (“OFS”), and a translating sleeve 134. Bypass air from an engine fan may flow in a generally annular bypass air duct defined between the IFS 132 and the translating sleeve 134. Portions of the inner fixed structure 132, the translating sleeve 134, and the inlet 110 may be commonly formed using acoustic panels.

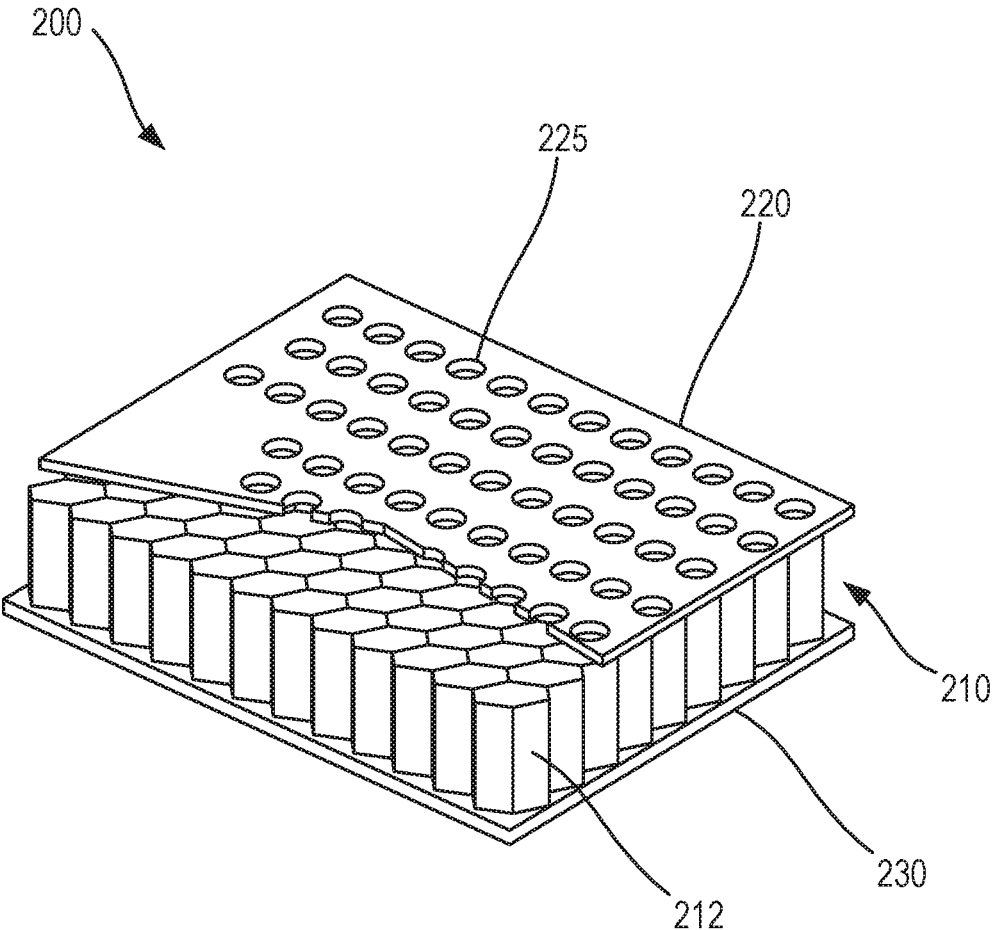
FIG. 2 illustrates a perspective view of an acoustic panel in accordance with various embodiments;

Referring to FIG. 2, an acoustic panel 200 is illustrated according to various embodiments. The acoustic panel 200 may comprise perforations 225, and could be used to form portions of a nacelle for an aircraft engine, as described above. The acoustic panel 200 may comprise a core 210, positioned between a first skin 220 and a second skin 230. The core 210 may have walls extending generally in a normal direction from the first skin to the second skin that form a plurality of cells 212. The cells 212 may be hexagonal in shape and are then commonly referred to as honeycomb core. In various embodiments, however, the cells 212 could have any of a number of different geometries. Core walls could be made from various metals such as titanium or aluminum, or composites, or hardened paper or other plastics, according to the particular application and material properties. Adjacent core walls may be bonded to each other with glue or may be welded, or other methods may be used to join core walls together to form the cellular structure. The first skin 220, core 210, and second skin 230 combine to form closed cells that may become resonator chambers when

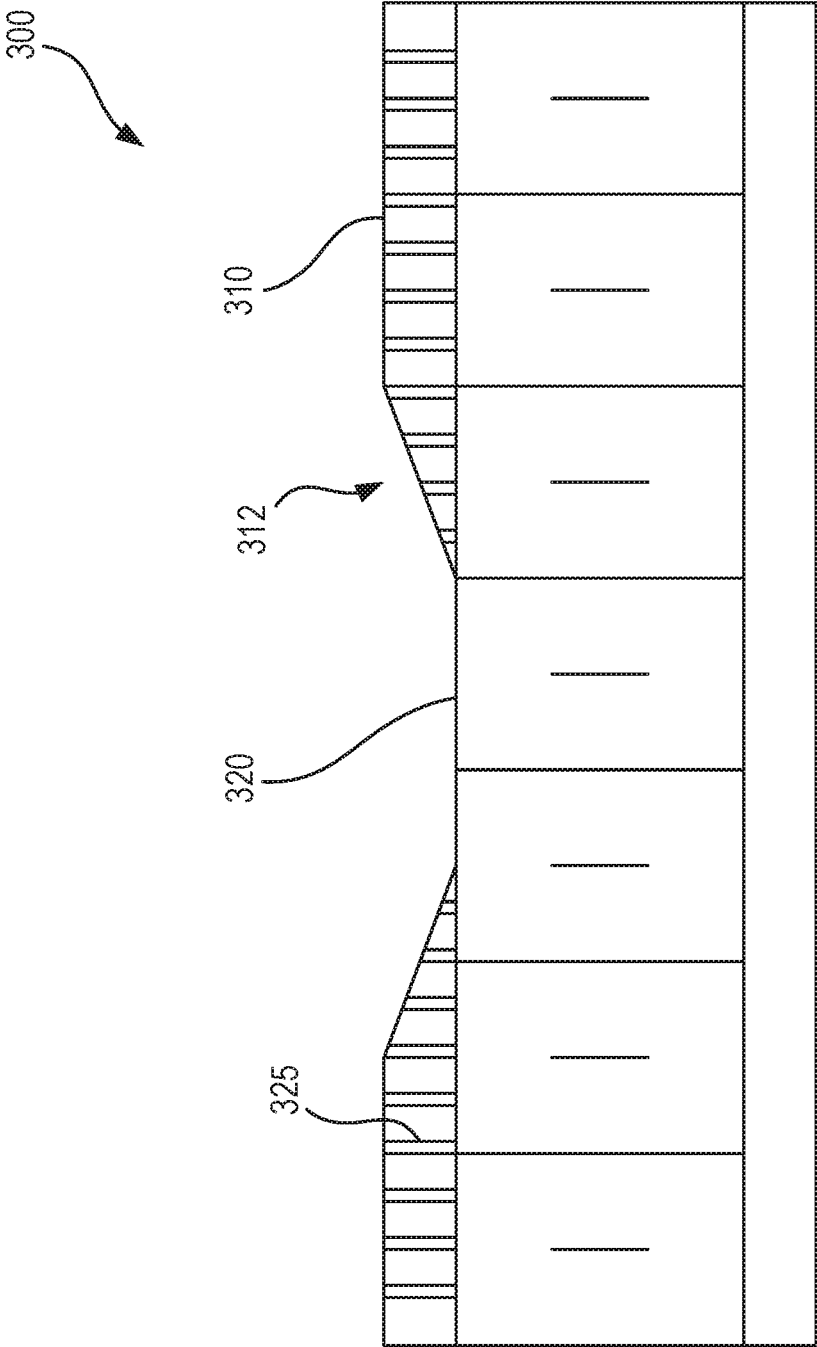
FIG. 3 illustrates a schematic cross-section view of an acoustic panel with a damaged portion of a perforated top skin removed in accordance with various embodiments;

Referring to FIG. 3, a schematic cross-section view of an acoustic panel 300 with a damaged portion of a perforated top skin 310 removed is illustrated according to various embodiments. The damaged portion may be cut with a continuously sloped ramp portion 312 between the top of the top skin 310 and the core section 320 where the top skin 310 is completely removed. However, in various embodiments, the damaged portion may be cut with a stepped profile. In various embodiments, the acoustic panel 300 may be curved in two or three dimensions. The curved shape may make it difficult to align perforations 325 between the remaining top skin and a replacement patch.

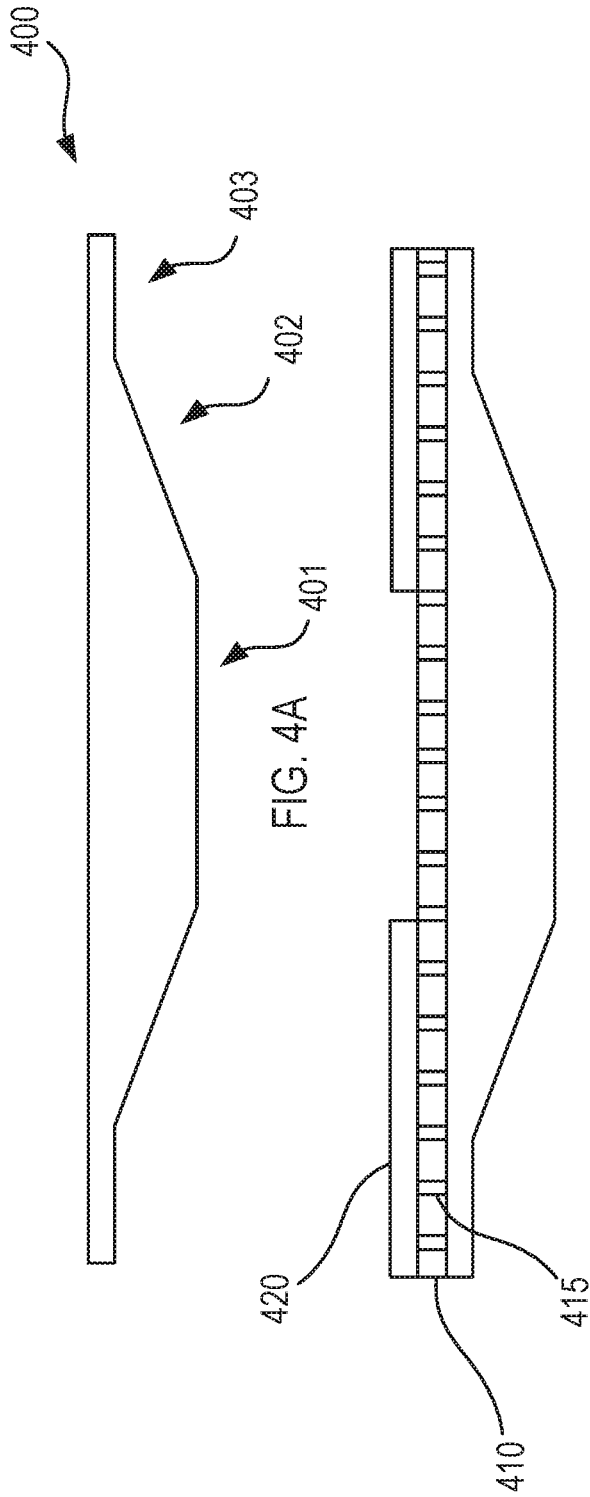
FIG. 4B illustrates a schematic cross-section view of a replacement patch with a maskant in accordance with various embodiments;

Referring to FIG. 4B, a maskant 410 may be coupled to the replacement patch 400. The maskant 410 may be a polymeric material. The maskant 410 may comprise a plurality of apertures 415 matching a perforation pattern of an acoustic panel. A tape 420 may be coupled to the replacement patch 400 or the maskant 410 over the ramp portion 402 and the overlap portion 403.

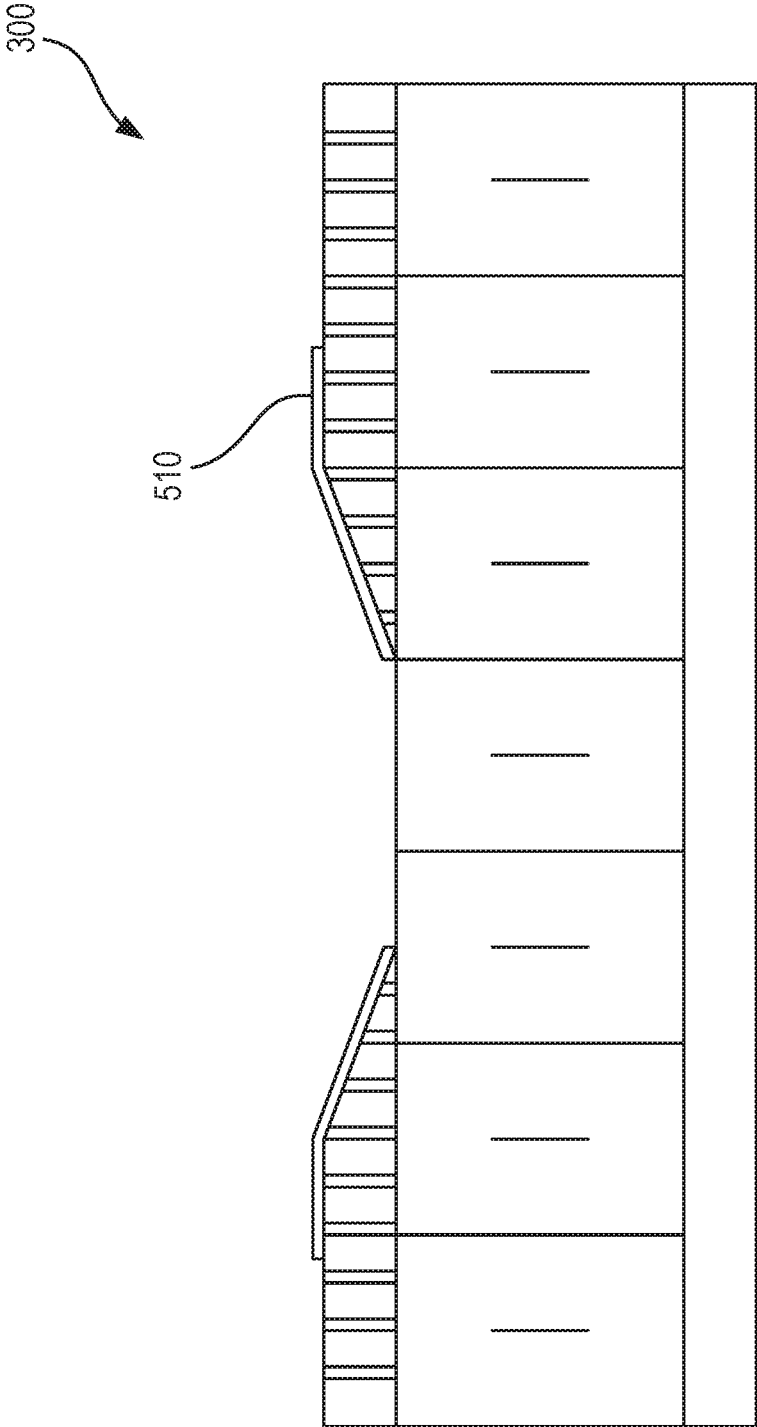
FIG. 5A illustrates a schematic cross-section view of an acoustic panel with an uncured fiberglass ply in accordance with various embodiments;

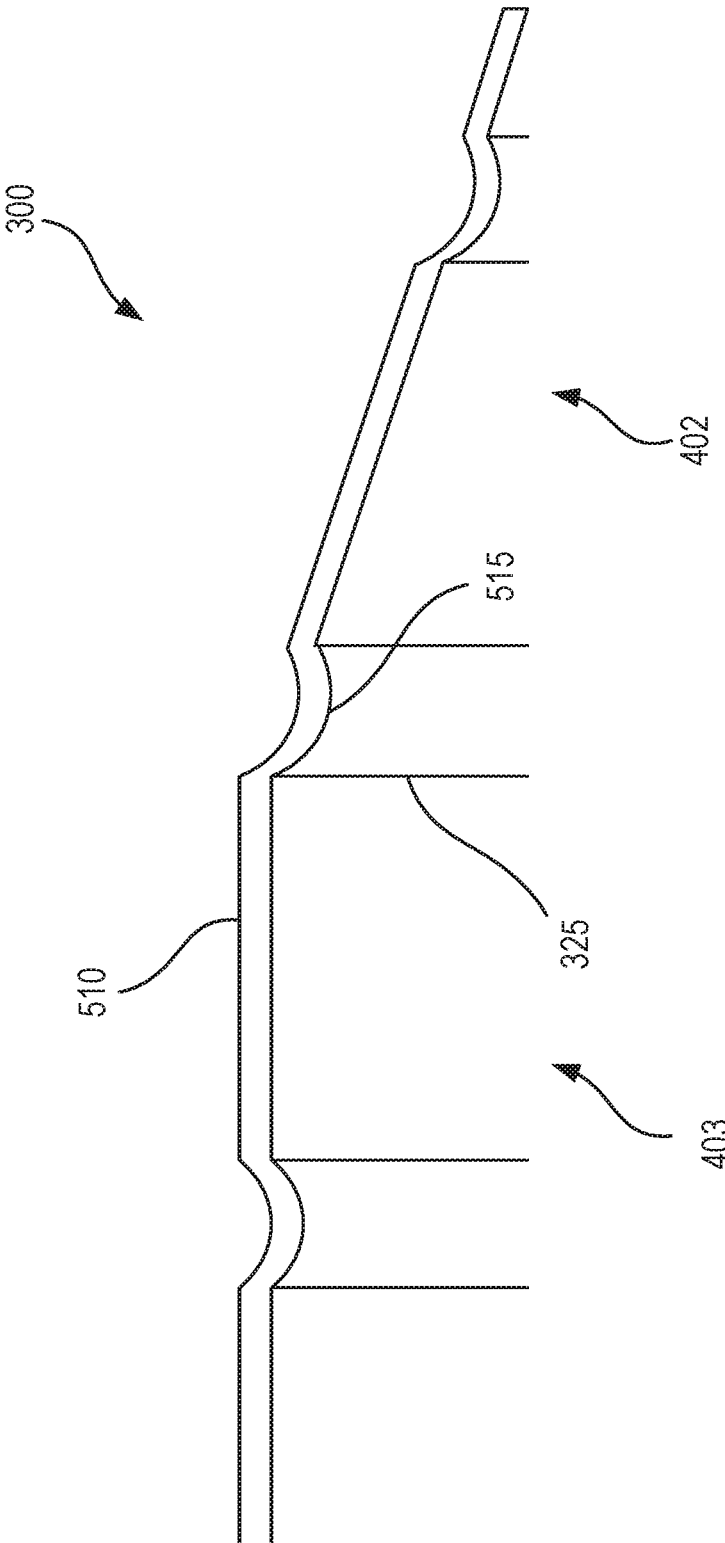
FIG. 5B illustrates a schematic cross-section view of an acoustic panel with a fiberglass ply with dimples in accordance with various embodiments

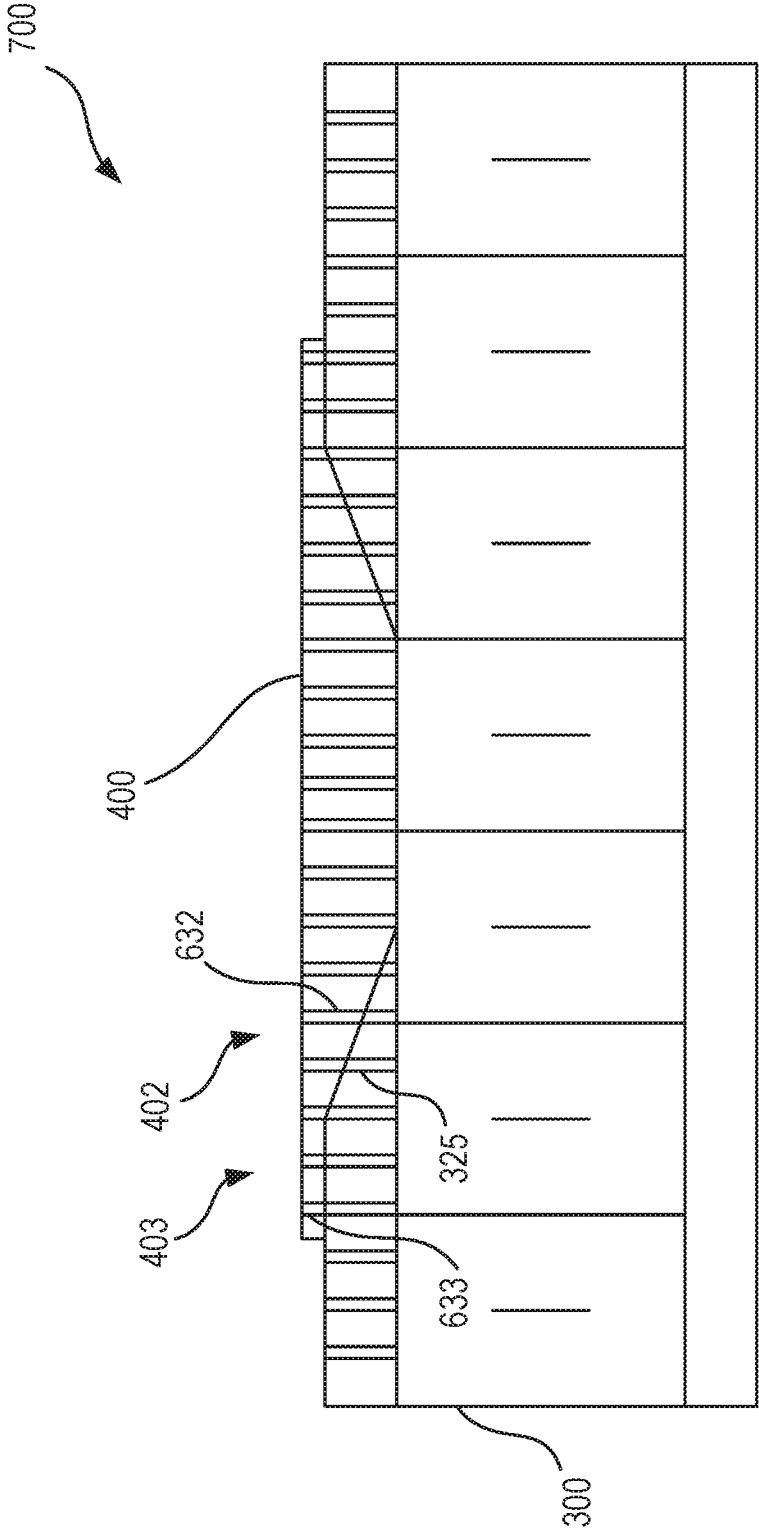
FIG. 7 illustrates a repaired acoustic panel, in accordance with various embodiments; and

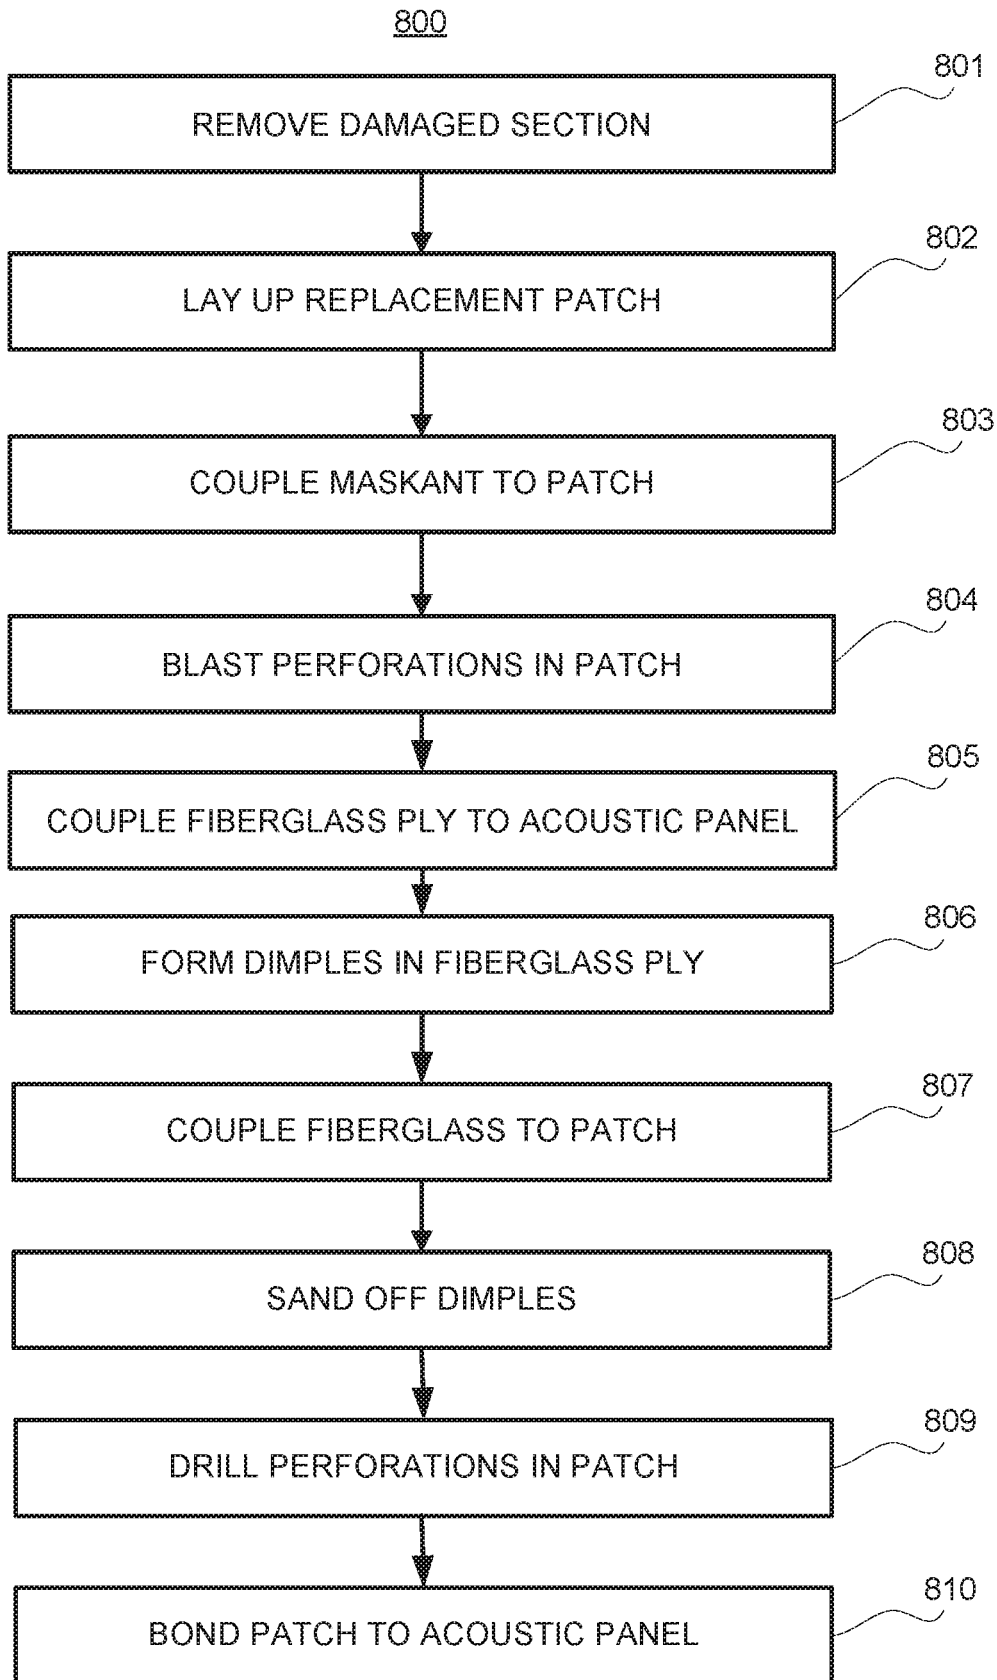
FIG. 8 illustrates a flowchart of a process for repairing an acoustic panel in accordance with various embodiments.
