(10) **Patent No.:** US 8,245,399 B2
(45) **Date of Patent:** Aug. 21, 2012

A method of repairing a case for a gas turbine engine includes removing a first portion of the case from a second portion of the case and metallurgically joining a replacement material to the second portion of the case to form a repaired case. The first portion of the case includes a connection flange having a plurality of bolt holes formed therein. The replacement material has a different coefficient of thermal expansion than a parent material of the second portion of the case.

REPLACEMENT OF PART OF ENGINE CASE WITH DISSIMILAR MATERIAL

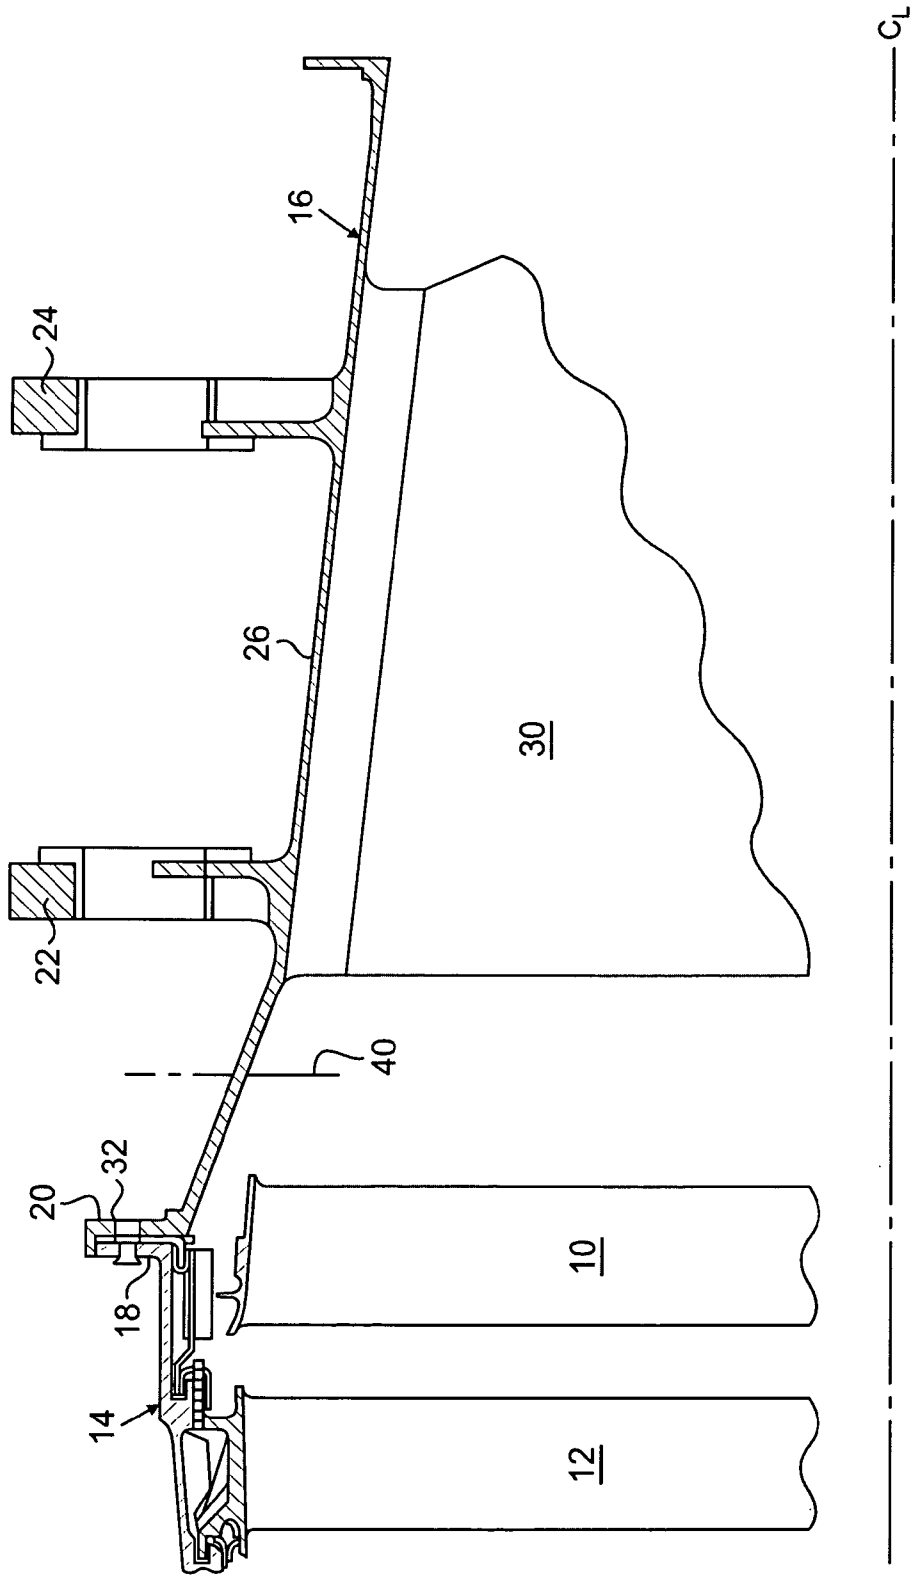
FIG. 1 is a cross-sectional view of a portion of a gas turbine engine.

FIG. 1 is a cross-sectional view of a portion of a gas turbine engine, including a low-pressure turbine (LPT) blade 10, a LPT vane 12, a LPT case 14, and a turbine exhaust case (TEC) segment 16, all arranged relative to an engine centerline CL. FIG. 2 is an isometric view of the TEC segment 16. The LPT case 14 includes a flange 18, which is located at an aft portion of the LPT case 14 near the aftmost LPT blade 10. The LPT case 14 can be made of a metallic material, for instance, a superalloy such as a nickel-based superalloy consistent with Aerospace Materials Specification (AMS) 5666 specifications (e.g., Inconel® 625).

During repair, a cut plane 40 on the TEC segment 16 is determined (see FIG. 1). The flange 20 is removed from the rest of the TEC segment 16 at the cut plane 40, using a suitable machining process for example. The cut plane 40 is generally located at a relatively low-stress area of the TEC segment 16. In one embodiment, the cut plane 40 is located such that the material removed includes the entire flange 20 as well as an approximately 3.81-5.08 cm (1.5-2 inch) portion of the OD wall 26. A replacement detail is created (or otherwise provided) to replace the removed material, and is welded to parent material of the TEC segment 16 at the location of the cut plane 40.

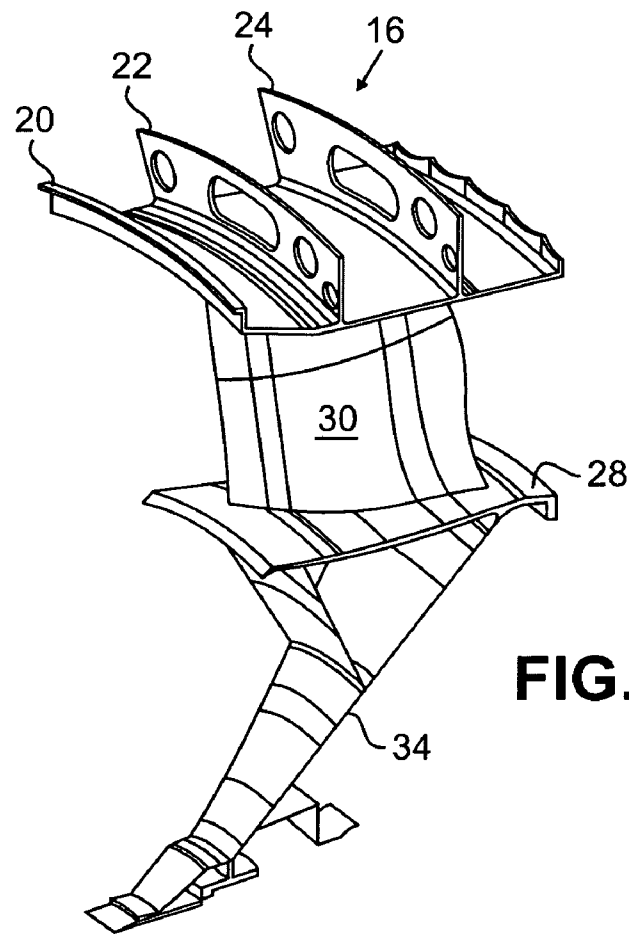
FIG. 2 is an isometric view of a turbine exhaust case segment of the gas turbine engine.

The TEC segment 16 includes flanges 20, 22 and 24 extending from an outer diameter (OD) wall 26, an inner diameter (ID) wall 28, and at least one vane 30 extending between the OD and ID walls 26 and 28. The flange 20 is located at a forward portion of the TEC 16, and is configured to be mechanically connected at a bolt hole 32 to the flange 18 of the LPT case 14 with a bolt or other suitable fastener. As shown in FIG. 2, support structures 34 can extend from the ID wall 28, to facilitate mounting the TEC segment 16 in the engine. A plurality of TEC segments 16 can be assembled together to form a generally annular TEC assembly about the engine centerline CL, with a generally annular exhaust flow-

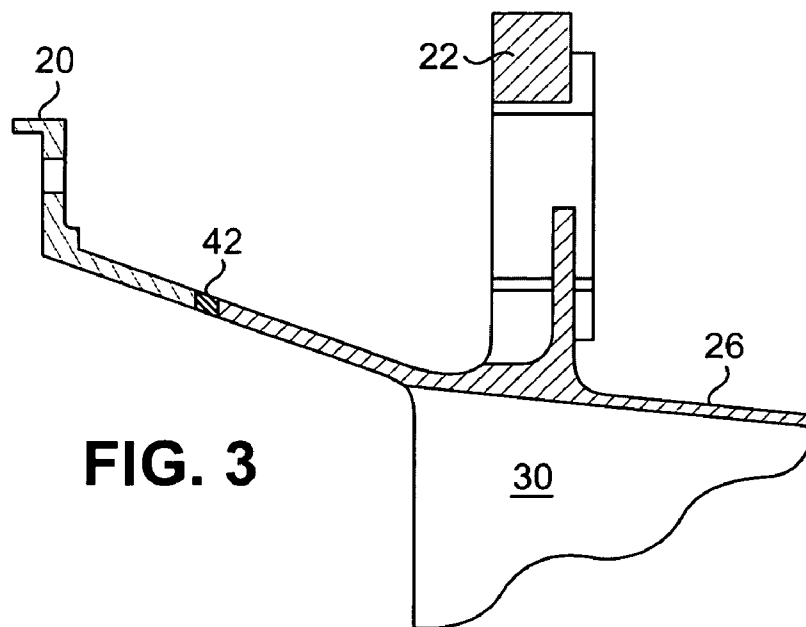
FIG. 3 is a cross-sectional view of a repaired portion of the turbine exhaust case segment.

FIG. 3 is a cross-sectional view of a repaired portion of the TEC segment 16. A replacement detail 20' is welded to the parent material of the TEC case 16 along the OD wall 26. A weld joint 42 is formed at a location that corresponds to the location of the cut plane 40 (see FIG. 1). Electron beam welding or other suitable techniques can be used to form the weld joint 42. The replacement detail 20' can have a shape that is substantially identical to the removed material of the TEC segment 16, and can be made of a different material than the parent material of the TEC segment 16. The replacement detail 20' can be made of the same material as the LPT case 14, or a material have substantially the same coefficient of thermal expansion as the material of the LPT case 14. For example, the replacement detail 20' can be made of an Inconel® 625 alloy while the parent material of the TEC segment 16 can be made of a Greek Ascoloy™ alloy. By making the replacement detail 20' of a dissimilar material from the parent material of the TEC segment 16, contact between the LPT case 14 and the TEC segment 16 can occur between materials with substantially the same coefficient of thermal expansion. In that way, creep at the connection between the LPT case 14 and the repaired TEC segment 16 can be reduced, which can help reduce rework, turnaround time (TAT), costs, future part damage, and engine time off-wing.

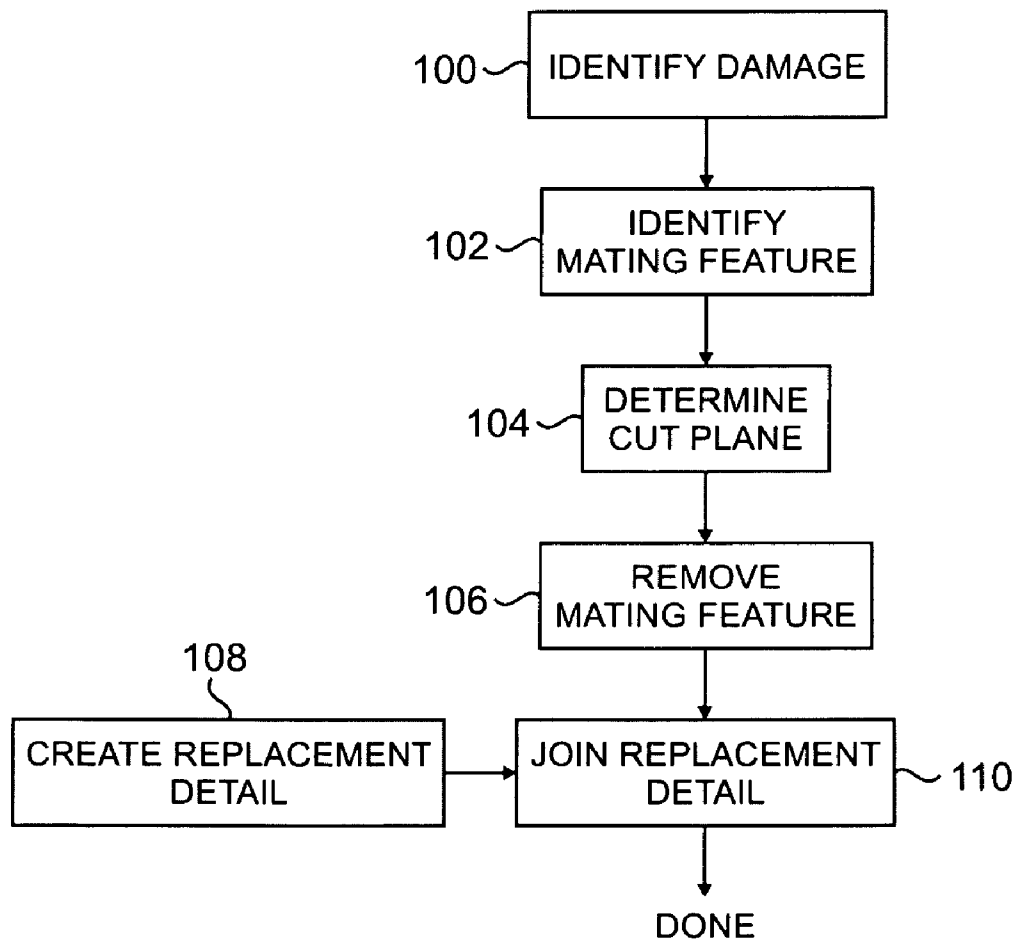
**FIG. 4**

FIG. 4 is a flow chart of a repair method.

FIG. 4 is a flow chart of one embodiment of a repair. After a part has been removed from an engine for service, a first step is to identify damage to the part (step 100). Damage can include creep, bolt hole elongation, flange bending, cracks, etc. Next, a mating feature of the part is identified (step 102). The mating feature can include a flange or other structure that connects to another part in the engine. A cut plane is then determined (step 104). A portion of the part including the mating feature is removed from another portion of the part at the cut plane (step 106). A replacement detail is created (or otherwise provided) of a replacement material having a dif-

During use, the TEC segment 16 can become warped or damaged, for example, due to thermal conditions and low-cycle fatigue (LCF). Moreover, creep can occur at the flange 20 of the TEC segment 16. Creep can be particularly problematic because the LPT case 14 and the TEC segment 16 can be made of different materials (e.g., Inconel® 625 and Greek Ascoloy™, respectively) with different coefficients of thermal expansion, which can cause undesirable elongation of the bolt hole 32 and bending of the flange 20. Wear or damage to the TEC segment 16 can be repaired according to the disclosed method (see FIG. 4).
