[11] Patent Number: **5,368,792**

[54] **METHOD FOR MOLDING THREADS IN GRAPHITE PANELS**

[73] Assignee: **The United States of America as represented by the United States Department of Energy**, Washington, D.C.

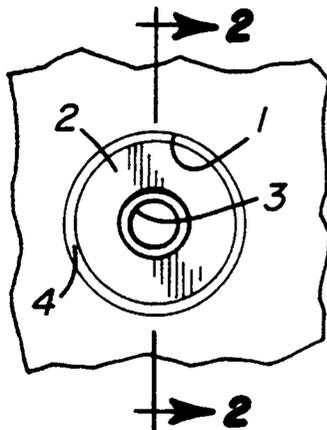
**FIGURE 1**  
(PRIOR ART)

FIG. 1 is a plan view of a prior art attempt to repair a threaded hole in a graphite panel.

Another repair attempt is that shown in FIGS. 1 and 2 herein. In this case, the region of the panel surrounding the damaged threaded hole was drilled or reamed out to form a pocket 1 having a diameter slightly more than twice that of the damaged hole. A circular graphite plug 2 having an outside diameter twice that of the drilled and tapped hole 3 therein was inserted into pocket 1 and held in place by a suitable epoxy glue 4.

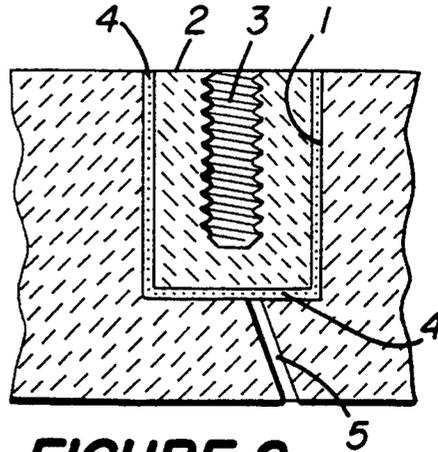
**FIGURE 2**  
(PRIOR ART)

FIG. 2 is a sectional view of the prior art attempt of FIG. 1, taken at a line 2—2 thereof.

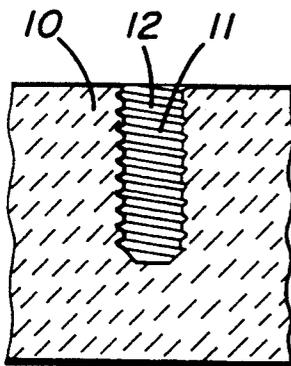
**FIGURE 3**

FIGS. 3—7 are sectional views of a graphite panel, illustrating the sequence of operations in repairing a hole with a damaged thread.

Referring now to the drawings, and in particular to FIGS. 3—7, FIG. 3 shows a graphite panel 10 having a hole 11 drilled thereinto and threaded by a conventional tap to form a thread 12 of a given desired diameter, shape and pitch.

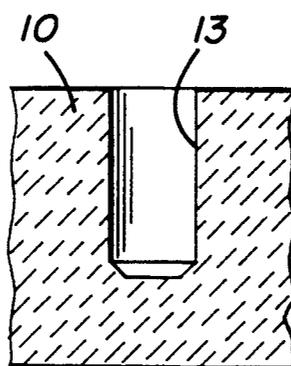
**FIGURE 4**

The damaged thread is repaired in accordance with the present invention as follows. First, the original hole 11 is drilled or reamed out to remove all of the original thread 12, thus leaving a hole 13 of a larger diameter (FIG. 4). For example, the damaged hole should be drilled out to 1/16 inch oversize (i.e., a hole with a ¼ inch×20 thread would be drilled out to a diameter of 5/16 inch), and if possible, the hole 13 should be drilled to 1/6 inch deeper depth than the bolt 14 will be set in FIG. 6.

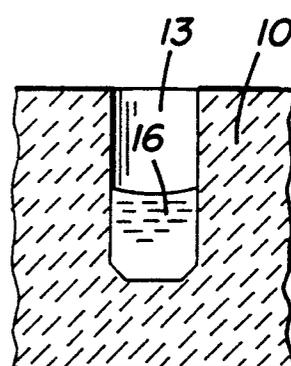
**FIGURE 5**

Next, the hole 13 is partially filled with a thermosetting graphite cement 16, FIG. 5. Such cement is preferably, by weight, 10 parts phenolic resin, 25 parts furfuryl alcohol and 45 parts graphite, without any other constituents that might evaporate when the panel is subsequently used in a vacuum environment. Also preferably, the graphite cement should be obtained ready mixed so that uniform results will be had from batch to batch in the repair of a plurality of holes. Suitable results have been obtained by use of a graphite cement of the above proportions available from Dylon Industries, Inc., Berea, Ohio.

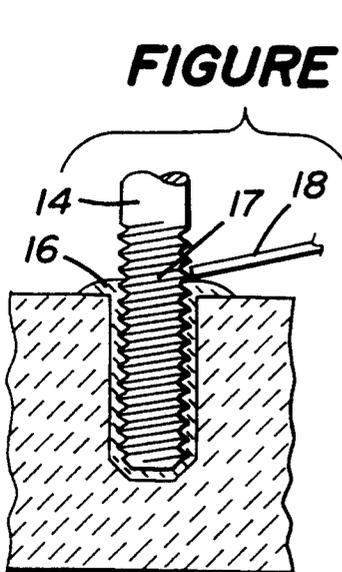
**FIGURE 6**

Referring now to FIG. 6, the bolt 14 is then inserted into hole 13, causing some of the graphite cement 16 to overflow from the hole. Bolt 14 has a thread 17 which has the desired diameter, shape and pitch of the bolt that will subsequently be used in reassembly of the panel 10. Prior to insertion, the thread 17 of the bolt is coated with a very slick lubricant that will provide lubrication of the thread but will not have any contaminants that would adversely affect the graphite cement 16. Preferably, the lubricant is sprayed on, and let dry, to form a thin, dry film on the thread 17 without filling in any of the thread. An aerosol solution containing molybdenum disulfide will provide the desired lubrication. Suitable results have been obtained by use of an aerosol with 4% molybdenum disulfide available from Dow Corning Corporation, Midland, Mich.

Again referring to FIG. 6, a druggist's spatula 18 or similar tool is used to force the overflowed graphite cement 16 back into hole 13 with enough force so that the cement will completely fill the hole and the thread 17 of bolt 14.

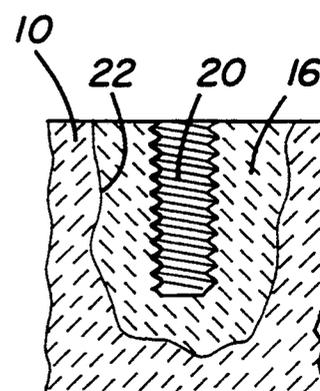
**FIGURE 8**

FIG. 8 is a sectional view of a graphite panel in which a threaded hole has been formed into a damaged portion of the panel.

FIG. 8 illustrates a graphite panel 10 in which a relatively large chunk of the panel was broken away during disassembly, leaving a cavity 22 in the face of the panel. Repair is made as above, with the graphite cement 16 filling the entire cavity and being bonded to the panel 10 during curing. The new thread 20 will again be at least as strong as that of the original drilled and tapped hole.
