(54) **PIPE REPAIR ASSEMBLY**

**PIPE REPAIR ASSEMBLY****FIELD OF THE INVENTION**

5 This invention relates to the repair of leaks in pipelines and, in particular, to a pipe repair assembly for sealing such leak.

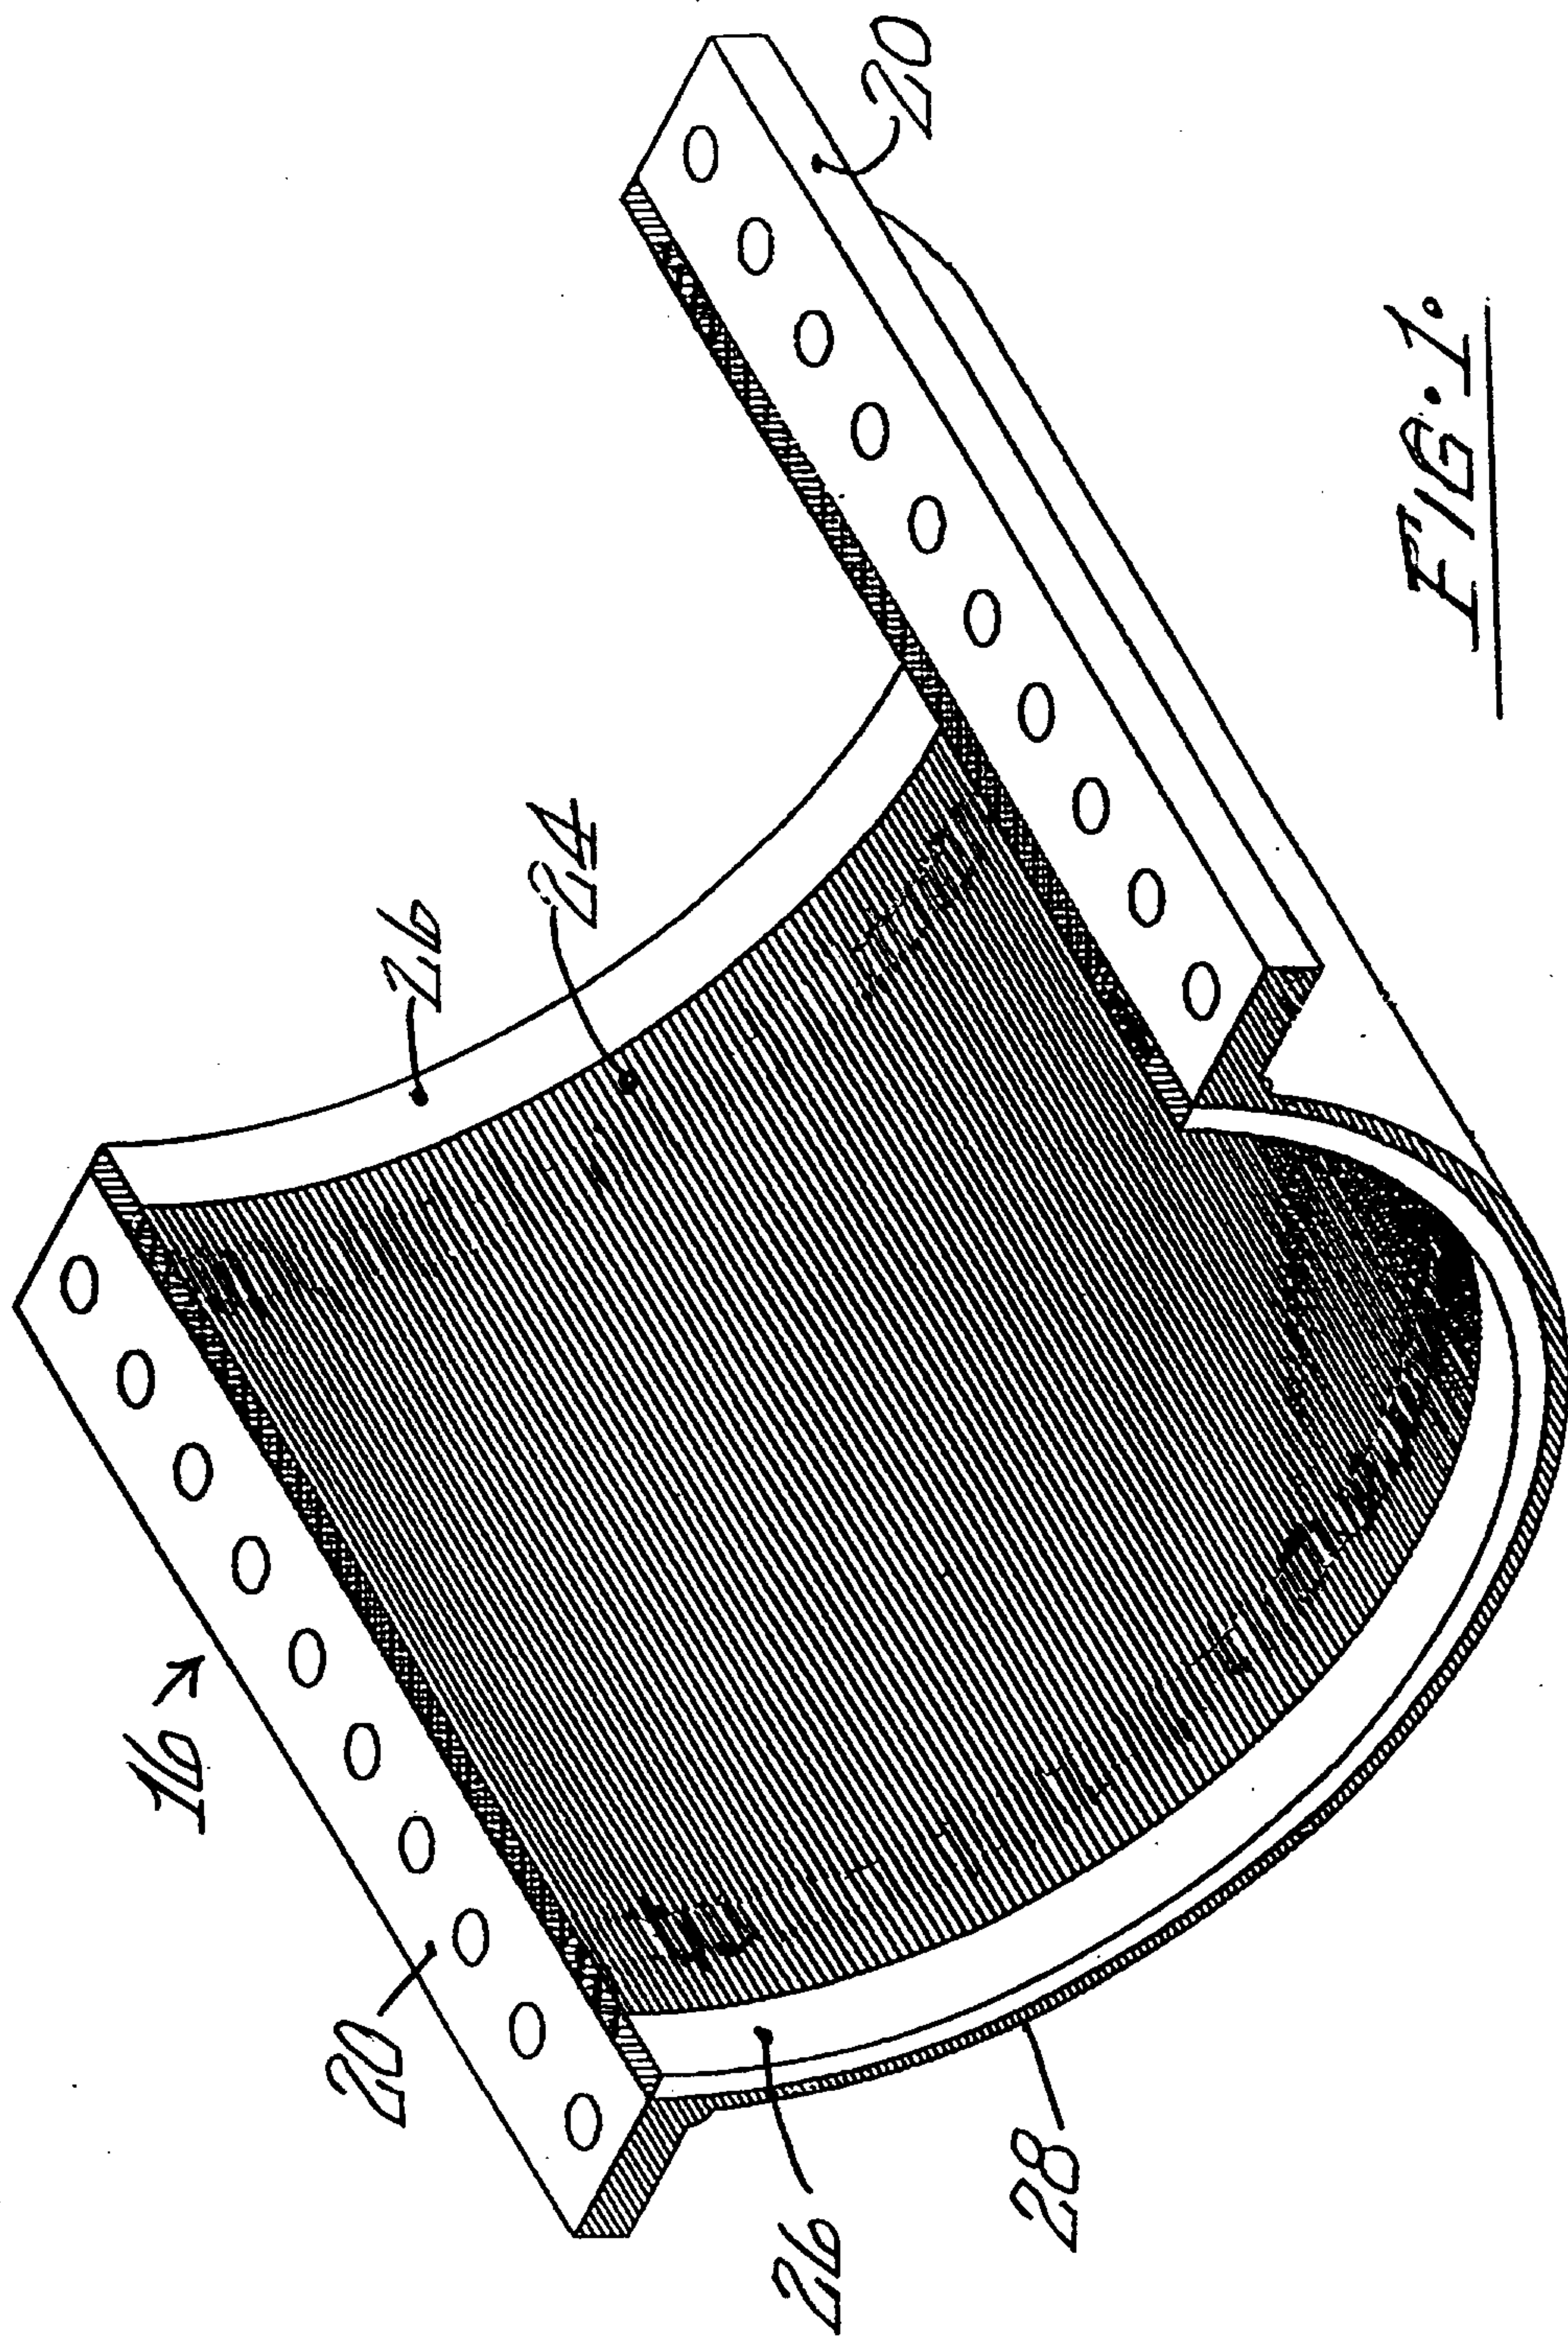
FIG. 1.

**FIGURE 1** is a perspective view of a half-sleeve of  
20 a pipe repair assembly according to the invention;

Looking now at **Figure 1**, the lower half-sleeve 16 is illustrated, the upper half-sleeve 14 (not shown) being identical. The half-sleeves are provided with a jacket 24 of sealing material and which is pre-fitted to each of the half-sleeves so as to provide a snug fit over the surface of the pipeline when the two half-sleeves are assembled together on the pipe as in **Figure 4**. While materials other than steel may be useful in a repair assembly according to the invention, the half-sleeves may for example be fabricated from a rolled steel plate or a section of pipe that conforms to the ASME standards and its inside diameter will be determined by the thickness of the sealant jacket 24 that is required for the job at hand. Again, as an example, the sealant would be approximately 1 inch or 25.5 millimetres thick, the box length being determined by the size of the damaged area. The mounting flanges 20 are welded along the edges of each half-sleeve and are drilled to accommodate the studs or bolts 22 required to secure the two half-sleeves together in the assembled position of **Figure 4**.

Each half-sleeve includes one half of a circumferential outer steel compression ring **26** secured to the inner surface of the sleeve adjacent the end edges **28** thereof. Rings **26** are welded to the inside of the sleeve and machined down to conform to the outside diameter of the pipe to be repaired. As an example, the width of rings **26** would be approximately 2 inches or 51 millimetres or more.

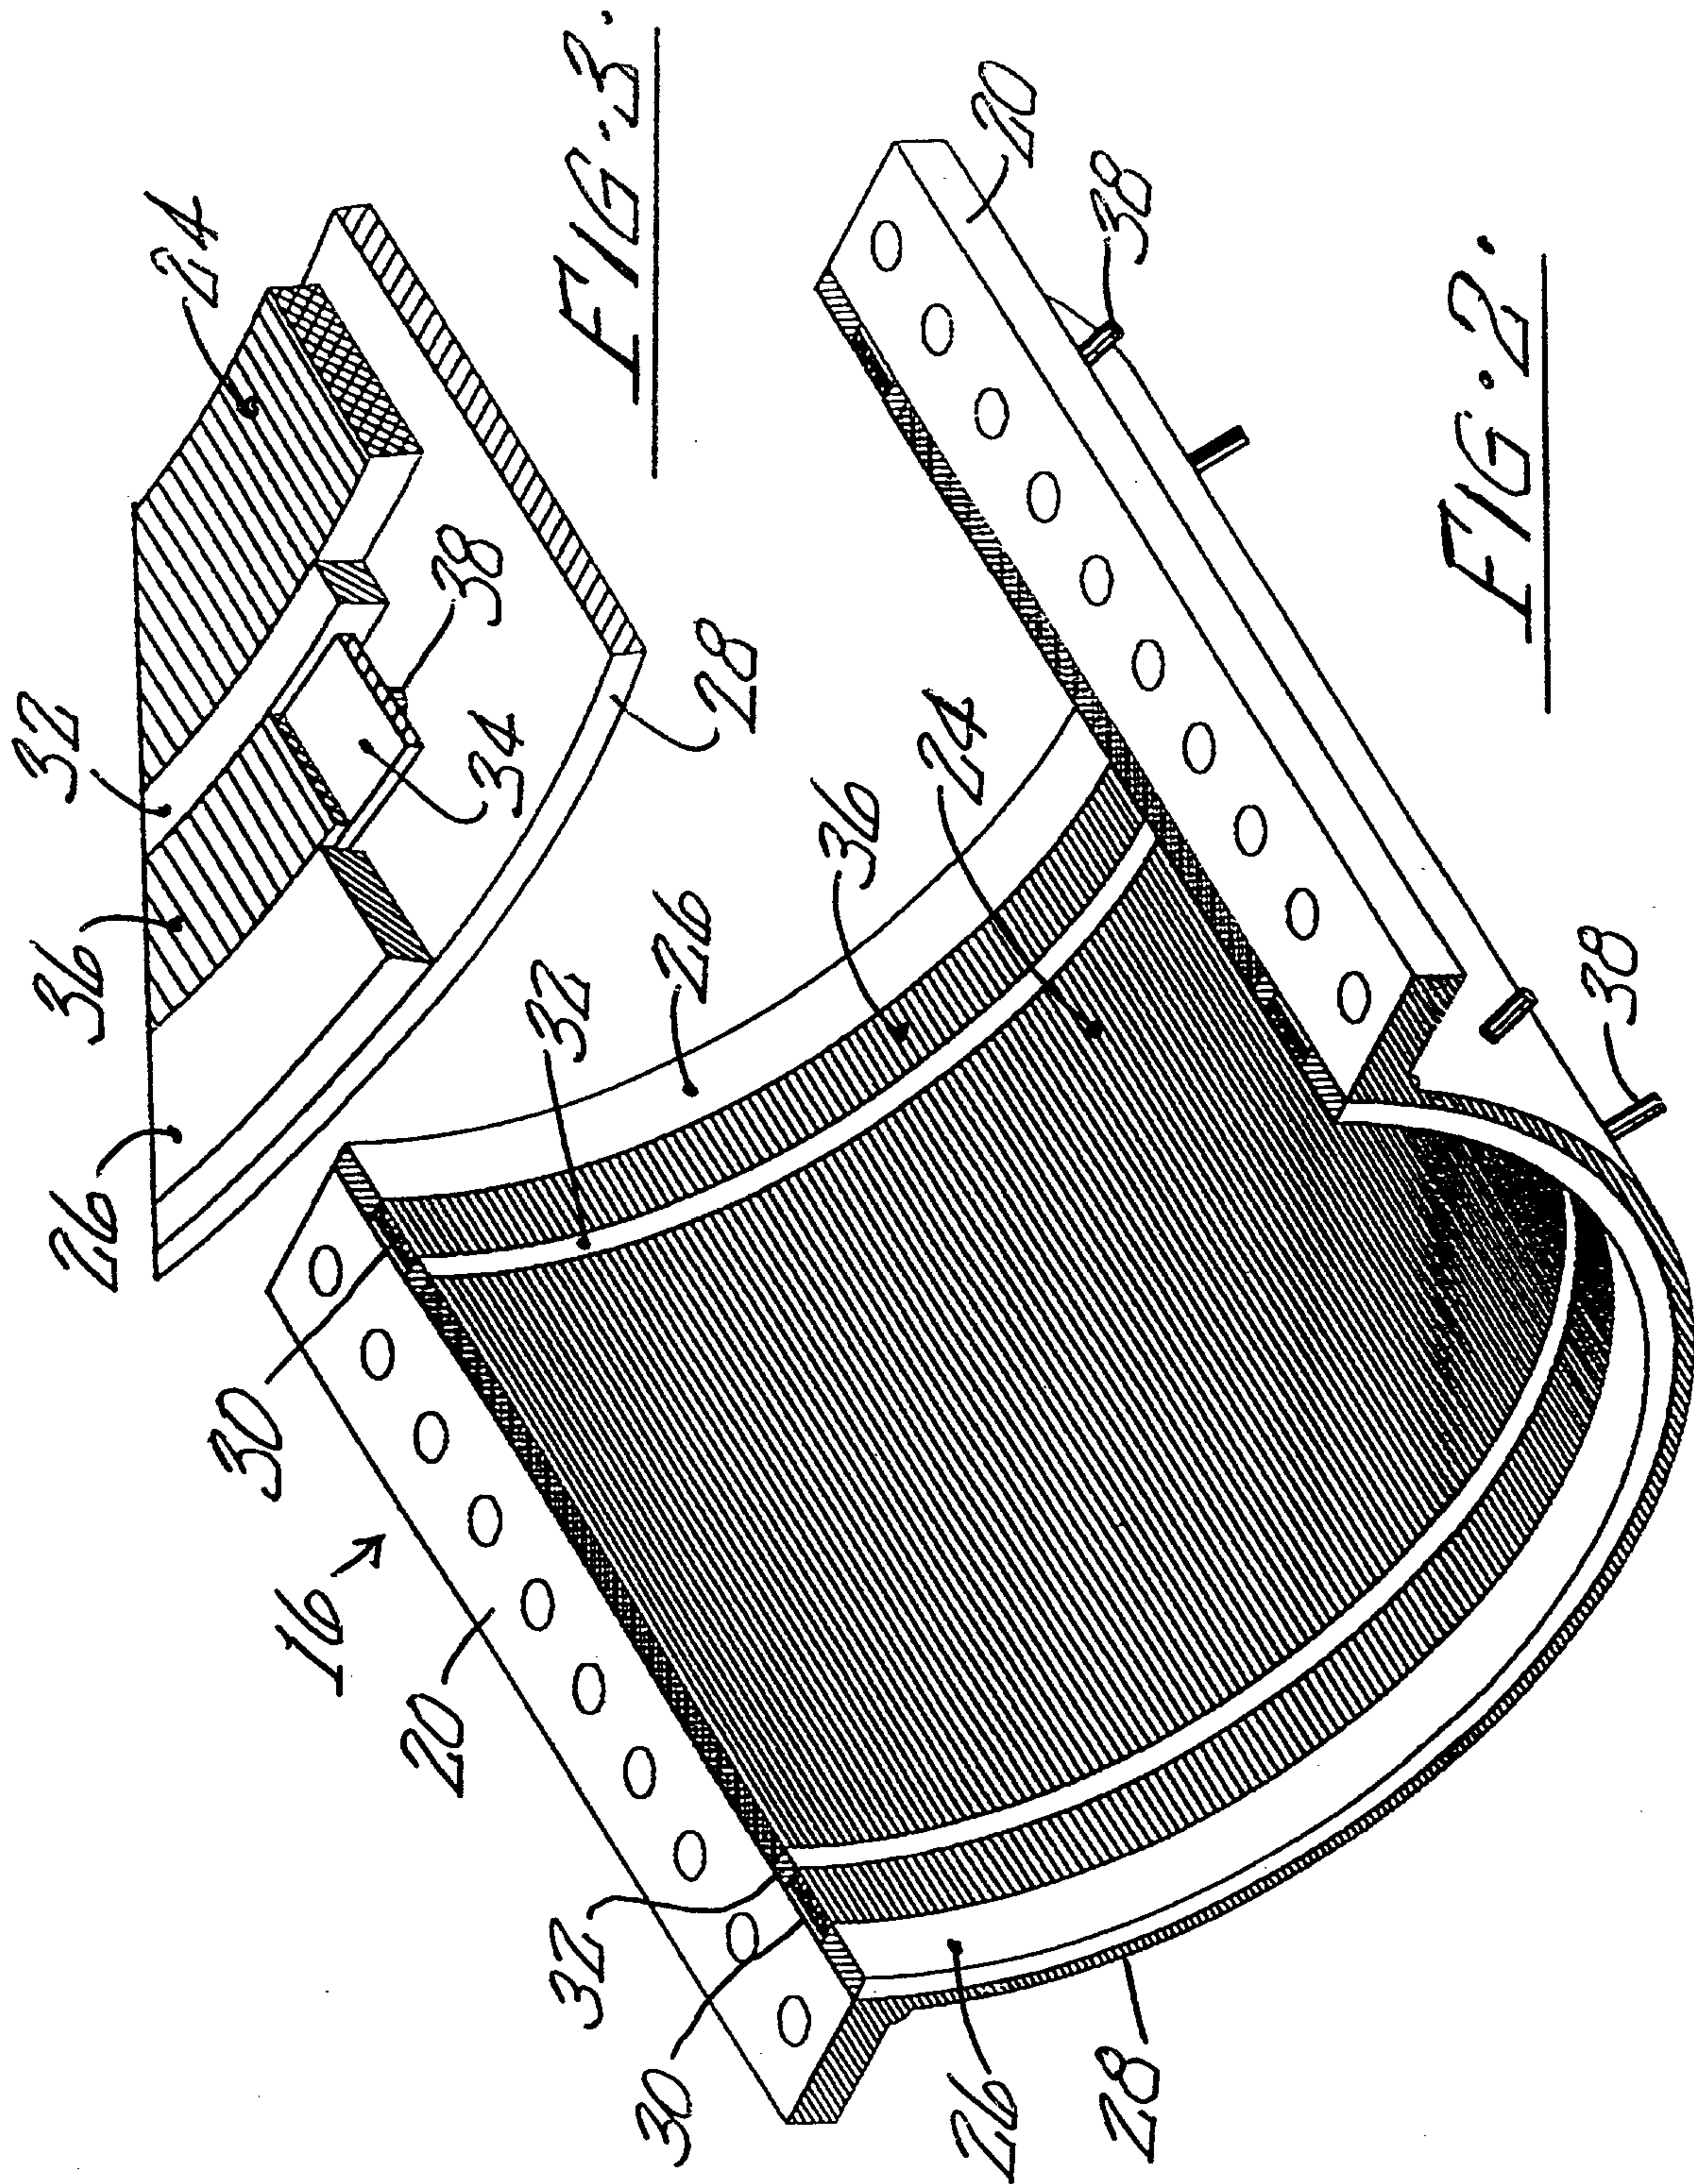
**FIGURE 2** is a view similar to Figure 1 but illustrating another embodiment of the invention;
