(54) **THERMOGRAPHY INSPECTION FOR NEAR-SURFACE INCONSISTENCIES OF COMPOSITE STRUCTURES**

(71) Applicant: **The Boeing Company**, Chicago, IL (US)

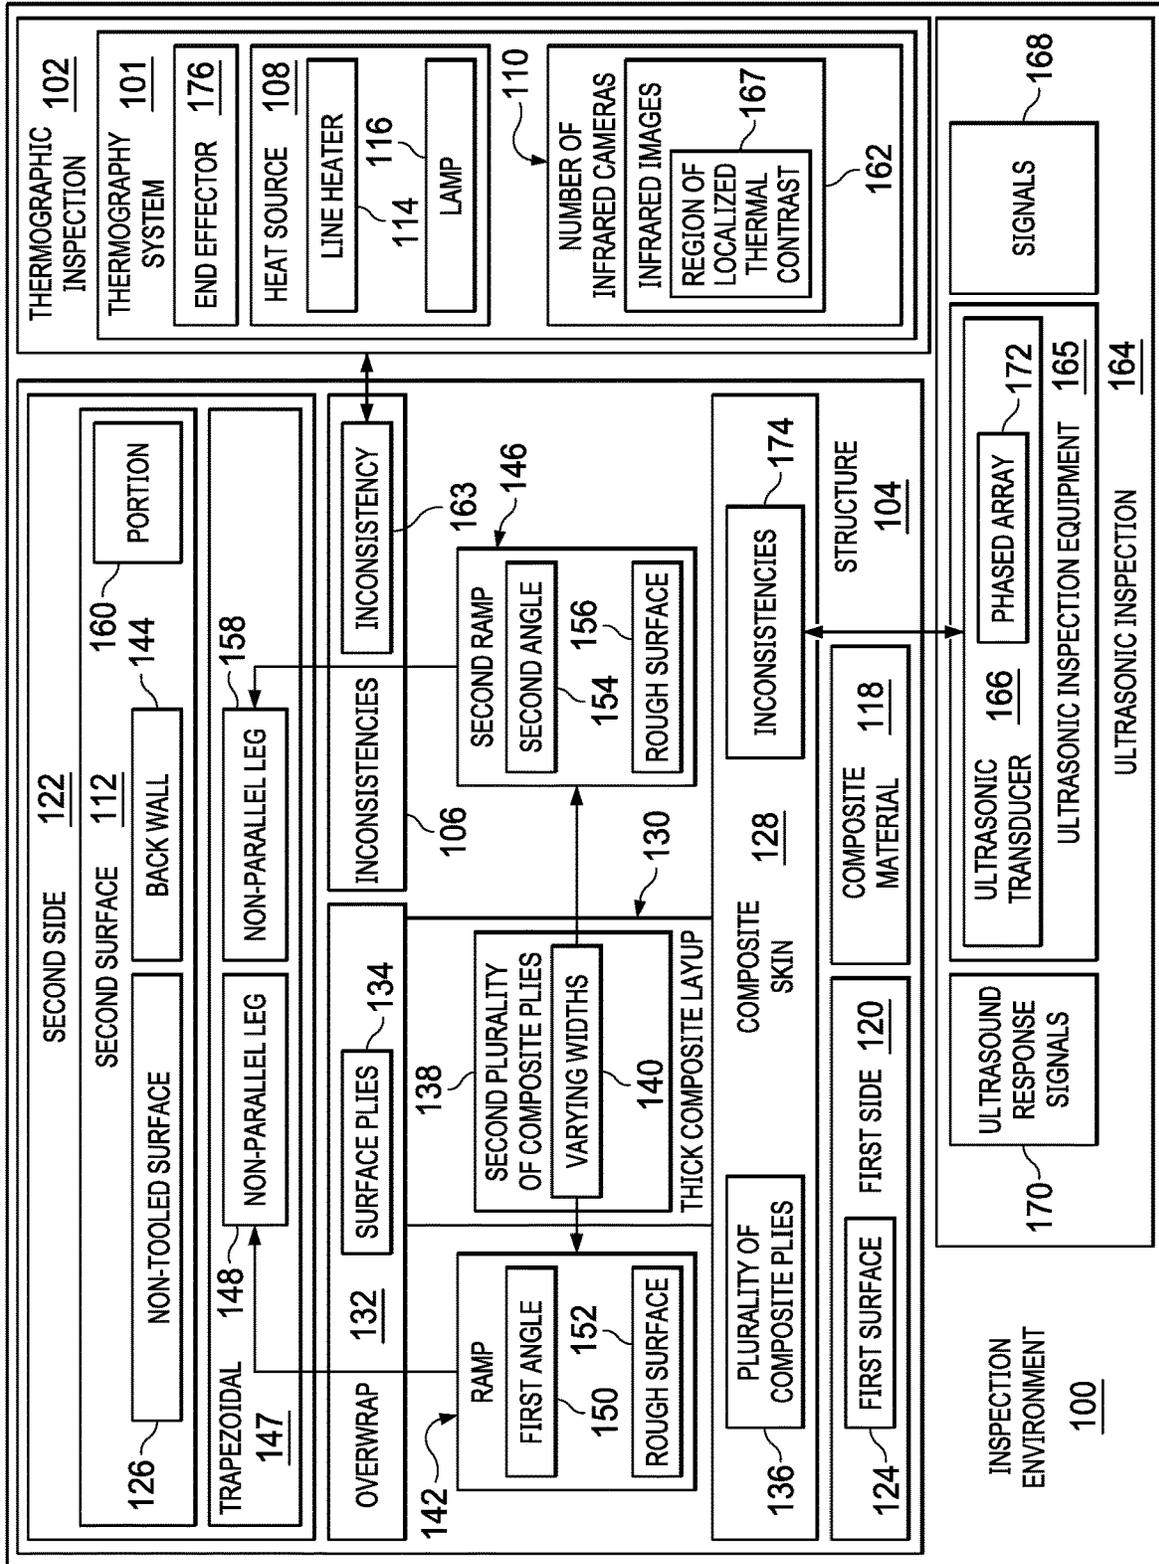
FIG. 1 is an illustration of a block diagram of an environment in which a composite structure is inspected using ultrasonic techniques in accordance with an illustrative embodiment;

Referring now to the figures and, in particular, with reference to FIG. 1, an illustration of a block diagram of an environment in which a composite structure is inspected using ultrasonic techniques is depicted in accordance with an illustrative embodiment. Inspection environment 100 includes thermography system 101 to perform thermographic inspection 102 on structure 104. Thermographic inspection 102 detects inconsistencies 106 in structure 104.

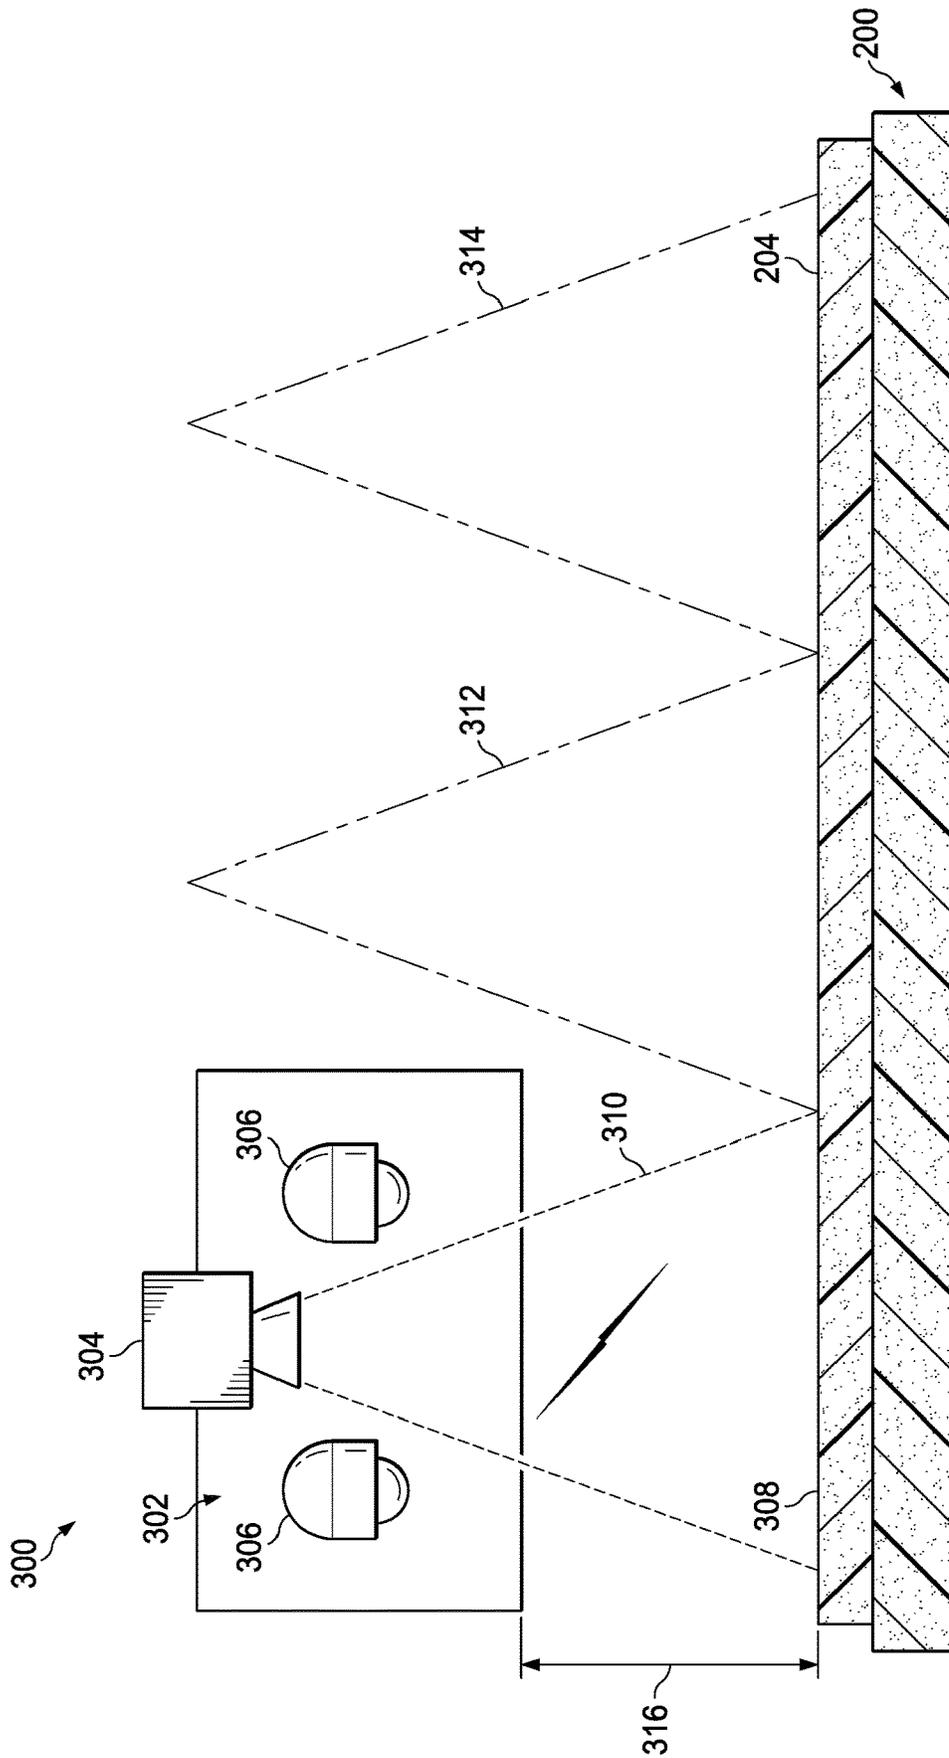
FIG. 3 is an illustration of a cross-sectional view of inspecting a composite structure using a thermography system in accordance with an illustrative embodiment;

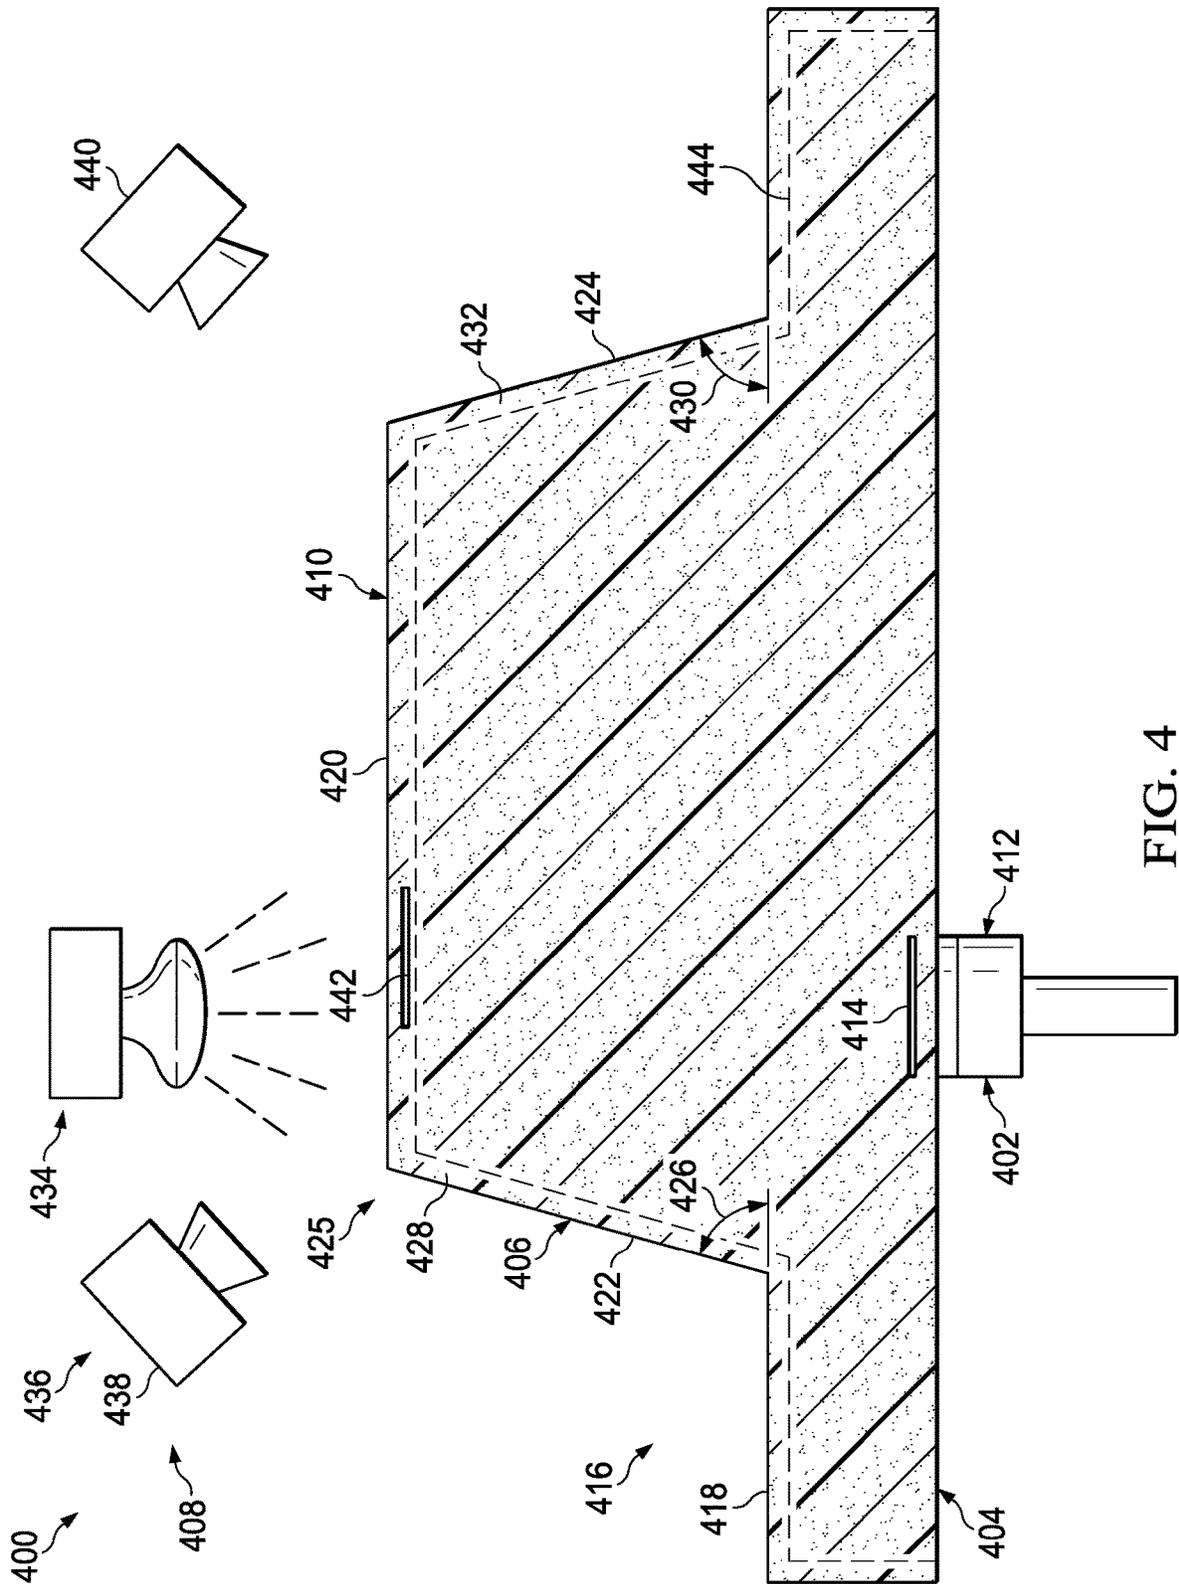
FIG. 4 is an illustration of a cross-sectional view of a simultaneous ultrasonic inspection and infrared inspection of a composite structure in accordance with an illustrative embodiment;

As depicted, dashed line **444** denotes a region of structure **406** formed by an overwrap, such as overwrap **132** of FIG. 1. The plies in the region from dashed line **444** to second surface **410** are not planar. Each ply in the region from dashed line **444** to second surface has the same shape as second surface **410**. In some illustrative examples, inconsistencies may be introduced by overwrap that are parallel to at least one of section **422** or section **424**.

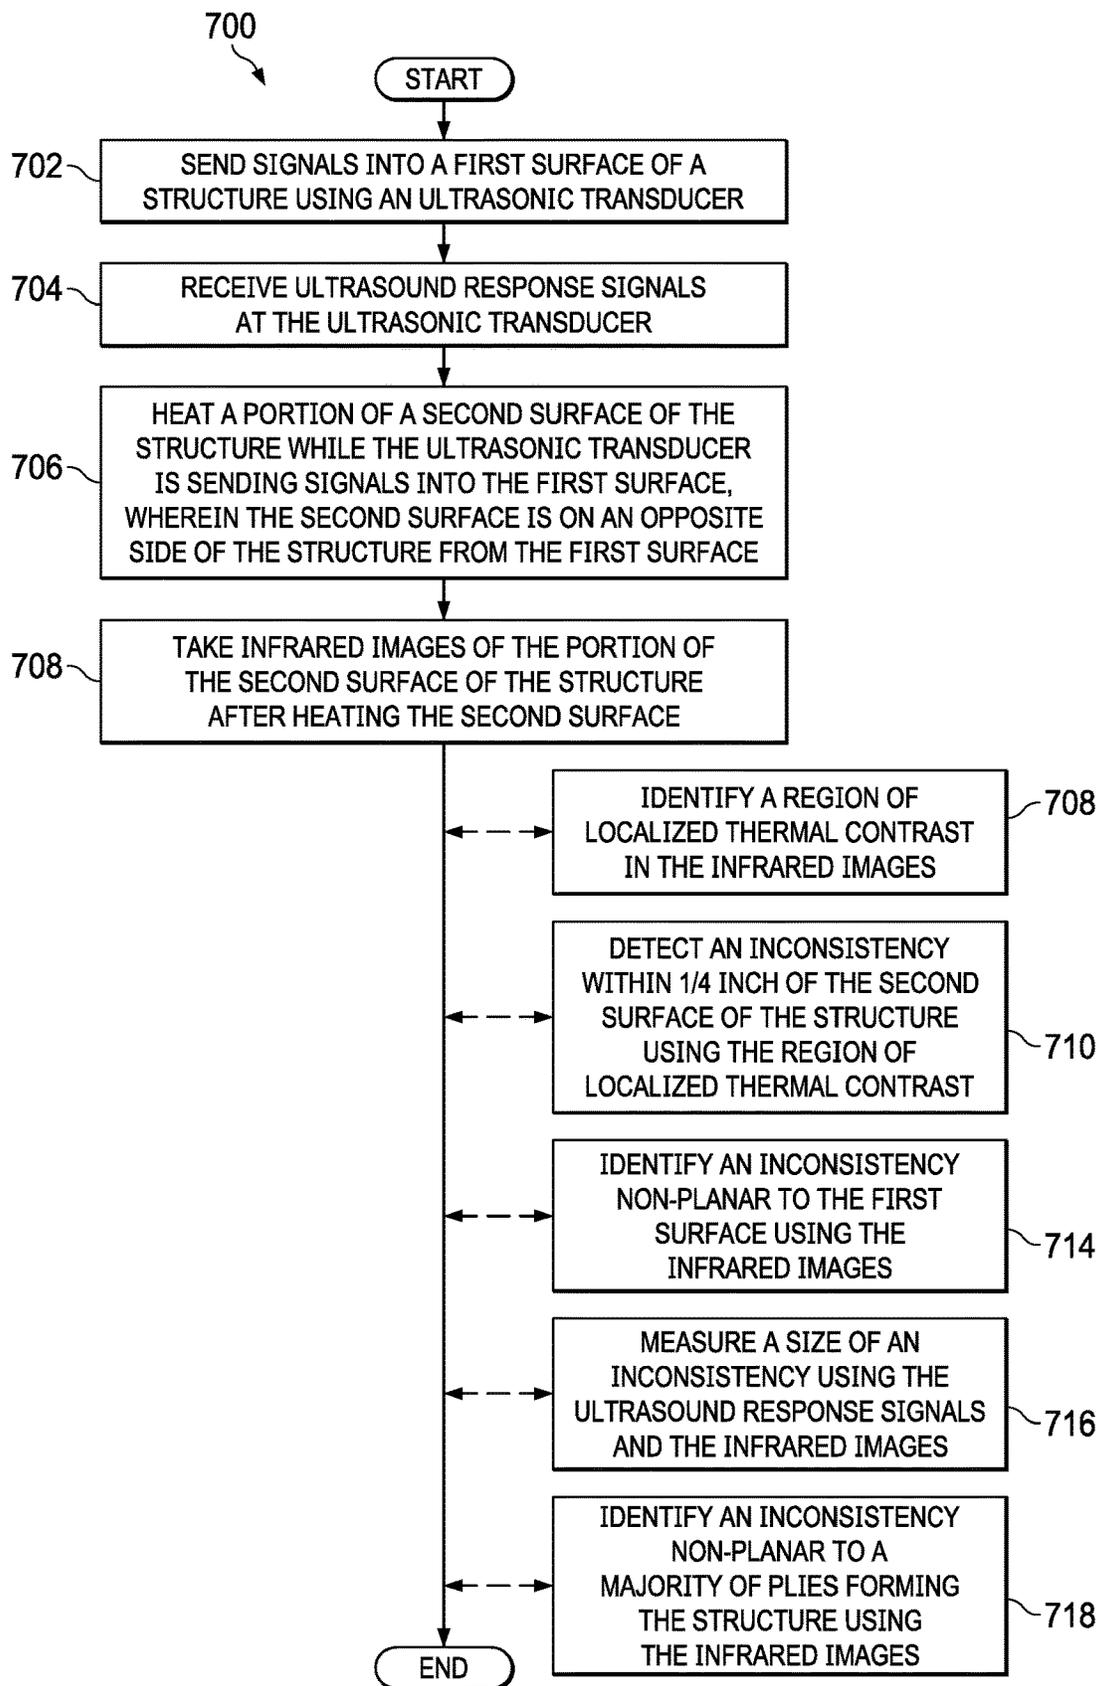
FIG. 7 is an illustration of a flowchart of a method for inspecting a composite structure in accordance with an illustrative embodiment;

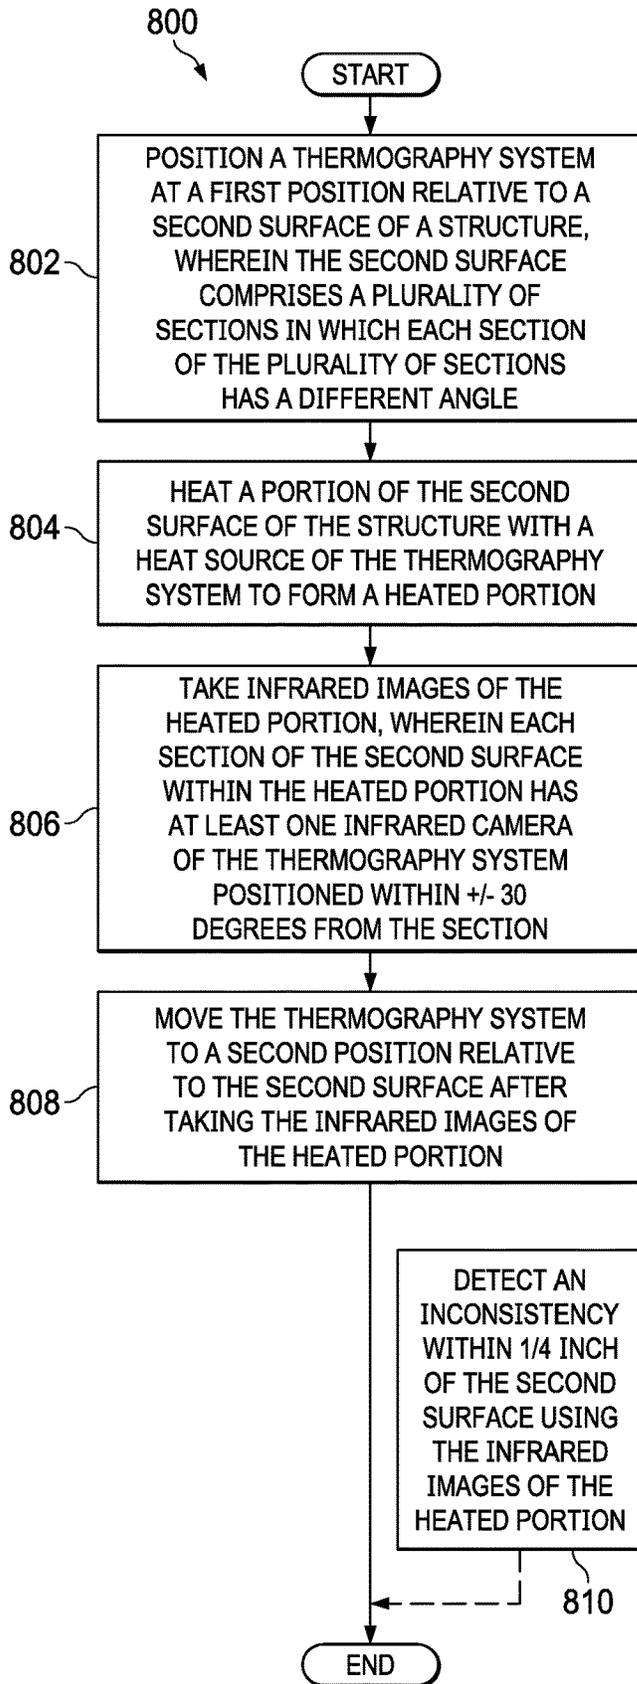
FIG. 8 is an illustration of a flowchart of a method for inspecting a composite structure in accordance with an illustrative embodiment; and

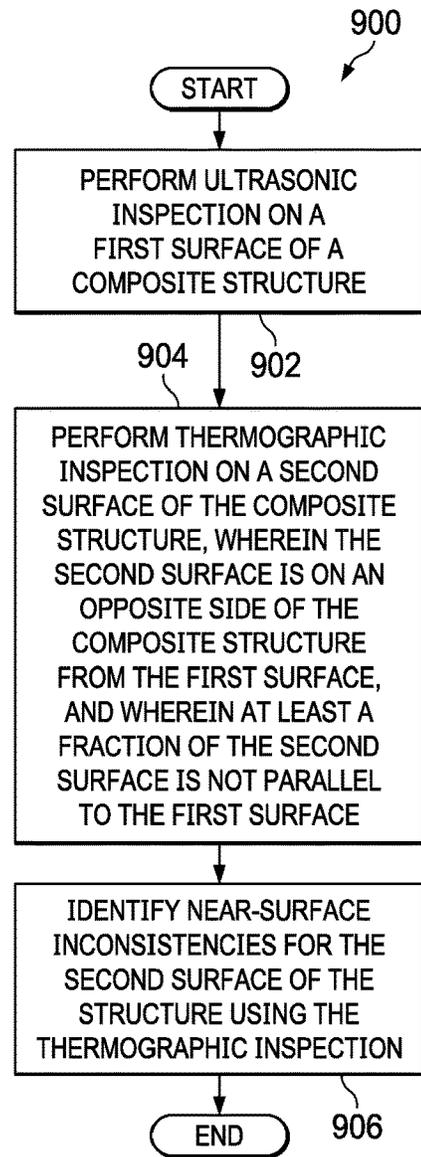
FIG. 9 is an illustration of a flowchart of a method for inspecting a composite structure in accordance with an illustrative embodiment.
