(12) **United States Patent**  
**Stadtlander**

(10) **Patent No.:** **US 8,454,775 B2**  
(45) **Date of Patent:** **Jun. 4, 2013**

(54) **BOND AND STITCH REPAIR FOR  
DELAMINATED COMPOSITE**

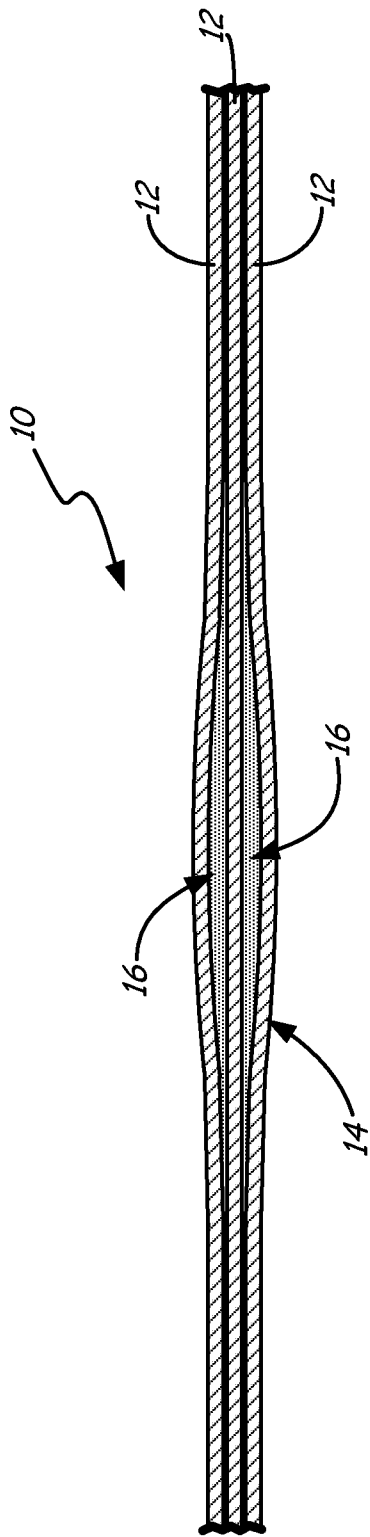
FIG. 1 is a cross-sectional view of a composite with plies that have a delaminated area.

FIG. 1 shows a sectional view of a composite 10 with a plurality of laminated plies 12 that have a delaminated area 14. The composite 10 is potentially applicable to a wide range of industries including the aerospace industry, and can be used for rotor components of gas turbine engines.

A core or additional plies of composite 10 are not illustrated in FIG. 1 and may have been removed due to delaminated area 14 leaving only plies 12. In the embodiment shown in FIG. 1, plies 12 comprise a lightweight material used in the aerospace industry such as Kevlar®, carbon fiber, fiberglass, basalt, and/or ceramic fiber. A resin (not numbered) is cured to form a matrix and bond the plies together. Non-exhaustive examples of resins that are stable in the harsh aerospace environment include epoxy, polyimide, bismaleimide (BMI) and cyanate ester. The material of the plies 12 and resin are selected, in part, based on stability in the operating environment where the composite 10 is to be located.

Ply 12 have become delaminated due to loads, defects, and other environmental factors that result from cyclic stresses, impact, elevated temperatures, and other phenomena. The loads are transferred from one layer to the next by shear through the resin or interfacing ply 12. The interlaminar shear forces, which transfer loads from one ply to the next ply, have in the embodiment shown in FIG. 1, initiated delamination of the composite structure. Thus, delaminated area 14 has developed with one or more cavities 16 disposed between plies 12.

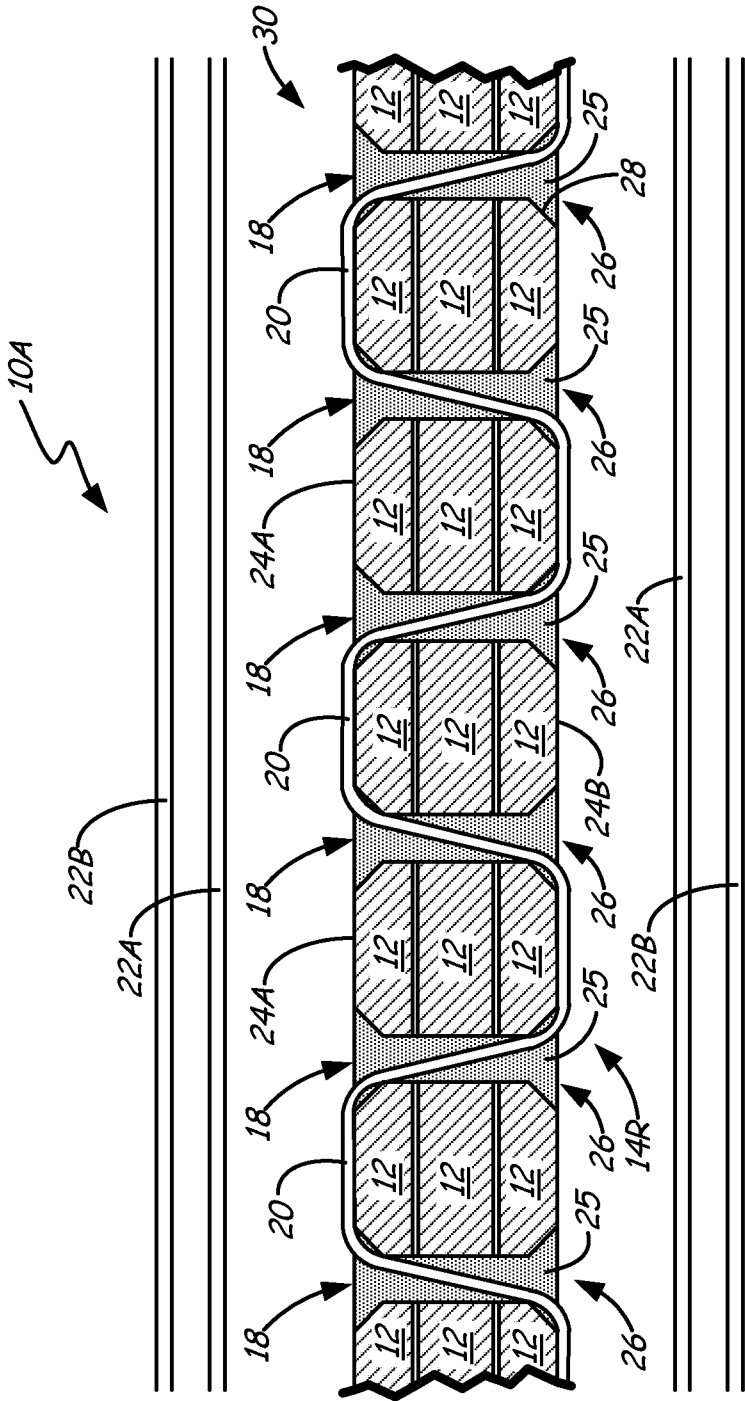
FIG. 5A is a cross-sectional view of one embodiment of the repaired composite with a tow extending therethrough in an over-under stitch manner and additional plies being applied thereto.

FIG. 5A is a cross-sectional view of one embodiment of repaired composite 10A with tow 20 extending therethrough and additional plies 22A and 22B being applied thereto.

In the embodiment shown in FIG. 5A, tow 20 is stitched through holes 18 in an over-under stitch manner 30. Thus, the single tow 20 extends into and through each hole 18 and travels from a first exterior surface 24A to a second interior surface 24B of composite 10A in an alternating pattern. Tow 20 is comprised of a lightweight material that can match the composition of the material used for plies 12. In one embodiment, tow 20 is comprised of Kevlar. In other embodiments, tow 20 is comprised of glass fiber.

For the embodiments shown in FIGS. 5A-5C, holes 18 can be filled with resin 25 so that holes 18 no longer exist but are solids 26 comprising tows 20A and 20B and resin. The introduction of resin 25 can occur prior to, during, or after introduction of tow(s) 20 or 20A and 20B into holes 18 and curing of composite 10. Prior to filling with resin 25 (and generally occurring during drilling) chamfers 28 can be added to holes 18 along first and second surfaces 24A and 24B of composite 10C. When resin 25 has cured, chamfers 26 act to help hold the resin 25 and tow 20A and 20B solid 26 together similar to a mechanical rivet. Thus, the design of the holes 18 with chamfers 28 does not rely solely on bonding to the sides of holes 18 but additionally the head (bounded by chamfers 28) on each end of resin/tow solid 26 bonds to additional surfaces and can support tension loads (parallel to the axis of each

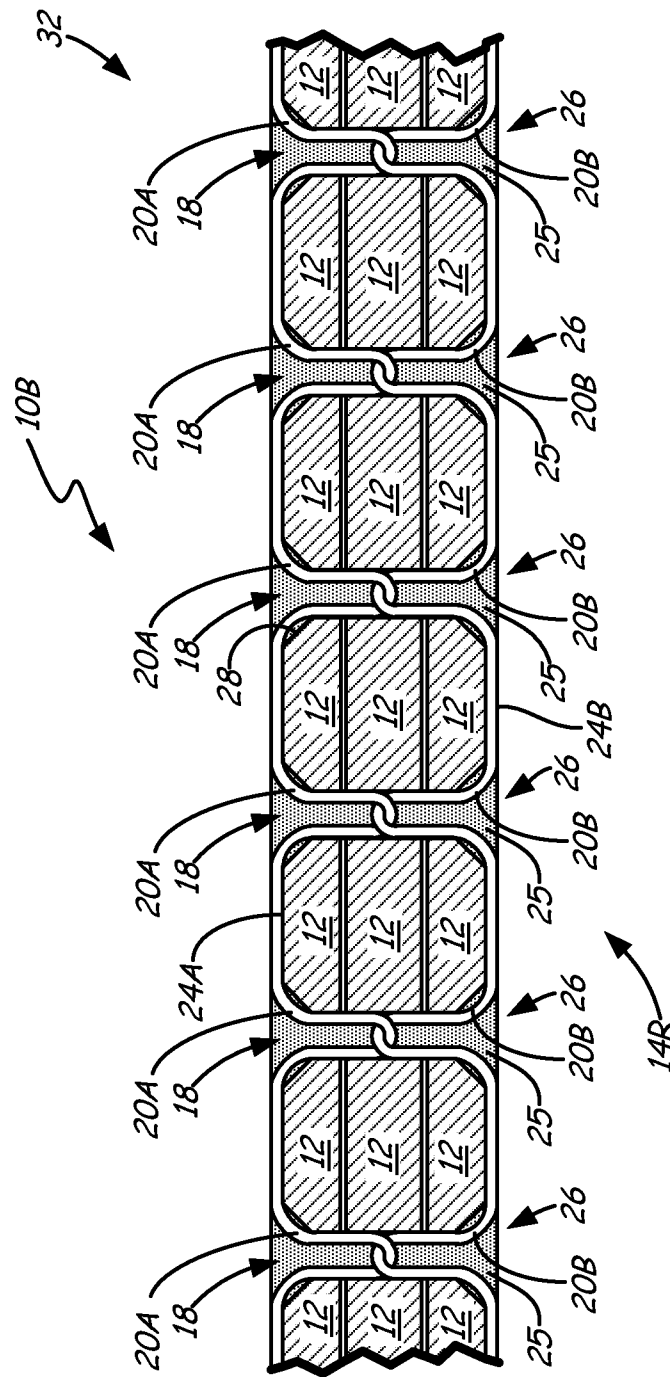
FIG. 5B is a cross-sectional view of another embodiment of the repaired composite with tows stitched into the plurality of holes in a lock stitch manner.

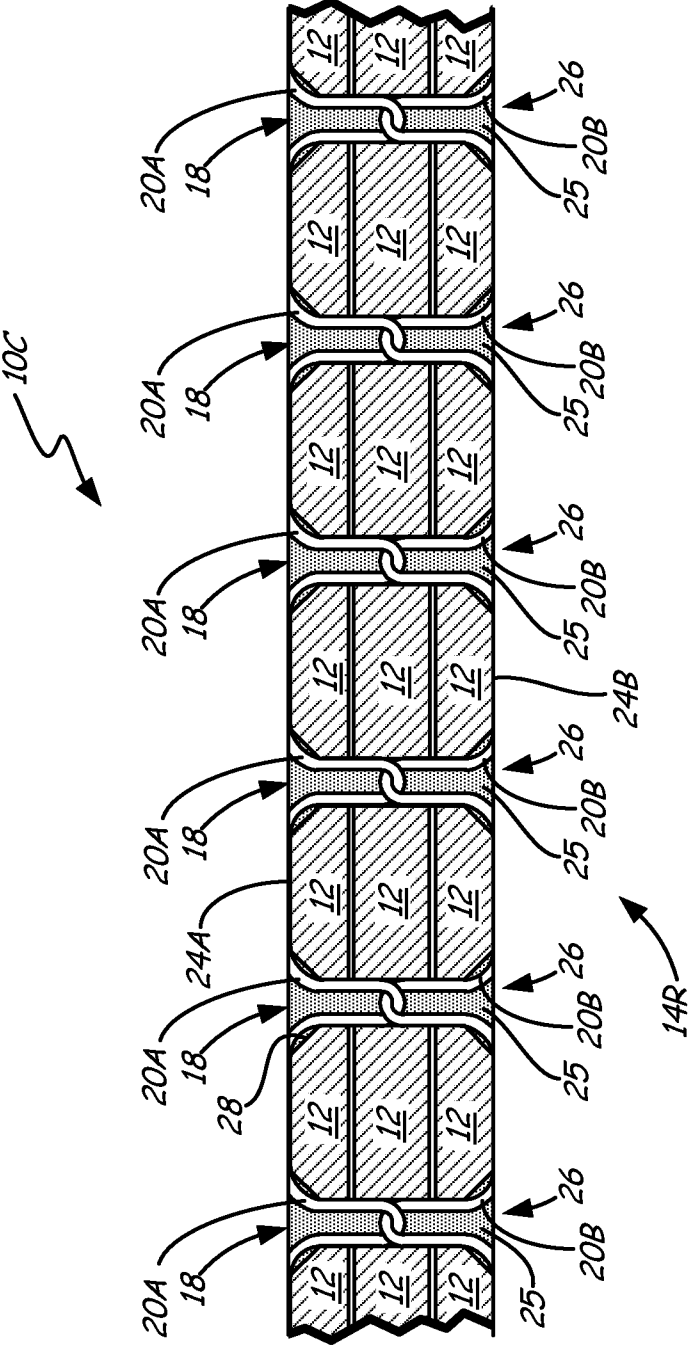
FIG. 5C is a cross-sectional view of yet another embodiment of the repaired composite with the tows removed flush to first and second surfaces of the composite.
