(12) **EUROPEAN PATENT APPLICATION**

(71) Applicant: **United Technologies Corporation**  
**Hartford, CT 06101 (US)**

(54) **Method for repairing a gas turbine engine component**

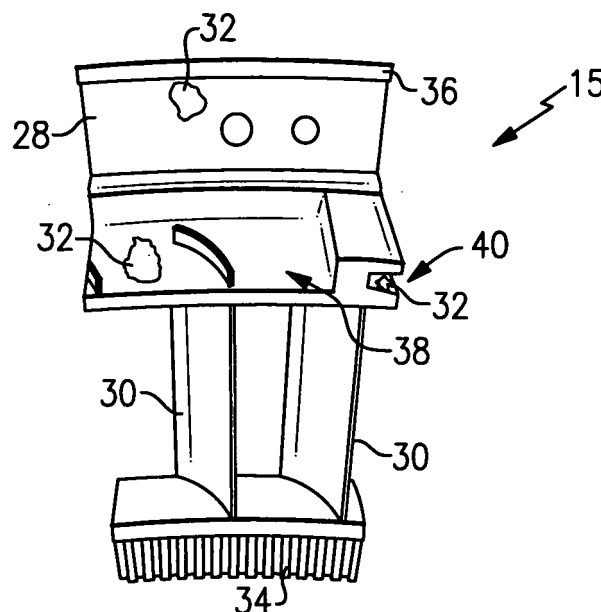
**FIG.2**

(57) A method of repairing a stator assembly (28) of a gas turbine engine includes removing (102) a worn sur-

face of the stator assembly to provide a revealed area, and securing (104) additional material to the stator assembly utilizing gas metal arc welding.

[0013] Figure 2 illustrates an example gas turbine engine component 15 having at least one worn surface 32. In this example, the gas turbine engine component 15 is a stator assembly 28 of the high pressure compressor 16. The stator assembly 28 includes a plurality of vanes

30 that extend between a radially inward honeycomb 34 and a radially outward flange 36. The flange 36 includes an outer diameter surface 38 and a plurality of featherseal slots 40 (one shown in Figure 2).

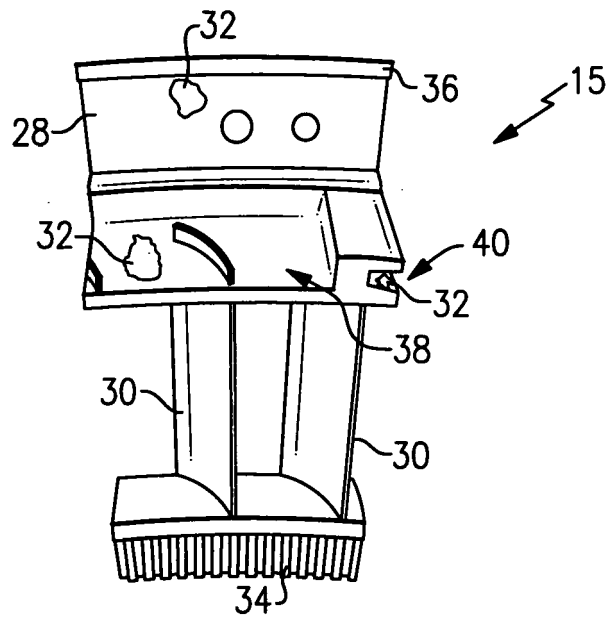
**FIG. 2**

Figure 2 illustrates a gas turbine engine component including a worn surface;

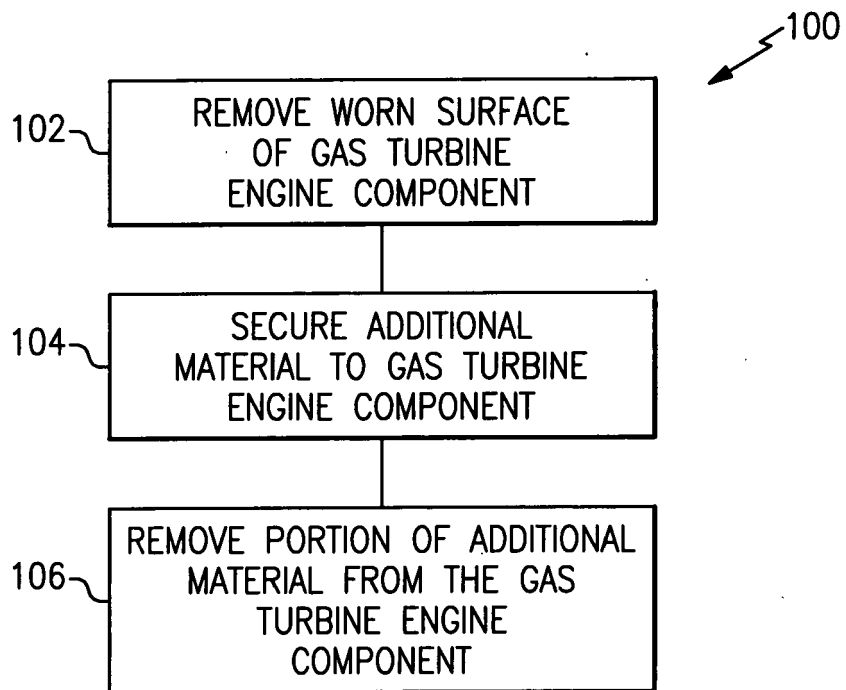
**FIG. 3**

Figure 3 illustrates an example method for repairing the gas turbine engine component illustrated in Figure 2;

**[0015]** Figure 3, with continued reference to Figures 1 and 2, illustrates an example method 100 for repairing a gas turbine engine component 15. The method 100 begins at step block 102 where a worn surface 32 of the gas turbine engine component 15 is removed. In one example, the worn surface 32 is removed by utilizing a machining operation. A person of ordinary skill in the art having the benefit of this disclosure would be able to select an appropriate machining operation for removal of the worn surfaces 32 of the gas turbine engine component 15. In one example, the worn surface 32 is machined down to remove any damaged portion of the gas turbine engine component 15 (See Figure 4A).

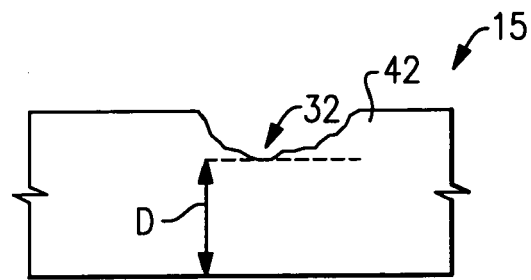
**FIG. 4A**

Figure 4A shows an initial step in an example repair process;

**[0018]** Figures 4A - 4C describe an example implementation of the method 100. Referring to Figure 4A, an initial step in the repair of the gas turbine engine component 15 includes machining the worn surface 32 down to a predefined dimension D. Machining the worn surface 32 down to the predefined dimension D includes removal of sufficient material to remove any damaged portion of the gas turbine engine component 15, in this example.

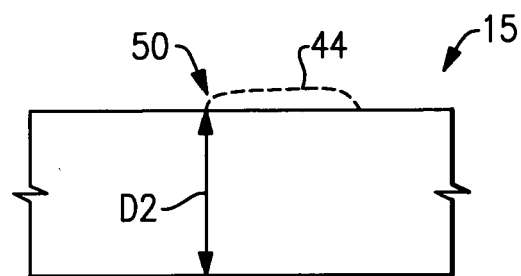
**FIG. 4C**

Figure 4C illustrates yet another step in the repair process.

**[0020]** Figure 4C illustrates removal of a portion of the additional material 44 from the gas turbine engine component 15. The additional material 44 is removed down to a predefined dimension D2 to provide a repaired section 50 of the gas turbine engine component 15. In one example, the predefined dimension D2 relates to an original dimension of the gas turbine engine component 15.
