**EP 1 701 004 A1**

(54) **Gas turbine blade having a monocrystalline airfoil with a repair squealer tip, and repair method**

(57) A repaired gas turbine blade (20) has a monocrystalline airfoil (22) made of a first nickel-base superalloy, and a repair squealer tip (46) welded to a tip of the airfoil (22). The repair squealer tip (46) is made of a second nickel-base superalloy different from the first nickel-base superalloy and having less than about 0.15 weight percent total of carbon, boron, silicon, zirconium, and hafnium.

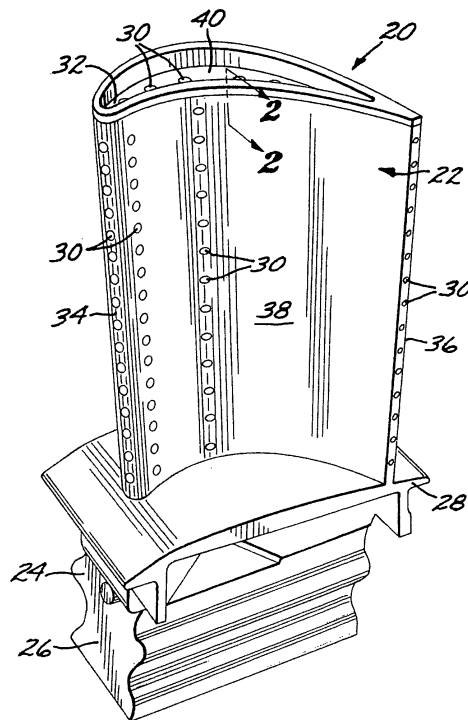
FIG. 1

Figure 1 is a perspective view of a gas turbine blade;

**[0015]** Figure 1 depicts a gas turbine blade 20 which has preferably previously been in service. The previous service is operation in a gas turbine engine in its normal operating circumstances. The gas turbine blade 20 has an airfoil 22 against which the flow of hot combustion gas impinges during service operation, a downwardly extending shank 24, and an attachment in the form of a dovetail 26 which attaches the gas turbine blade 20 to a gas turbine disk (not shown) of the gas turbine engine. A platform 28 extends transversely outwardly at a location between the airfoil 22, and the shank 24 and dovetail 26. The airfoil 22 may be hollow so that cooling air may be forced through the airfoil 22, with the flow of cooling air exiting the airfoil 22 through air-flow holes 30 found on a tip 32, a leading edge 34, a trailing edge 36, and the lateral sides 38 of the airfoil 22.

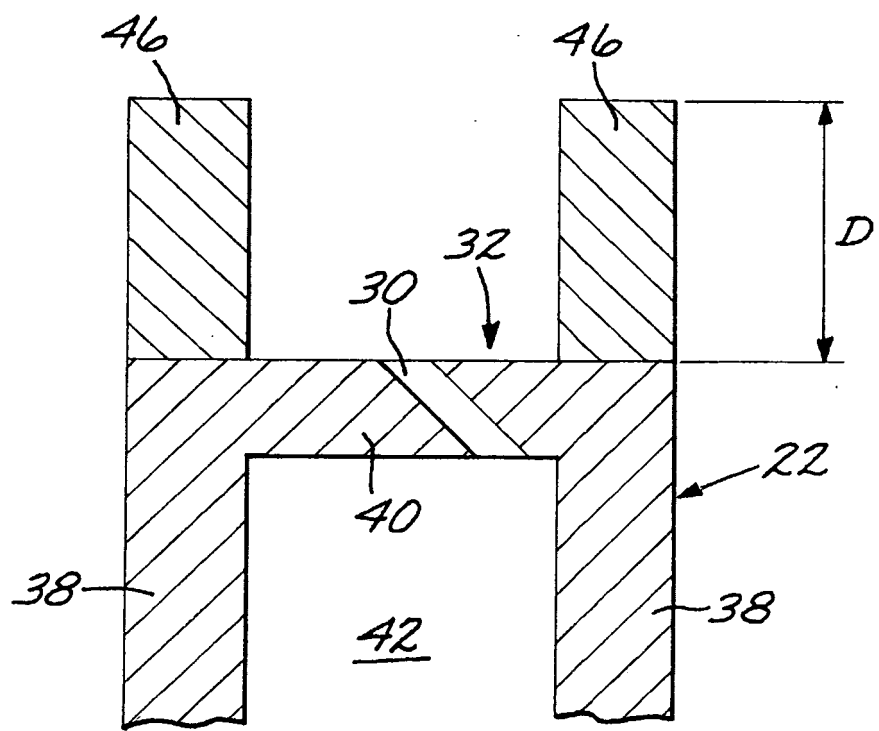
FIG. 3

Figure 3 is a sectional detail of the gas turbine blade of Figure 1, taken on line 2-2, after service and after repair; and

**[0021]** To effect the repair, there is a repair squealer tip 46 welded to the tip 32 of the airfoil 22 to restore the length of the squealer tip to the desired value D, as shown in Figure 3. The repair squealer tip 46 is made of a second nickel-base superalloy having less than 0.15 weight percent total of carbon, boron, silicon, zirconium, and hafnium. More preferably, the repair squealer tip 46 has less than 0.10 weight percent total of carbon, boron, silicon, zirconium, and hafnium, and most preferably less than 0.05 weight percent. The second nickel-base superalloy preferably has a composition that is different from that of the first nickel-base superalloy, particularly in that it is weldable.

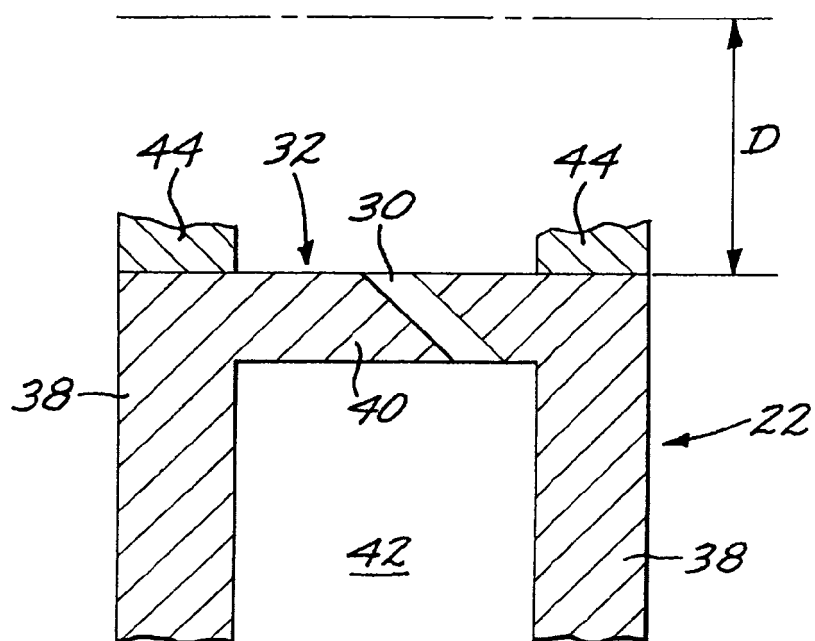
FIG. 2

Figure 2 is a sectional detail of the gas turbine blade of Figure 1, taken on line 2-2, after service but prior to repair;

**[0018]** Figure 2 illustrates the region near the tip 32 of the airfoil 22 (which is also the tip of the turbine blade 20) in greater detail. The airfoil 22 includes its lateral sides 38 and a tip cap 40, which together define a hollow volume 42 through which the cooling air passes to exit at the air-flow hole 30.

**[0020]** The squealer tip of a new-make gas turbine blade 20 starts out with a length indicated by the dimensional marker D, but is gradually worn, oxidized, corroded, and burned away to a length such as shown for the squealer tip 44 of Figure 2. This shortening of the squealer tip 44 allows hot combustion gas to leak around the gas turbine, so that the efficiency of the gas turbine is reduced. It is therefore conventional practice during refurbishment of the gas turbine to repair and lengthen the squealer tips of the gas turbine blades 20 back to substantially the same length as indicated by the dimension D. The loss of efficiency of the gas turbine due to damage to the squealer tip is thereby eliminated.

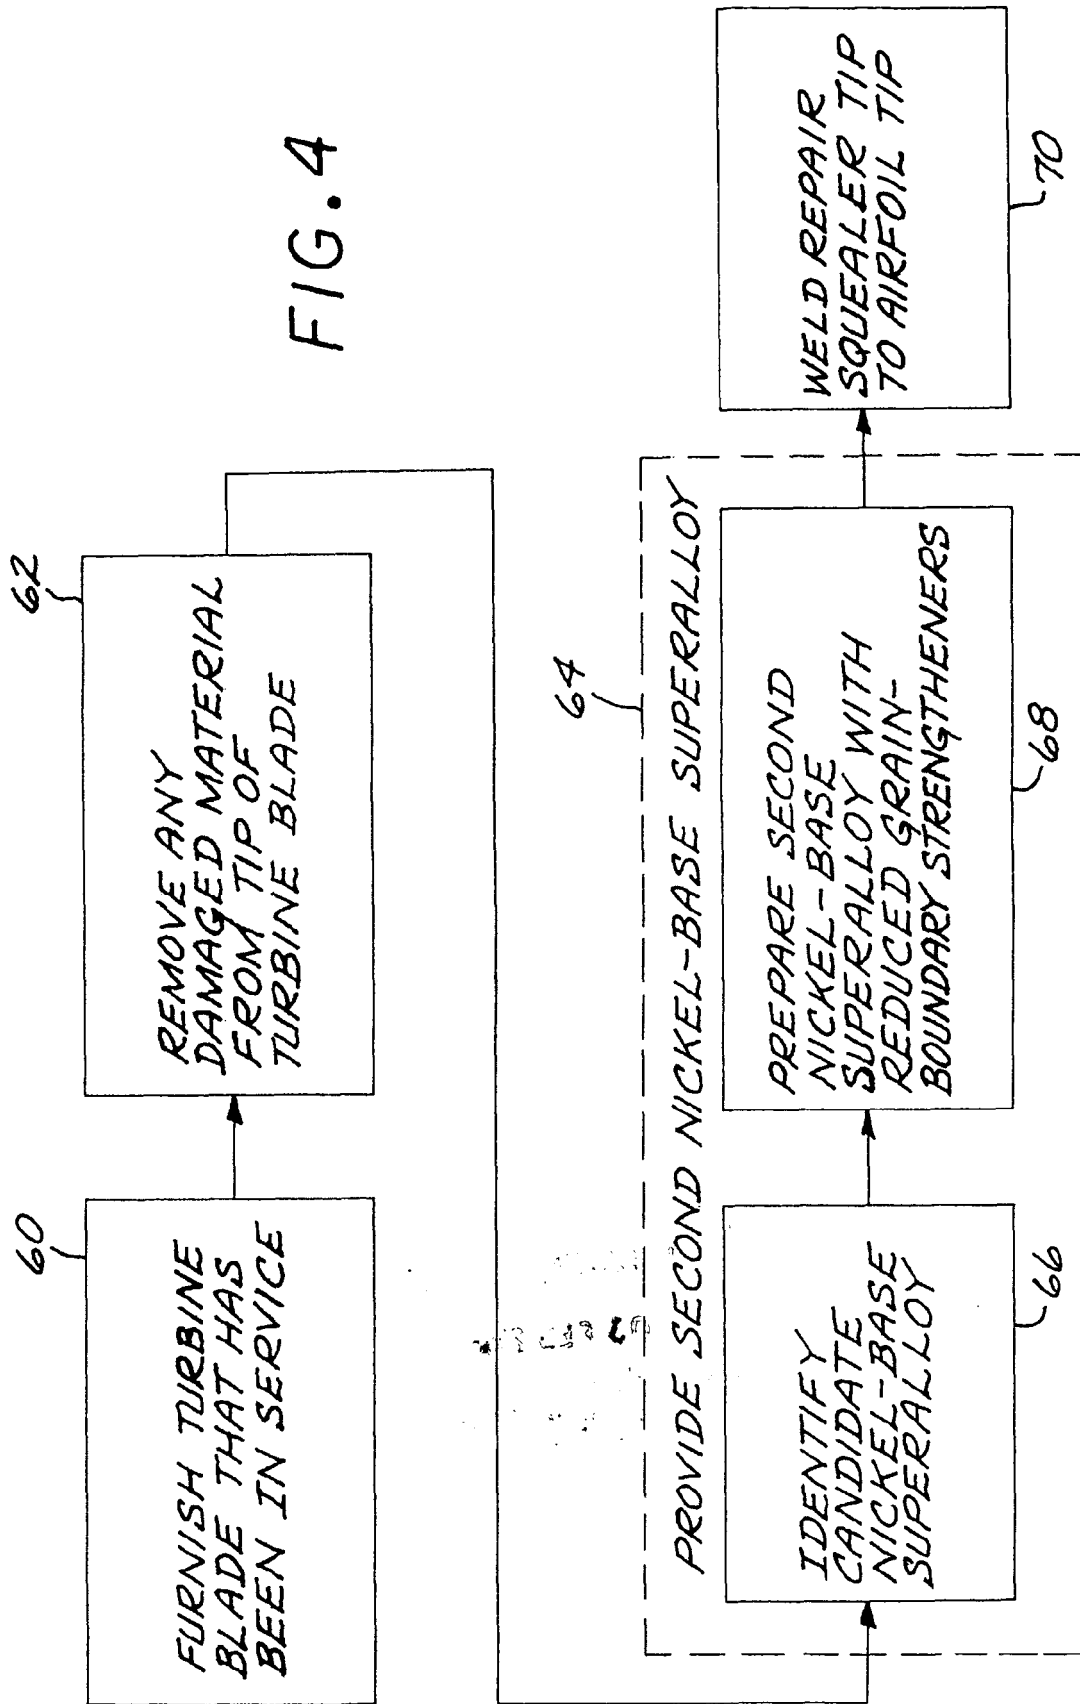
FIG. 4

Figure 4 is a block flow diagram of an approach for practicing an embodiment of the invention.

**[0026]** Figure 4 is a block diagram illustrating a preferred embodiment of a method for repairing the gas turbine blade 20. The turbine blade 20 as described earlier, which has been in service, is furnished, step 60. Any damaged material is removed from the airfoil tip 32, step 62. The removing step 60 typically is performed by grinding away damaged material, and usually includes the remaining part of the original squealer tip 44 and any other damage at the tip 32 of the airfoil 22.

**[0027]** The second nickel-base superalloy, with a low content of the grain-boundary strengthening elements carbon, boron, silicon, zirconium, and hafnium as described above, is provided, step 64. This step may be performed by designing an entirely new nickel-base superalloy. More typically, it is performed as illustrated in Figure 4, by first identifying a candidate second nickel-base superalloy that otherwise meets the requirements for the squealer tip, step 66, and then preparing a modified composition having a reduced total amount of the grain-boundary strengthening elements carbon, boron, silicon, zirconium, and hafnium at an acceptable level, step 68.
