(54) **METALLIC DOUBLER REPAIR OF  
COMPOSITE ARCUATE FLANGES**

An assembly includes a composite flange, an insert, an adhesive and a support. The composite flange has at least one damaged aperture. The insert is positioned in the damaged aperture and extends therefrom to provide compressive load transfer through the composite flange. The adhesive is positioned directly on at least a portion of the composite flange proximate the damaged aperture. The support is positioned over the adhesive and contacts the insert.

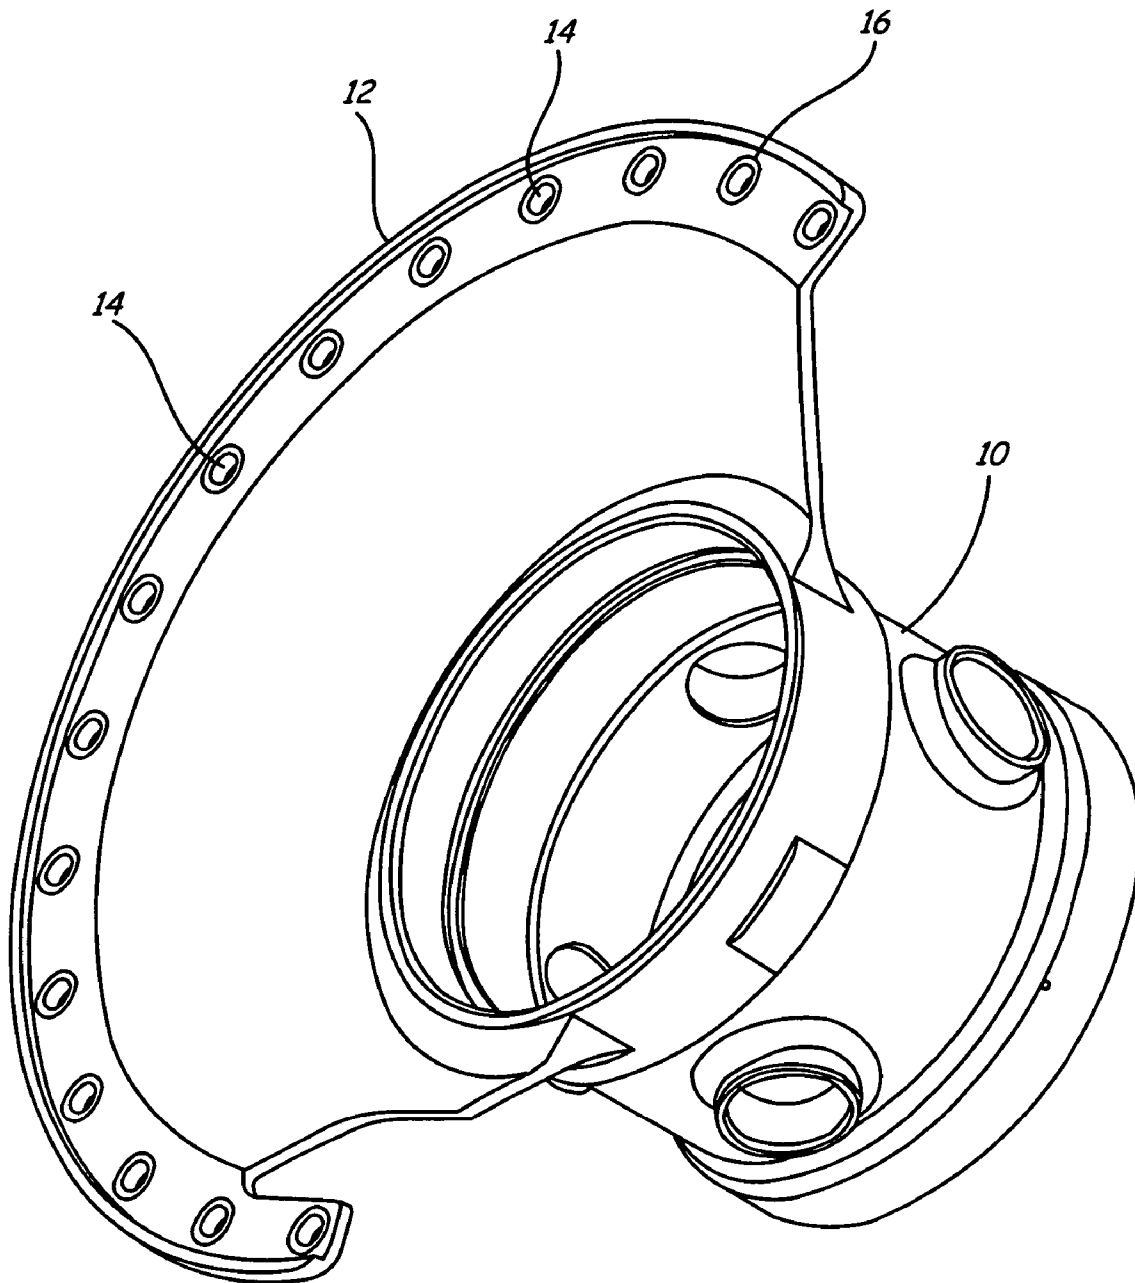
*FIG. 1*

FIG. 1 is a perspective view of an arcuate flange having apertures.

FIG. 1 shows a perspective view of composite seal 10 with arcuate flange 12. Composite seal 10 is formed of a thermoplastic material and is typically exposed to extreme environments such as high-temperature jet engine oils. Arcuate flange 12 extends from composite seal 10 and has a plurality of apertures 14 along its perimeter. Bushings 16 and bolts 18 (shown in FIG. 5A) are positioned within apertures 14 of arcuate flange 12 and are used to connect composite seal 10 to a structure, such as a gearbox housing. Due to the extreme environment in which composite seal 10 is typically located, thermal stress resulting from coefficient of thermal expansion mismatches is constantly exerted on composite seal 10, and particularly on apertures 14 of arcuate flange 12. Thus, the area proximate apertures 14 can crack, with the crack typically radiating outward on arcuate flange 12 to the perimeter of composite seal 10.

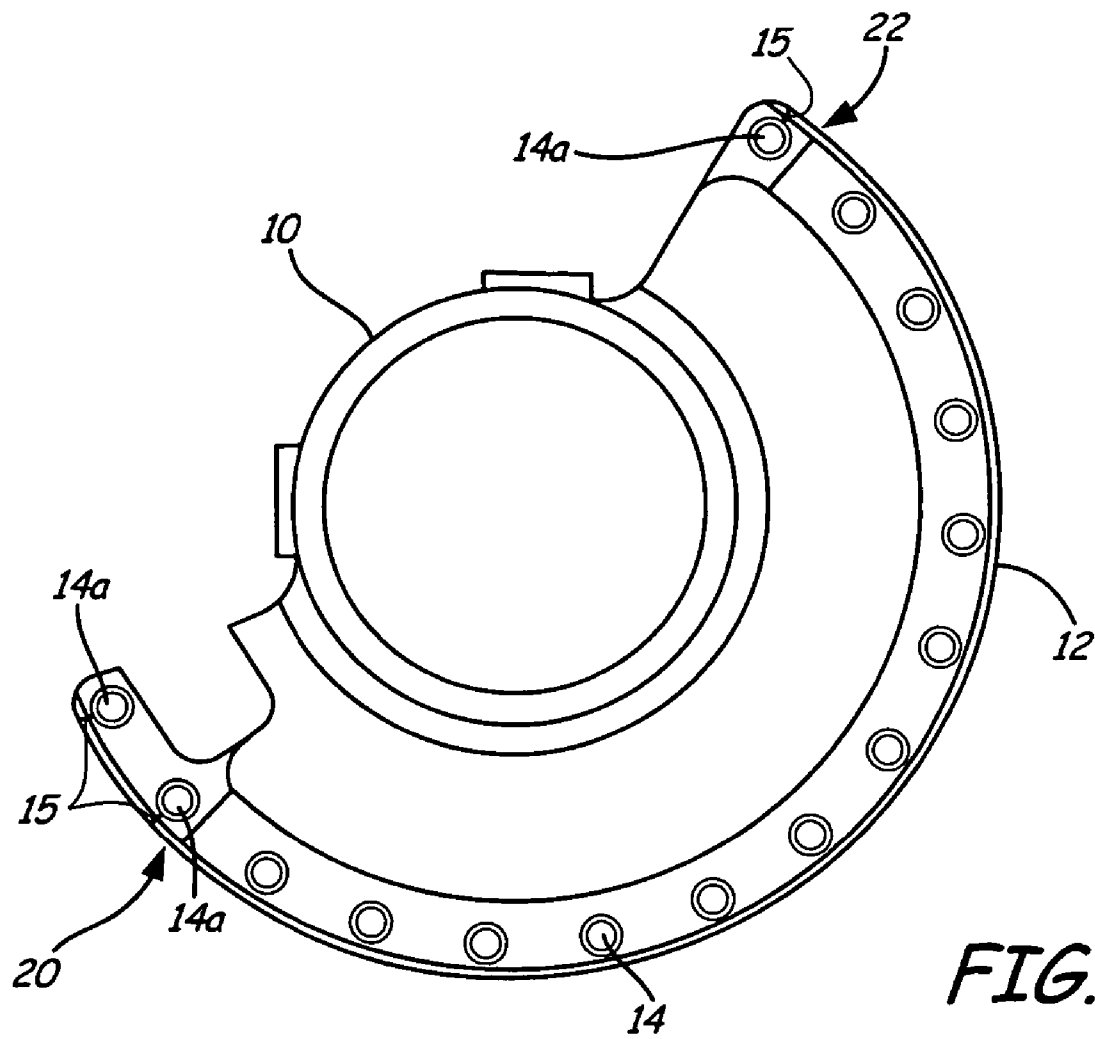
**FIG. 2**

FIG. 2 is a top view of the arcuate flange having damaged ends.

FIG. 2 shows a top view of arcuate flange 12 having a damaged aperture 14a with crack 15 at wing end 20 and a damaged aperture 14a with crack 15 at non-wing end 22. Arcuate flange 12 could be repaired by conventional methods by trimming the cantilevered area, or the area proximate the damaged apertures 14a to remove damaged wing end 20 and damaged non-wing end 22 from arcuate flange 12, leaving only the undamaged apertures 14 on arcuate flange 12. Alternatively, the systems and methods of this invention can be used to repair such damage.

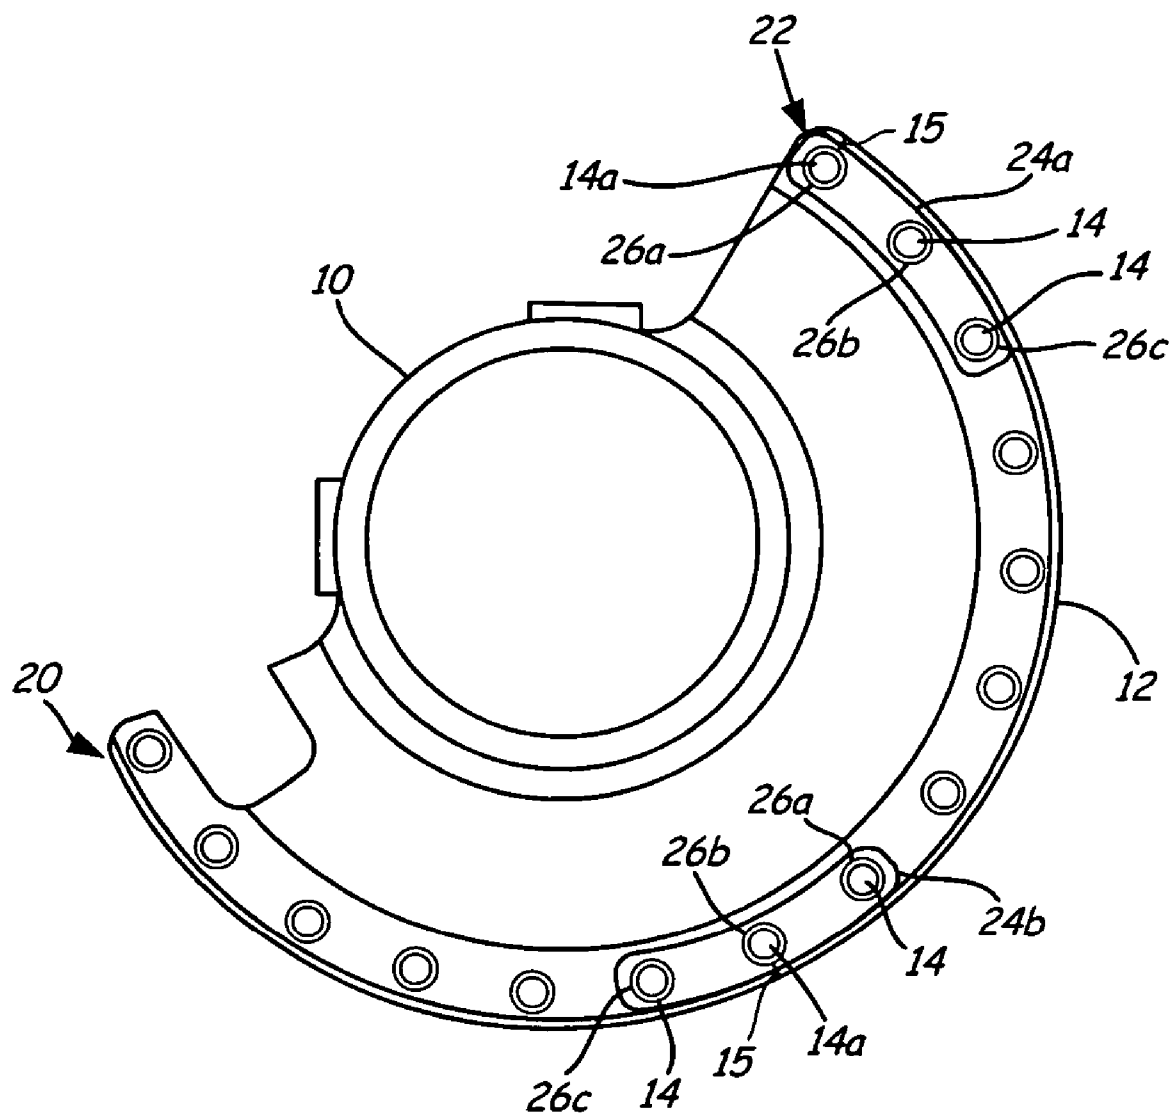
**FIG. 3**

FIG. 3 is a top view of the arcuate flange having a three-hole doubler in two different locations.

FIG. 3 shows a top view of arcuate flange 12 having doubler 24, and specifically, two different three-hole doublers 24a and 24b. The following general discussion involving doubler 24 refers to all doublers subsequently disclosed. Doubler 24 is preferably fabricated having holes 26 with a diameter similar to apertures 14 of arcuate flange 12 to overlap damaged aperture 14a as well as undamaged apertures 14 proximate damaged apertures 14a. Doubler 24 is preferably formed of a material that is stronger than the material of composite arcuate flange 12 and that has a coefficient of thermal expansion similar to the coefficient of thermal expansion of the material that arcuate flange 12 is rigidly attached to. That allows the damaged area of arcuate flange 12 to be strengthened by doubler 24, which is designed to act as a repair of an existing part. Cracks 15 radiating from damaged aperture 14a can be bridged using doubler 24, which is operatively connected (i.e. bonded) to arcuate flange 12. While those skilled in the art will understand that doubler 24 can be made of any suitable material, in one embodiment, doubler 24 is made of stainless steel.

First and second three-hole doublers 24a and 24b as shown in FIG. 3, represent two exemplary uses of three-hole doubler 24. In these particular embodiments, only one aperture 14a covered by each three-hole doubler 24a or 24b is damaged, while the remaining two apertures 14 covered by each three-hole doubler 24a or 24b are undamaged. In first doubler 24a, damaged aperture 14a is at non-wing end 22 of arcuate flange 12. First doubler 24a is thus positioned on arcuate flange 12 such that an end hole 26a of first doubler 24a is positioned over damaged aperture 14a, while the remaining two holes 26b and 26c of three-hole doubler 24a are positioned over undamaged apertures 14.

Second doubler **24b** is positioned on arcuate flange **12** such that center hole **26b** of second doubler **24b** is positioned over damaged aperture **14a**, while the remaining two holes **26a** and **26c** of three-hole doubler **24b** are positioned over undamaged holes **14**. In some embodiments, it may be desirable to have no more than six of the fifteen apertures **14** of arcuate flange **12** covered by doublers **24**, with no more than two damaged apertures **14a** having cracks **15** radiating therefrom. As shown in FIG. 3, three-hole doublers **24a** and **24b** may be most effective if only one of the three apertures that three-hole doublers **24a** and **24b** cover is damaged, but other embodiments are also possible.

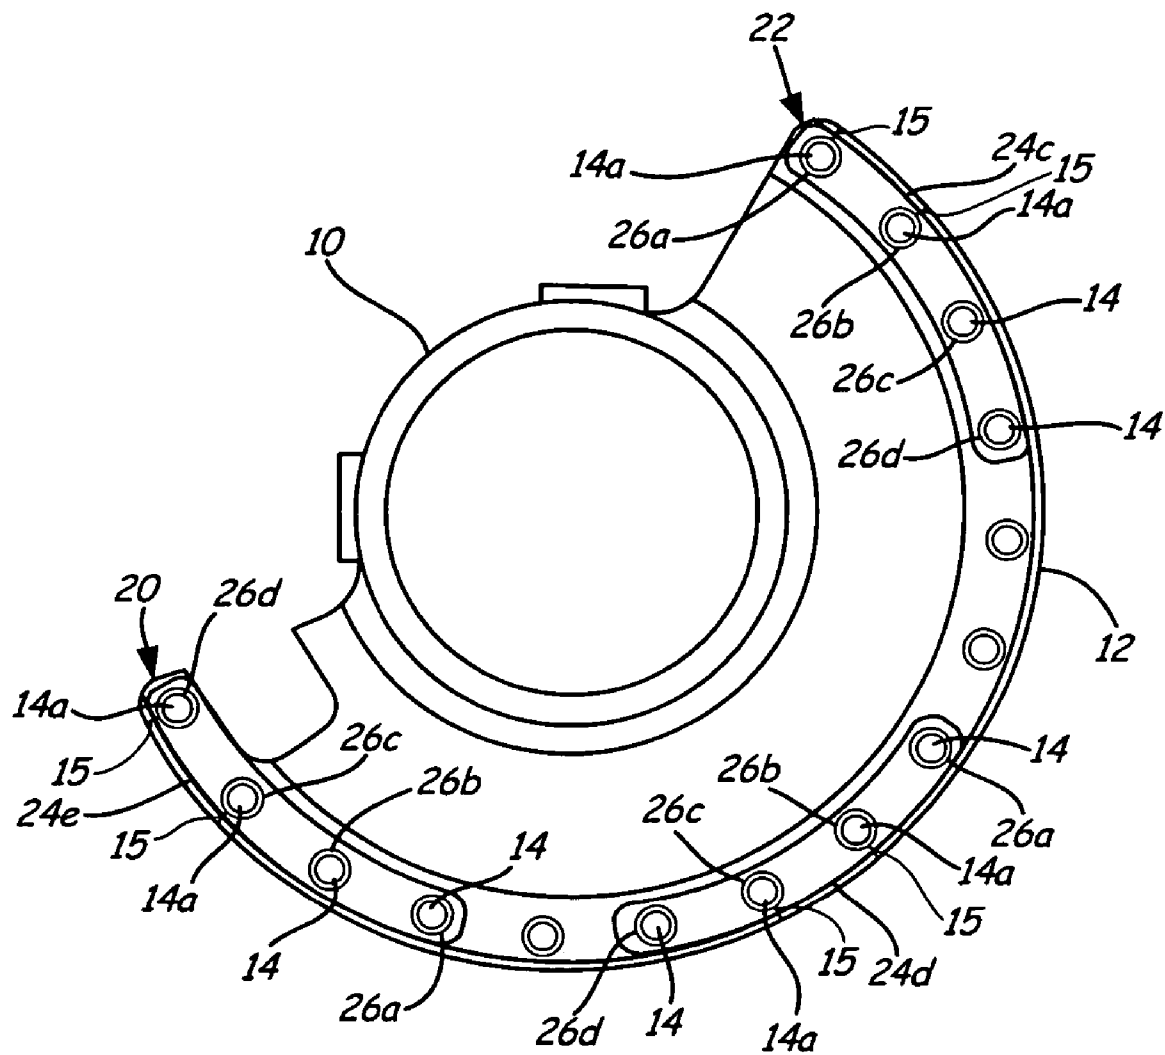
**FIG. 4**

FIG. 4 is a top view of the arcuate flange having a four-hole doubler in three different locations.

Three different exemplary uses of four-hole doublers are shown in FIG. 4. Four-hole doublers **24c-24e** function in the same manner as three-hole doublers **24a** and **24b**, except that four-hole doublers **24c-24e** are designed with four-holes, rather than just three. In four-hole doubler **24c**, damaged aperture **14a** is on non-wing end **22** of arcuate flange **12**. Four-hole doubler **24c** is thus positioned on arcuate flange **12** such that an end hole **26a** of third doubler **24c** is positioned over damaged aperture **14a**, while the remaining three holes **26b-26d** of four-hole doubler **24c** are positioned over undamaged apertures **14**. In some embodiments, the last hole **26d** of four-hole doubler **24c** will cover an undamaged aperture **14**, and at least one of the middle holes **26b** and **26c** will also cover an undamaged aperture **14**.

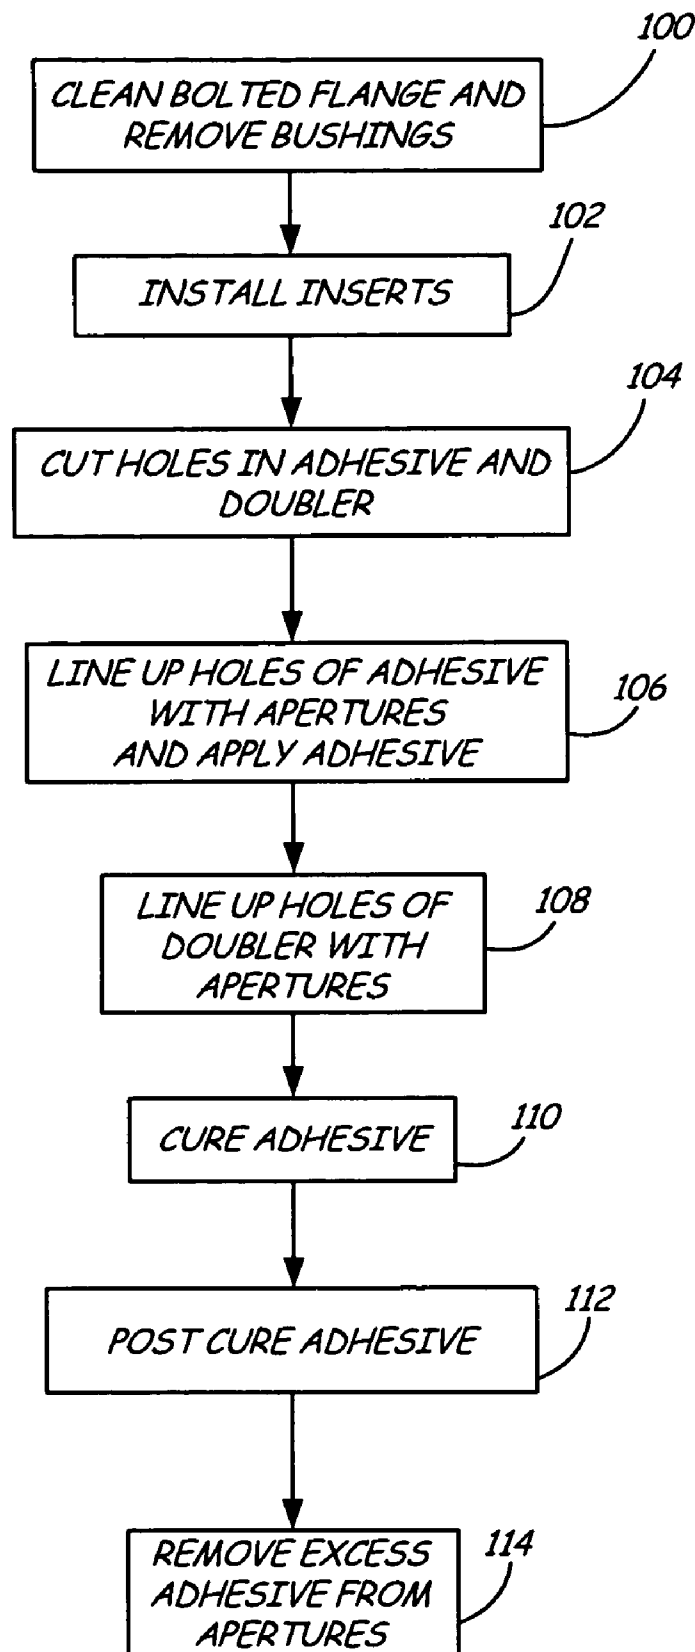
FIG. 7 is a block diagram of a method of installing the doubler to the arcuate flange.
