(54) **Method for repair and replacement of combustor liner panel**

(57) A method for repairing a damaged portion of a combustor inner liner assembly (48, 80). The method includes removing the combustor (45) from a gas turbine engine (10). After inspecting the combustor (45) to determine whether cracks exist in portions of the inner liner assembly (48, 80), the method includes removing a cracked inner liner assembly (48, 80) from the combustor (45). Then the portion of the inner liner assembly (48,80), comprising a multi-hole panel region (84), an aft lip region (86), an aft seal flange region (87) and an aft panel sup-

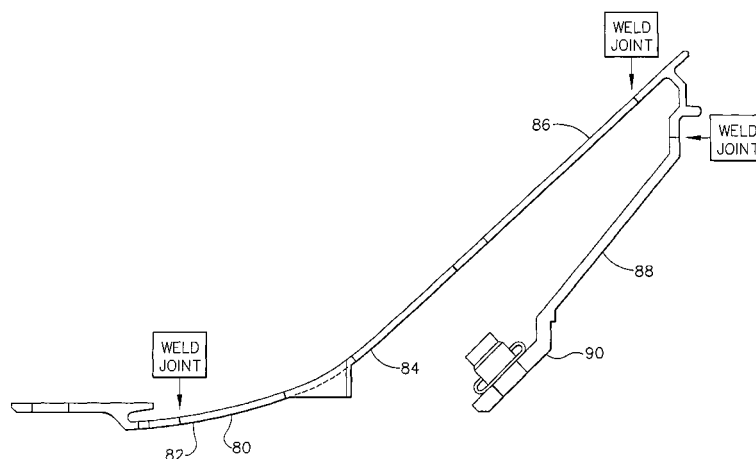
FIG. 3

Figure 3 is a cross-sectional view of the inner liner assembly of the present invention having a single film cooling nugget and a multi-hole cooled panel.

**[0018]** Figure 3 is a sectional view of an inner liner assembly 80 of a combustion chamber from GE90 engine, which is representative of the present invention. The inner liner assembly 80 from the GE90 differs from the inner liner assembly of the CFM 56 in that inner liner assembly 80 is not comprised of a plurality of panels and an aft panel assembly. Rather, inner liner assembly 80 from the GE90 has a similar configuration to the aft panel assembly 60 of the CFM 56 engine, the GE90 inner liner assembly not having the plurality of panels such as are found in the inner liner assembly of other designs. Notwithstanding this difference, the repair techniques dis-

cussed herein are applicable to the inner liner assembly 80 of the GE90 and to the aft panel assembly 60 of the CFM 56 engine, as well as to aft panel assemblies of other designs have the same type of configuration. The inner liner assembly 80 comprises a forward bolt flange 81, a nugget 82, a portion having a plurality of apertures, typically which are drilled, referred to as the multi-hole panel region 84, a portion attached to and aft of the multi-hole panel region, referred to as the aft lip region 86, the aft seal flange region 87 extending downward from the aft lip region 86 and the aft panel support leg 88 attached to the aft seal flange region 87, the aft panel support leg 88 further including an end distal from the attachment to the aft seal flange region, this distal end 90 including a means for attachment with the inner casing. As shown in Figure 3, the means for attachment is an aperture/bolt arrangement, the threaded aperture in the distal end receiving a bolt extending through inner casing 70. The multi-hole panel region 84 extends across the inner liner assembly substantially perpendicular to the flow of the hot combustion gases. Aft support leg 88 extends downward from aft seal flange region 87 as shown.

the multi-hole panel region 84 by cutting it from the combustor at joint 1, Figure 3. Joint 1 can be cut at any convenient location forward of the holes in the multi-hole region forward to forward bolt flange 81, and may be formed at nugget 82. However, typically joint 1 is formed along the thin, uniform thickness of metal aft of nugget 82, as machining preparations for reattachment are more easily formed in this relatively thin, uniformly thick metal. This removal is performed as set forth in the prior art by using any convenient cutting means. However, instead of discarding the portion of the inner liner assembly aft to joint 1, which includes multi-hole panel region 84, aft lip region 86, aft seal flange region 87 and aft panel support leg 88, the aft panel support leg 88 is cut from the aft panel assembly circumferentially 360° at joint 3. The portion of the inner liner assembly 80 between joint 1 and joint 3 can be discarded. This includes not only multi-hole panel region 84, but also aft lip region 86 and aft seal flange region 87.

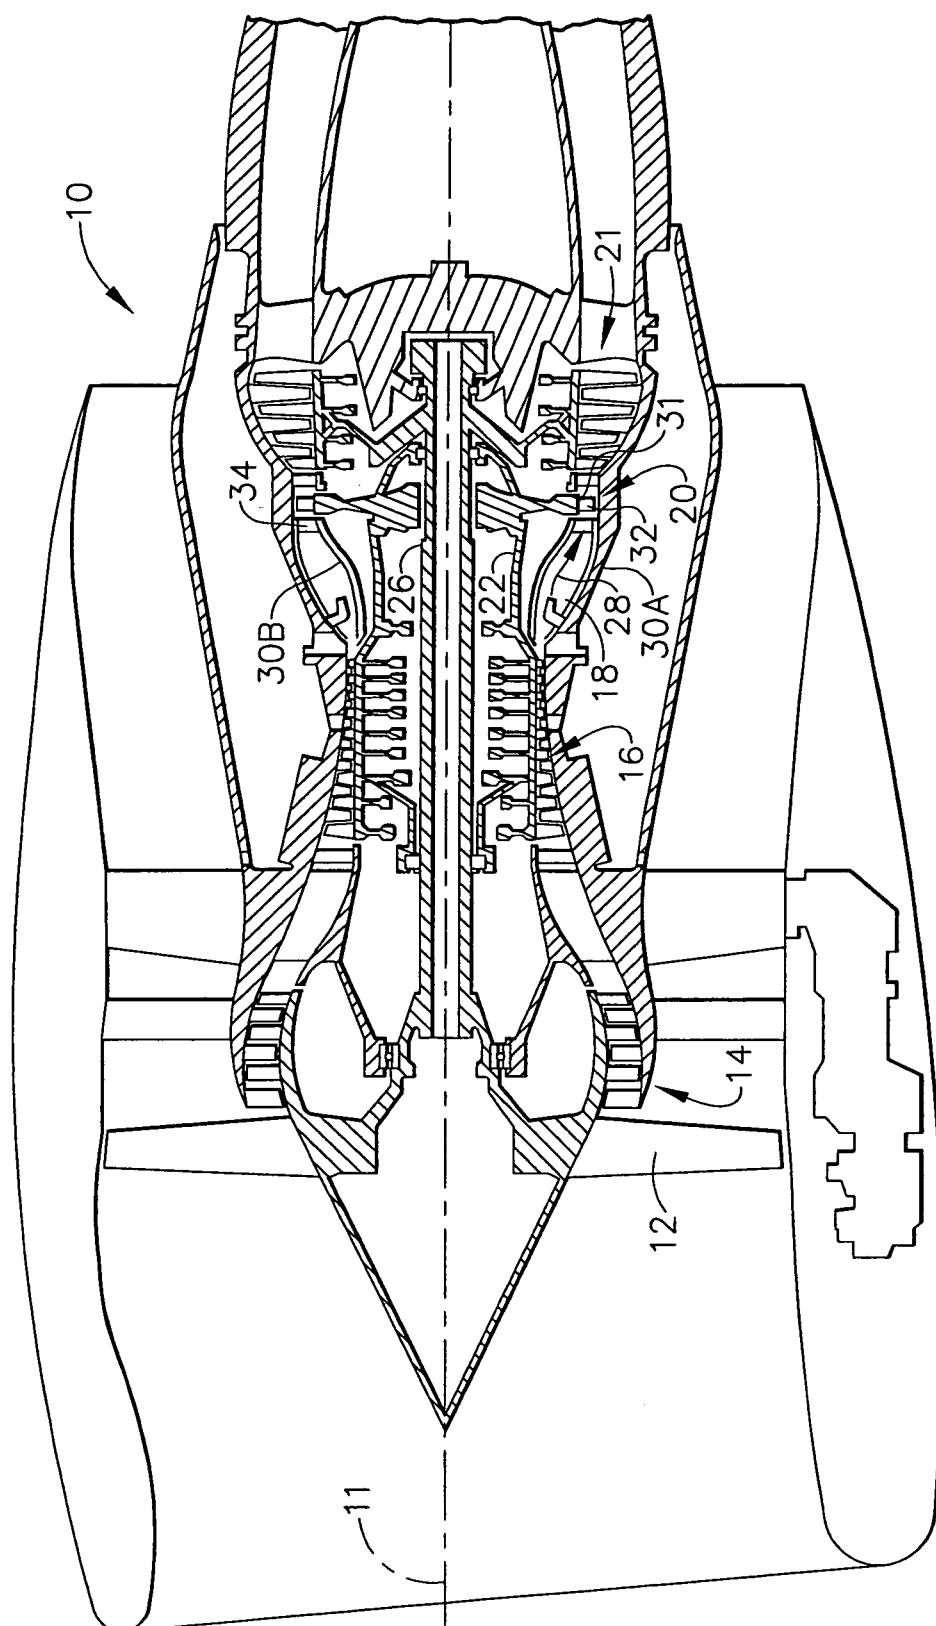
FIG. 1

Figure 1 is a schematic of a typical high bypass gas turbine engine.

**[0016]** Figure 1 is a schematic of a typical high bypass turbine engine 10. The centerline of the engine is shown at 11, along which the engine shaft 26 is positioned. Air enters the engine 10, passing front fan 12. Some of the air enters the engine core 14 and is directed to the compressor section 16 where it is compressed, while the remainder bypasses the engine core. The compressed air enters the combustion chamber, shown at 30A and 30B where it is mixed with fuel metered from the swirl cup of the fuel injector 18 and ignited. The hot gases of combustion proceed toward the rear of the combustion chamber past the turbine vanes or nozzles 34 and into the turbine rotor 20 where turbine blades 32 in the path of the high pressure gases of combustion are mounted on turbine wheels or disks 31. The high pressure gases pushing on the turbine blades 32 turn the wheels 31 which rotate the engine shaft 26. After the hot gases pass through the turbine section 20, they exit the turbine section at 21 and enter the exhaust as a lower temperature and pressure. The front of the engine is referred to as the forward end and the exhaust of the engine is referred to as the aft end.

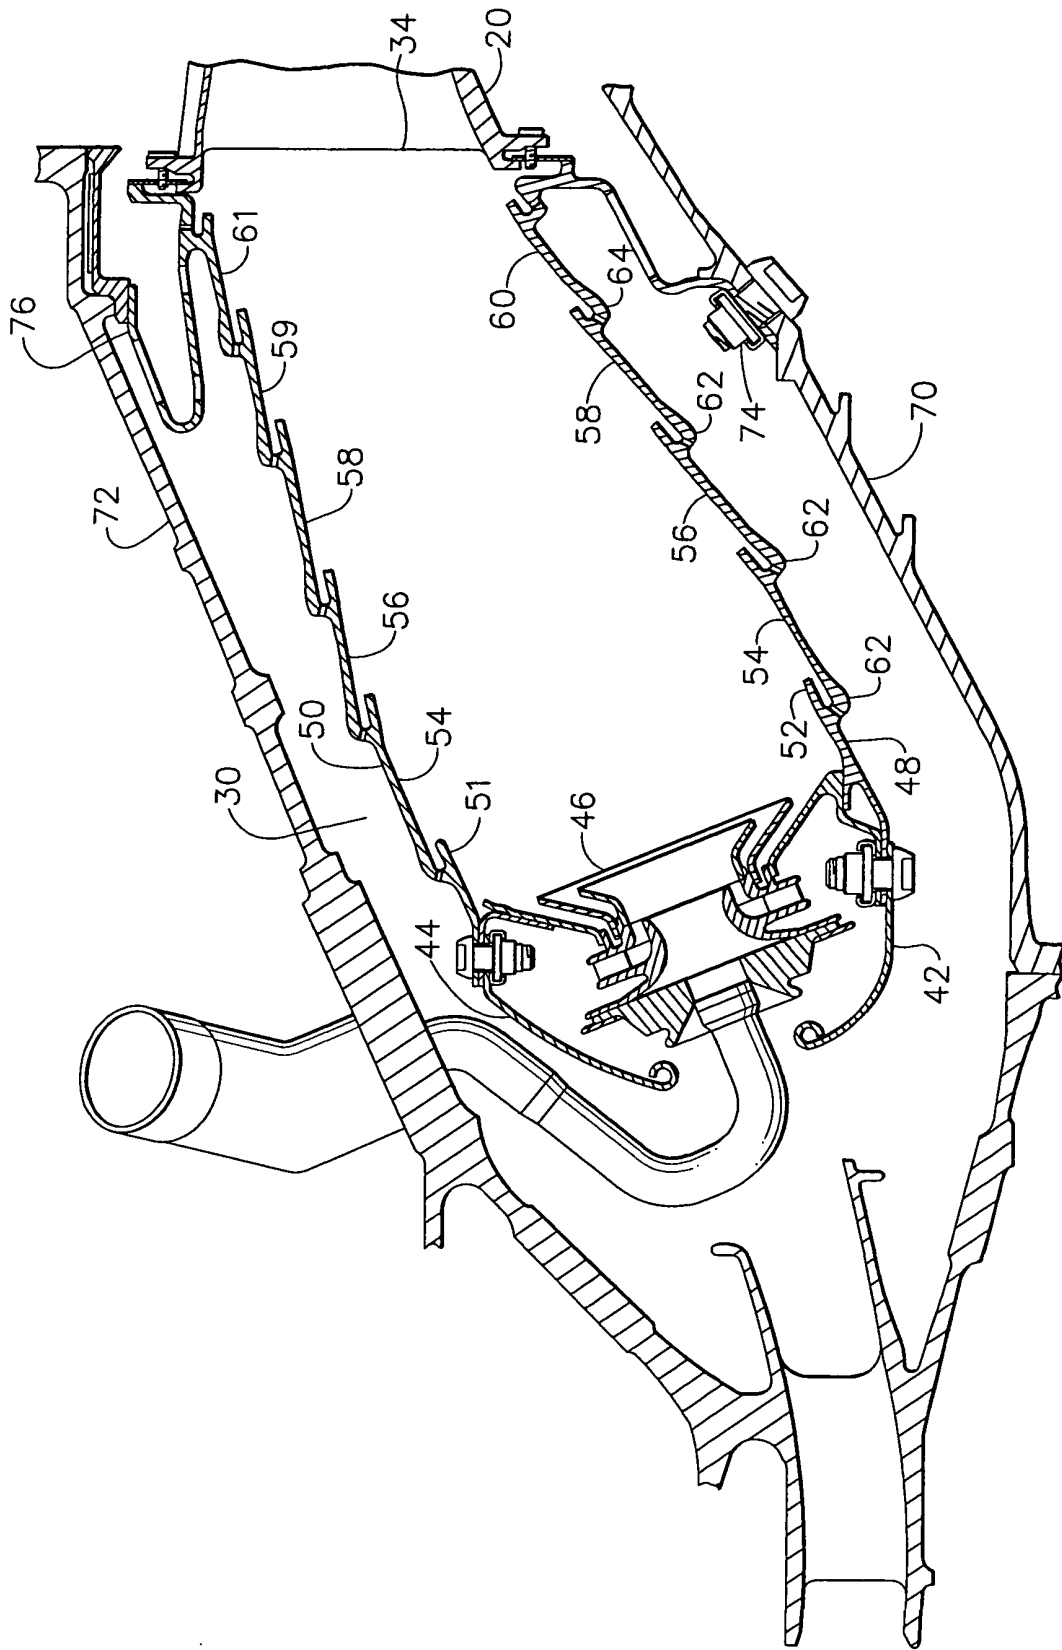
FIG. 2

Figure 2 is a cross sectional view of a typical combustion chamber having liners with multiple film cooling nuggets.

**[0017]** Figure 2 is a cross sectional view of a typical combustion chamber 30 (either A or B) such as may be found on a CFM-56 engine. This annular combustion chamber 30 is typical of combustion chambers found in all gas turbine engines, and is not restricted to the high bypass turbine engine 10, which is discussed above for illustration purposes. The combustion chamber 30 includes inner cowl 42 and outer cowl 44 bolted to dome assembly 46. The inner liner assembly 48 is comprised of a plurality of panels, panels 52, 54, 56, 58 and an aft panel assembly 60. The panels 52, 54, 56, 58 are shown joined together at joints referred to as nuggets 62. The aft panel assembly 60 is similarly joined to the panels forward of it at a nugget 64. The aft panel assembly 60 contacts the high pressure turbine section 20 at the combustor seal support 36. The panels 51, 54, 56, 58, 59 and 61 are similarly joined together to form the outer liner 50. The outer liner 50 and inner liner 44 are joined together to form combustor 45. Combustor 45 is attached to inner casing 70 and outer casing 72, at locations 74 and 76, the inner liner 48 of combustor 45 being bolted to the inner casing 70 at location 74 and the outer liner 50 attached to the outer casing 72, as shown, by any convenient means to form combustion chamber 30.

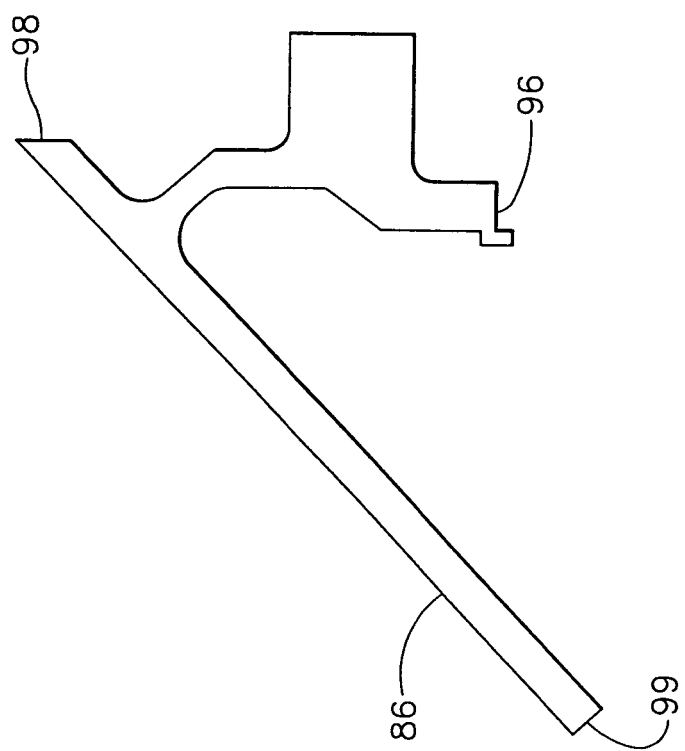
FIG. 4

Figure 4 is a cross-sectional view of the aft panel flange region, including the aft panel, aft lip and seal flange area of the present invention, including the aft panel, aft panel lip and seal flange area.

acceptable method and acceptable weld preps for electron beam welding of plate assemblies for a GE90 aft panel assembly are shown in Figure 4.
