[54] TIRE REPAIR CONSTRUCTION AND METHOD

[57] ABSTRACT

A repair construction and method are disclosed for repairing a damaged portion in the wall of a tire. A patch is installed over the damaged portion on the inside of the tire, and the inside of the tire is pressurized to force the patch into the damaged portion, preferably in a concave shape. The remainder of the plug area then is filled on the outside of the patch with a suitable plug material, and the plug material and patch are then cured while the patch is maintained in position at least partially within the damaged portion. This construction and repair method eliminates bulging on the exterior of the tire after the repair is completed.

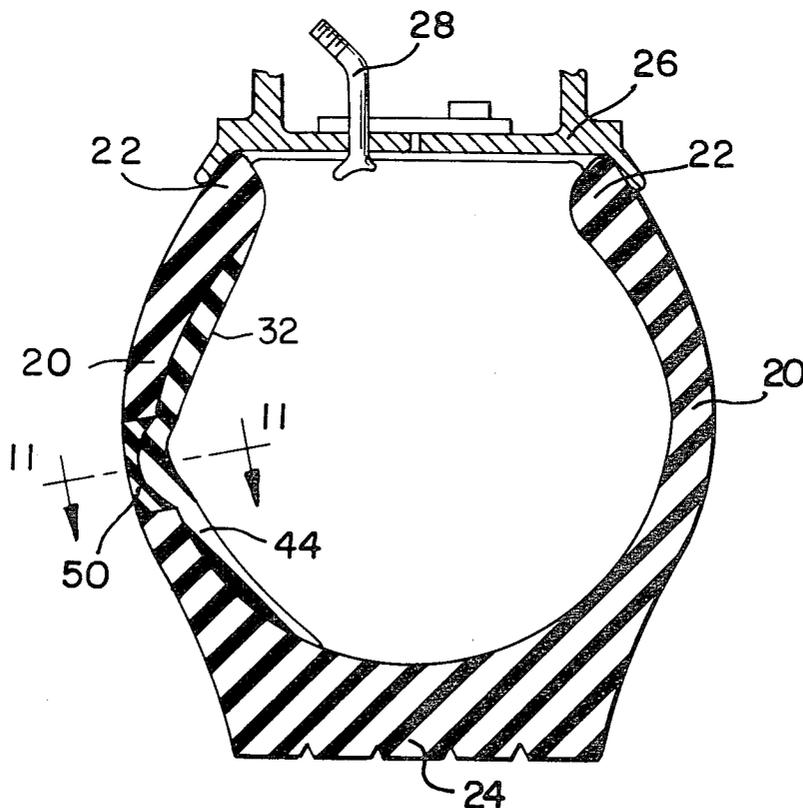
FIG. 1  
PRIOR ART

FIG. 1 is a sectional view radially through a tire having a sidewall repair construction in accordance with the prior art;

By way of comparison, FIGS. 1 and 2 show respective tires repaired in accordance with the prior art (FIG. 1) and the present invention (FIG. 2). Each tire includes sidewalls 20 extending between beads 22, and a tread portion 24 of the tire. Through beads 22, the tire is mounted on a rim 26, and an air valve stem 28 extends through the rim for inflating the tire. Referring particularly to FIGS. 1 and 3, a conventional prior art method of repairing damaged areas in the walls of tires first will be described. FIG. 3 shows tire wall 20 with a section of the wall, including the damaged portion, cut out to form a plug area 30. This is a common procedure normally referred to as "skiving" the tire injury. A patch 32 is placed over the plug area on the inside of the tire, and the remainder of the plug area is filled with a plug material 34. The patch cord 32' runs generally parallel to the tire cord 20'. The plug material and patch are then cured to complete the repair construction except for final dressing. To better understand this conventional construction and repair method, it should be noted that the patch is installed on the inside of the tire over the plug area and the plug material is applied to the plug area with the tire in an uninflated condition. As a consequence the patch is positioned either flat across the plug area or possibly with an inward or convex bulge as shown by full lines in FIG. 3. Under the influence of internal tire pressure P, patch 32 assumes a bulge condition generally as shown by the dotted lines 40. The bulge condition is also shown in FIG. 1. By comparison, a typical patch construction in accordance with the present invention is shown at the same location on a tire sidewall in FIG. 2, with no resulting outward bulge even when the internal tire pressure reaches approximately 100 p.s.i., i.e. similar to road running conditions.

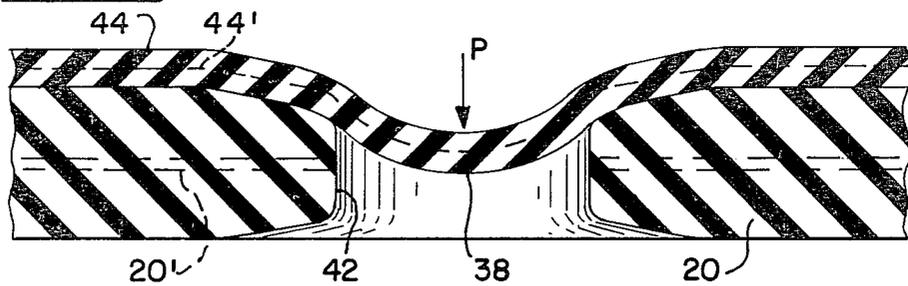
FIG-6-

FIG. 6 is a view similar to that of FIG. 5, illustrating the step of applying filler material in the plug area on the outside of the prepositioned patch;

The next step in the process of the present invention, is illustrated in FIG. 6 and comprises filling the remainder of plug area 42 on the outside of patch 44 with a suitable uncured plug material 50, such as uncured rubber. The plug material is preferably applied beyond the plug area 42 to an area 52 which has been lightly buffed and recessed as shown.

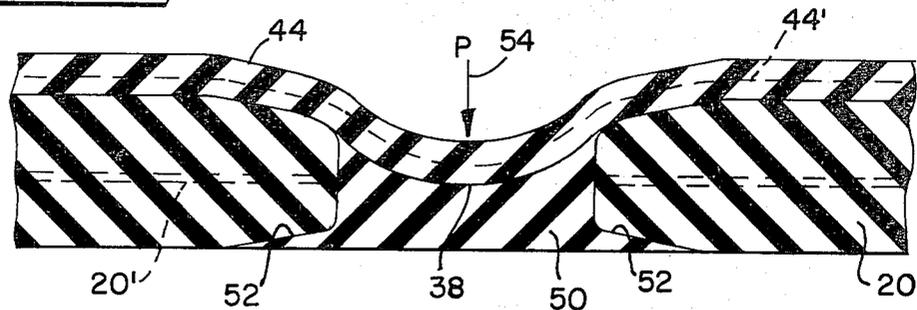
FIG-7-

FIG. 7 is an enlarged circumferential sectional view illustrating a completed repair construction after the patch and filler material have been cured in accordance with the present invention, and illustrating the completed repair construction having used an uncured patch material;

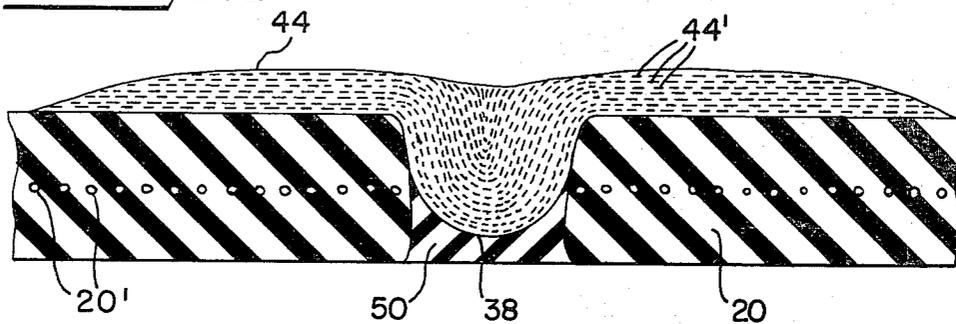
FIG-8-

FIG. 8 is a view similar to that of FIG. 7 illustrating the completed repair construction of the present invention having used a cured patch material;
