[54] ROTOR BLADE SHAFT INTEGRITY MONITORING SYSTEM

ROTOR BLADE SHAFT INTEGRITY MONITORING SYSTEM

This invention relates to helicopter rotors and more particularly to an improved blade retention apparatus including a redundant tension member and an indicator system to monitor the reliability of the primary member.

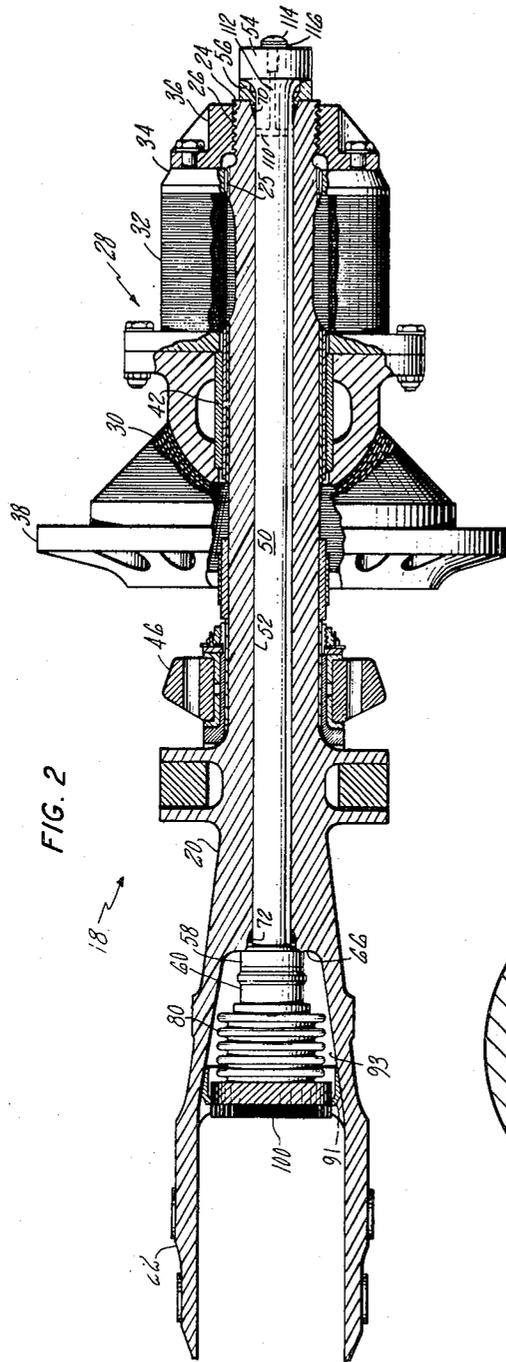
FIG. 2 illustrates both the redundant means added to the spindle assembly as an improvement to the configuration illustrated in the '708 patent together with the integrity monitoring means associated therewith that provides knowledge to the operator or service personnel that damage has occurred to the spindle assembly, and the normal load path has been diverted to a backup path. Spindle replacement can then be scheduled. Still referring to FIG. 2, we can realize that the primary load

path of the reaction to blade centrifugal force travels inboard the length of spindle 20 to its innermost end 24 at thread 26. Tension loading in spindle 20 translates to compression loading in the bearing array 28 as the load reverses through jam nut 36. Such was the sole load path until the addition herewith of bolt 50, located in the bore 52 of spindle 20, with generous clearance between bolt and bore providing an annulus 53 of several thousandths of an inch that is illustrated in FIG. 4. Bolt head 54 and spherical washer 56 are provided at the inner end 24 of spindle 20, while spacer 58, nut 60, nut lock 62, and nut lock ring 64 are provided at the opposite end. A pre-load may be provided to bolt 50 prior to installation of the spindle assembly into the hub arm 12. Under centrifugal operating loads imposed on the spindle 20, shoulder 66 will bear against spacer 58 and impose a tension load into bolt 50. This tension load will be reversed at the bolt head 54 so as to create a compression load path through bushing 56, spindle end 24, and nut 36 into the bearing array 28. The spherical shape of the washer 56 aids in centering the bolt 50 so as to provide tensile loading only across its cross section. Thus, the bolt 50 creates a secondary load path that may either share the total load or be held in reserve until failure of a member in the primary load path. When a pre-load is applied to the bolt, the degree of load sharing between the two load paths will be a function of the amount of pre-load. A failure of the spindle in its cross section, such as a crack which would open to an enlarged condition under centrifugal force, would render the spindle incapable of continued tensile loading. Upon such failure, the bolt 50 will become the primary load path. The spindle will be relieved of loading for its length inboard of the shoulder 66.
