US006849972B1

(54) **GENERATOR ROTOR FRETTING FATIGUE CRACK REPAIR**

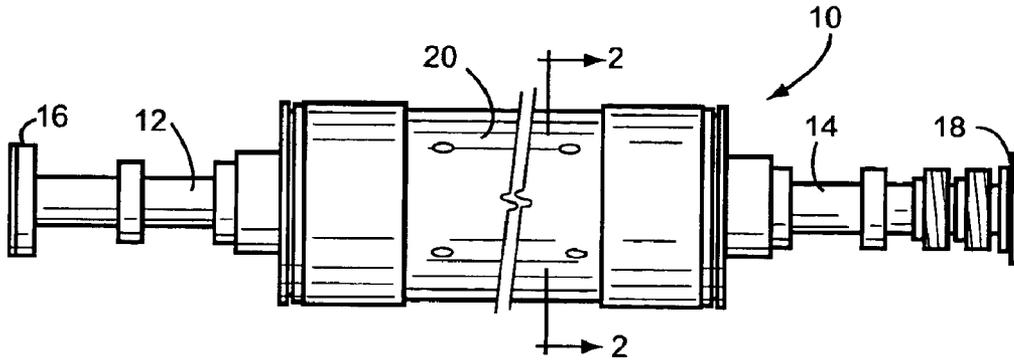
Fig. 1  
(PRIOR ART)

FIG. 1 is a side elevation of a conventional generator rotor including radially oriented coil slots;

FIGS. 1 and 2 illustrate a typical rotor 10 for a dynamo-electric machine wherein the rotor includes conventional elements such as rotor end shaft portions 12, 14 and couplings 16, 18 for connection with a turbine or gear reduction unit. Of particular significance here are the axially oriented coil slots 20 arranged circumferentially about the mid-section of the rotor, that are used for holding the copper field windings or coils.

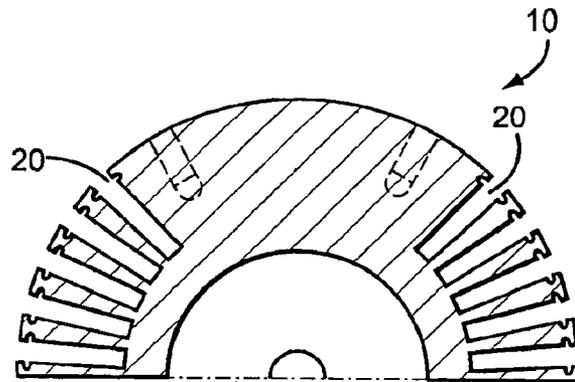
Fig. 2  
(PRIOR ART)

FIG. 2 is a partial cross section of the rotor body taken along the lines 2—2 of FIG. 1;

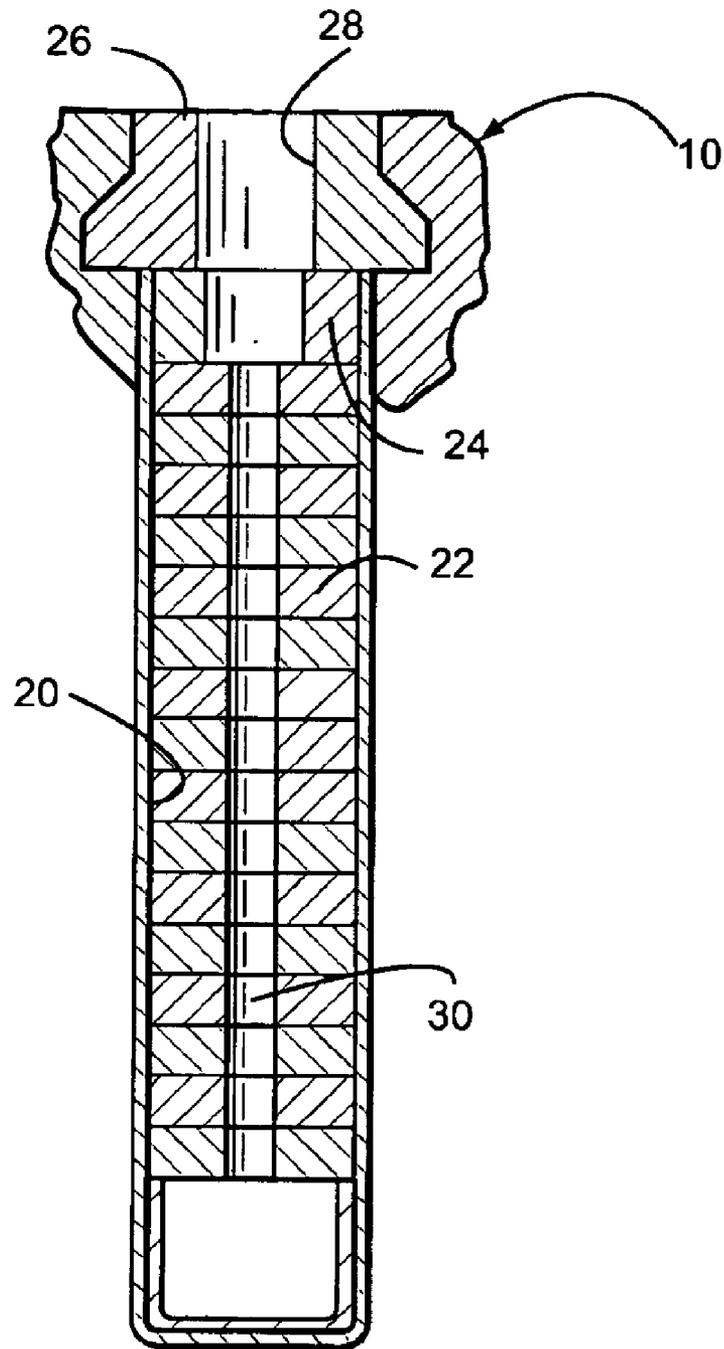
**Fig.3**  
(PRIOR ART)

FIG. 3 is a cross section through a typical coil slot and contents thereof;

With further reference to FIG. 3, the coil slots 20 are each radially directed and typically contain, in a radially outward sequence, insulated copper coils 22, a creepage block 24, and a plurality of axially aligned slot wedges 26. The wedges have a generally dovetail shape in cross section, and are located and arranged so as to maintain the copper coils 22 and creepage block 24 in place while the rotor is spinning. The slot wedges 26 may also contain ventilation holes 28 (one shown) which are in general alignment with ventilation channels 30 (one shown) which pass through the copper conductors or coils, as well as through the creepage block 24.

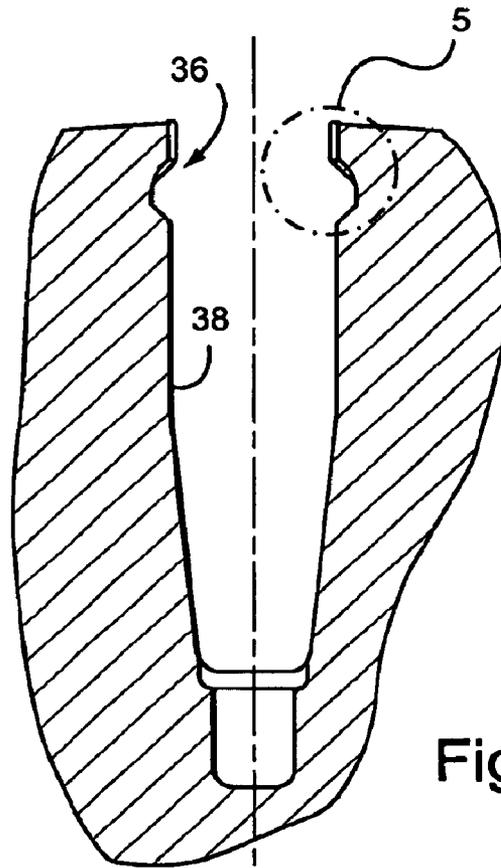
Fig. 4

FIG. 4 is a cross section of a rotor slot with damaged areas machined away in accordance with a first exemplary embodiment of the invention;

The present invention has two significant aspects in terms of repair of fretting cracks in rotor teeth. First, the damaged material is ground out of the rotor and a local stress field is altered near the repaired ends. With reference to FIGS. 4 and 5, the machined area is in the wedge-receiving dovetail portion 36 of the slot wall 38. As already noted, this is the area of the slot wall that is susceptible to fretting cracks, and particularly, at the interface of two abutting steel wedges. Initially, a suitably shaped and sized machining bit (e.g., a 0.625 dia. bit) is used to machine the vertical slot entry surface 40 and thereafter, most of the radially outer tapered dovetail surface 42, best seen in FIGS. 5 and 8. The machining work creates a first concave groove 43, including groove portions 44 and 46. Note that a small area 48 (FIG. 8) of the tapered surface 42 remains in its original state, and, as such, the groove portion 46 does not extend into the radial intermediate surface 47. Once the material is machined to form groove portions 44 and 46, the sharp edges along the boundaries of both portions are radiused. Machining in this manner only minimally reduces the low and high cycle fatigue life of the rotor. Where appropriate (i.e., depending on the crack location and extent of the crack), the repair may be effected by forming the first groove portion 46 only. When the wedges are replaced, the butt joint between adjacent wedges 32, 34 may be centered on the machined regions (i.e., on the radial centerline through the groove 43, as shown in FIG. 7. Alternatively, the wedge butt joint may be axially offset from the repaired area.

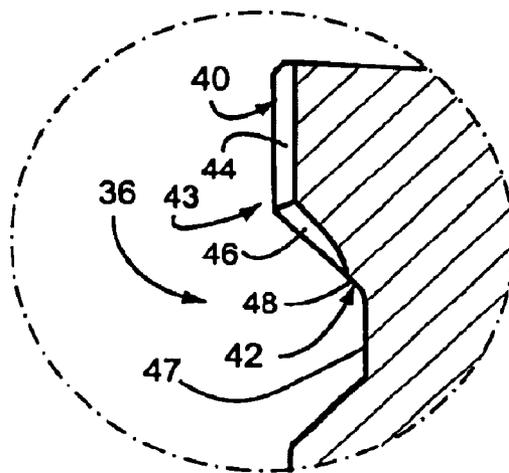
Fig. 5

FIG. 5 is an enlarged detail taken from FIG. 4;

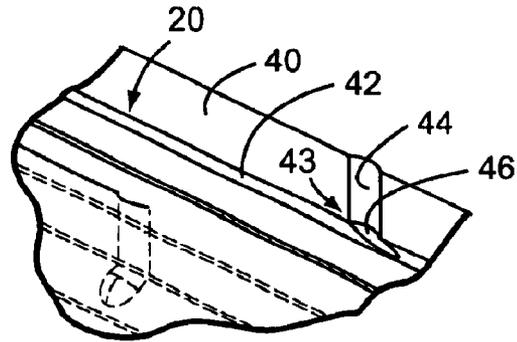
Fig. 6

FIG. 6 is a partial perspective view of the rotor slot, showing damaged areas machined away from opposite sides of the slot wall;

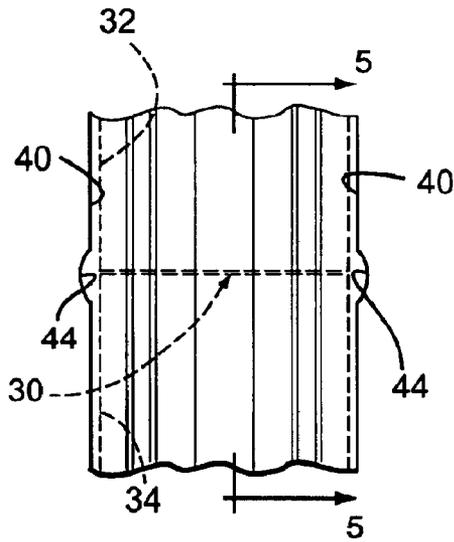
Fig. 7

FIG. 7 is a plan view of the rotor slot shown in FIG. 6, with adjacent wedges shown in phantom;

Fretting fatigue damage has occurred in the coil slots 20, specifically in the slot walls, at the butt joints of the axially adjacent steel rotor wedges 26 (a butt joint 30 between a pair of adjacent wedges 32, 34 is shown in phantom in FIG. 7). Fretting occurs whenever a junction between components is subjected to a cyclic load that leads to small tangential displacement over part of the interface. A two dimensional (radial-axial) finite element fretting model was developed to model the mechanics of contact between the rotor slot 20, and particularly the dovetail-shaped portion 36 of the slot wall 38 (see FIGS. 4 and 5) and the wedge 26, where fretting initiated cracks were observed in the rotor. The model provided a qualitative understanding of the fretting mechanism and provided a basis for preliminary assessment of various wedge redesign options.

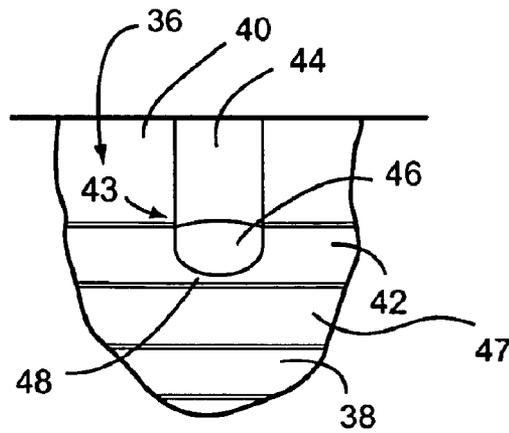
Fig. 8

FIG. 8 is a side elevation of one of the rotor slot side walls shown in FIGS. 5 and 6;

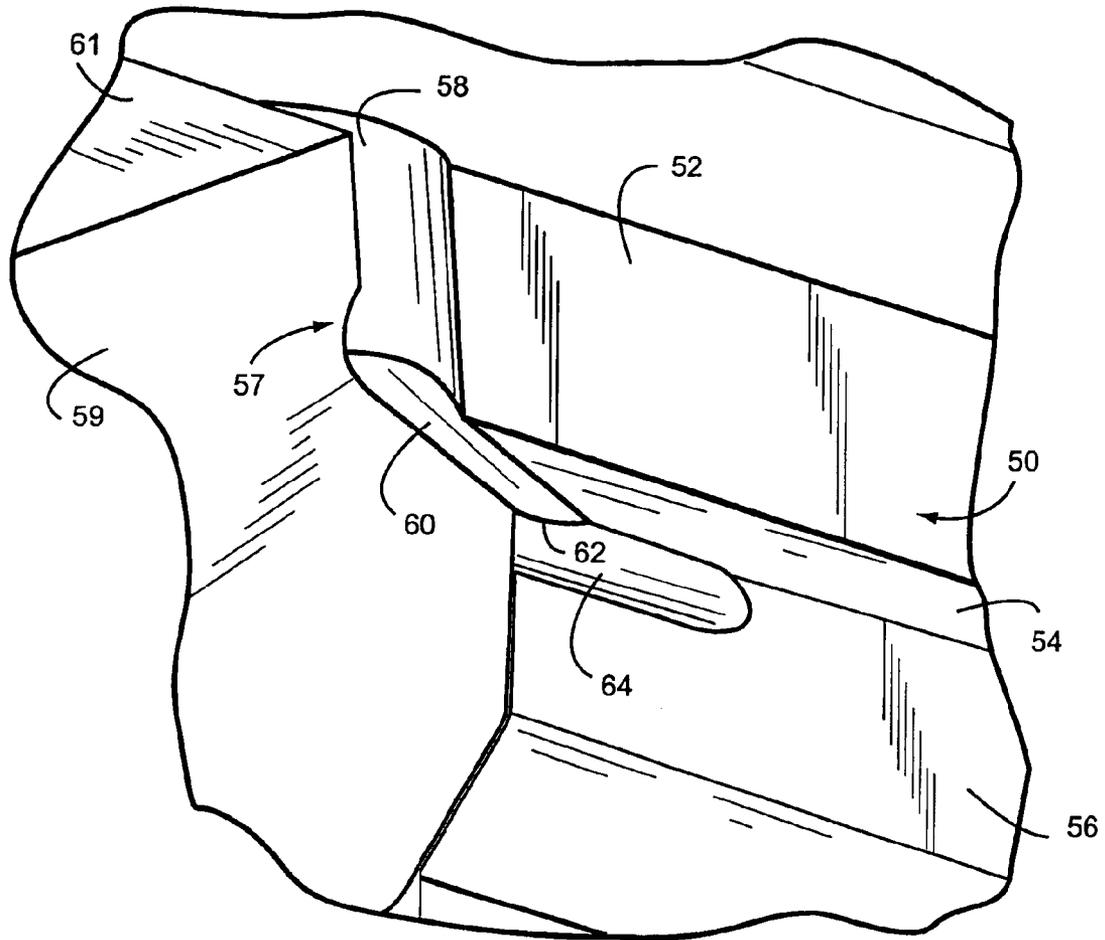
Fig.9

FIG. 9 is a partial perspective of a radial coil slot and wedge, showing damaged material machined away in accordance with a second exemplary embodiment of the invention;

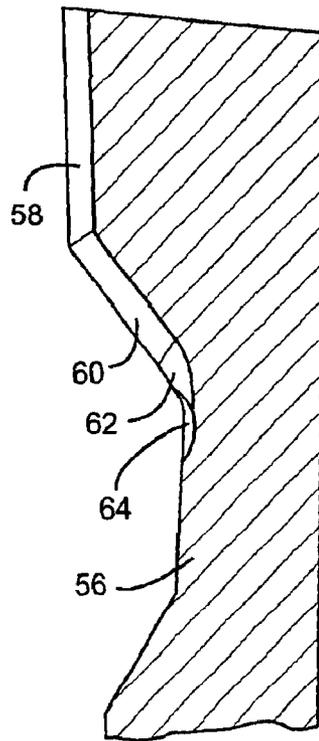
Fig.10

FIG. 10 is a partial cross section of the radial coil slot shown in FIG. 9; and

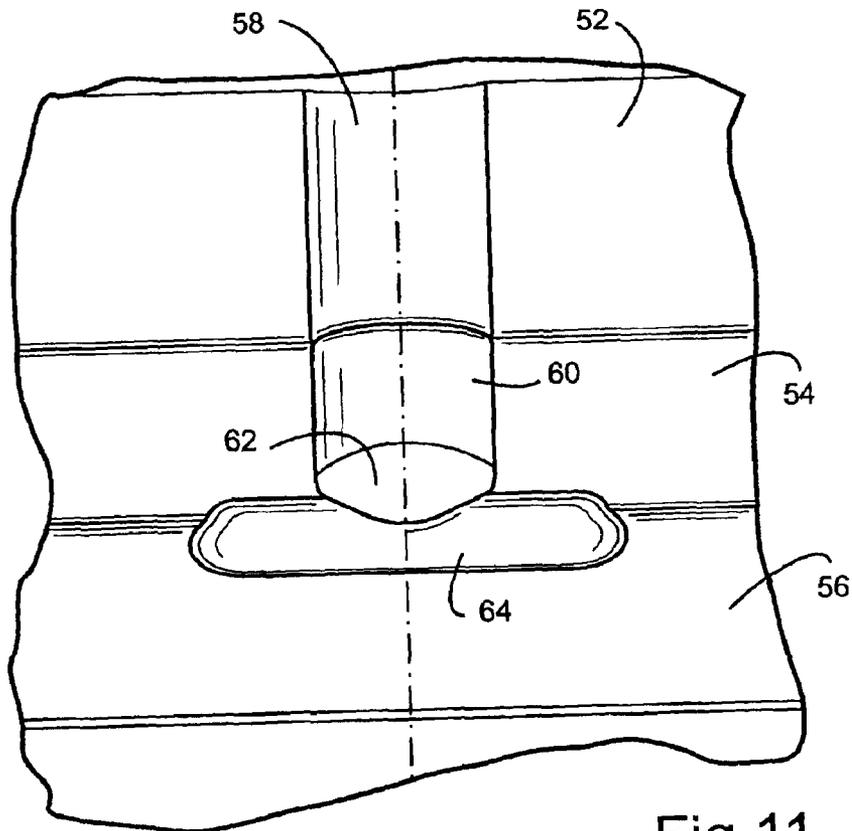
Fig.11

FIG. 11 is a partial side elevation of the coil slot shown in FIG. 10.
