(10) **Patent No.:** **US 6,520,836 B2**  
(45) **Date of Patent:** **Feb. 18, 2003**

(54) **METHOD OF FORMING A TRAILING EDGE CUTBACK FOR A TURBINE BUCKET**

(73) Assignee: **General Electric Company**, Schenectady, NY (US)

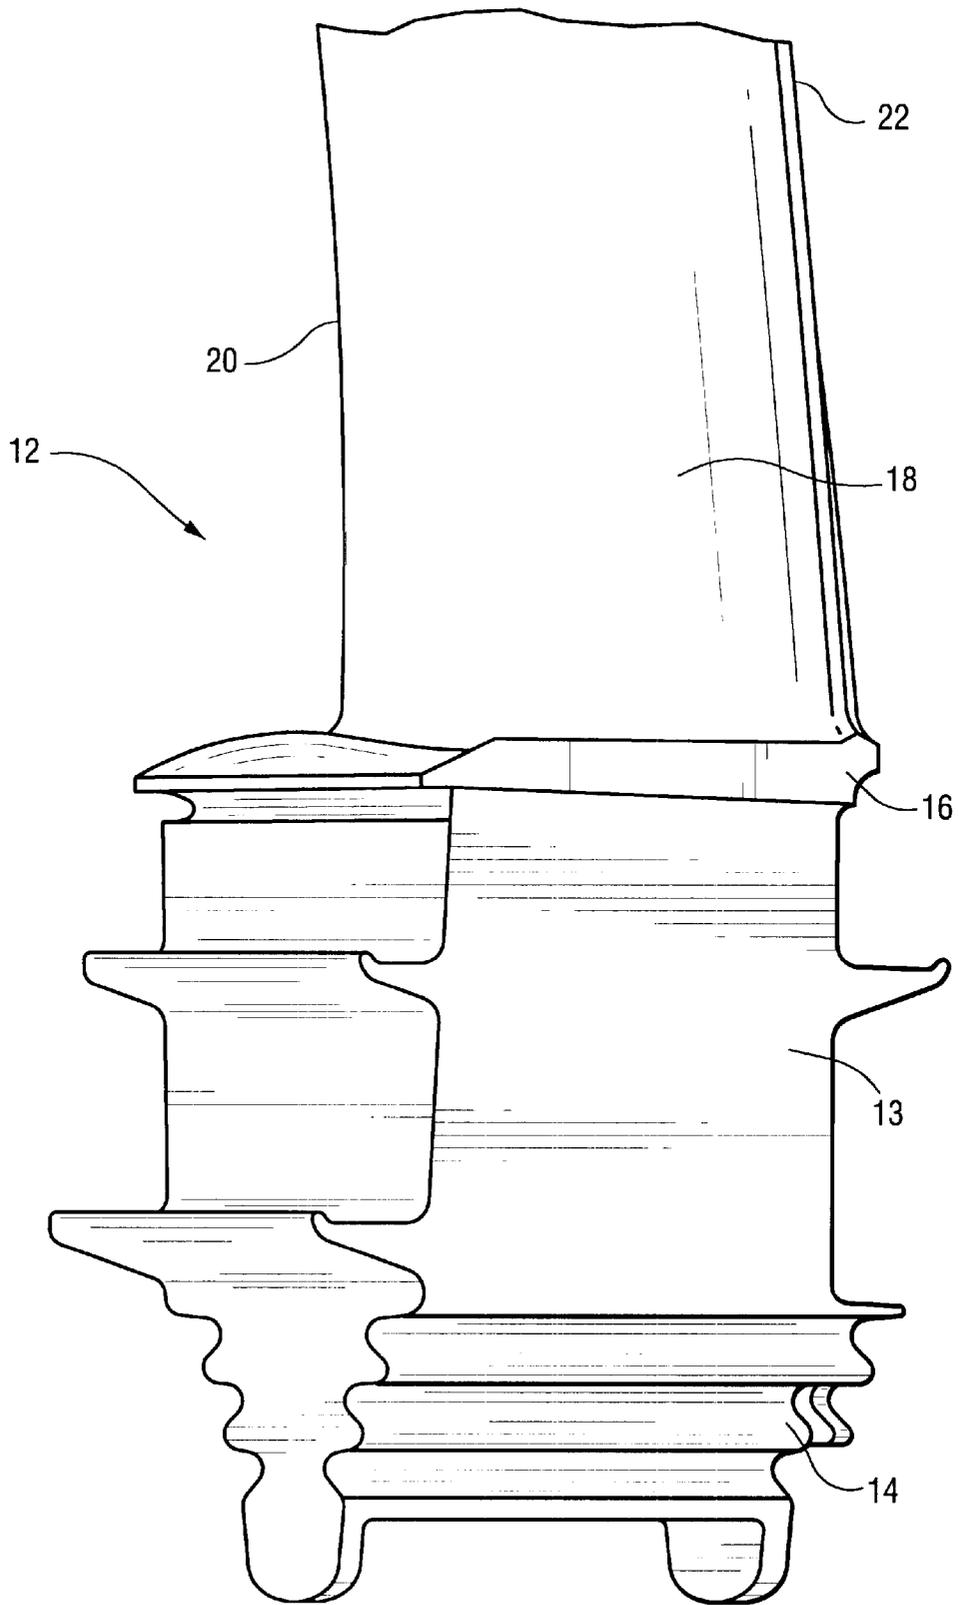
Fig. 2

FIG. 2 is an enlarged, generally axial view of a turbine bucket;

forming part of a turbine rotor. It will be appreciated, and with reference to FIG. 2, that the buckets 12 typically comprise a shank portion 13 having a dovetail 14 for coupling the bucket to a corresponding dovetail in the wheel 10. The root portion 16 of the bucket 12 mounts the airfoil-shaped body 18 of the bucket, it being appreciated that the bucket 12 is typically formed as an integral casting. As illustrated in FIG. 2, the airfoil body 18 has a leading edge 20 and a trailing edge 22. While not illustrated, the buckets are provided with generally radially extending passages for conducting a cooling medium along the length of the bucket from the shank portion 13 to the tip portion of the bucket where the cooling medium, e.g., compressor discharge air, exits into the hot gas path.

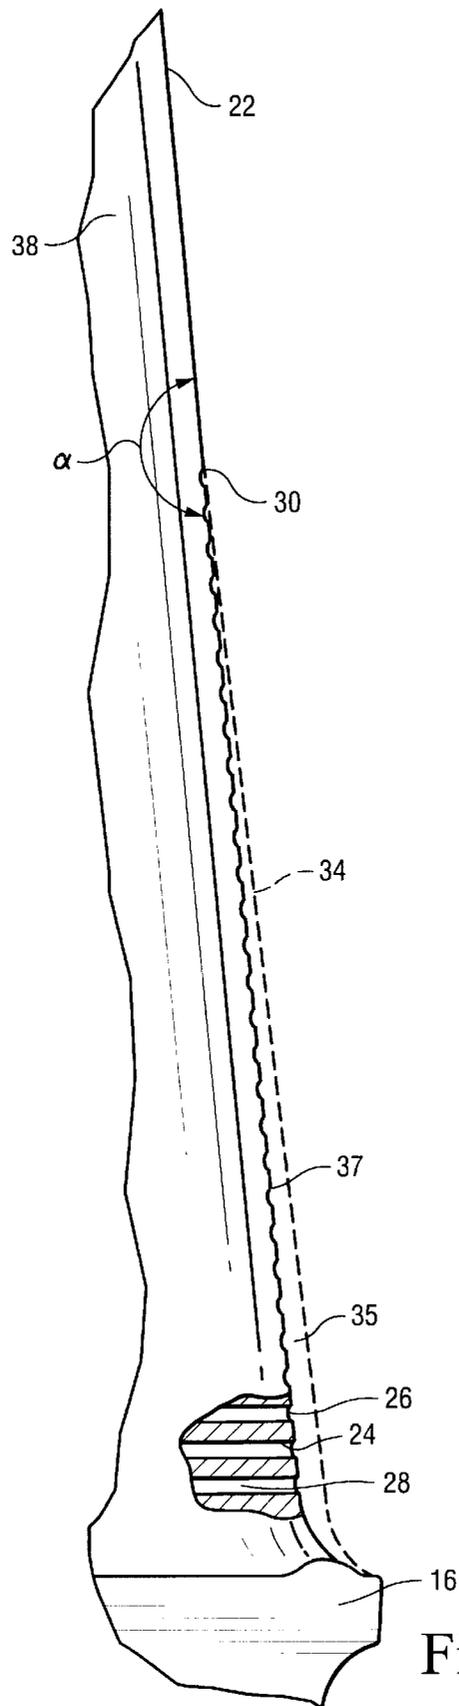
Fig. 3

FIG. 3 is an enlarged fragmentary view, with portions broken out and in cross-section, of a bucket trailing edge subject to repair; and

Referring now to FIG. 3, it is conventional to provide a plurality of cooling holes 24 communicating at their inner ends with one of the radially extending passages for flowing cooling air from the passage along the trailing edge portion of the bucket and which cooling air exits the trailing edge at outlet openings 26. Generally, the cooling holes 24 are spaced one from the other along the length of the bucket and are generally circular or elliptical in cross-sectional configuration. As noted above, cracks often develop after usage and propagate along the airfoil along paths of least resistance. Typically, the cracks develop in the first cooling passage 28 adjacent the root portion 16. The cracks develop near the exit opening 26 along the inside of the passage 28 and propagate generally inwardly from the trailing edge along the passage in a direction toward the leading edge. Once the crack is observed upon inspection during an out-of-service interval, the crack must be repaired, as otherwise it would continue to propagate.

It will be appreciated that as the radii are formed, the cutback 37 of the trailing edge affords a scalloped configuration as illustrated in FIG. 3 as viewed from opposite sides of the airfoil. The scalloped configuration is a result of the cooling holes 24 exiting the cutback trailing edge. Also, it will be appreciated that the new conical section recreated in the trailing edge cutback is slightly larger in transverse dimension than the original conical section at locations all along the cutback.

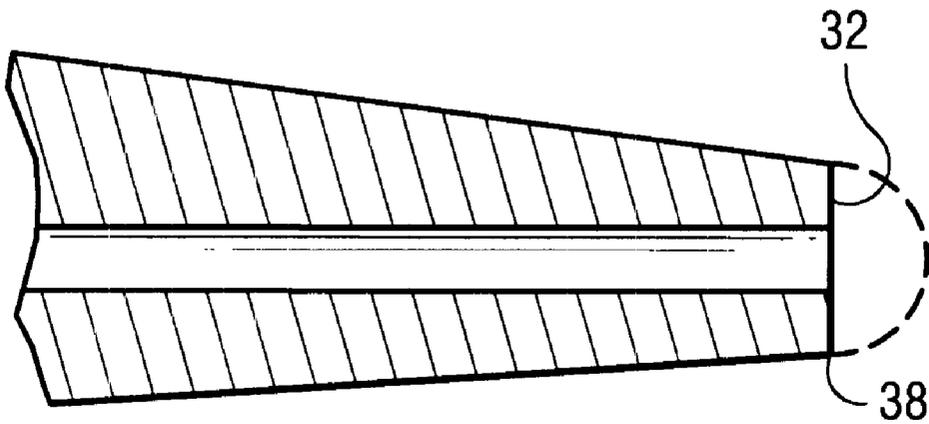
Fig. 4

FIGS. 4 and 5 are cross-sectional views of the trailing edge adjacent the root portion illustrating intermediate and final configurations thereof during a repair process.

In one form of the present invention, and referring to FIGS. 4 and 5, a machining operation is performed along the trailing edge to initially form a flat, planar surface 32, as illustrated in FIG. 4. The material 35 removed to form the cutback 37 is identified by the area of the trailing edge between the dashed line 34 representing, in FIG. 3, the unrepaired or original trailing edge, and the flat planar surface 32 of the trailing edge cutback after removal of the material therebetween as well as the radii 40 discussed below. It will be appreciated that a milling machine may be used to grind the trailing edge from the midspan portion 30 to the root portion 16 to form a planar surface 32 along the trailing edge cutback. The new flat planar surface 32 identifies the aft extent of the repaired or refurbished bucket and forms an obtuse angle  $\alpha$  between the unrepaired outer span portion 38 and the repaired portion. The resulting surface constitutes the recreated trailing edge cutback 37.

From a review of FIG. 4, it will be appreciated that sharp edges 38 are formed between the planar surface 32 and the suction and pressure sides of the airfoil. Radii 40, as illustrated in FIG. 5, are formed between the planar edge 32 and the opposite sides of the airfoil along the cutback. This is accomplished by grinding the airfoil edges to the appropriate radii at various locations along the span of the trailing edge from a datum line. The radii and cutback surfaces are calculated to provide a close approximation of the original airfoil shape to maintain minimal variation between original non-repaired and repaired airfoils. Radius gauges are employed at the various span locations from the datum to ensure accurate radii formation.
