(10) **Patent No.:** **US 10,843,421 B2**
(45) **Date of Patent:** **Nov. 24, 2020**

(54) **REPAIR INCLUDING A CHAMFERED BRACKET AND A CHAMFERED BRACKET COMPONENT FOR REINFORCING A DAMAGED STRUCTURAL ELEMENT MADE FROM COMPOSITE MATERIALS**

(71) Applicant: **SHORT BROTHERS PLC**, Belfast (GB)

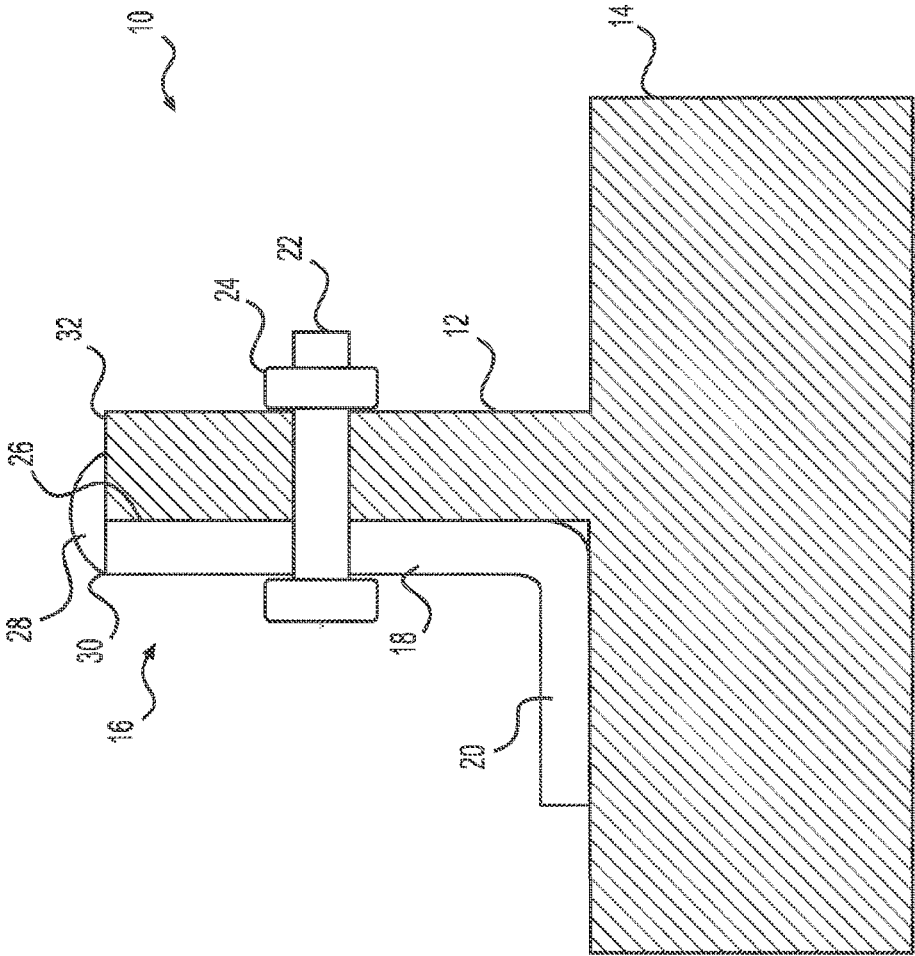
FIG. 1
(PRIOR ART)

FIG. 1 is a graphical, side view of the construction of a traditional repair for a damaged structural element made from a composite material;

FIG. 1 is a graphical, side view of the construction of a traditional repair 10 for a structural element 12 made from a composite material. In the non-limiting embodiment where the structural element 12 is an aircraft component, the structural element 12 may be a damaged stringer, frame member, spar, or other element, as should be appreciated by those skilled in the art. The structural element 12 may be connected to a substrate 14, such as an aircraft skin for example, as illustrated in FIG. 1.

As also illustrated in FIG. 1, a gap 26 exists between the bracket 16 and the structural element 12. Air pockets may get trapped within the gap 26 between the bracket 16 and the structural element 12. These air pockets can be dangerous during a lightning strike, since current conduction across the interface between the two parts may cause the air pockets to become super-heated and burst, which could possibly present an unwanted ignition risk within an aircraft fuel tank.

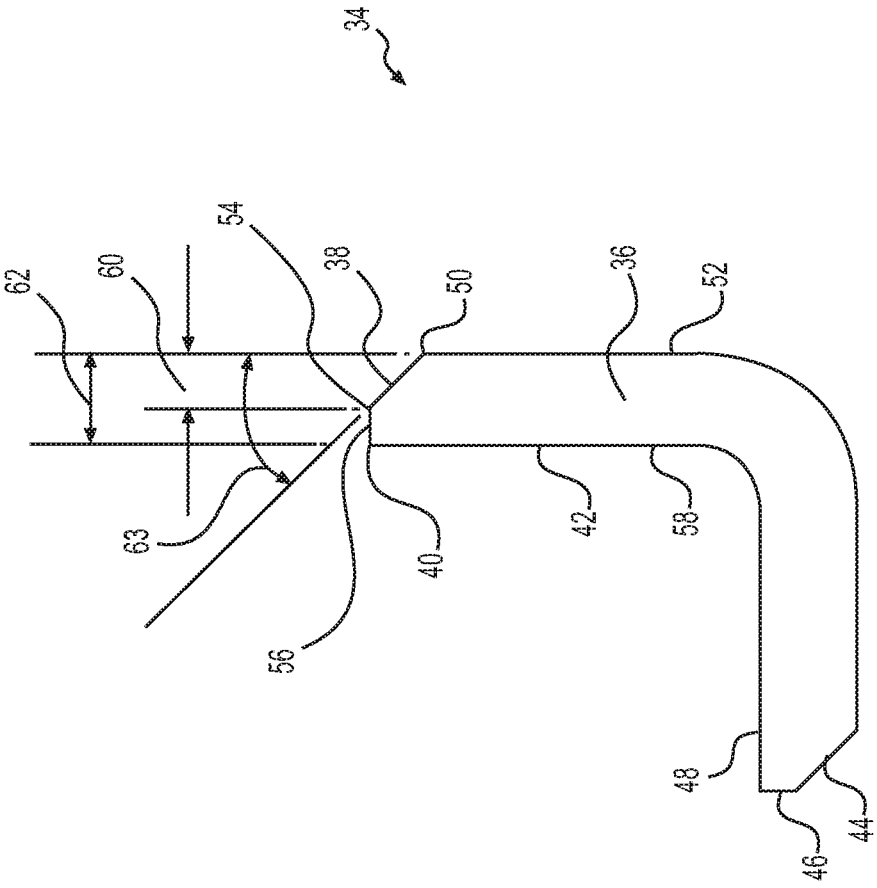
FIG. 2 is a graphical, side view of a portion of a repair for a structural element made from a composite material, as contemplated by the present invention;

To avoid this possible outcome, among others, FIG. 2 illustrates one aspect of the present invention. FIG. 2 provides an enlarged, graphical illustration of a portion of a repair 34 according to the present invention.

As illustrated in FIG. 2, the chamfer 38 extends from a first position 50 on a first side 52 of the bracket 36 to a second position 54 on a second side 56 of the bracket 36. The second side 56 of the bracket 36 is located at the top end 40 of the bracket 36 and is, therefore, the top side of the bracket 36 in this embodiment. It is noted that the first side 52 of the bracket 36 is the side facing toward the structural element 12. For clarity, the third side 58 of the bracket 36 is the side facing away from the structural element 12.

As illustrated in FIG. 2, the thickness 60 of the chamfer 38 is less than the thickness 62 of the bracket 36 (also referred to as the bracket thickness 62). The bracket thickness 62 is measured between the first side 52 and the third side 58 also along a line perpendicular (normal) to a plane defined by the first side 52. With this construction, the second position 54 lies on the second side 56, between the first side 52 and the third side 58. It should however be appreciated that in an alternative embodiment, the chamfer 38 may extend between the first side 52 and the third side 58, such that the top end 40 is defined entirely by the chamfer 38.

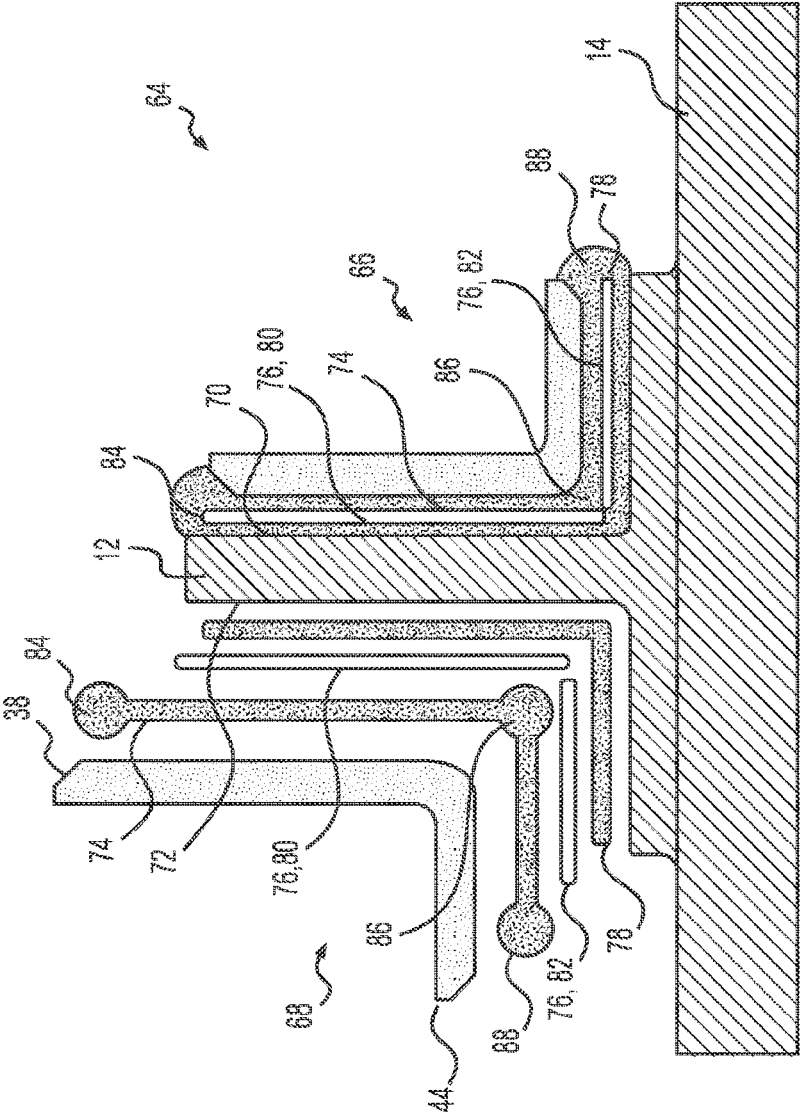
FIG. 3 is a graphical, side view of the construction of a first embodiment of a repair for a structural element made from a composite material, as contemplated by the present invention;

As discussed in connection with FIGS. 3 and 4, the repair 34 of the present invention relies upon an L-shaped bracket 36 with a chamfer 38 incorporated at the end 40 of the vertical segment 42 and a chamfer 44 incorporated at the end 46 of the horizontal segment 48. In connection with the discussion of the present invention, it is noted that the terms "vertical" and "horizontal" are employed with reference to

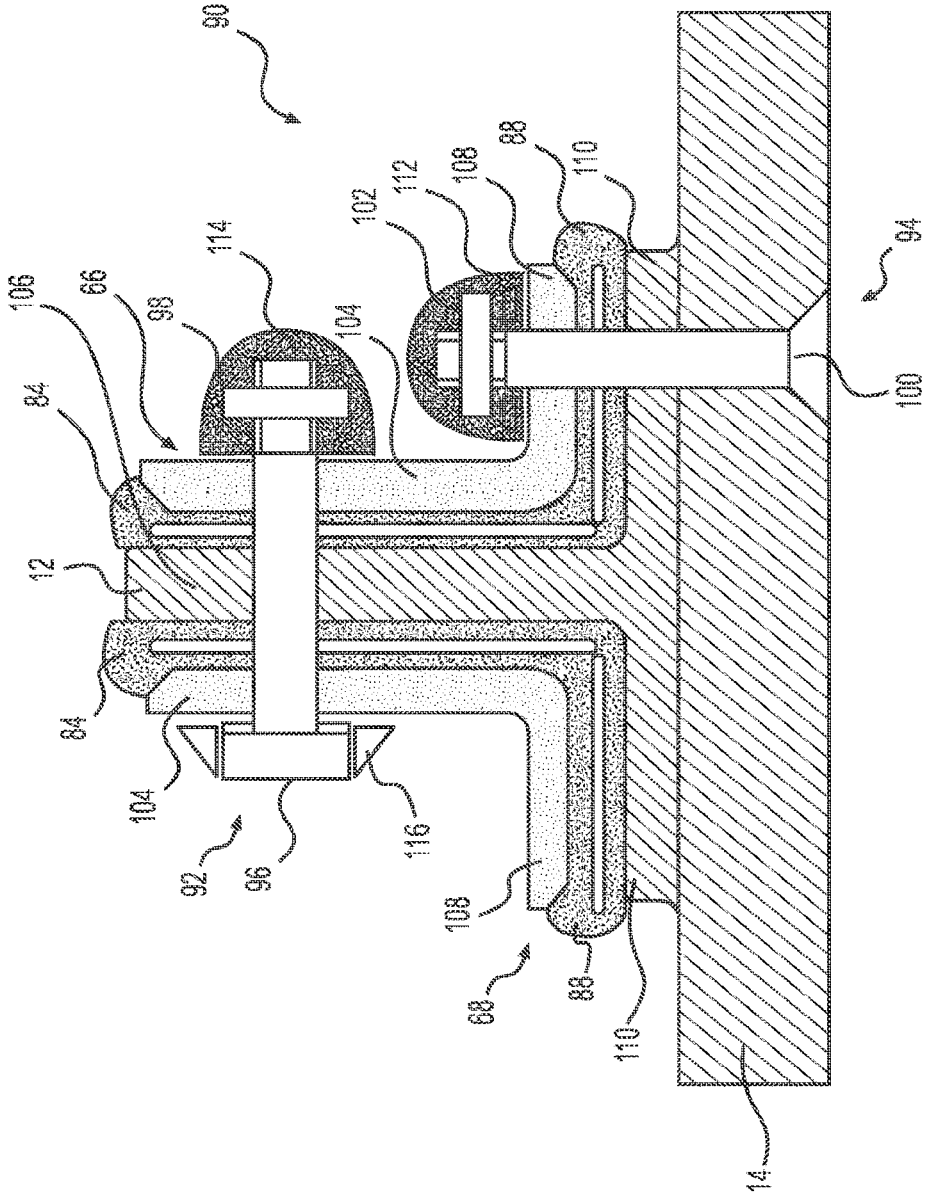
FIG. 4 is a graphical, side view of the construction of a second embodiment of a repair for a structural element made from a composite material, as contemplated by the present invention; and

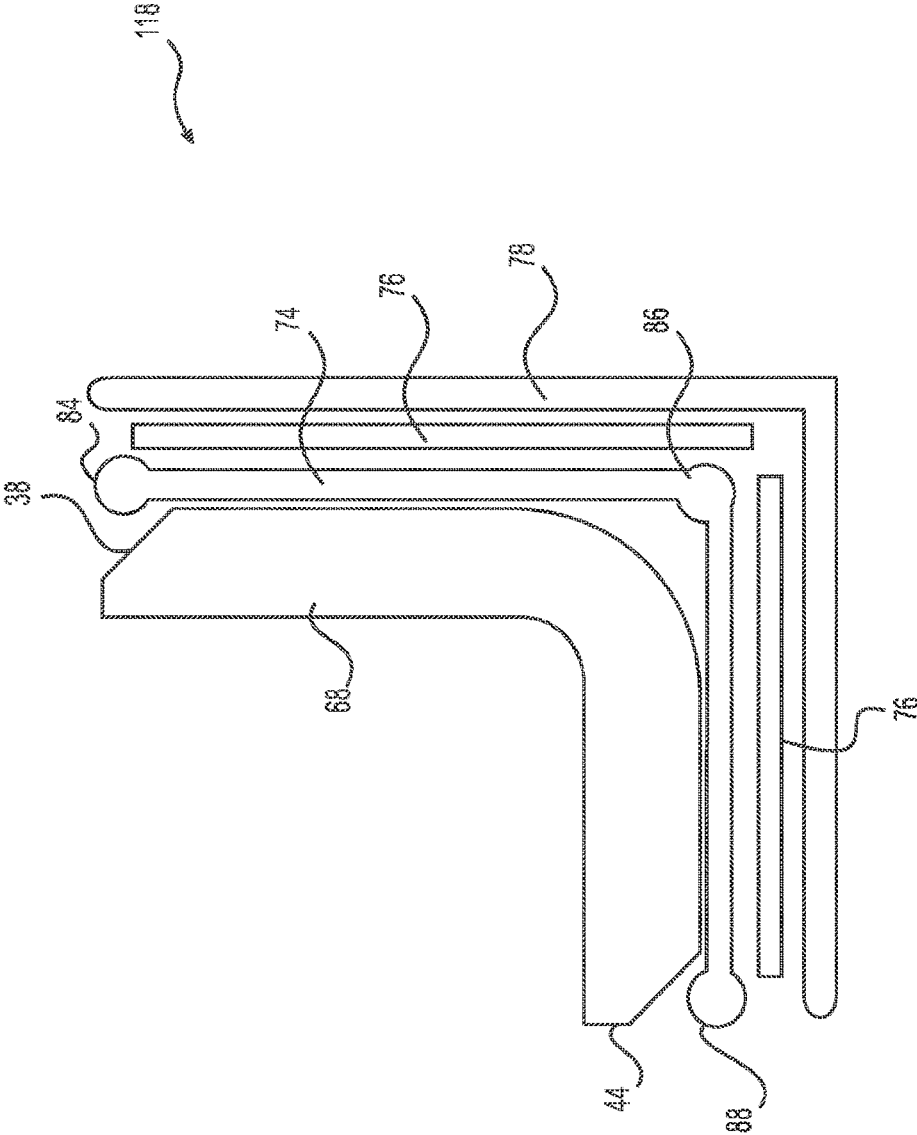
FIG. 5 is a graphical, side view of a chamfered bracket component according to the present invention.
