[54] REFURBISHED TURBINE COMPONENTS, SUCH AS VANES OR BLADES

A refurbished turbine vane or blade. Used turbine vanes and blades are cleaned, annealed and in some cases slotted adjacent their ends, after which any cooling passages are welded closed and all cracks welded over, on both leading and trailing edges. The trailing edge, for a vane or blade having a short chord, is built up by welding along its full length with an alloy wire, after which any slots that were cut adjacent the ends are closed, also by welding. Then the worn surfaces of the vane or blade are built-up by a plasma spray process, using a metal powder with added silica, to a thickness as great as 30 to 40 thousandths of an inch. The built-up vane or blade is then sintered and thereafter surface finished to conform to the original contour of the component when new. Any cooling holes are finally recut, and the vane or blade polished as required and inspected.

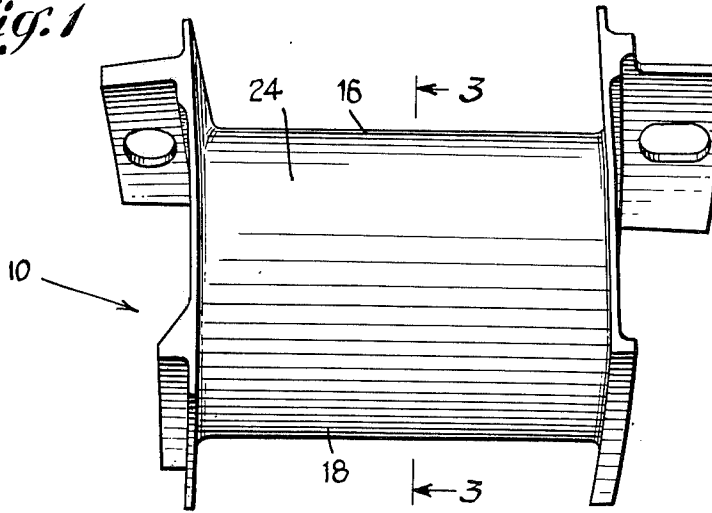
Fig. 1

FIG. 1 is an elevational view of the convex side of a vane of the type refurbished by a process involved with the invention.

Considering first FIGS. 1-4, a finished or refurbished component in the form of a vane designated 10 is shown, said vane comprising convex and concave airfoil portions 12, 14 joined at a broad leading edge 16 and also at a narrow trailing edge 18. The vane 10 is hollow, having an airfoil-shaped inner space 20 between the airfoil portions. Adjacent the trailing edge 18, the vane 10 has cooling passages 22 which communicate with the interior space 20. Such passages are clearly seen particularly in FIG. 2.

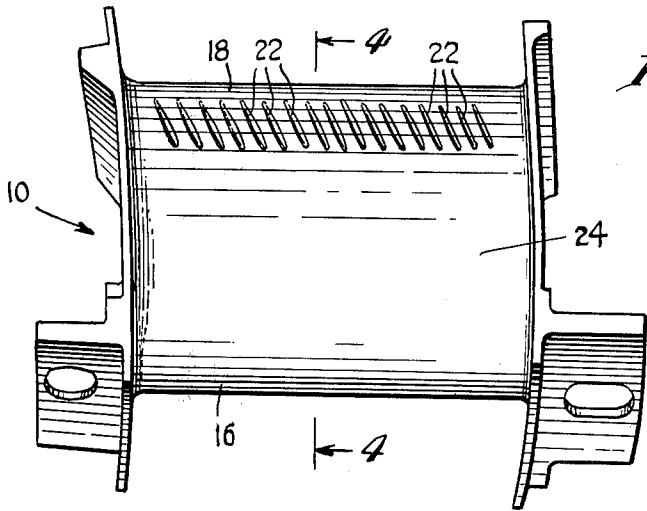
Fig. 2

FIG. 2 is an elevational view of the concave side of the vane.

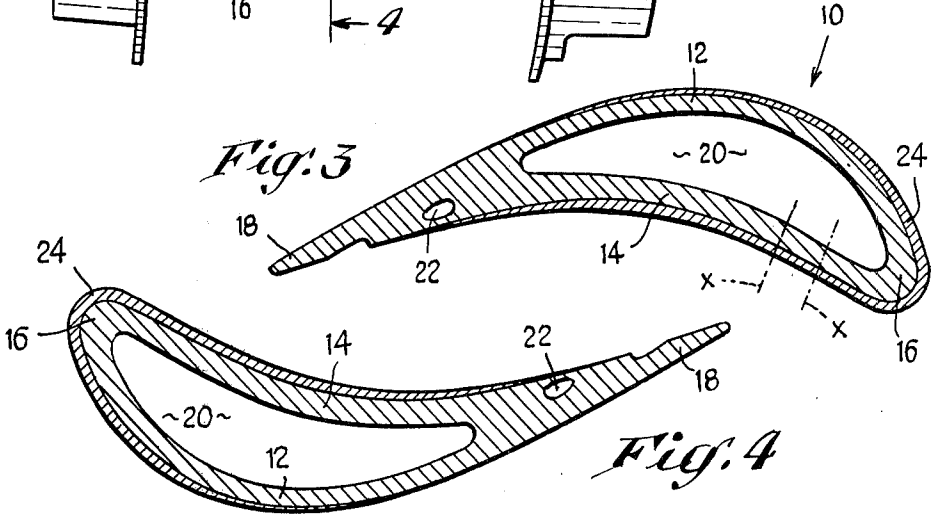
Fig. 3

FIG. 3 is a cross-section through the vane, taken on the line 3—3 of FIG. 1.

The vane 10 of FIGS. 1-4 has been refurbished according to the process by which the invention is carried out, and in FIGS. 3 and 4 the cross-sectional areas 24 designate overlay metal which has been added to the vane surfaces by a plasma spray process and thereafter refinished to conform to the original contours as specified for new vanes. The overlay metal of the areas 24 can be applied to build up a thickness of as much as 30 to 40 thousandths of an inch, and can be feathered as shown, as the overlay approaches the trailing edge 18 of the vane.

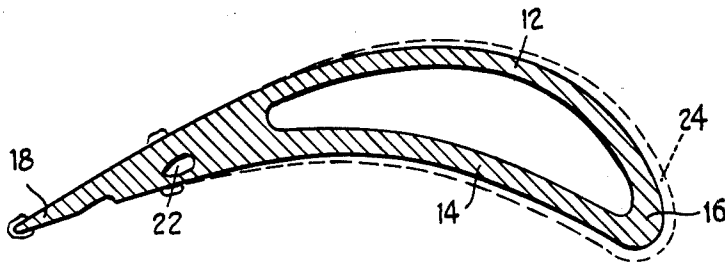
Fig. 8

FIG. 8 is a cross-section through the vane, taken on the line 8—8 of FIG. 6.

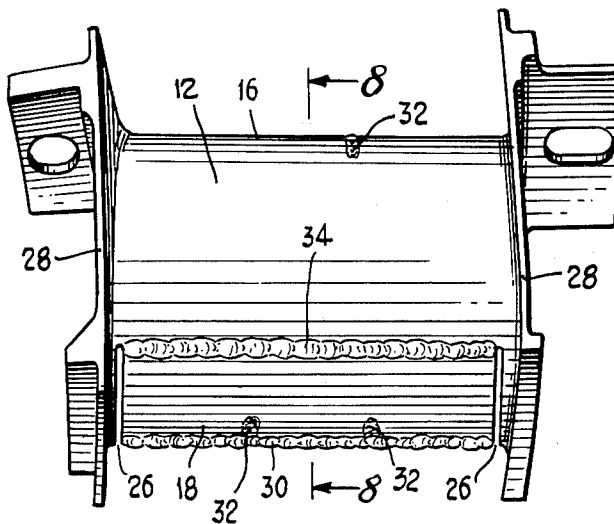
Fig. 6

FIG. 6 is an elevational view of the convex side of a worn vane. This view is similar to the showing of FIG. 1 but illustrates certain steps in the processing of the component.

Referring to FIG. 6, a vane to be refurbished according to the invention, as exemplified by one embodiment thereof, is cut to provide a pair of slits 26 adjacent the end flanges 28, said slits being made from the trailing edge 18 substantially parallel with the end flanges and for a distance roughly as shown in the figure. The slits 26 are made, where required, to relieve stresses caused by any unequal heating of the vane during the processing. After formation of any slits 26, a welded bead 30 can be applied to the trailing edge, in cases where the chordal distance (from the leading edge) has become shortened by wear. Also, welded repairs indicated as short beads 32 are made to the leading and trailing edges to fuse over any hairline cracks. A pair of beads 34, 36 (formed by welding worn areas of the convex and concave surfaces respectively) are provided in those instances where the vanes are badly worn, to reinforce the vane airfoil structure, such beads extending in

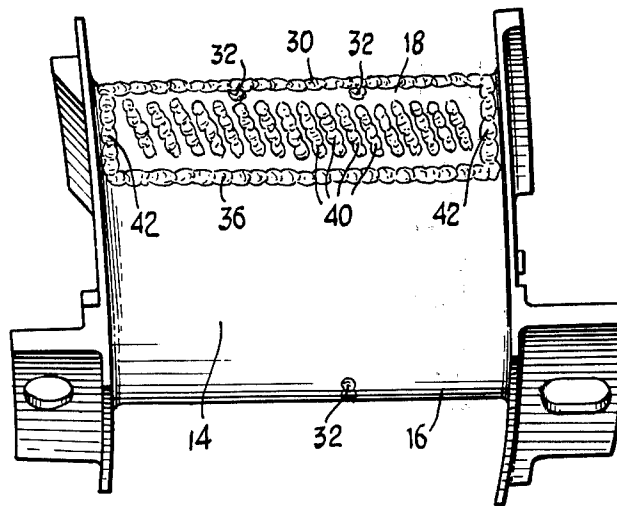
Fig. 7

FIG. 7 is an elevational view of the concave side of the vane of FIG. 6, showing other steps and welded beadments as incorporated on the vane prior to the plasma spraying.

Also, as seen in FIG. 7, any air cooling passages 22 of the vane are welded closed by beads 40. Finally, the slots 26 are welded closed by beads 42. Thereafter, following any surface processing that is employed, the airfoil surfaces are plasma sprayed to deposit a layer of alloy metal 24 indicated by the broken outline in FIG. 8. The layer 24 which is the built-up surfacing done by plasma spraying, can be as thick as from 30 to 40 thousandths of an inch, tapering to feathered edges as the trailing edge 18 of the vane is approached. Prior to the plasma spraying build-up, a surface processing of the vanes is carried out, in the form of a sand blast, or shot peen.

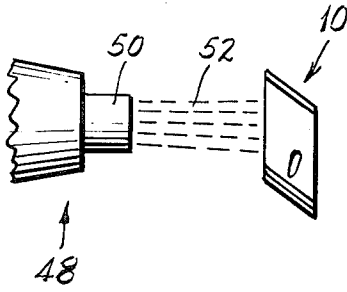
Fig. 9

FIG. 9 is a side elevational view of a plasma spray gun, shown applying a coat of molten metal to one surface of a turbine vane.

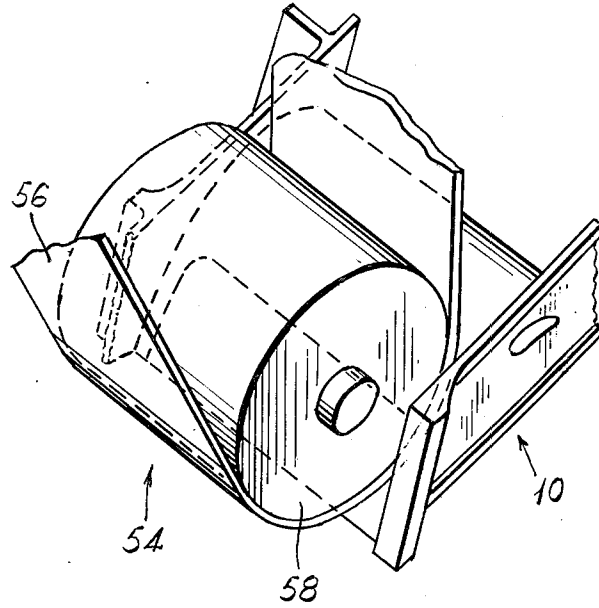
Fig. 10

FIG. 10 is a perspective fragmentary view of a grinding apparatus for removing controlled quantities of the built-up surface of the vane, to therefore restore the airfoil surface of the vane to its original dimensions.
