EP 1 967 693 A2

(54) **Splitter fairing repair**

[0001] The present invention relates to the repair of turbine engine components, and in particular but not exclusively to the repair of the front portion of a splitter fairing section located at the front of the low pressure compressor.

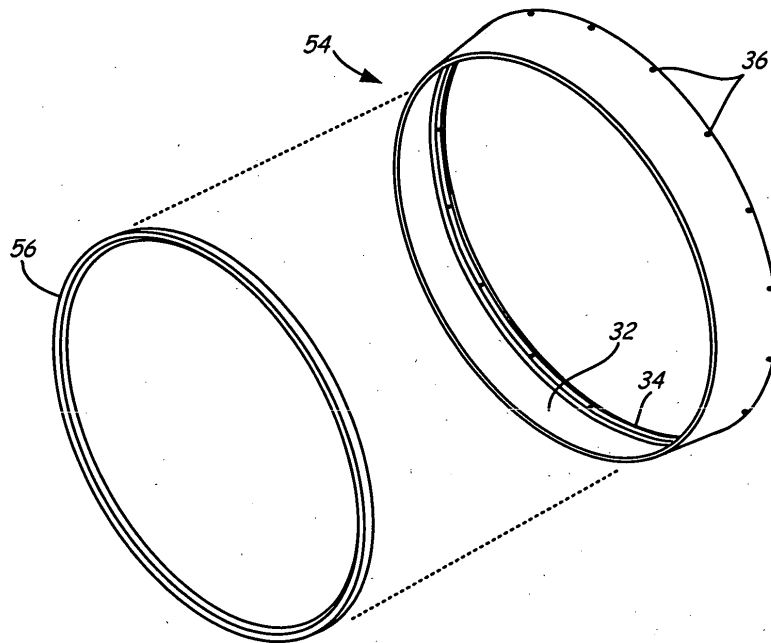
FIG. 4 is a perspective view of the splitter fairing with a front portion removed, along with a replacement ring.

[0014] FIG. 4 is a perspective view of the splitter fairing 26 with the forward portion 30 removed, leaving an original portion 54, which contains the majority of body 32 and aft portion 34 with the apertures 36. Also illustrated is a replacement ring 56. Replacement ring 56 is constructed from the same or similar material as the original portion 54, such as AL 6061. Replacement ring may be a forged part.

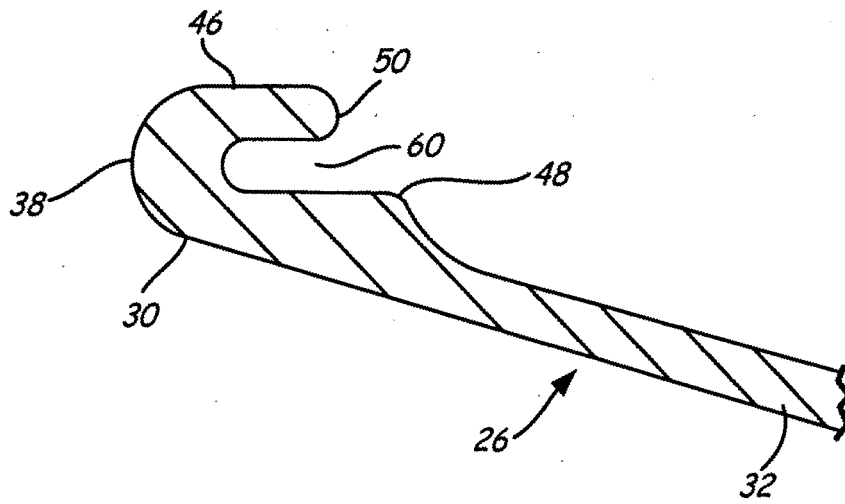
FIG. 6 is a cross-sectional view of the repaired portion of the splitter fairing ring.

[0016] FIG. 6 is a cross-sectional view of a repaired forward portion 30 of the splitter fairing 26. Replacement ring 56 has been machined down to obtain the original dimensions for the forward portion 30, including the inner flange 46 and outer edge 48. The machining also creates a channel 60 which allows for the attachment of low pressure compressor components to the splitter fairing 26. Inner flange 46 contains a round fillet on aft edge 50, which promotes fluid flow past the surface.

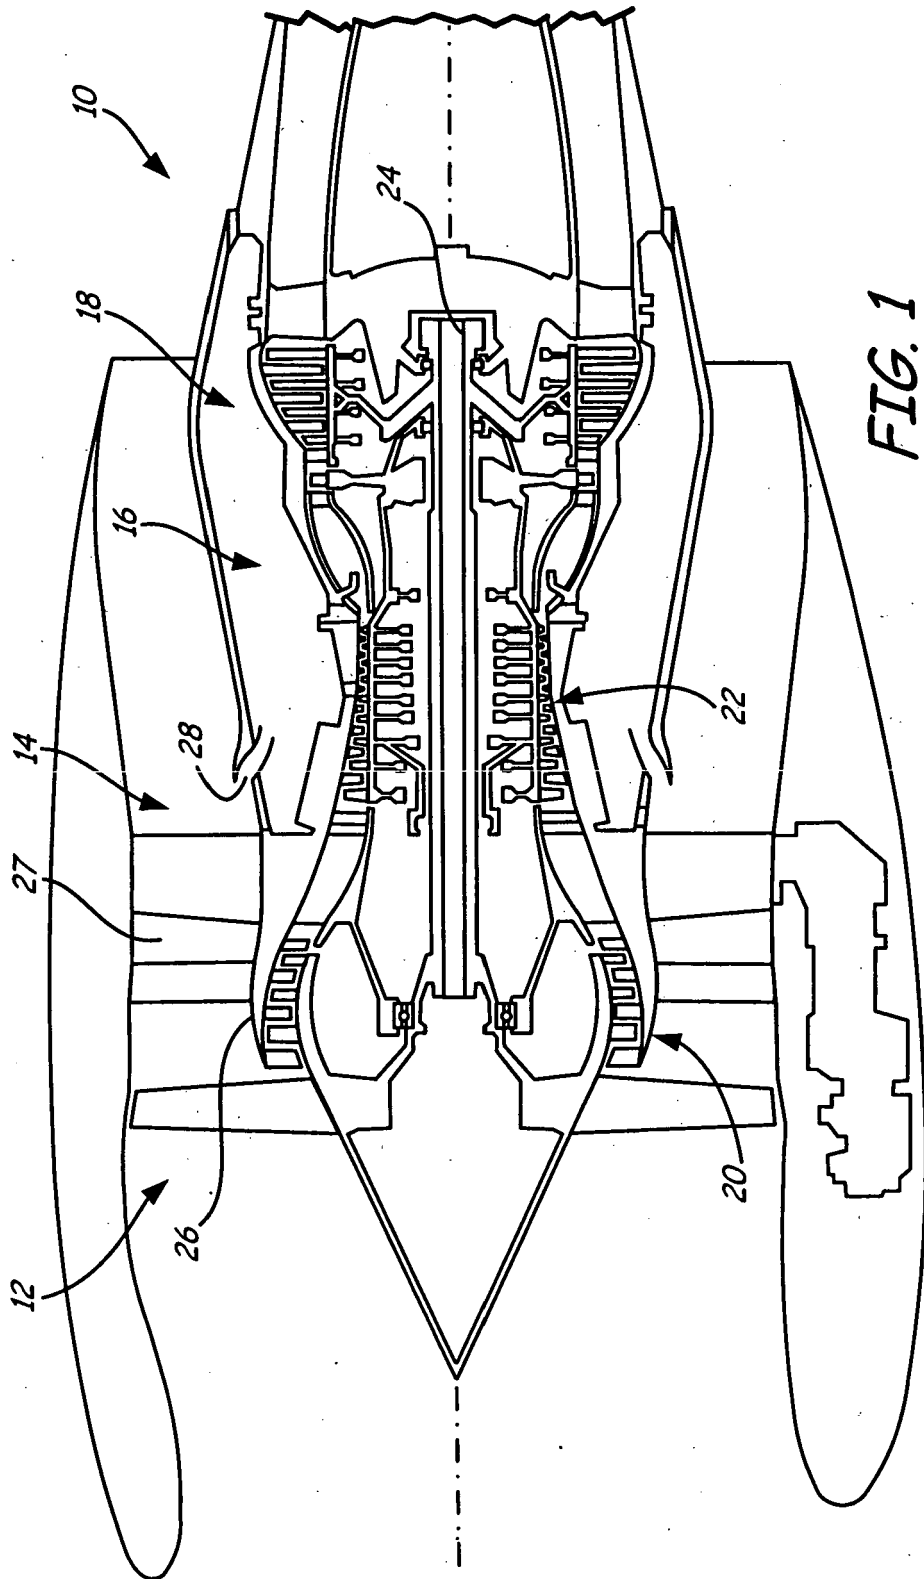
FIG. 1 is a cross-sectional view of a gas turbine engine.

[0007] FIG. 1 is a cross-sectional view of a gas turbine engine 10. Engine 10 has an inlet fan 12, a compressor section 14, a combustion section 16, and a turbine section 18. Compressor section 14 has a low pressure compressor 20 and a high pressure compressor 22. Air is taken in through fan inlet 12 and a portion is directed to the compressor section 14. The air is then compressed by a series of rotating blades and static vanes in the compressor section. The compressed air is mixed with fuel, and then ignited in the combustion section 16. The combustion exhaust is then directed towards the turbine section 18, which is also comprised of blades and vanes. The blades extract kinetic energy from the exhaust to turn a shaft 24, which provides power output for the engine.

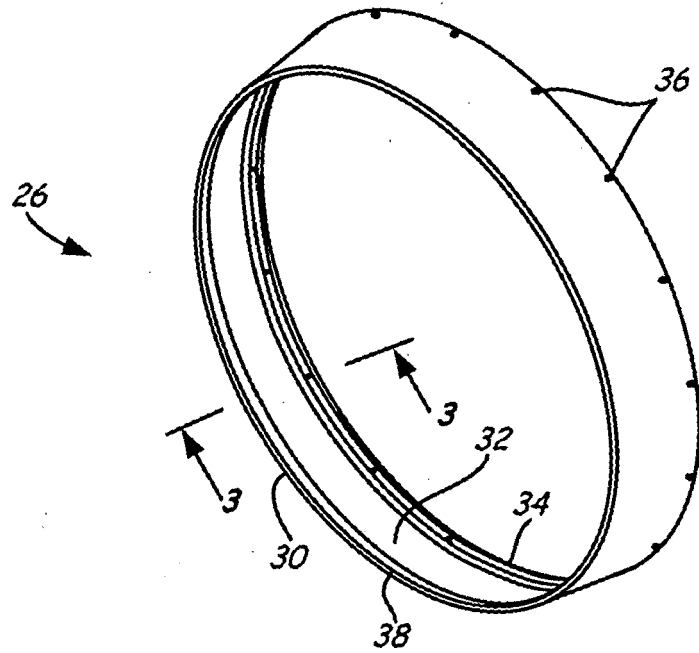
FIG. 2 is a perspective view of a splitter fairing of a turbine engine.

[0009] FIG. 2 is a perspective view of splitter fairing 26 of a turbine engine 10. Splitter fairing 26 is generally cylindrical or frustaconical in shape and includes a forward portion 30, a body 32, and an aft portion 34 containing several apertures 36. Splitter fairing 26 is typically constructed from aluminum or similar light weight metal, including AL 6061. Splitter fairing 26 is a forged component of turbine engine 10; forging assures structural strength for the part. Splitter fairing 26 operates in an environment of minimally enhanced temperatures, typically operating at just slightly above ambient temperature.

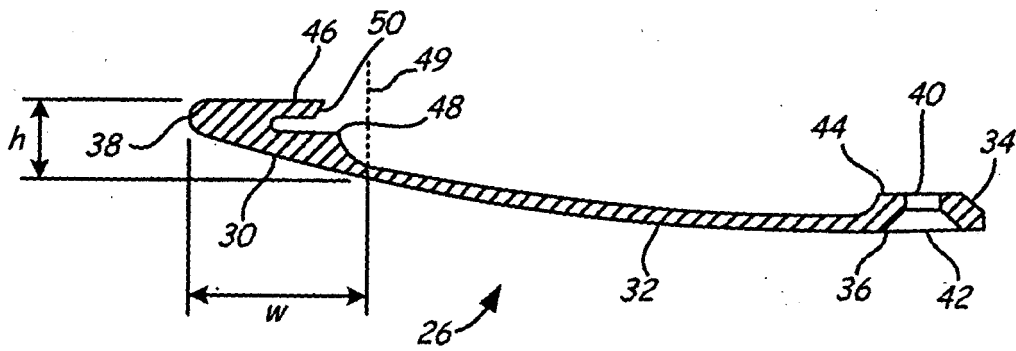
FIG. 3 is a cross-sectional view of the splitter fairing taken along line 3-3 illustrated in FIG. 2.

[0011] FIG. 3 is a cross-sectional view of splitter fairing 26 taken along line 3-3 illustrated in FIG. 2. In this view, the aft portion 34 is illustrated as being thicker than the adjacent body 32. The additional thickness provides support for the apertures 36. Aperture 36 contains a hole 40 and a countersink 42. Countersink 42 allows for placing a fastener into the aperture 36 while keeping a flush surface along the splitter fairing 26. A smooth surface promotes fluid flow through the bypass duct 27. Aft portion 34 also contains an inner surface 44 perpendicular to the hole 40.

removed by machining or a similar process. Measurements are taken and recorded for the average wall thickness, inner diameter, and overall axial height to cut-off. Material removal is kept to a minimum. The cut plane location illustrated in FIG. 3 is placed to accommodate a second section replacement, should one be necessary in the future.

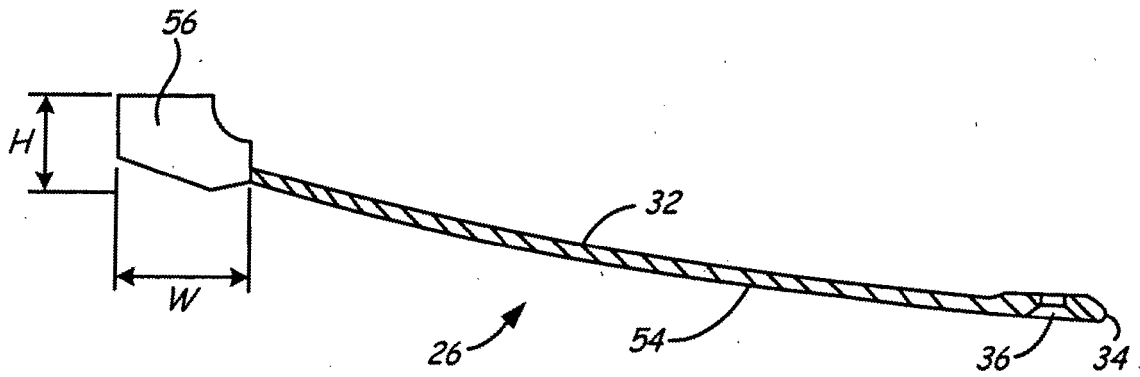
FIG. 5 is a cross-sectional view of the remaining portion of the front splitter fairing joined to the replacement ring.
