- [54] FIELD REPAIR ROOF PANEL FOR A RAILWAY CAR
- [75] Inventors: Richard C. Snyder, Michigan City, Ind.; Donald C. Bodinger, Pelham, Ala.
- [73] Assignee: Pullman Incorporated, Chicago, Ill.
- [21] Appl. No.: 958,084
- [22] Filed: Nov. 6, 1978
- [51] Int. Cl.³ E04G 23/02; B61D 17/12
- [52] U.S. Cl. 52/514; 52/45; 52/529; 52/741
- [58] Field of Search 52/45, 55, 514, 470, 52/468, 537, 529, 464, 741

FIELD REPAIR ROOF PANEL FOR A RAILWAY CAR

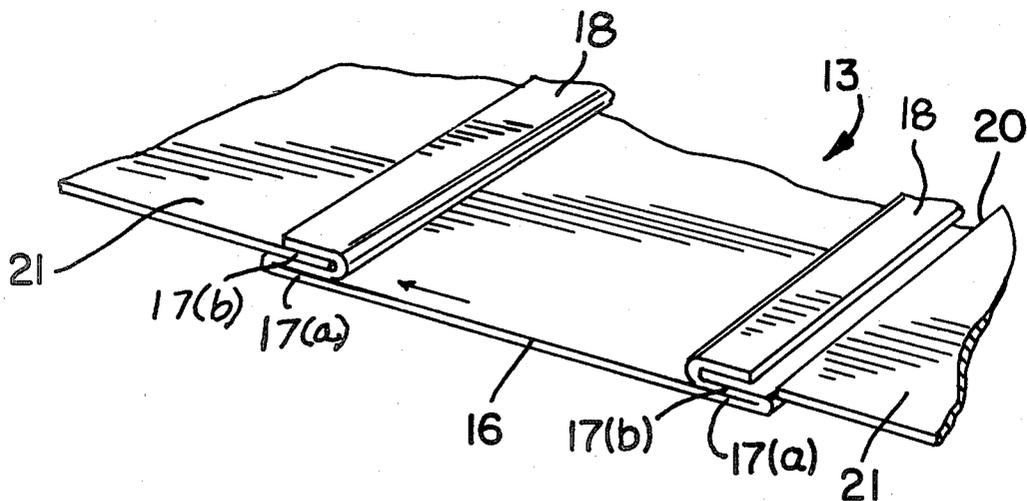
FIG. 1 is a top plan view of a portion of a railway car roof with a damaged section;

FIG. 1 shows a portion of a railway car roof, generally designated 10, having longitudinally extending side plates 11 and a damaged portion 12 which must be repaired. As best shown in FIG. 3 the repair or replacement panel 13 has a pair of lateral end portions 14 and a

The damaged section 12 of the roof 10 is cut away having a generally rectangular opening in the roof formed by the margins 20 of the roof sheet and the side plates 11. As best shown in FIGS. 4 and 5, the repair panel 13 is placed in the opening and the bottom flange 17 of the first end portion is shoved under one margin 21 of the existing roof sheet. The roof sheet 21 is then nested between the top 18 and bottom 17 flanges of the first end portion. As shown in FIG. 5 the repair panel 13 is then pulled back positioning the bottom flange 17 of the second end portion 14 under the other margin 21 of the existing roof sheet. Once it is in position the repair sheet is then welded to the existing edges of the roof and to the side plates.

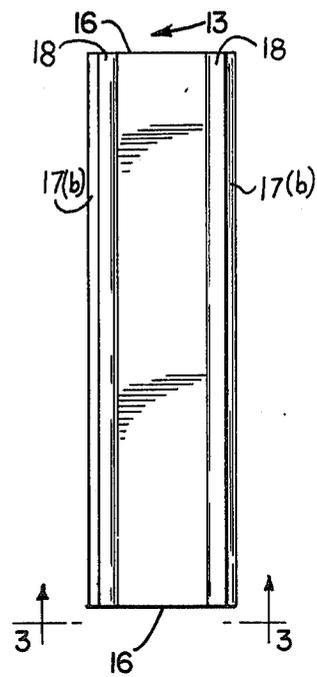
FIG. 3 is a side view of the repair sheet taken along line 3—3 of FIG. 2;

middle or central portion 15. The repair panel also has longitudinally extending edges 16.

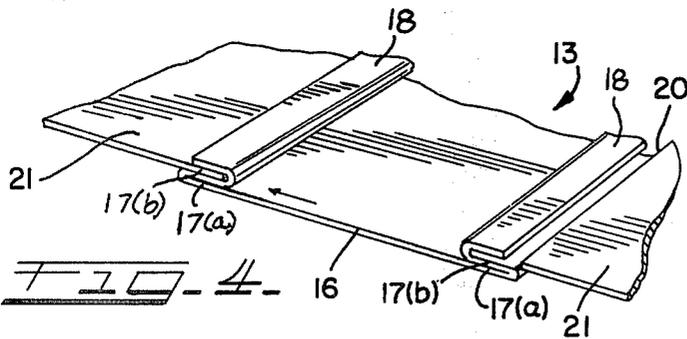
FIG. 4 is a fragmentary perspective view of the repair sheet partially installed;

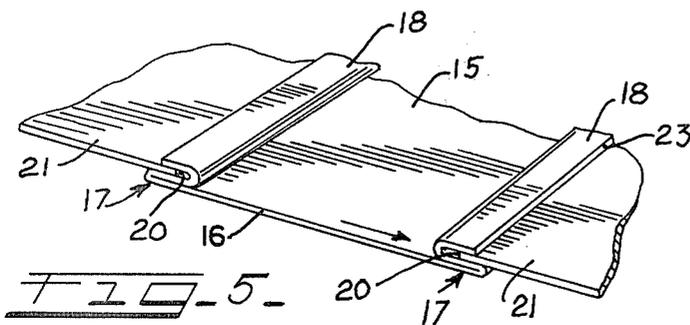
FIG. 5 is a fragmentary perspective view of the roof sheet in the fully installed position;

As best shown in FIG. 5, in the installed position the margins 20 of the roof are nested in the slots 19 formed by the top and bottom flanges, 18 and 17 respectively, of the repair panel 13. The top flanges 18 are then welded to the existing roof sheets 21 along their free edges 23 and the longitudinally extending edges 16 of the repair panel are welded to the side plates 11. The double thickness of the bottom flanges 18 rigidifies the structure and the welding provides for a water-tight connection.

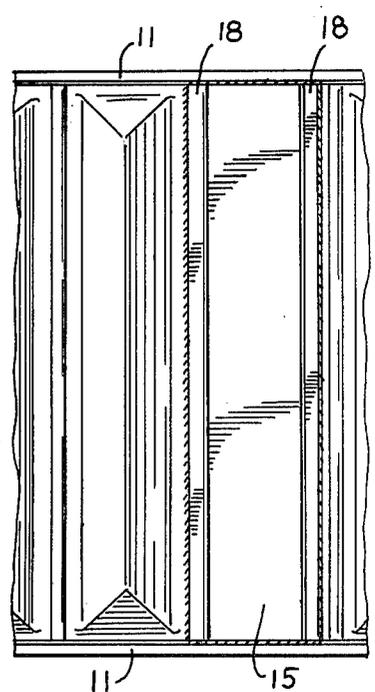
FIG. 6 is a top plan view of the repair sheet welded in place.
