(54) **IN-SITU TURBINE BLADE TIP REPAIR**

(57) **ABSTRACT**
The tip portion of a blade of a gas turbine is repaired in-situ in the gas turbine without removing the blade from the turbine rotor disk. To facilitate the in-situ repair of the tip portion of the turbine blades, one or more access holes may be provided in the turbine shroud or blade outer air seal circumscribing the plurality of turbine blades extending radially outward from the turbine rotor disk.

IN-SITU TURBINE BLADE TIP REPAIR

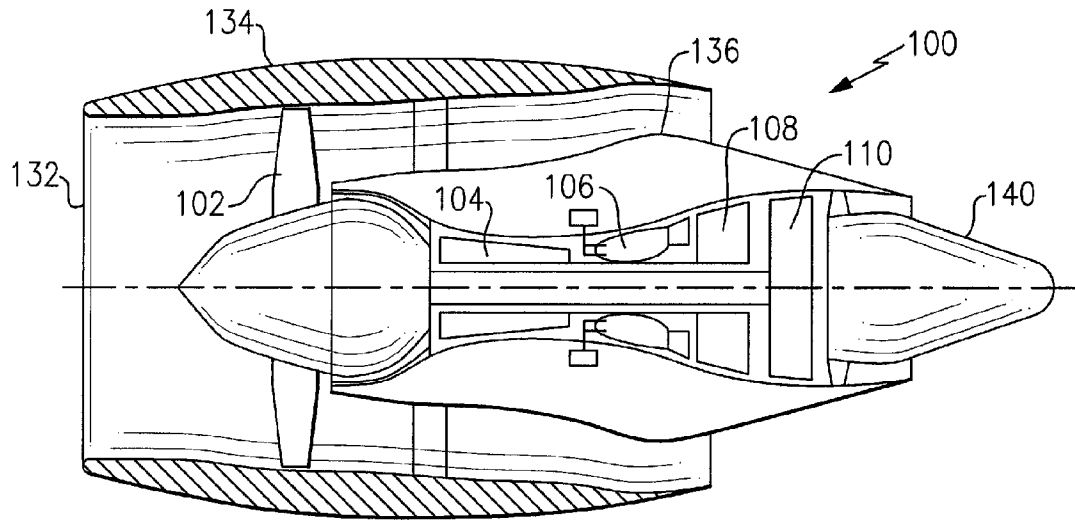
FIG. 1 is a schematic view of a longitudinal section of an exemplary embodiment of a turbofan gas turbine engine;

Referring now in FIG. 1, there is shown an exemplary embodiment of a turbofan gas turbine engine, designated generally as 100, that includes a turbine having rotating blades that could be repaired when the tips thereof are eroded by use of the method for repairing a turbine blade as disclosed herein. The turbofan gas turbine engine 100 includes, from fore-to-aft, a fan 102, a compressor module 104, a combustor module 106, a high pressure turbine module 108, a low pressure turbine module 110 and an exhaust nozzle. A nacelle forms a housing or wrap that surrounds the gas turbine engine 100 to provide an aerodynamic housing about gas turbine

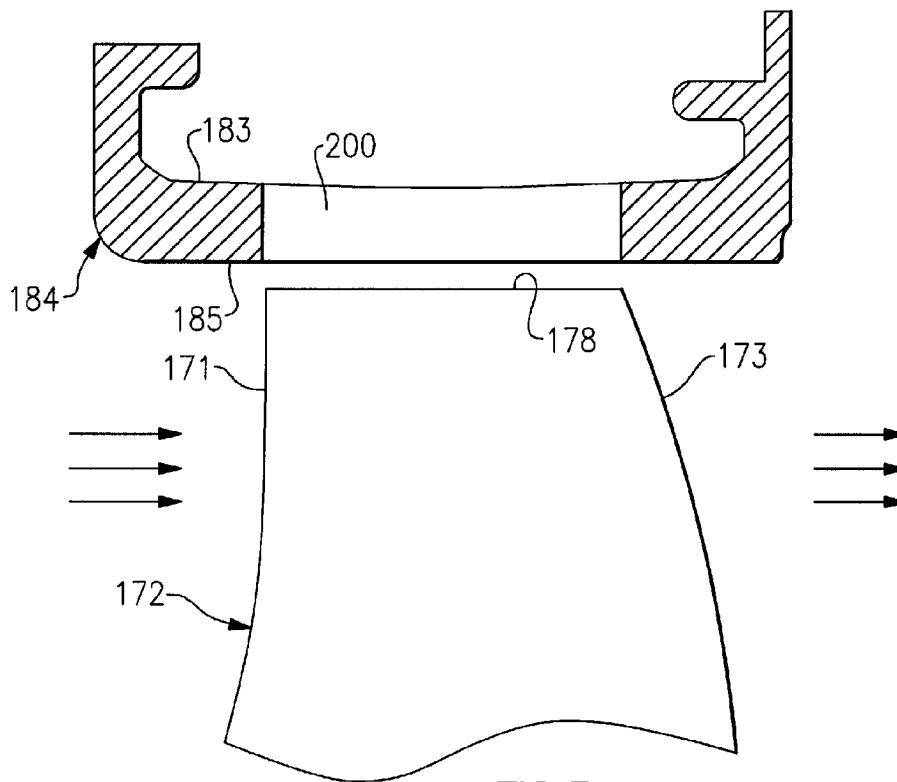
FIG. 3 is an enlarged view of the area of interface between the blade outer air seal and the tip of the turbine blade of FIG. 2;

Referring now to FIGS. 3 and 4 in particular, in the embodiment of the blade outer air seal depicted therein, the blade outer air seal includes a single access hole 200 for providing access to the tip 178 of a turbine blade 172 when parked therebeneath. The single access hole 200 passes generally radially through the blade outer air seal segment 184 from the back surface 183 to the facing surface 185 and is sized large enough to permit access to the entire tip 178 of the blade 172 for repairing the tip 178. The single access hole 200 may, as illustrated in the particular exemplary embodiment depicted in FIG. 4, be shaped in the form of an airfoil commensurate with the shape of the tips 178 of the turbine blades 172 in an originally pre-erosion form.

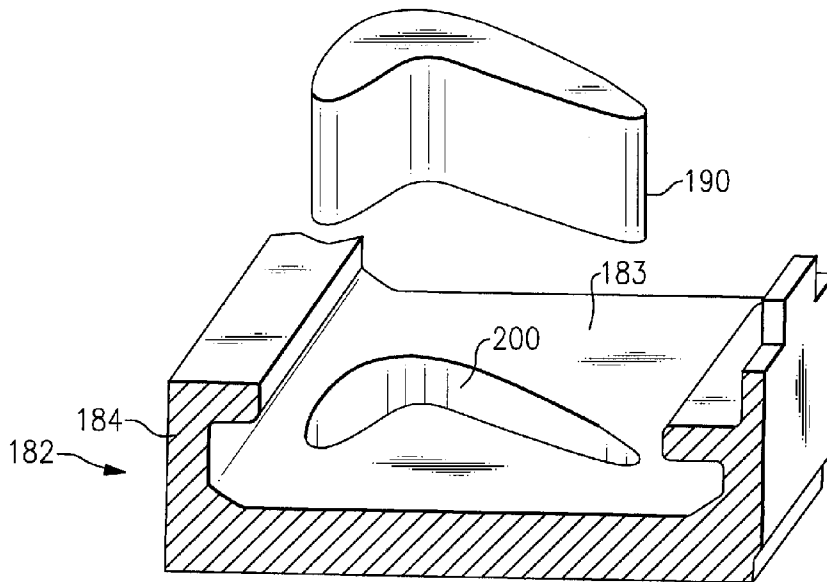
FIG. 4 is a perspective view of an exemplary embodiment of a blade outer air seal segment having a single access hole opening through the blade outer air seal;

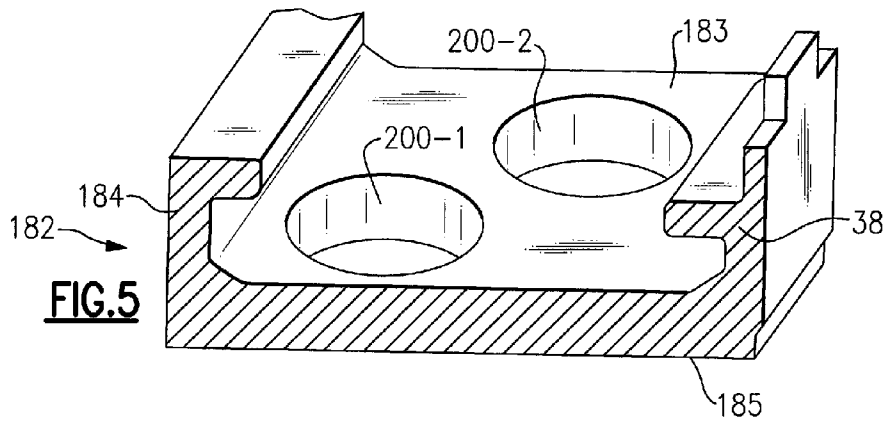
FIG. 5 is a perspective view of an exemplary embodiment of a blade outer air seal segment having a pair of access holes opening through the blade outer air seal; and

In the embodiment depicted in FIG. 5, the blade outer air seal 182 includes a first access hole 200-1 and a second access hole 200-2. Both of the access holes 200-1, 200-2 extend through the blade outer air seal 182 from the back side 183 of the blade outer air seal to the facing surface 185 of the blade outer air seal. The second access hole 200-2 is spaced circumferentially away from the first access hole 200-1. The first access hole 200-1 located is in the blade outer air seal 182 so as to provide access to at least a leading portion of the tip 178 of the blade 172 to be repaired and the second access hole 200-2 is located to provide access to at least a trailing portion of the tip 178 of the blade 172 to be repaired. Together, the first and second access holes 200-1, 200-2 provide access to the entire tip 178 of each of the turbine blades 172 that need repair.

In the embodiment depicted in FIG. 5, the first access hole 200-1 and the second access hole 200-2 extend through a single blade outer air seal segment 184 of the blade outer air seal 182. However, it is to be understood that the first and second access holes may, if desired, be located in separate blade outer air seal segments that are circumferentially adjacent or even spaced circumferentially apart by at least one intervening blade outer air seal segment not having an access hole therein. Additionally, the method for in-situ blade tip repair disclosed herein may be applied through the use of more than one blade outer air seal segment having a single

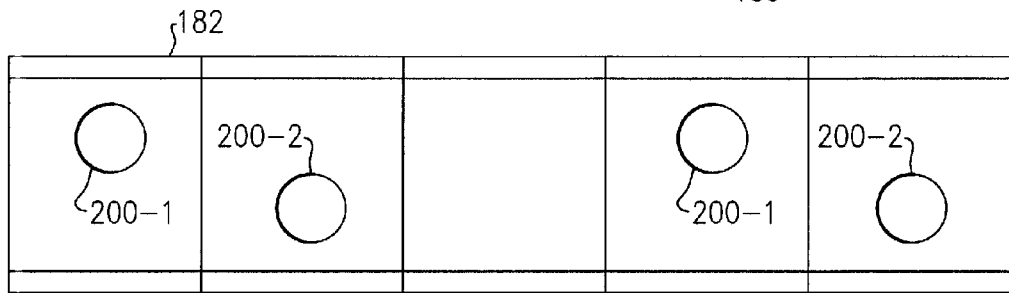
FIG. 6 is a plan view of an exemplary embodiment of a blade outer air seal having a plurality of access holes located over a span of blade outer air seal segments.

access hole 200, or through the use of two or more pairs of axially spaced first and second access holes 200-1, 200-2 located over a span of circumferentially spaced blade outer air seals segments, such as for example depicted in FIG. 6. In any multiple access hole scenario, the turbine rotor disk 174 may be selectively rotated to pass the tip portion 178 of each blade of the plurality of blades 172 in juxtaposition with an access hole or sequence of access holes, as appropriate.
