(10) **Patent No.:** **US 9,512,724 B2**
(45) **Date of Patent:** **Dec. 6, 2016**

(54) **METHOD FOR REPAIRING WEAR MARKS ON A ROTOR SUPPORTING THE FAN OF A BYPASS ENGINE**

(71) Applicant: **SNECMA**, Paris (FR)

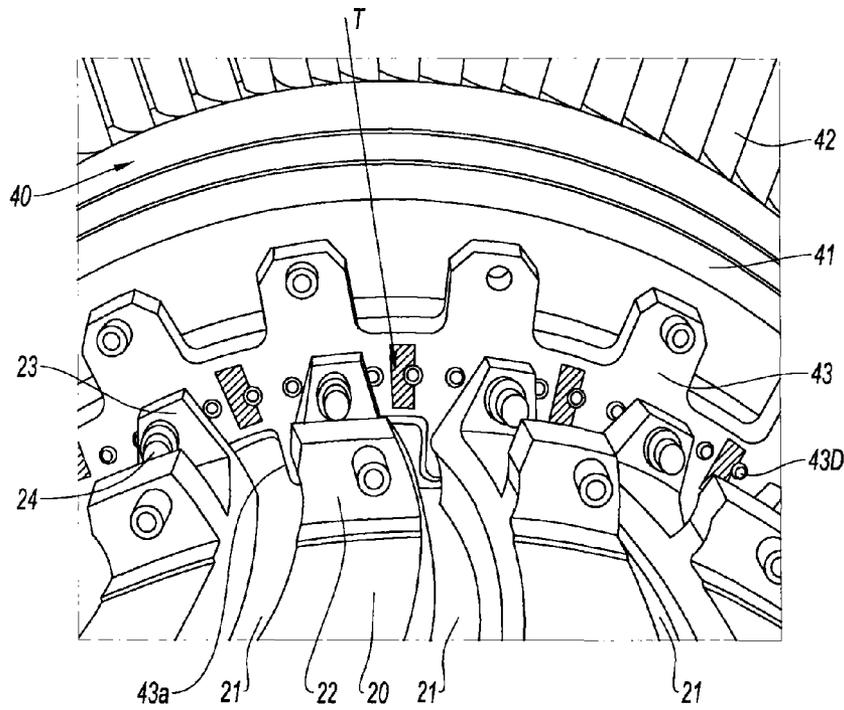
Fig. 2

FIG. 2 shows, in perspective, the details of a rotor of the fan of a jet engine on the side of the upstream flange of the boost compressor;

FIG. 2 shows, in perspective and seen from upstream, the inside of this region in which, for the sake of clarity, the fan blades have been omitted.

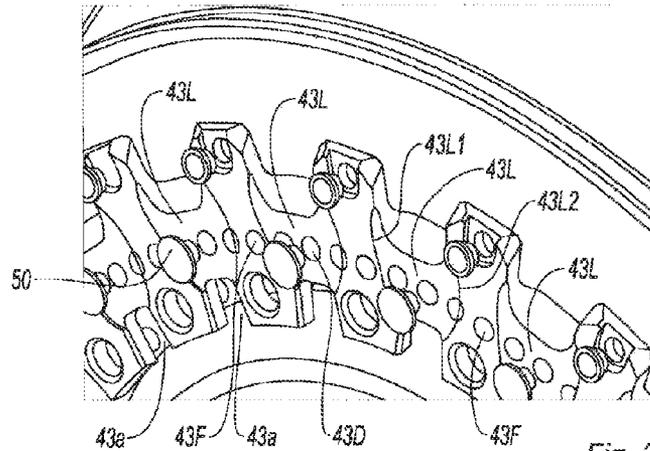
Fig. 3

FIG. 3 shows, in perspective, the upstream flange of the drum of the compressor with spot facing regions;

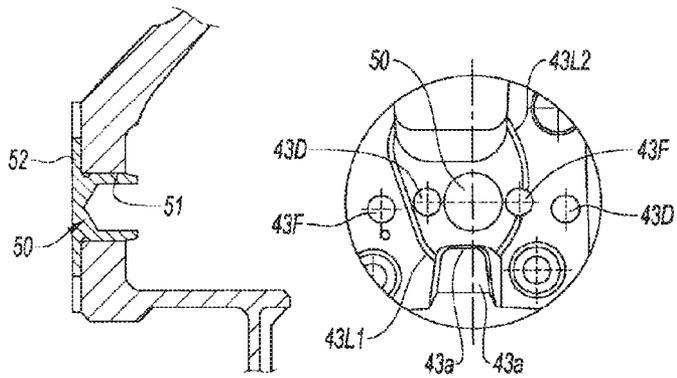
Fig. 4

FIG. 4 shows the flange front on and, in section, the anti-wear peg fitted in a stress-relief hole;

There follows a description of the repair method of the invention. This involves machining an optimized spot face 43L in the region of each wear mark T, see FIG. 4. This spot face 43L is defined by its circumferential extent between two radial borders 43L1 and 43L2, its radial extent and its depth. Once the spot faces have been created, the surface of the flange 43 is reconstituted by putting in place anti-wear pegs 50 in the stress-relief openings 43D opposite the slots of the disk 20. These anti-wear pegs have a stem 51 which is accommodated in the corresponding hole and a collar 52 which presses against the base of the spot face 43L.

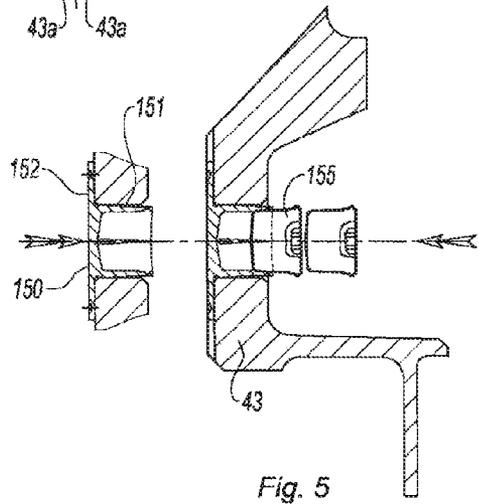
Fig. 5

FIG. 5 shows a variant embodiment of the fitting of the anti-wear pegs with and without male locking element.

FIG. 5, for example, shows a solution for fitting a peg 150 with a stem 151 and a collar 152 which comprises a male element 155 which is placed in the stem by being introduced on the side opposite the collar. The stem is split in the longitudinal direction such that it can stretch in the radial direction. Once in place in the hole, the male element, which is slightly frustoconical, is guided axially in the stem which induces radial forces on the walls of the stem of the peg. Guidance can be obtained by screwing or by force-fitting.
