(54) **FIBER COMPOSITE SYSTEM AND METHOD FOR PIPE REINFORCEMENT**

(57) **ABSTRACT**
A reinforced pipe and a method of preparing the reinforced pipe are provided. The reinforced pipe has repair area where a wrinkle bend is present in a center section of the repair area. The reinforced pipe comprises a unidirectional fabric circumferentially wrapped around the repair area of the pipe so as to result in multiple layers of the unidirectional fabric around the repair area. The unidirectional fabric is composed of high-performance fibers with at least 90% of the high-performance fibers oriented in the 90° direction, and the unidirectional fabric is wrapped such that the high-performance fibers run in the axial direction. The reinforced pipe further comprises a bidirectional fabric wrapped of over the unidirectional fabric such the at least one layer of bidirectional fabric is wrapped over the unidirectional fabric.

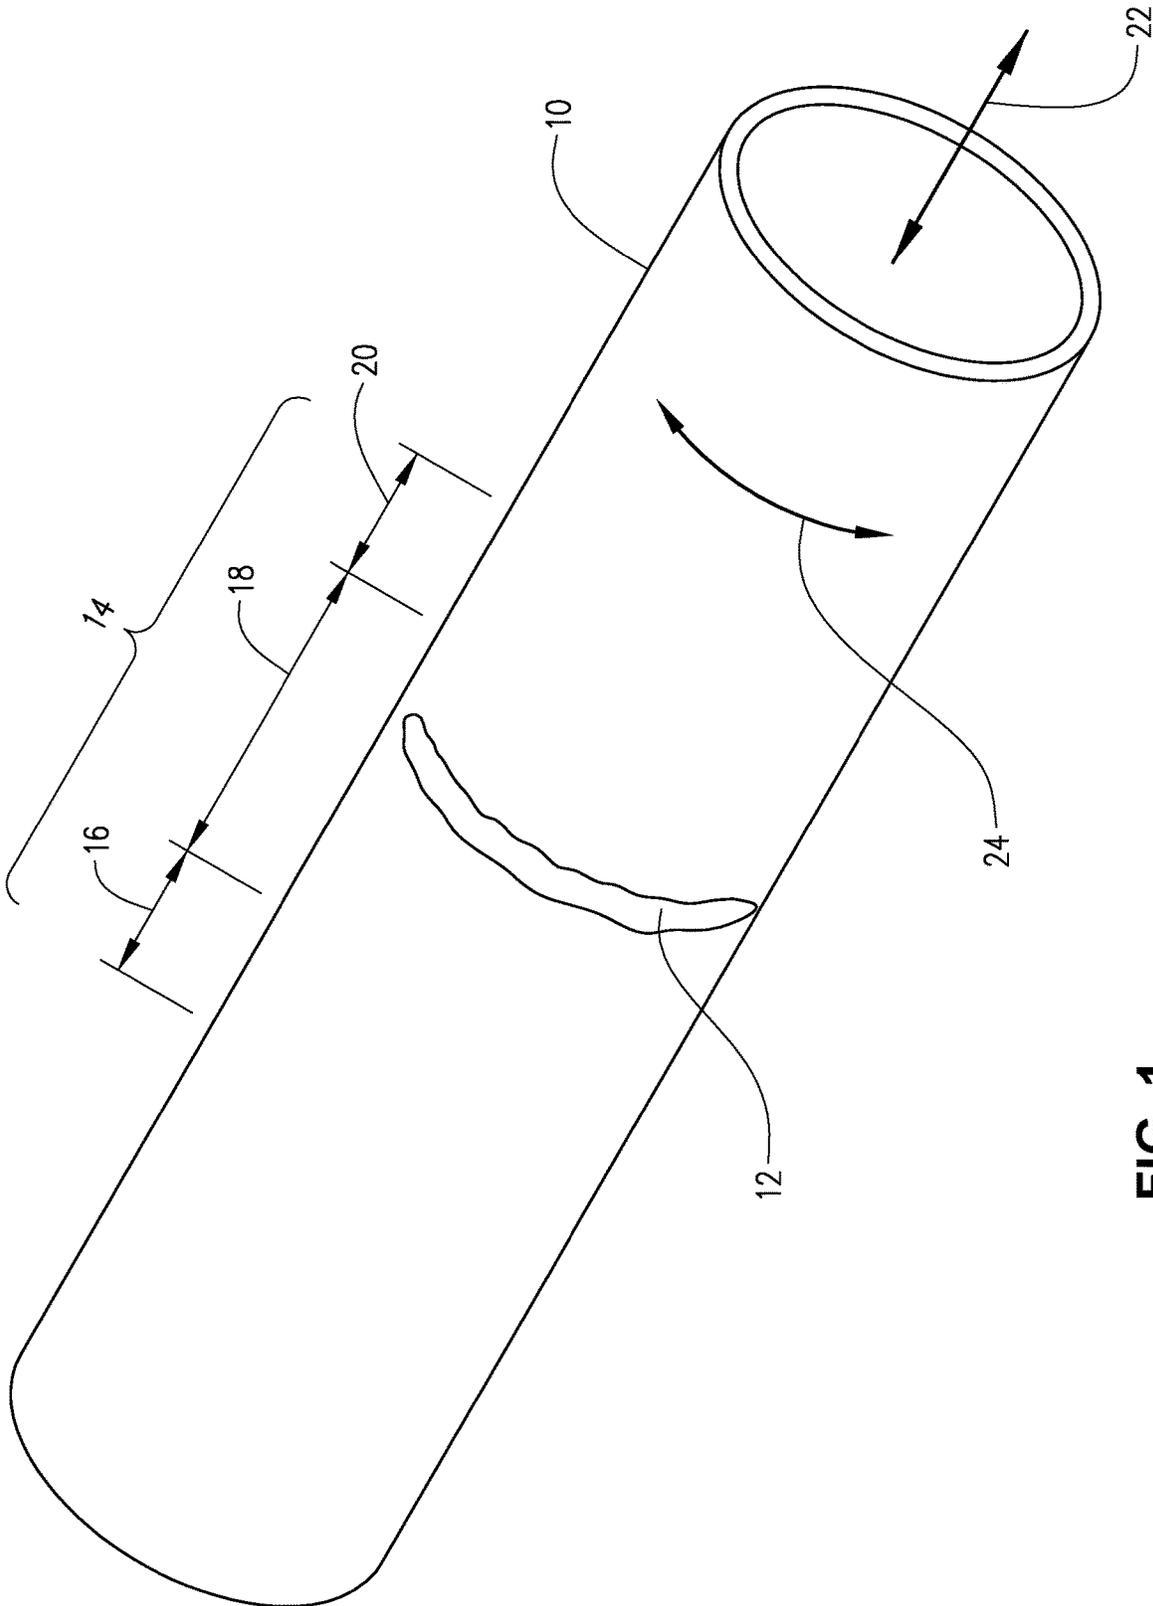
FIG. 1 is a perspective view illustrating a pipe having a wrinkle bend.

Referring now to FIG. 1, a pipe 10 is illustrated. Pipe 10 is a pipe having a wrinkle bend 12. Typically, pipe 10 will be a metal pipe, such as steel, aluminum, etc. More typically, pipe 10 is a steel pipe. Wrinkle bend 12 is the type that is introduced in a pipe during construction during alignment of the pipe by bending. Wrinkle bend 12 runs circumferentially along pipe 10. A repair area 14 is defined around wrinkle bend 12. The repair area has a left section 16, a center section 18 and a right section 20. Center section 18 is between left section 16 and right section 20, and center section 18 contains wrinkle bend 12. Pipe 10 has an axial direction (or longitudinal direction) 22 and a circumferential direction 24. As previously indicated, wrinkle bend 12 is oriented in the circumferential direction.

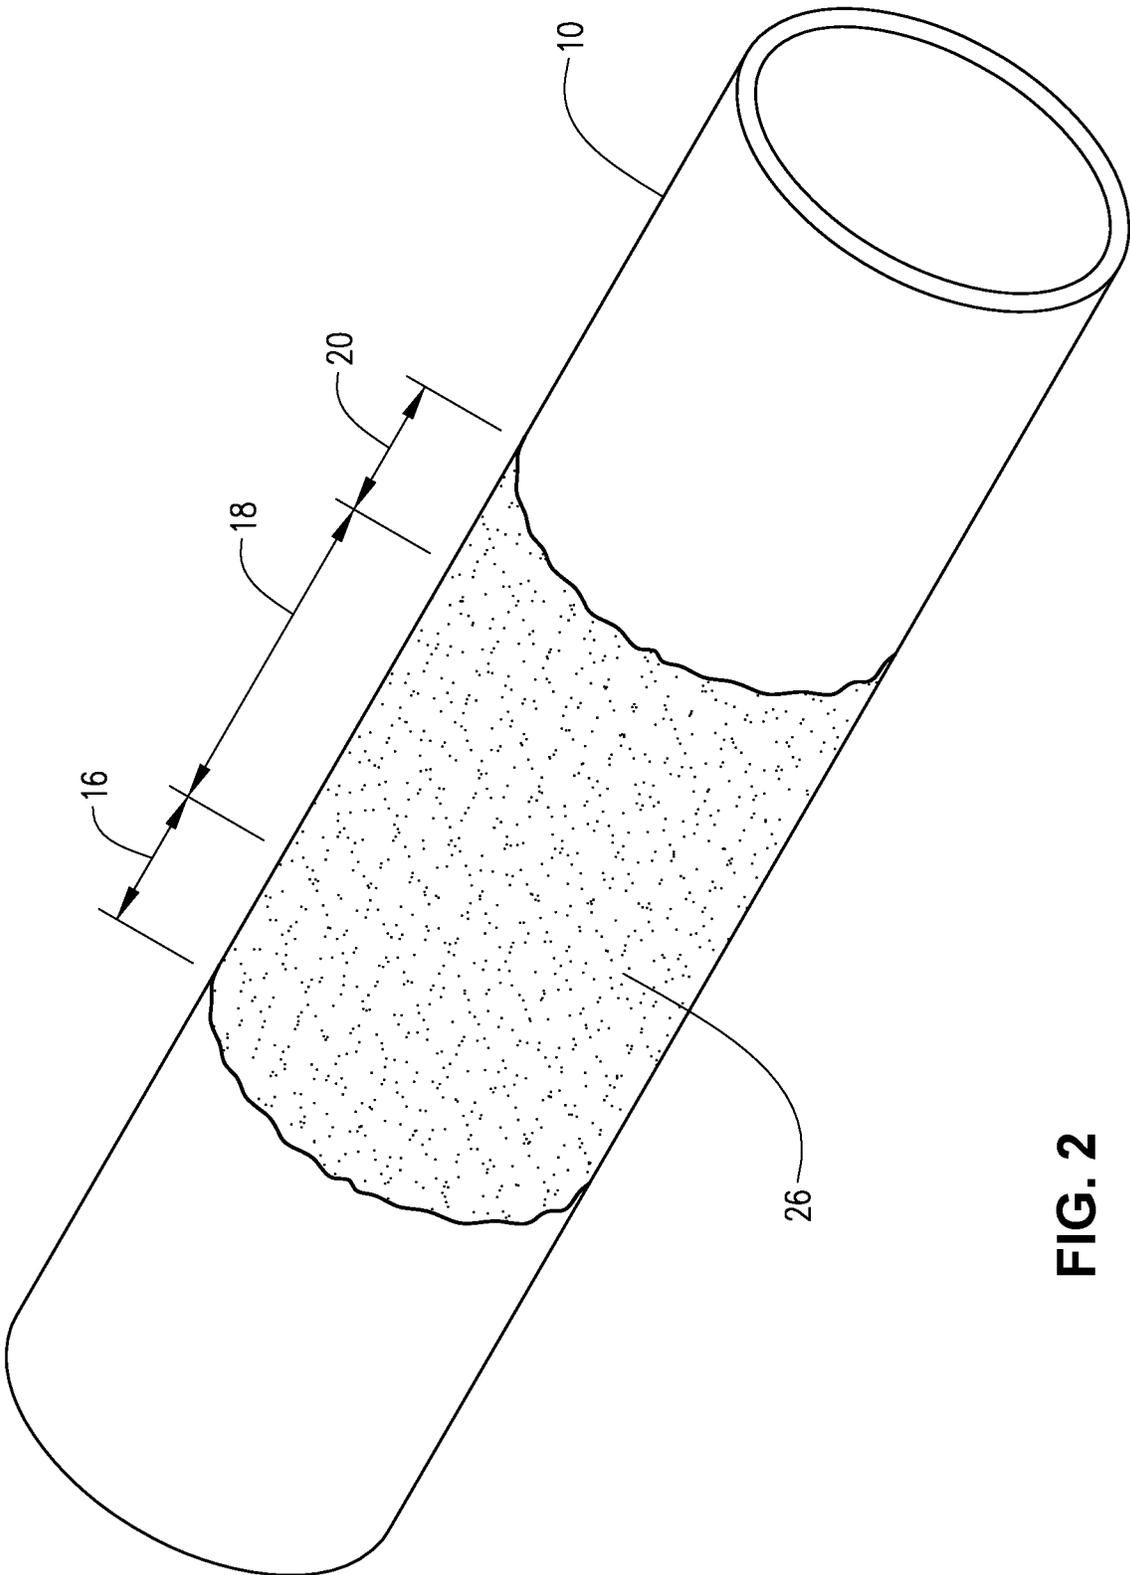
FIG. 2 is a perspective view of the pipe of FIG. 1 with a resin coating on the repair area.

Turning now to FIG. 2, the first layer to be deposited on pipe 10 typically will be a load transfer material 26 to even out the surface of the repair area and fill in any gaps or voids in the surface, such as dents, gouges and/or cracks. The load transfer material typically is tested for compressive strength and modulus, and additionally for compatibility with the composite system being applied to the pipe 10. While generic load transfer materials are often unsuitable for use in this application, the load transfer material generally can be any suitable putty such as epoxy putties designed for making fast and curable repairs to metals, or ceramic load transfer fillers. Load transfer material 26 is applied to center section 18, in the location of the wrinkle bend, and in localized areas within repair section 14 where any other defects may exist.

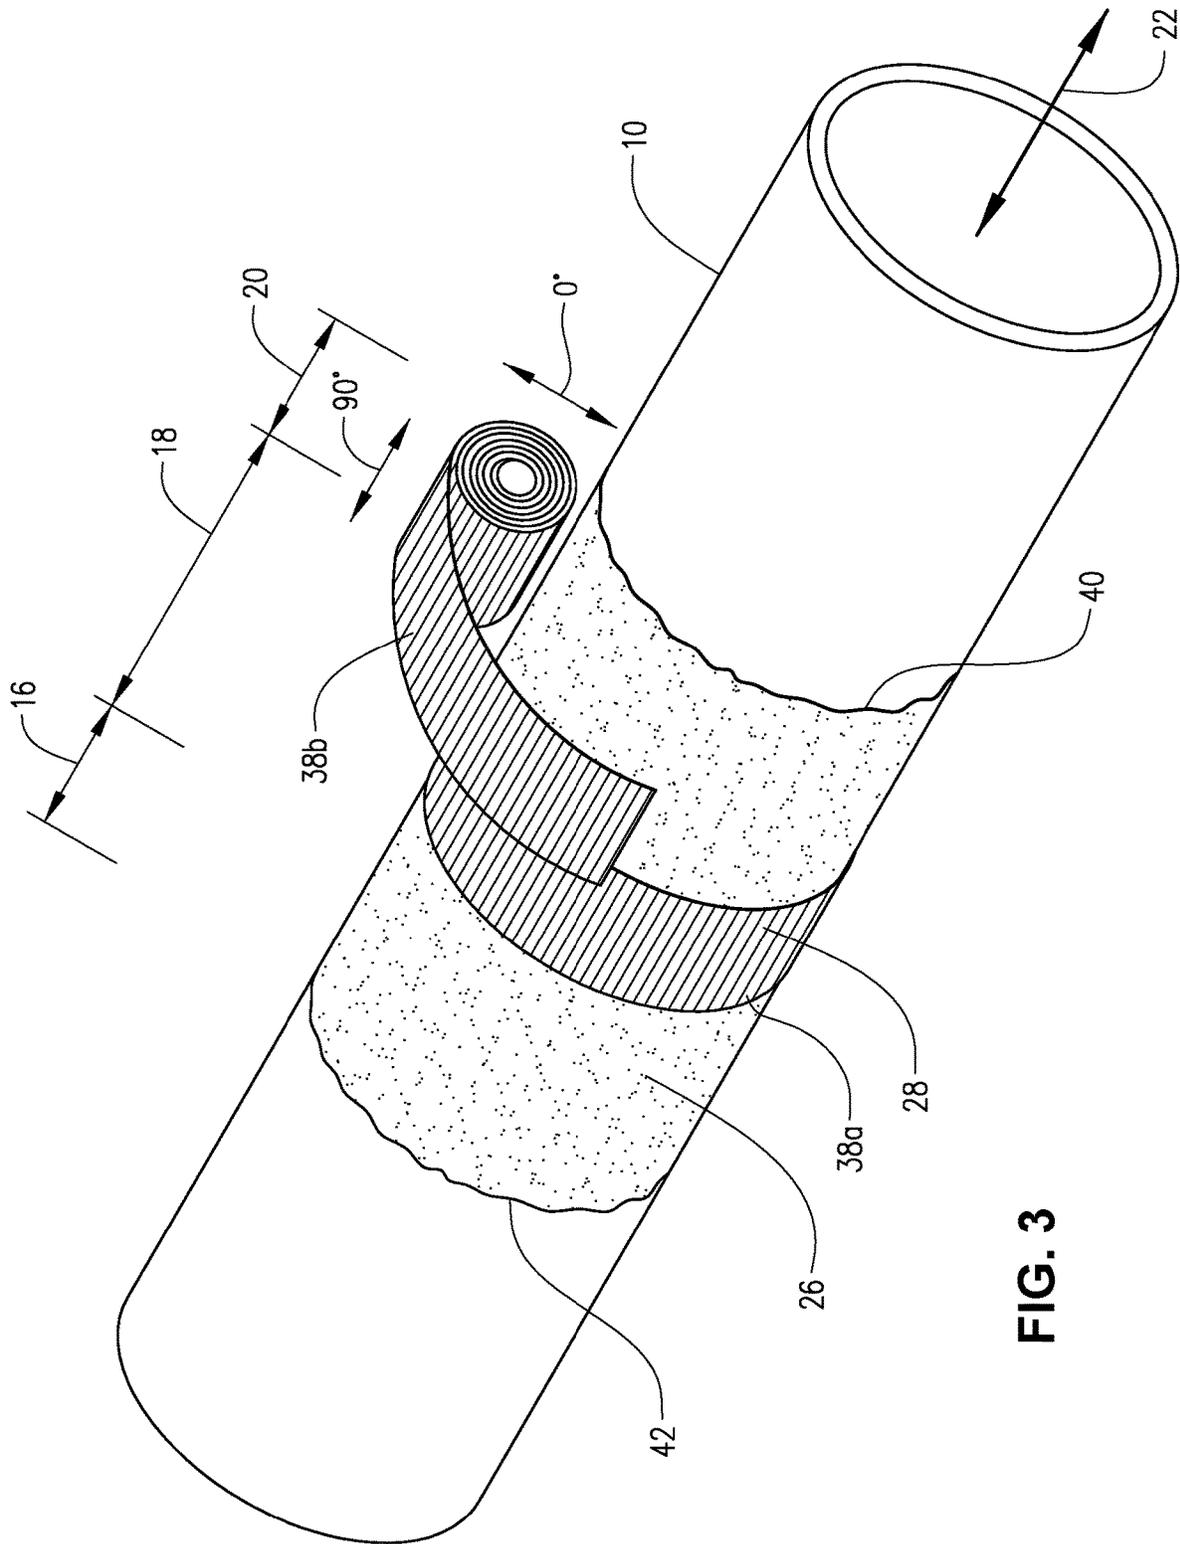
FIG. 3 is a perspective view of the pipe of FIG. 2 illustrating the application of a unidirectional fabric to the repair area.

As illustrated in FIGS. 3 and 4, a unidirectional fabric 28 is placed on top of load transfer material 26 and resin, if applied. Unidirectional fabric 28 is circumferentially

As illustrated in FIG. 3, the unidirectional fabric is wrapped around pipe **10** such that the 90° direction of the fabric runs parallel to axial direction **22** of pipe **10**. Accordingly, when the unidirectional fabric is applied to pipe **10**, the high-performance fibers run in the axial direction.

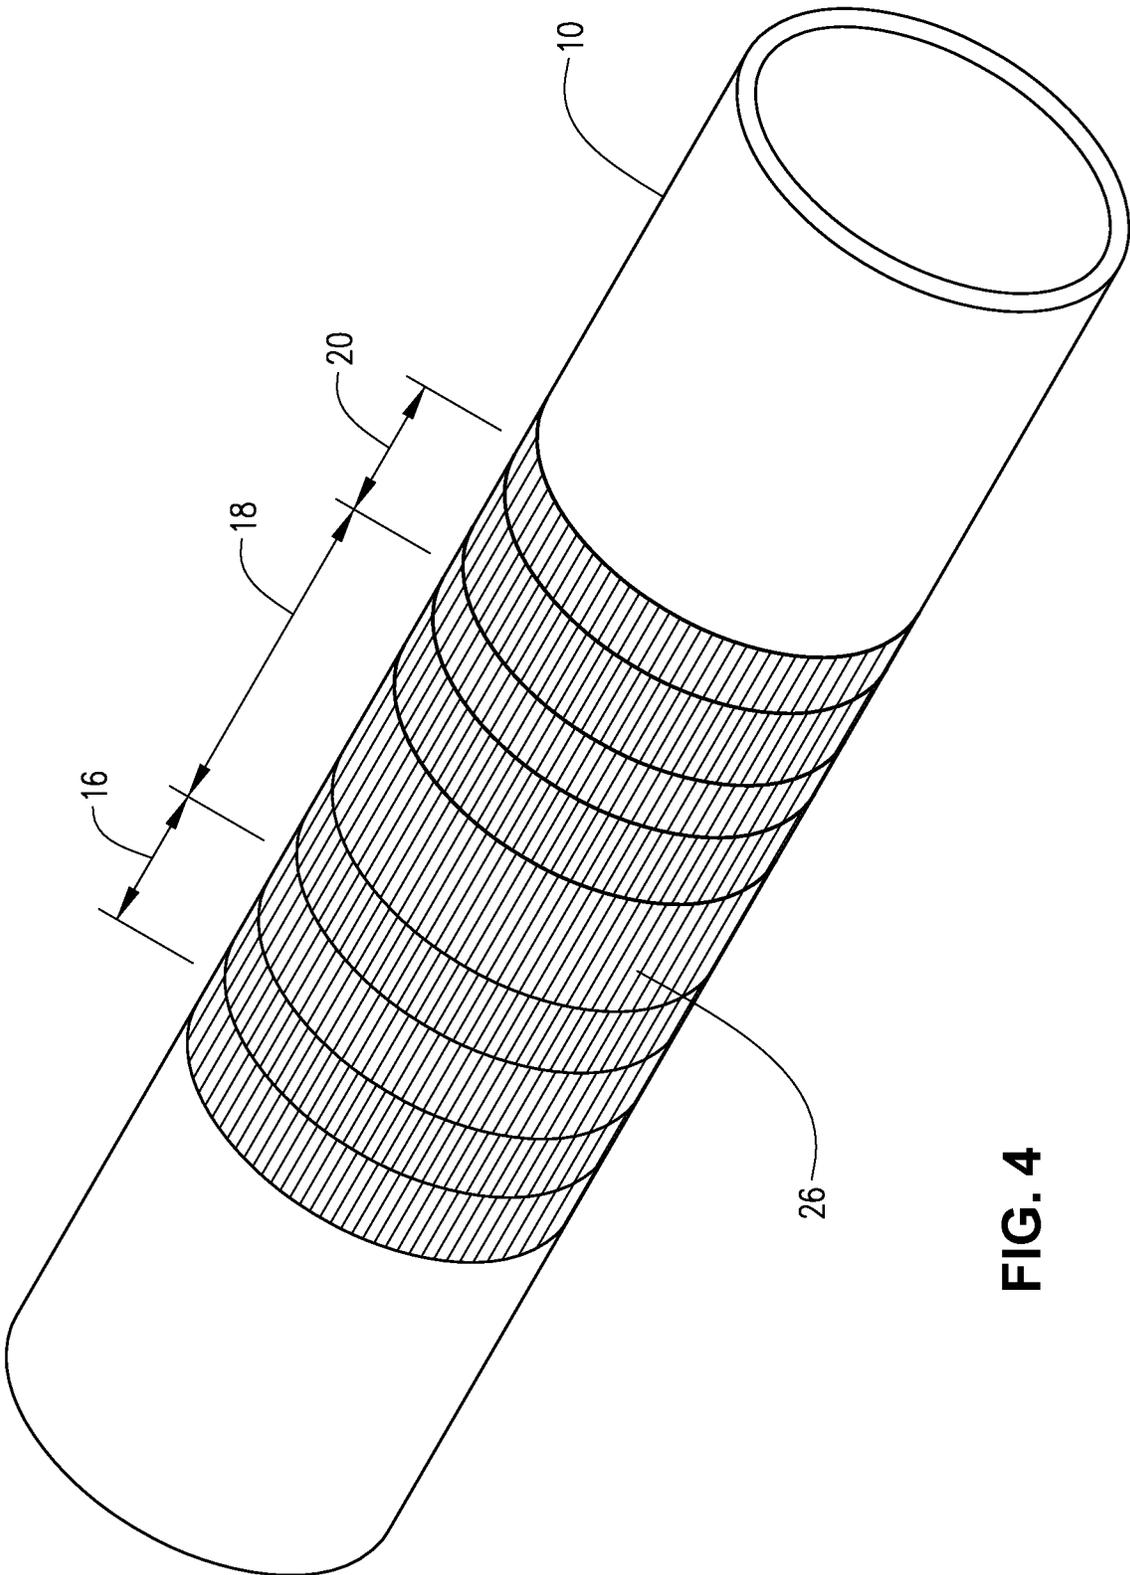
FIG. 4 is a perspective view of the pipe of FIG. 3 illustrating the completed application of the unidirectional fabric.

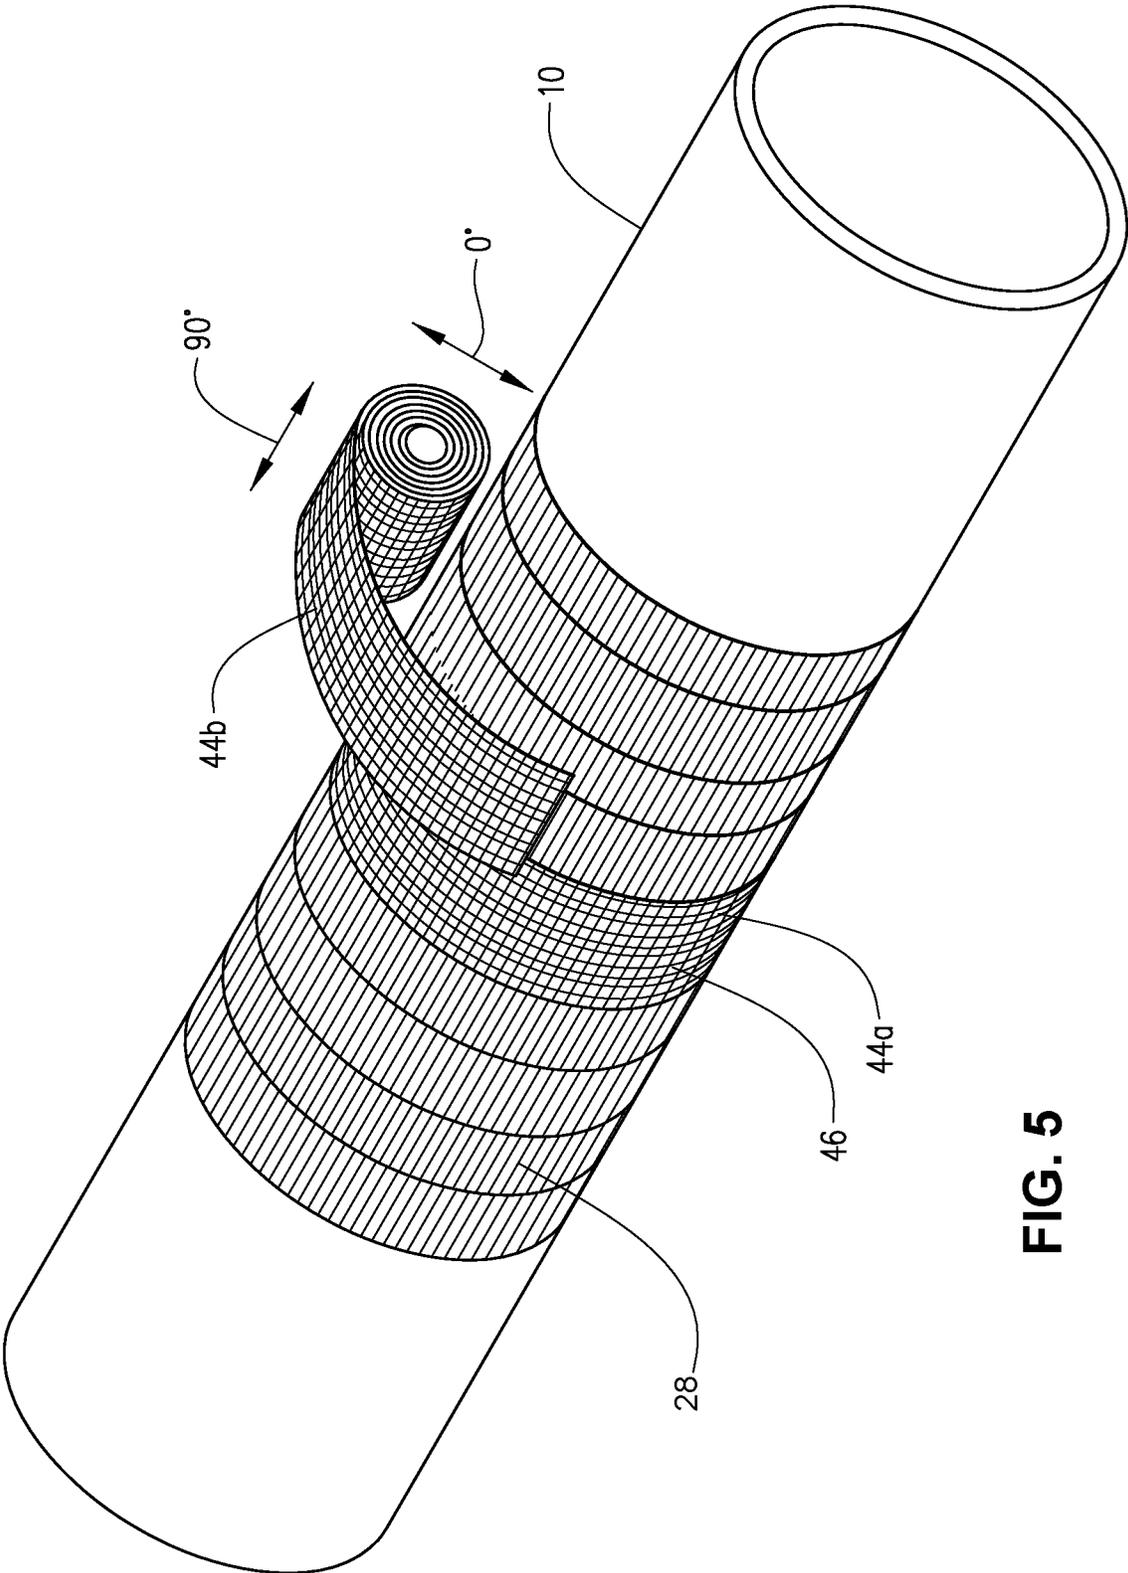
FIG. 5 is a perspective view of the pipe of FIG. 4 illustrating the application of a bidirectional fabric to the repair area.

In accordance with this disclosure, there is provided a reinforced pipe wherein the pipe 10 has wrinkle bend 12, and repair area 14 around the wrinkle bend has been reinforced by several distinct layers. The reinforced pipe is described below in relation to FIGS. 2 to 6, which illustrate the distinct layers.

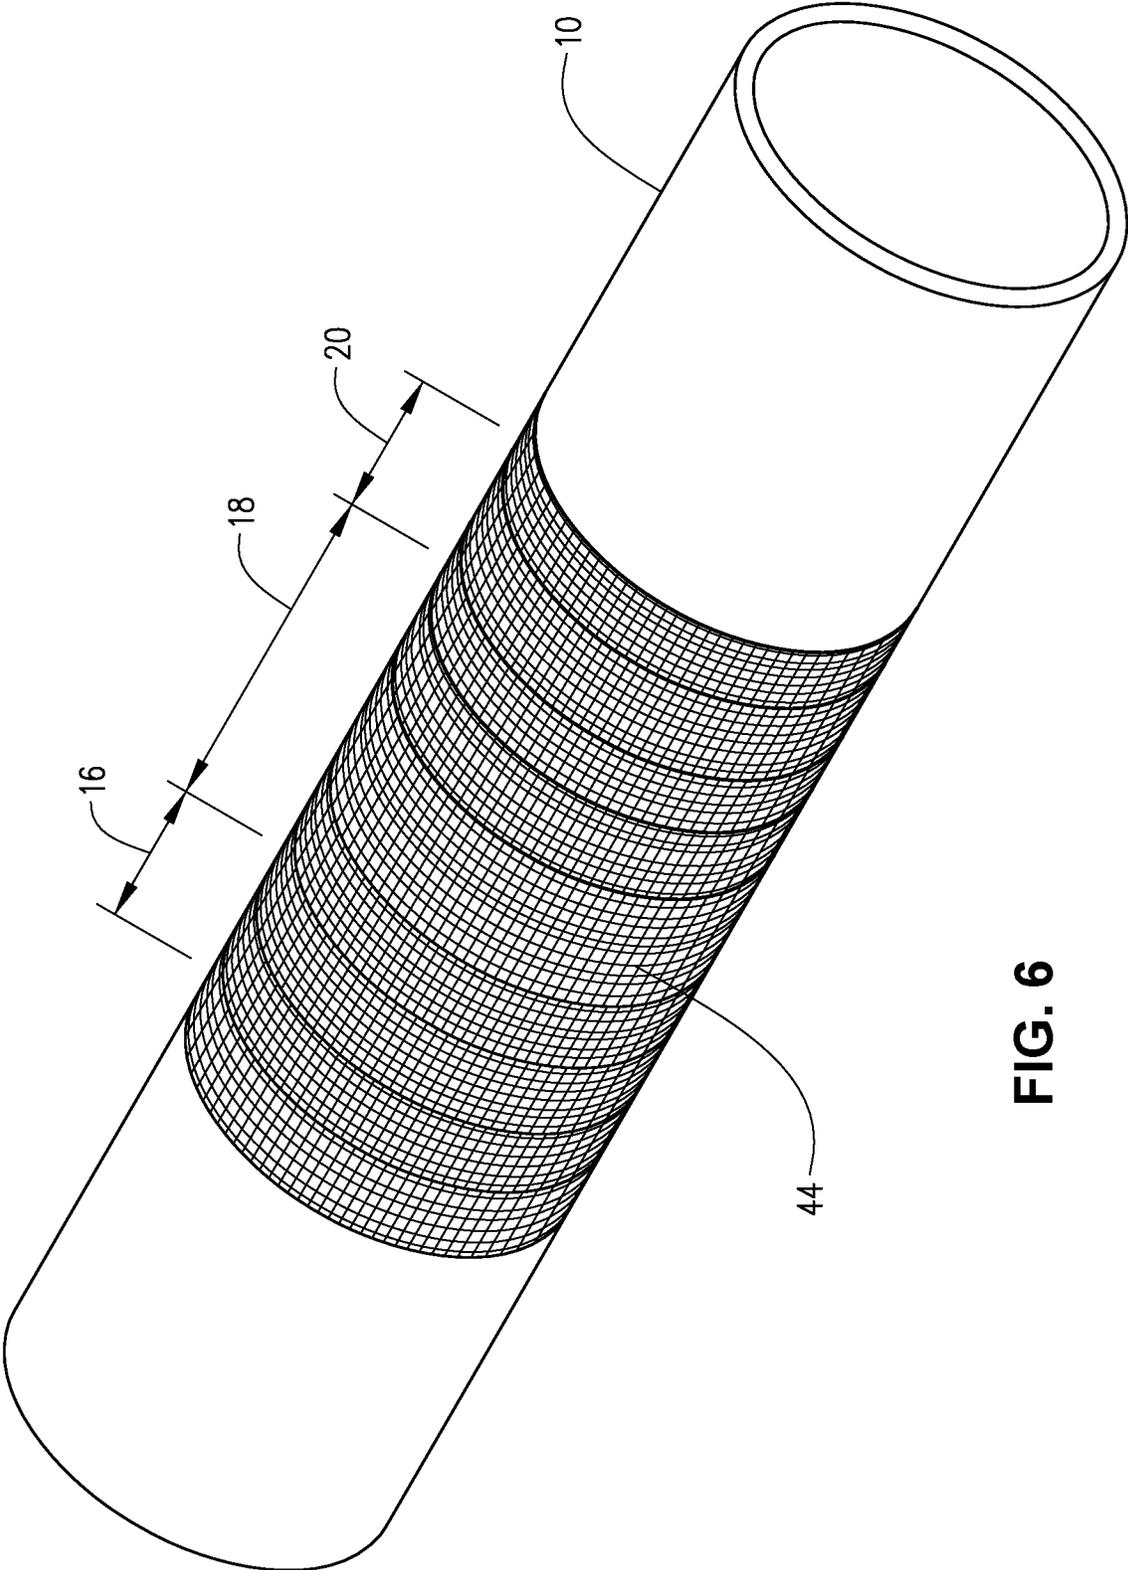
FIG. 6 is a perspective view of the pipe of FIG. 5 illustrating the completed application of the bidirectional fabric.

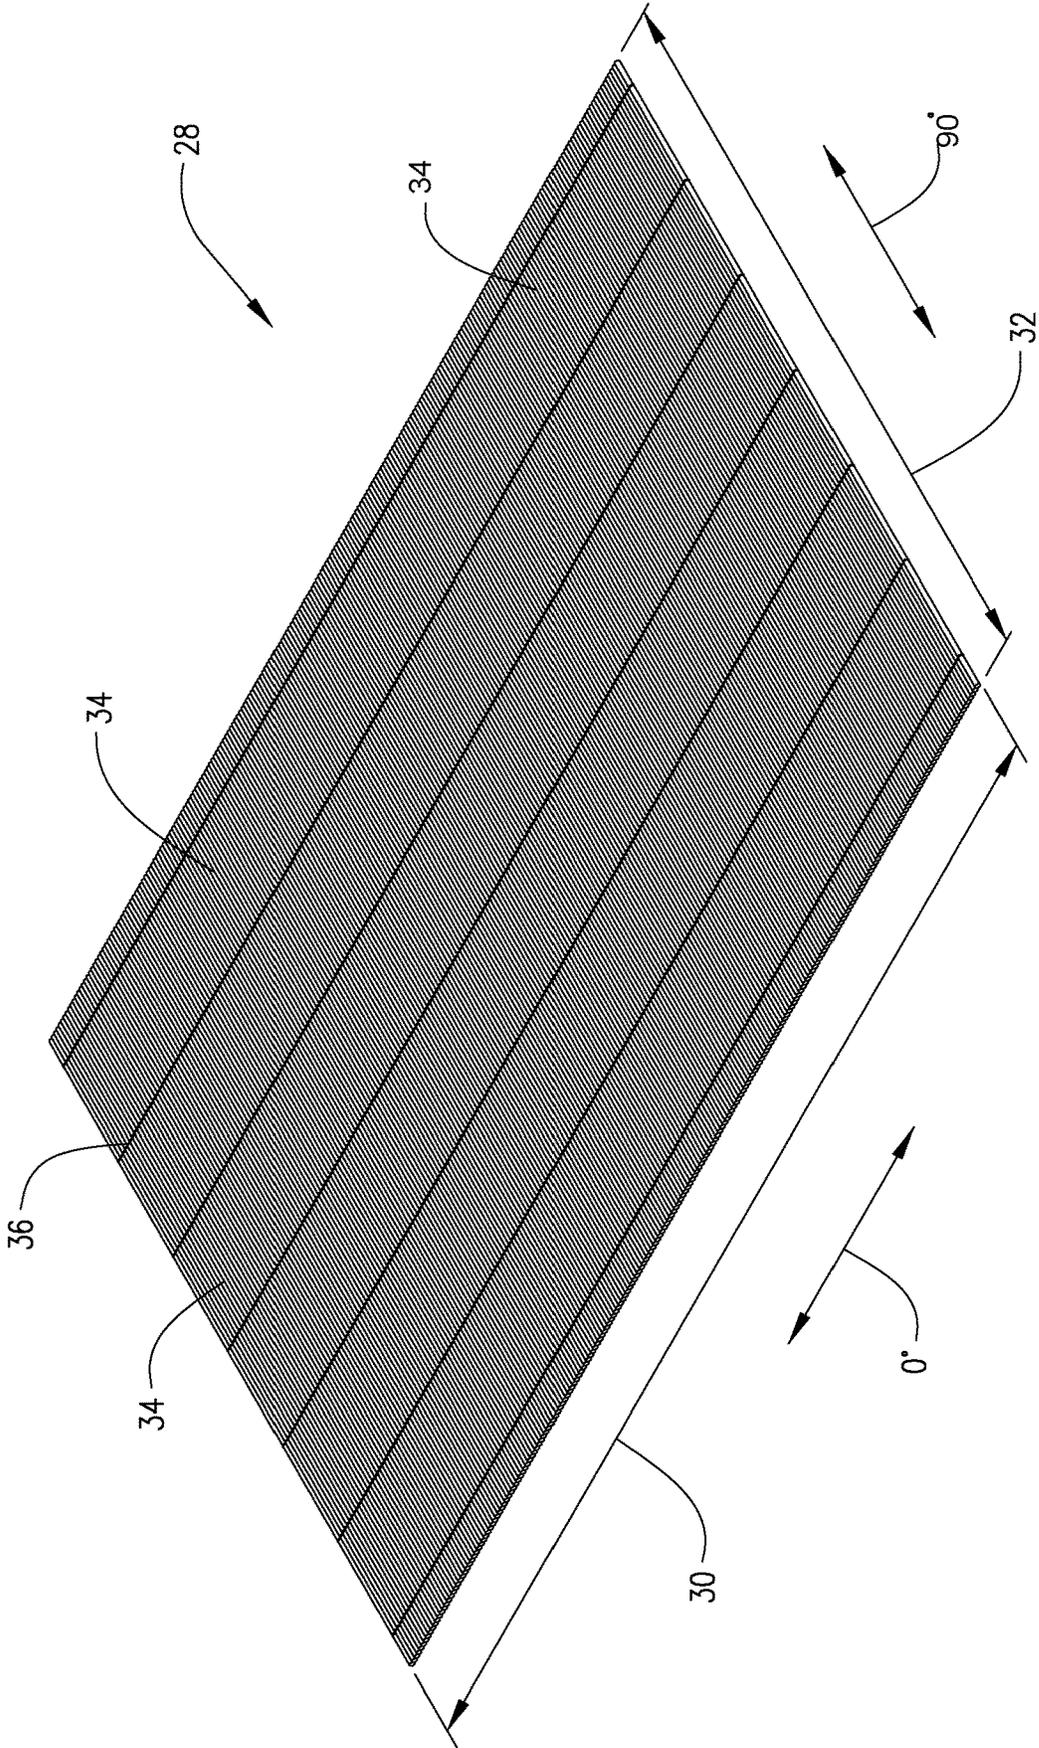
FIG. 7 is an illustration of a unidirectional fabric for use in the reinforcement of a pipe in accordance with this disclosure.

Referring to FIG. 7, unidirectional fabric **28** has a length **30** and width **32**, with length **30** typically being greater than width **32**. Often, width **32** will be less than the pipe circumference, and length **30** will be greater than the pipe circumference and even greater than two pipe circumferences. The length corresponds to the 0° direction for the fabric and the width corresponds to the 90° direction of the fabric. Unidirectional fabric **28** will have substantially all of its high-performance fibers **34** oriented in the 90° direction. Generally, this will mean that at least 90% of high-performance fibers **34** are oriented in the 90° direction. Typically, at least 95% or at least 98% of high-performance fibers **34** are oriented in the 90° direction. More typically, at least 99%, at least 99.5%, at least 99.9% or 100% of high-performance fibers **34** are oriented in the 90° direction.

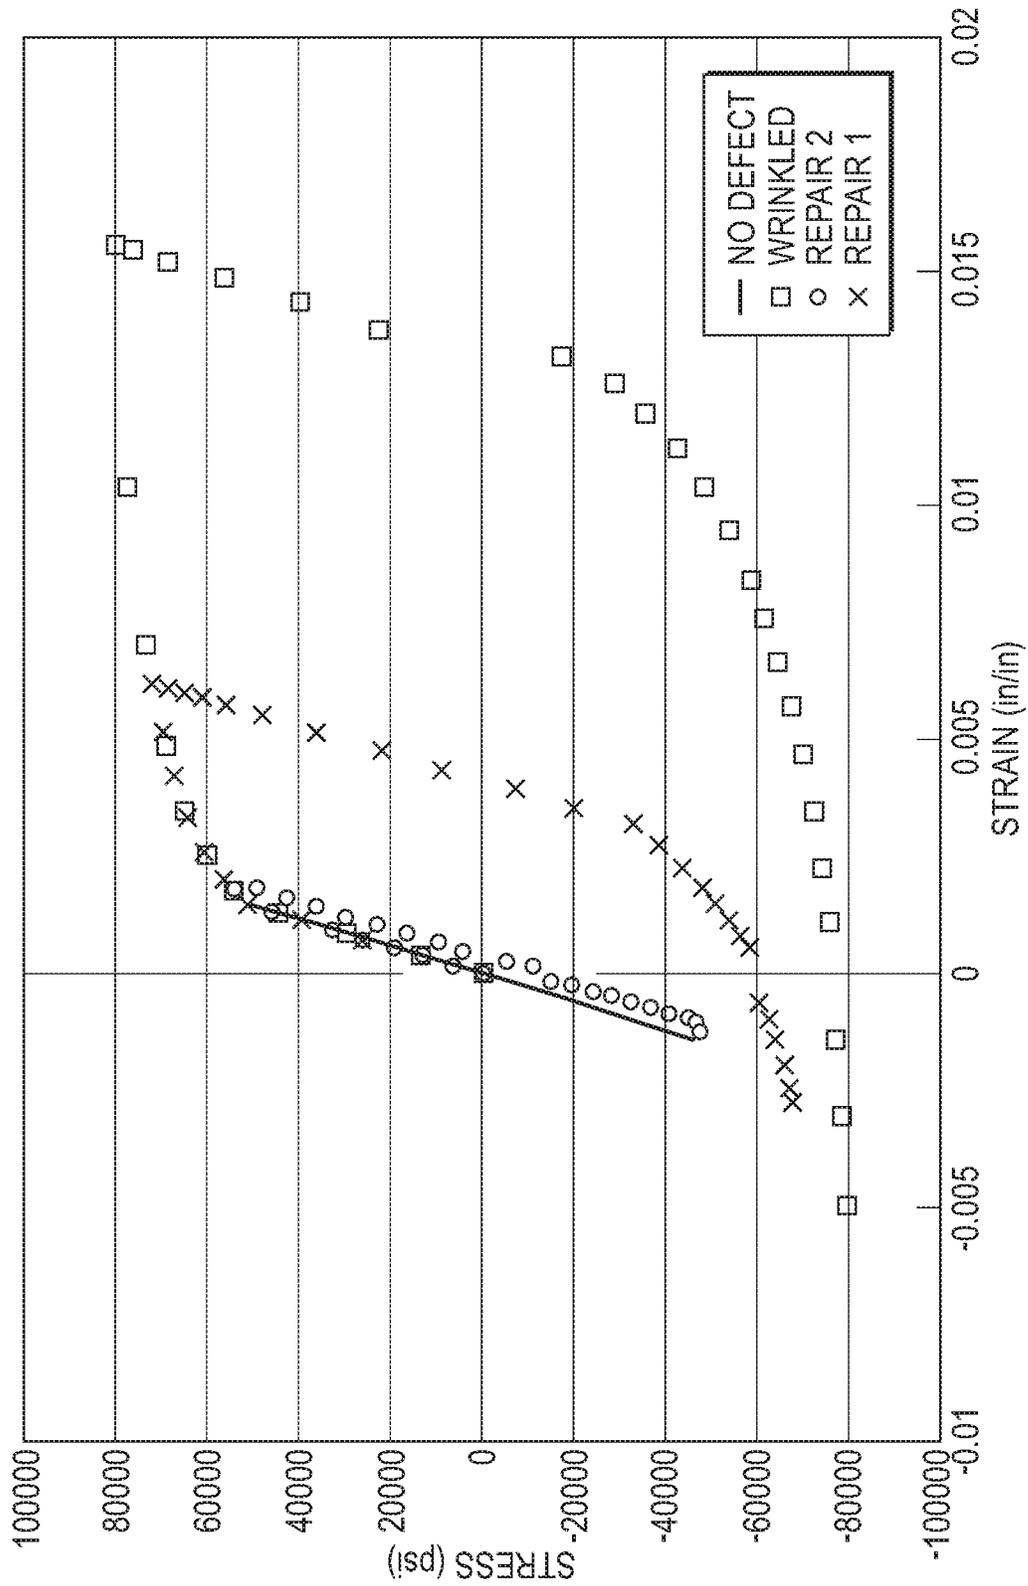
FIG. 8 is a graph of stress v. strain that illustrates the stress and strain ranges for a typical bending cycle for Control I, Control II, Control III and Example I.
