US012240627B2

The present disclosure provides a method of repairing a hat stringer. The method includes arranging a repair stringer in a mounting location that is one of a plurality of possible mounting locations along a cross section of a hat stringer. In each of the plurality of possible mounting locations, at least a portion of an internal profile of the repair stringer matches at least a portion of a profile of an internal cavity defined by the hat stringer. A cross-sectional area of the repair stringer as viewed along a first direction is less than a total cross-sectional area of the hat stringer as viewed along the first direction. The method also includes coupling the repair stringer with a stringer of the hat stringer in the mounting location. Repair stringers and repaired hat stringers are also provided.

**REPAIRING A HAT STRINGER**

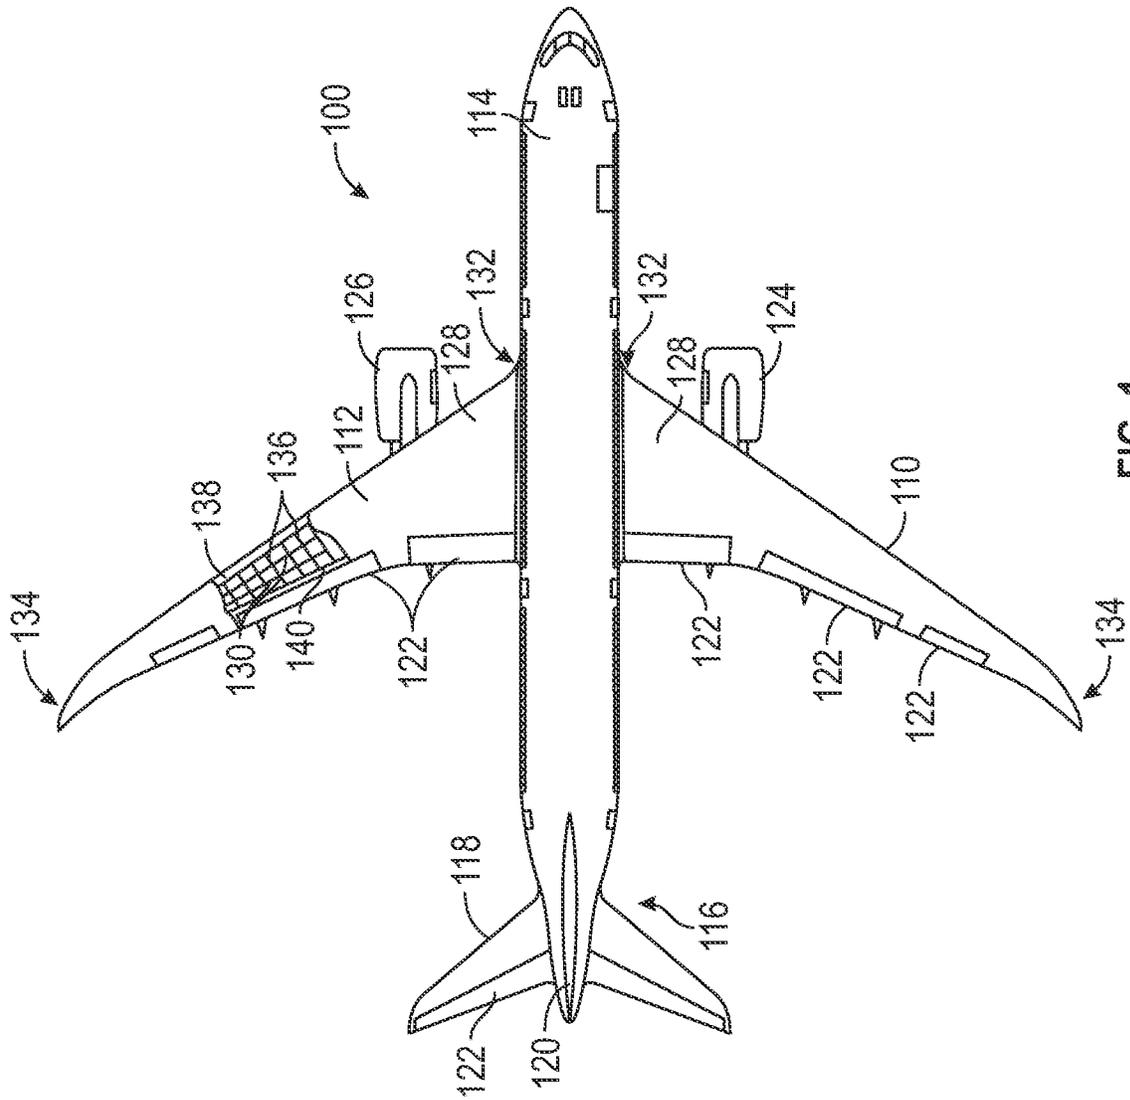
FIG. 1 is a top plan view of an example aircraft having a wing that includes at least one hat stringer;

Referring now to the drawings, FIG. 1 depicts a top plan view of an aircraft 100 according to example aspects of the present disclosure. As shown, the aircraft 100 includes a pair of wings 110, 112 and a fuselage 114. The wings 110, 112 extend laterally outward from the fuselage 114. The aircraft 100 also includes a tail section 116 having a horizontal stabilizer 118 and a vertical stabilizer 120. The wings 110, 112, the horizontal stabilizer 118, and the vertical stabilizer 120 all include control surfaces 122 (e.g., ailerons, elevators, rudder, etc.) that can be controlled to maneuver the aircraft 100 during flight. The aircraft 100 further includes propulsion units 124, 126 mounted to respective wings 110, 112. In FIG. 1, the propulsion units 124, 126 are gas turbine engines configured as turbofans. However, in other example aspects, the propulsion units 124, 126 can be other types of propulsion units, such as electrically-driven fans.

The wings 110, 112 each include skin members 128 that can be internally supported by various structures, such as stringers 130 and ribs 136 as illustrated by the cutaway portion of the wing 112 in FIG. 1. The stringers 130 are positioned in spaced relation to one another and generally extend spanwise from an inboard portion 132 to an outboard portion 134 of their respective wings 110, 112. One or more of the stringers 130 can have a hat-shaped cross section, e.g., as viewed along a spanwise direction of its associated wing. In this regard, the stringers 130 can be “hat stringers” in some example aspects. As further depicted in FIG. 1, the ribs 136 are positioned in spaced relation to one another and generally extend chordwise, e.g., from a forward structure, such as a front spar 138, to a rear structure, such as a rear spar 140, of their respective wings 110, 112.

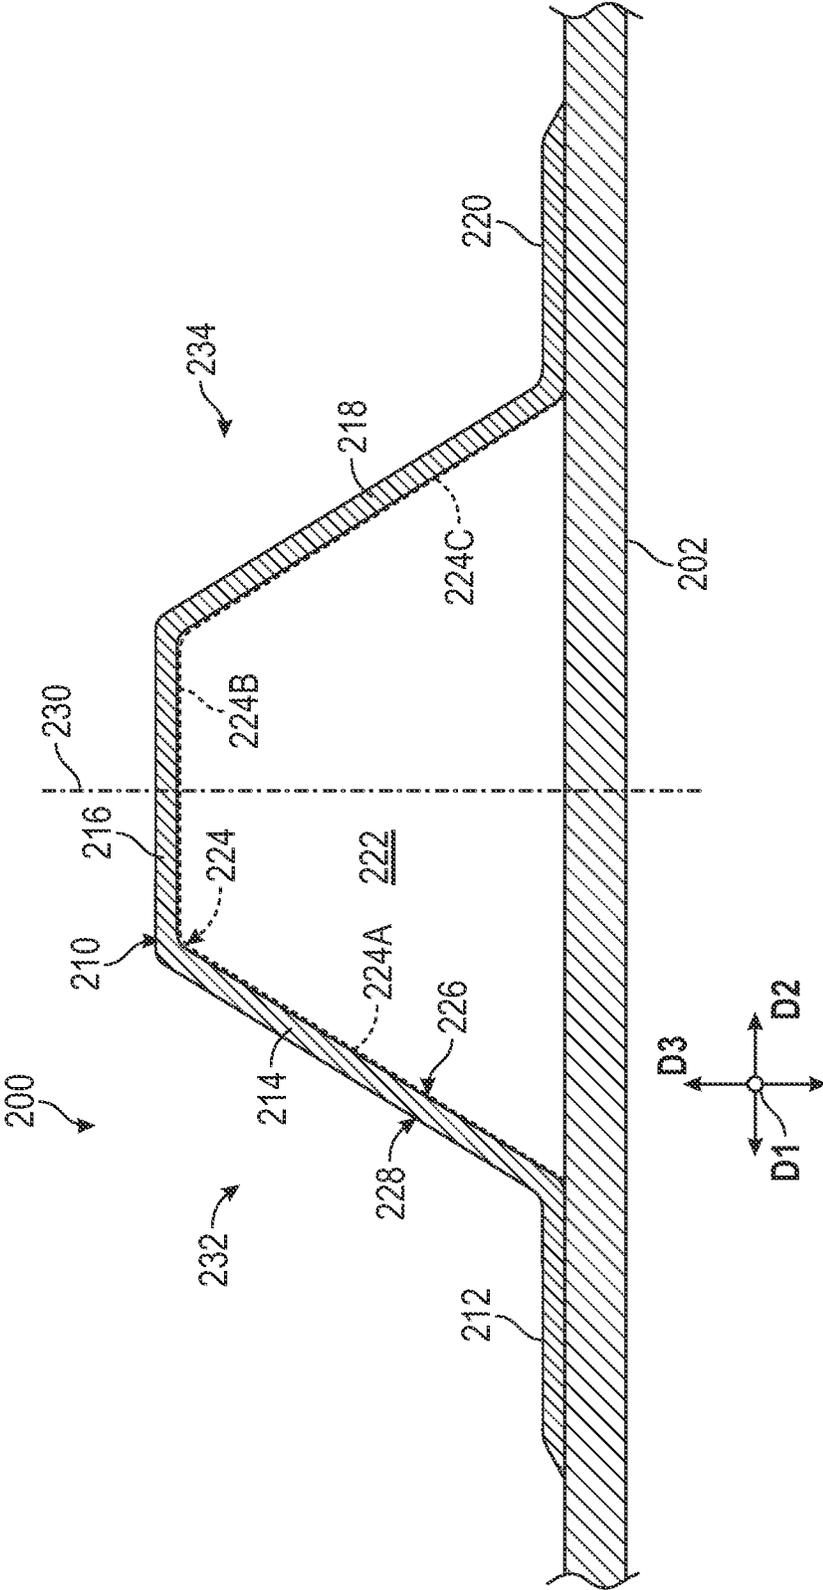
FIG. 2 is a cross-sectional view of a hat stringer;

FIG. 2 is a cross-sectional view of a hat stringer 200. The hat stringer can be one of the hat stringers 130 of the aircraft 100 of FIG. 1, for example. For reference, a first direction D1 (extending into and out of the page in FIG. 2), a second direction D2, and a third direction D3 are defined. The first, second, and third directions D1, D2, D3 are mutually perpendicular and form an orthogonal direction system. In FIG. 2, the first direction D1 is a spanwise direction along a wing of an aircraft. In this regard, FIG. 2 depicts a cross section of the hat stringer 200 as viewed along a spanwise direction of a wing. The third direction D3 can be a vertical direction.

As illustrated in FIG. 2, the hat stringer 200 is coupled with a skin member 202 to provide support thereto. The skin member 202 can be a lower wing skin of a wing, for example. The hat stringer 130 includes a base stringer 210. The base stringer 210 can be formed of one or more plies, such as one or more Carbon Fiber-Reinforced Polymers (CFRP) plies. The base stringer 210 can be formed as a monolithic unitary structure, for example. The base stringer 210 has, from left to right in FIG. 2, a first flange segment 212, a first web segment 214, a cap segment 216, a second web segment 218, and a second flange segment 220. The first and second flange segments 212, 220 are coupled with the skin member 202. The first and second web segments 214, 218 extend from their respective first and second flange segments 212, 220 and converge toward one another as they extend away from their respective first and second flange segments 212, 220. The cap segment 216 connects the first and second web segments 214, 218 and generally extends parallel to the first and second flange segments 212, 220 and the skin member 202.

The base stringer 210 and the skin member 202 collectively define an internal cavity 222. A profile 224 of the internal cavity 222 is defined by the base stringer 210. Particularly, the profile 224 of the internal cavity 222 as viewed along the first direction D1 is defined by an internal surface 226 of the base stringer 210 (e.g., when in serviceable condition). In FIG. 2, the profile 224 of the internal cavity 222 is represented by a dashed line extending along the internal surface 226 of the base stringer 210, or more specifically, along the internal surfaces of the first and second web segments 214, 218 and the cap segment 216. The profile 224 has a first web portion 224A, a cap portion 224B, and a second web portion 224C. The first web portion 224A extends along the internal surface of the first web segment 214, the cap portion 224B extends along the internal surface of the cap segment 216, and the second web portion 224C extends along the internal surface of the second web segment 218. The base stringer 210 has an external surface 228 opposite the internal surface 226. Moreover, for reference, the hat stringer 200 defines a central plane 230 demarcating a first side 232 and a second side 234 of the hat stringer 200. The central plane 230 is orthogonal to the second direction D2.

In some instances, a hat stringer, such as the hat stringer 200 of FIG. 2, can be become damaged or otherwise in need of structural reinforcement, e.g., due to an impact event during service. For instance, a segment of the hat stringer 200 may be damaged to an extent that its structural integrity is compromised, or in some extreme cases, missing completely. This may present a safety issue or render the aircraft unfit for service. In accordance with inventive aspects of the present disclosure, hat stringer repair techniques and repair stringers that facilitate repair or reinforcement of a hat stringer are provided herein. Example restoration techniques and repair stringers are provided below.
