(54) **METHOD FOR REPAIRING GENERATOR STATOR CORE**

(71) Applicant: **Siemens Energy, Inc.**, Orlando, FL (US)

The present invention relates generally to a method for repairing a stator core of a generator.

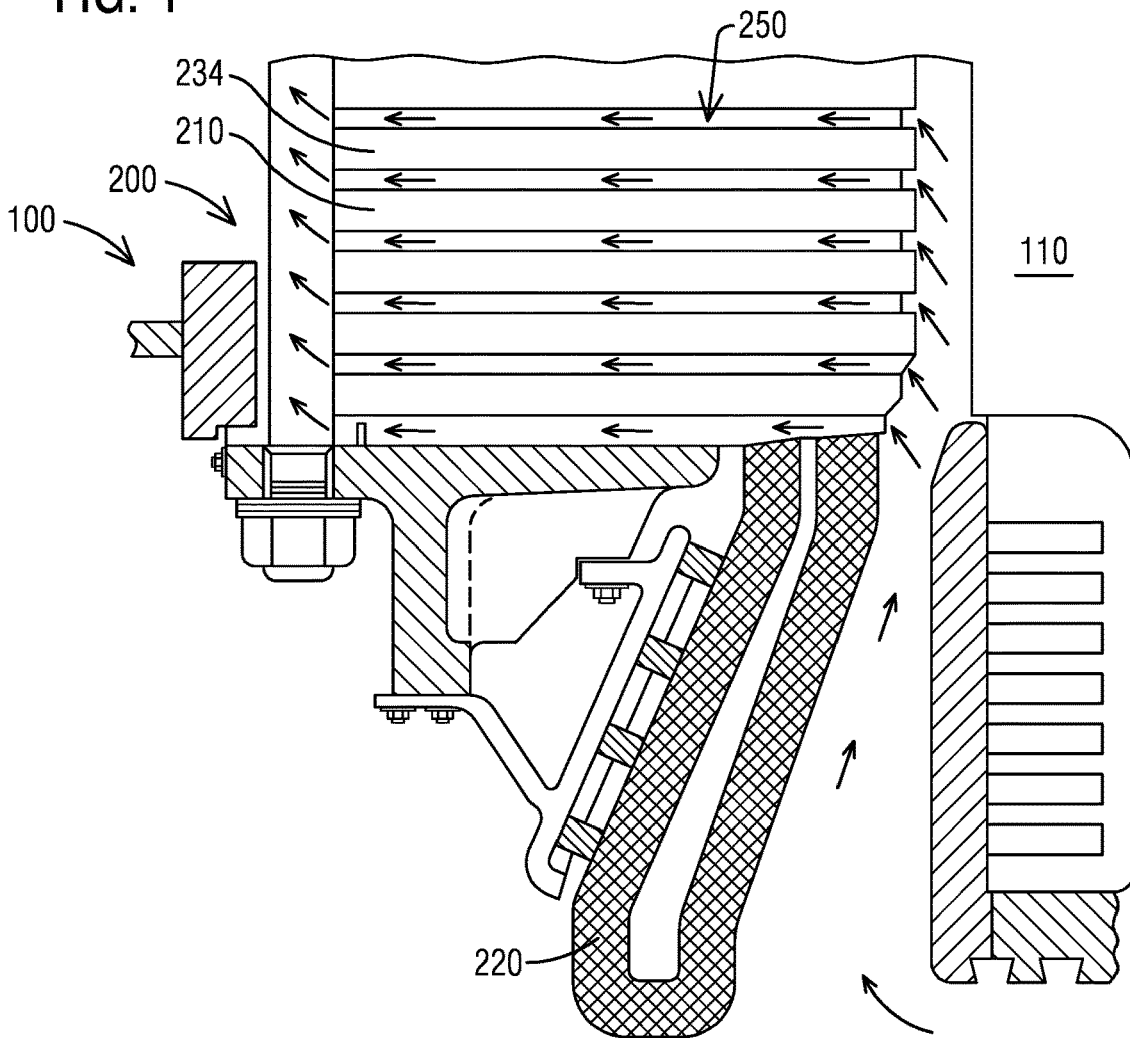
FIG. 1 illustrates a schematic partial cross section view of a generator in which embodiments of the present invention may be implemented;

FIG. 1 illustrates a schematic partial cross section view of a generator 100. The generator 100 includes a rotor 110 and a stator 200. The stator 200 has a stator core 210. The rotor 110 is installed within the stator core 210. A stator winding 220 may be arranged within the stator core 210.

The stator core 210 may be comprised of a plurality of packs 234 of stacked thin metal laminations 230. Each pack 234 includes multiple laminations 230 which are shown in more detail in FIG. 2. The stator core 200 may be cooled by a plurality of ventilation ducts 250 radially oriented between adjacent packs 234. The ventilation ducts 250 may be formed by ventilation spacers 260 which are shown in more detail in FIG. 3. The ventilation spacers 260 are disposed on the last lamination 230 in each pack 234 and are in contact with a surface of a lamination 230 in an adjacent pack 234 facing to the ventilation ducts 250. The ventilation spacers 260 may be secured to the lamination 230 to prevent the ventilation spacers 260 from moving. The ventilation spacers 260 may be secured to the lamination 230 by any suitable manners, such as by being spot welded to the lamination 230, by being pressed into holes in the lamination 230, or by being nailed to the lamination 230. The ventilation spacers 260 may tighten and provide support to the laminations 230 in adjacent packs 234 to prevent vibration of the laminations 230. The ventilation spacers 260 may include any suitable materials, such as metals, carbon steel, etc.

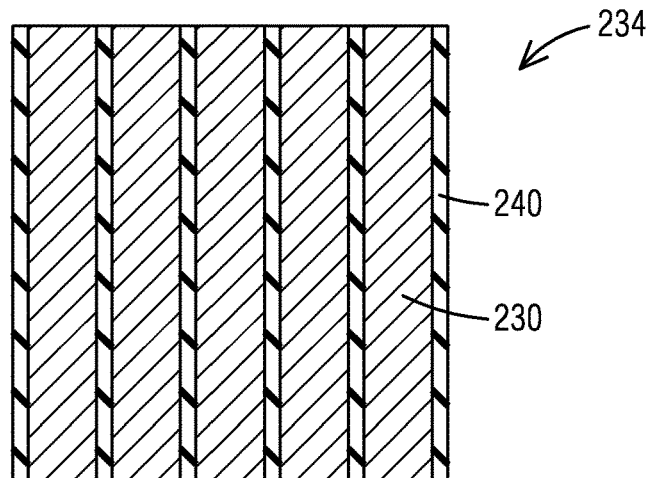
FIG. 2 illustrates a schematic cross section view of a lamination pack in which embodiments of the present invention may be implemented;

FIG. 2 illustrates a schematic cross section view of a pack 234 having a plurality of laminations 230. As shown in FIG. 2, the laminations 230 are separated from each other by an insulation layer 240. The insulation layer 240 may include any suitable materials, such as insulation paper, fiber glasses, etc. The insulation layer 240 is much thinner than the lamination 230. For example, the lamination 230 may have a thickness in an order of millimeters. The insulation layer 240 may have a thickness in an order of micrometers.

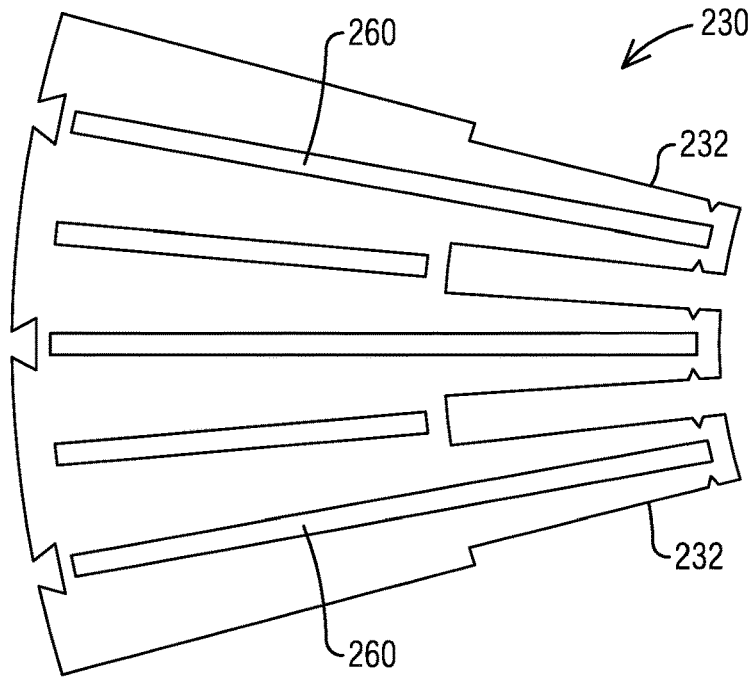
FIG. 3 illustrates a schematic plan view of a lamination having ventilation spacers of which embodiments of the present invention may be implemented;

FIG. 3 illustrates a schematic plan view of a last lamination 230 in a pack 234. As shown in FIG. 3, an inner portion of the lamination 230 has a tooth shape comprised of a plurality of tooth 232. Typically, damage of the insulations layers 240 occurs near the tooth 232 of the laminations 230. The ventilation spacers 260 are disposed on a surface of the lamination 230 facing to the ventilation duct 250. The ventilation spacers 260 may have a block rail shape and are radially oriented. The ventilation spacers 260 are in contact with a surface of a lamination 230 of an adjacent pack 234 facing to the ventilation duct 250. The ventilation spacers 260 may tighten the laminations 230 in the adjacent packs 234. Removal of the ventilation spacers 260 may locally loosen the laminations 230 in the adjacent packs 234 so that damaged insulation layers 240 between the laminations 230 in the adjacent packs 234 may be repaired. The repair may include reapplying insulation layers 240 between the lami-

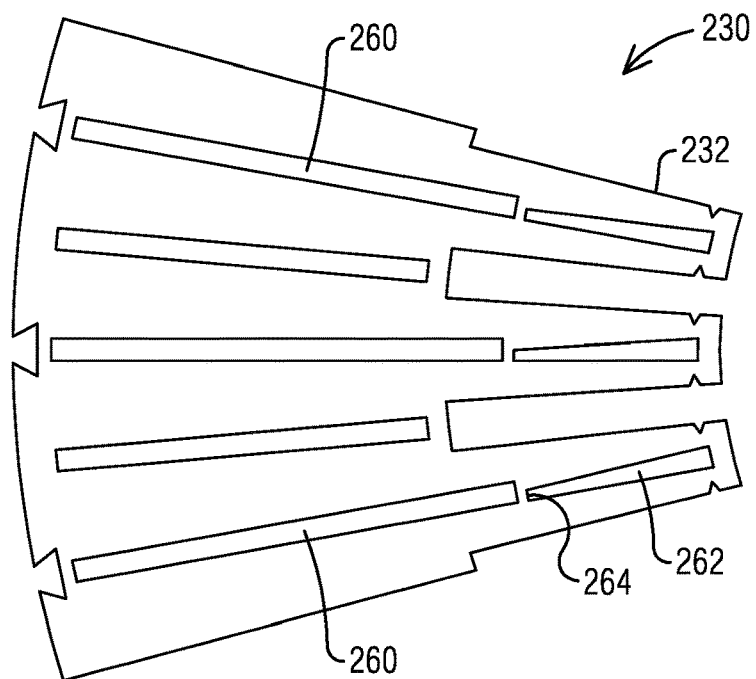
FIG. 4 illustrates a schematic plan view of a lamination having new ventilation spacers according to an embodiment of the present invention; and

After completion of the repair, new ventilation spacers 262 are reinstalled back to areas where the ventilation spacers 260 are removed. FIG. 4 illustrates a schematic plan view of a last lamination 230 having reinstalled new ventilation spacers 262. As shown in FIG. 4, a portion of ventilation spacers 260 are removed prior to repair. New ventilation spacers 262 are reinstalled between adjacent packs 234 back to areas where the ventilation spacers 260 are removed after completion of the repair. The reinstalled new ventilation spacers 262 retighten the loosen laminations 230 in the adjacent packs 234. The new ventilation spacers 262 may have a block rail shape. The new ventilation spacers 262 may have a tapered shape for easy reinstallation. Tapered tips 264 of the new ventilation spacers 262 are inserted toward to the remaining portion of the ventilation spacers 260. A radial length of the new ventilation spacers 262 may be equal to or less than a radial length of the ventilation spacers 260 being removed. For illustration purpose as shown in FIG. 4, a radial length of the new ventilation spacers 262 is less than a radial length of the ventilation spacers 260 being removed so that the tapered tips 264 of the new ventilation spacers 262 are not in contact with the remaining portion of the ventilation spacers 260. It is understood that a radial length of the new ventilation spacers 262 may be equal to a radial length of the ventilation spacers 260 being removed so that the tapered tips 264 of the new ventilation spacers 262 are in contact with the remaining portion of the ventilation spacers 260. It is also understood that tapered tips 264 of some of the new ventilation spacers 262 may be in contact with the remaining portion of the ventilation spacers 260 and tapered tips 264 of some of the new ventilation spacers 262 may be not in contact with the remaining portion of the ventilation spacer 260. The new ventilation spacers 262 may include polymer plastic materials, epoxy composite resins, such as G-11 fiber glass. The new ventilation spacers 262 may be adhesively secured between the adjacent packs 234. For example, the new ventilation spacers 262 may be coated with glue prior to reinstallation. Alternatively, areas between the adjacent packs 234 where the ventilation spacers 260 being removed are coated with glue prior to reinstalling the new ventilation spacers 262. The glue may include any suitable glue materials, such as Dacron™, or Nomex™.
