(10) **Patent No.:** **US 9,442,076 B2**  
(45) **Date of Patent:** **Sep. 13, 2016**

(54) **INFRARED RADIOMETRIC IMAGING INSPECTION OF STEEL PARTS**

(71) Applicant: **Bell Helicopter Textron Inc.**, Fort Worth, TX (US)

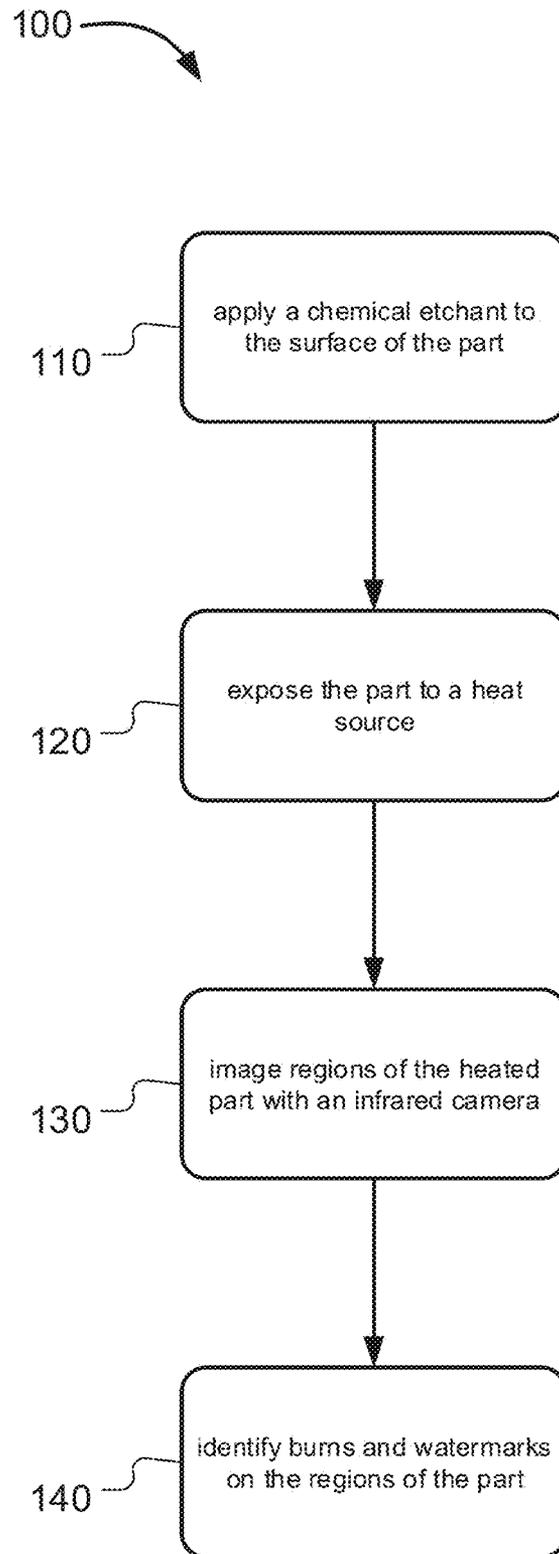
**FIG. 1**

FIG. 1 is a flowchart showing an example process for inspecting a part.

FIG. 1 shows an example infrared inspection process 100. The inspection process 100 can be used to inspect a machined, ground, or otherwise processed metallic part, e.g., a hardened steel part or other metallic part. For example, the part can be any metallic part manufactured by grinding such as a gear, shaft, spline, bearing, screw, rod, or other part. For example, the part can be a ground gear used in a rotorcraft transmission.

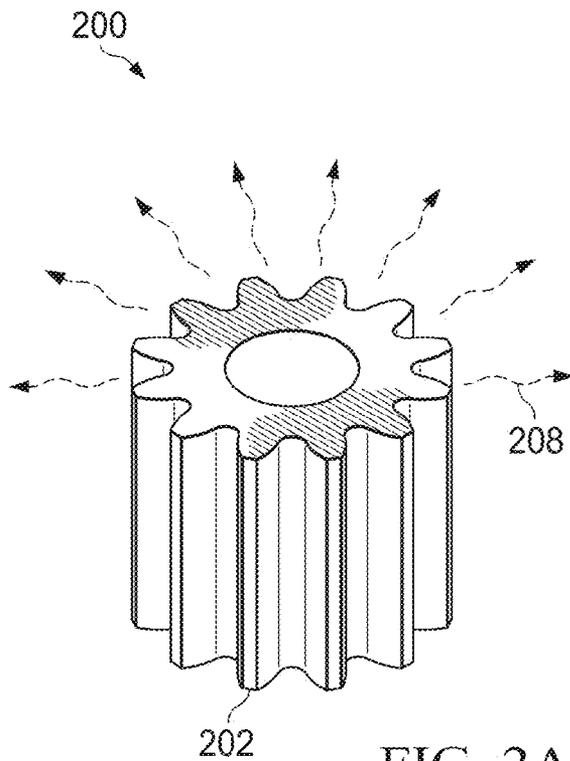
FIGS. 2A-2B are schematic diagrams showing examples of a system for inspecting a part.

At 120, the chemical-etched part is heated by exposure to a heat source. For example, the part can be heated to a temperature greater than the ambient temperature (e.g., greater than room temperature). In some implementations, the entire part is heated to a temperature, and in some implementations, a portion of the part is heated to a temperature. The part can be heated by any suitable heat source, such as the light source 204 shown in FIG. 2A or the heat source 210 shown in FIG. 2B, or another heat source.

FIG. 2A and FIG. 2B illustrate schematic diagrams of example inspection systems 200 and 250, respectively. The example inspection systems 200, 250 can implement the inspection process 100. Each of the example inspection systems 200, 250 includes an example part 202 and an example infrared camera 206. In FIGS. 2A-B, the part 202 is shown as a ground gear that has been chemical-etched.

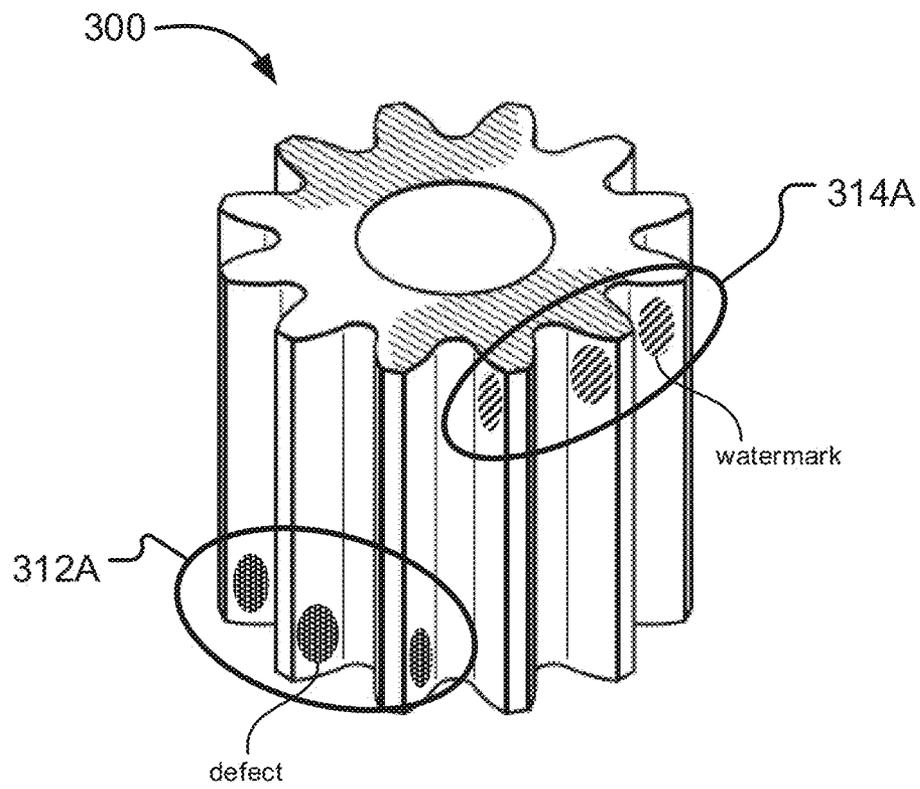
**FIG. 3A**

FIG. 3A is a schematic diagram of an example part inspection.

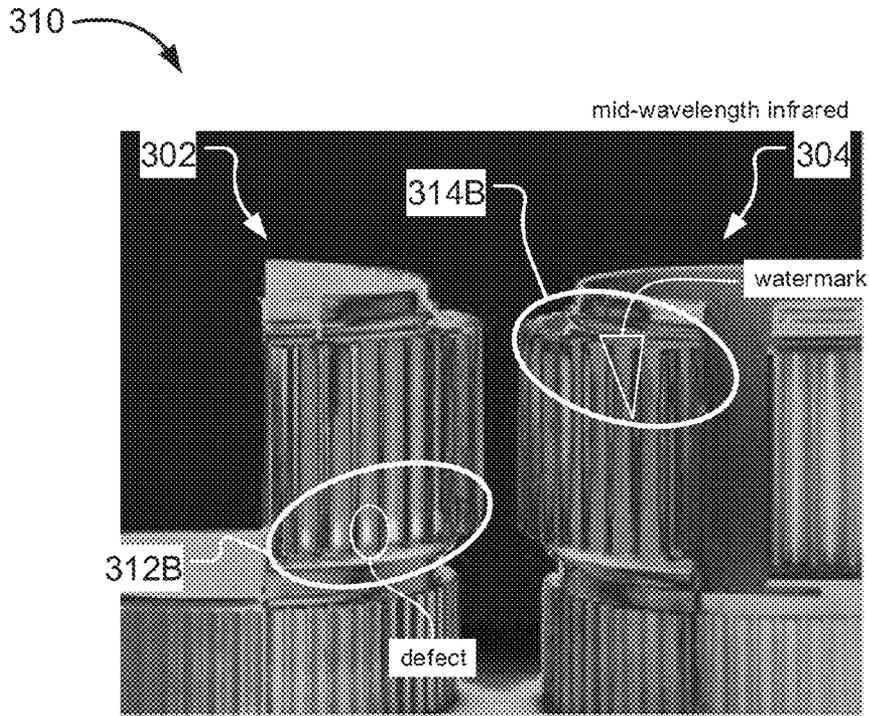
**FIG. 3B**

FIGS. 3B-3C are example images of a part inspection.

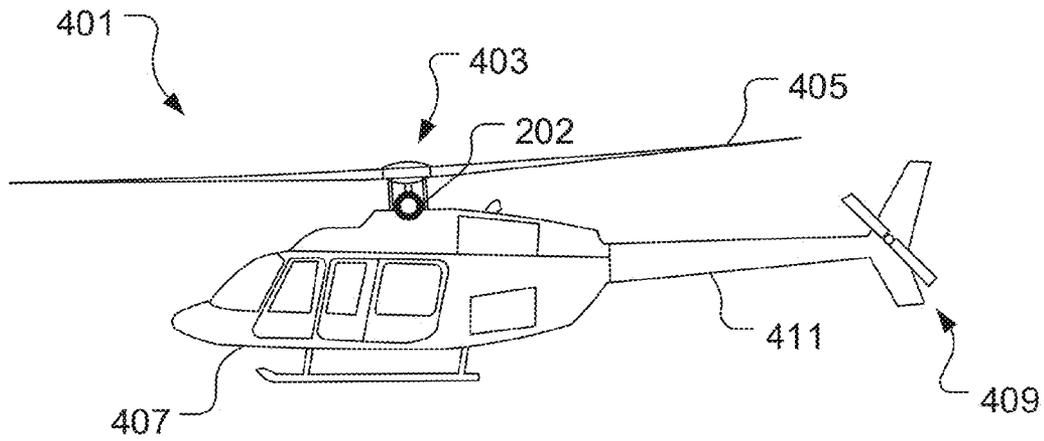
**FIG. 4**

FIG. 4 is a schematic diagram showing an example of a rotorcraft.

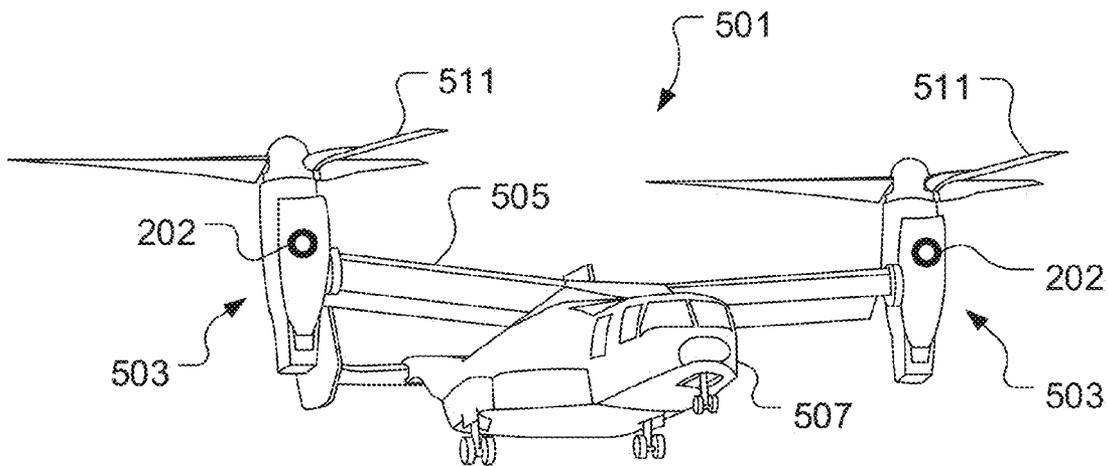
**FIG. 5**

FIG. 5 is a schematic diagram showing an example of a tiltrotor aircraft.
