(10) **Patent No.:** **US 11,247,733 B2**

(54) **DEFORMING WHEELHOUSE STRUCTURE FOR A VEHICLE**

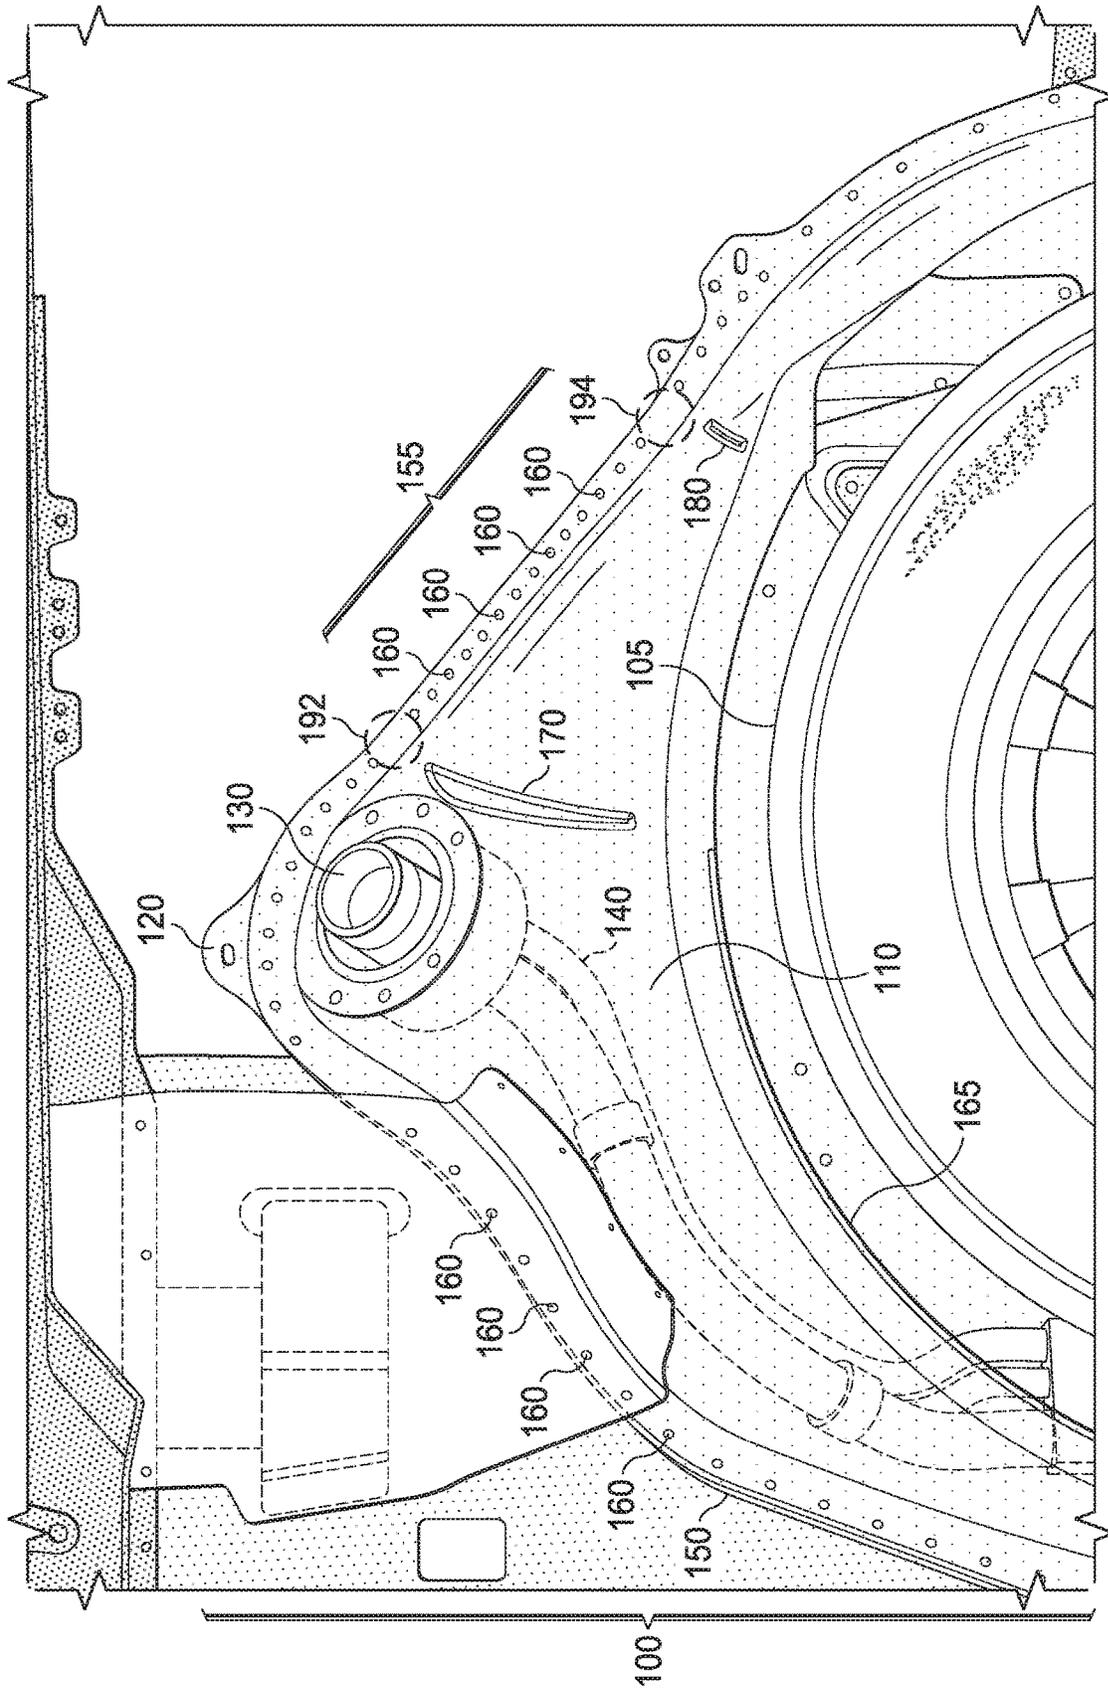
Fig. 1

FIG. 1 is a side view of an example deforming rear wheelhouse structure, according to at least one embodiment of the present disclosure.

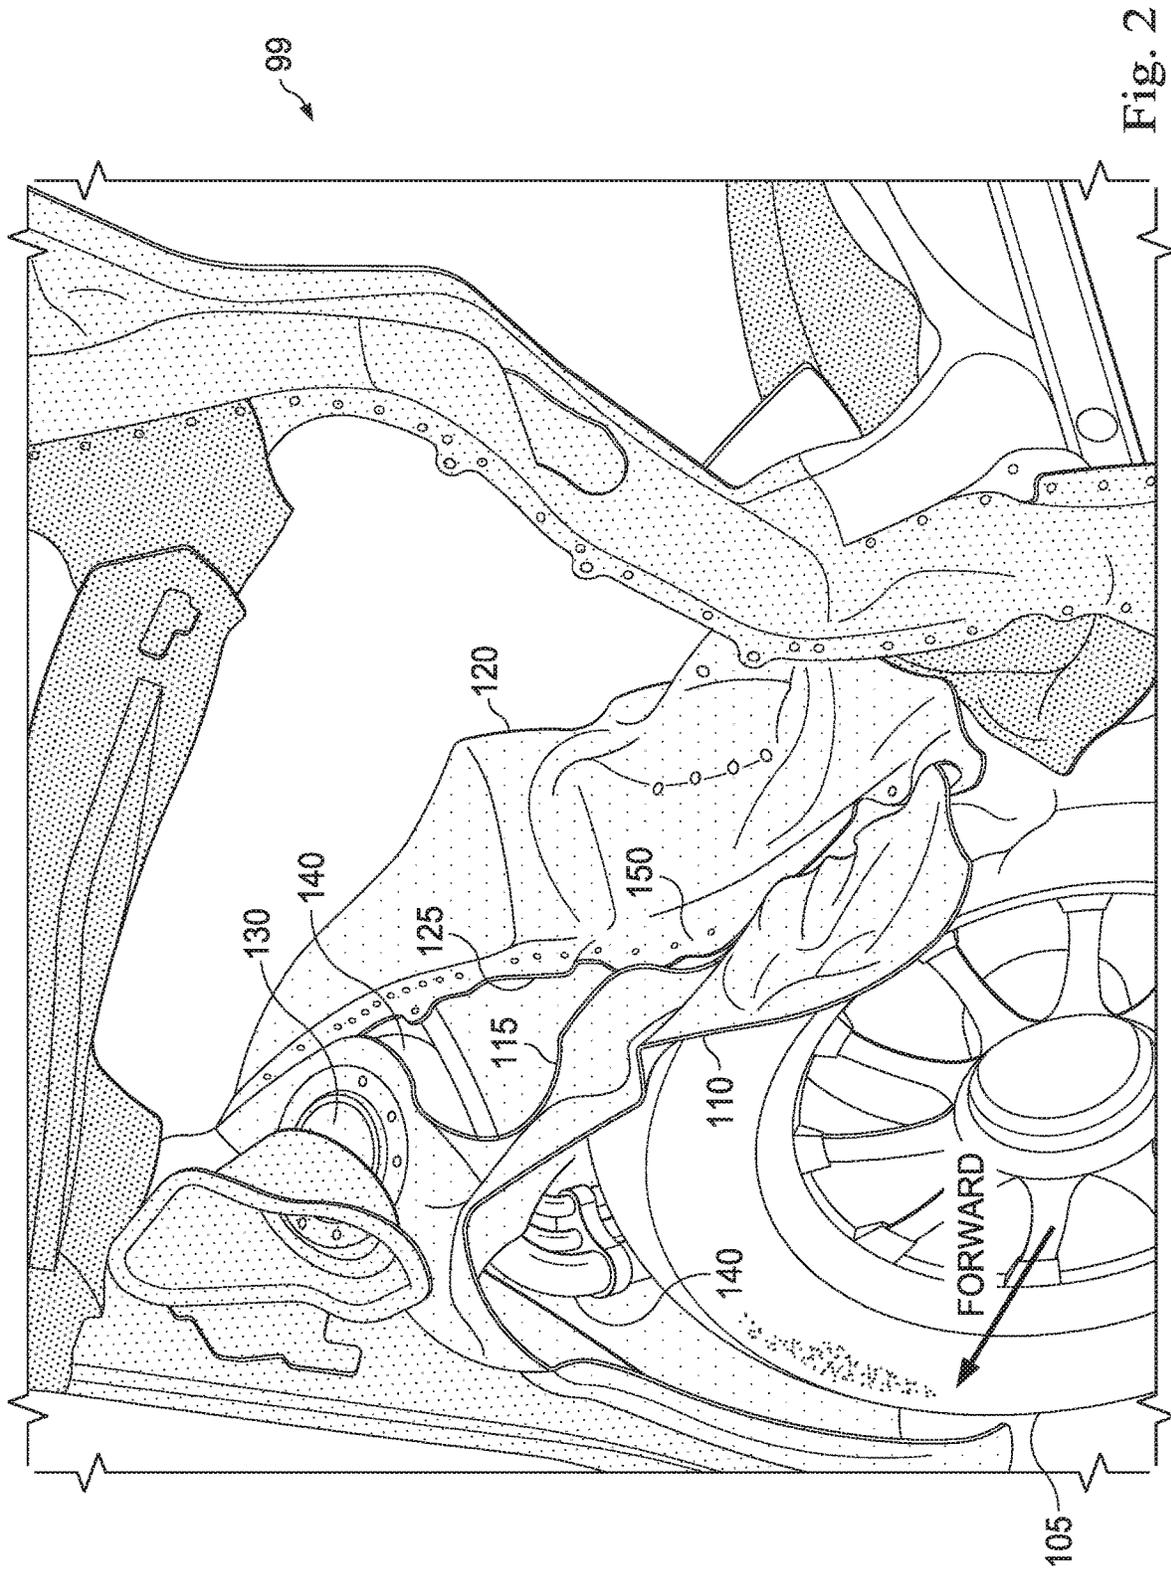
Fig. 2

FIG. 2 is a side rear perspective view of a baseline-case wheelhouse structure following a rear-impact collision, according to aspects of the present disclosure.

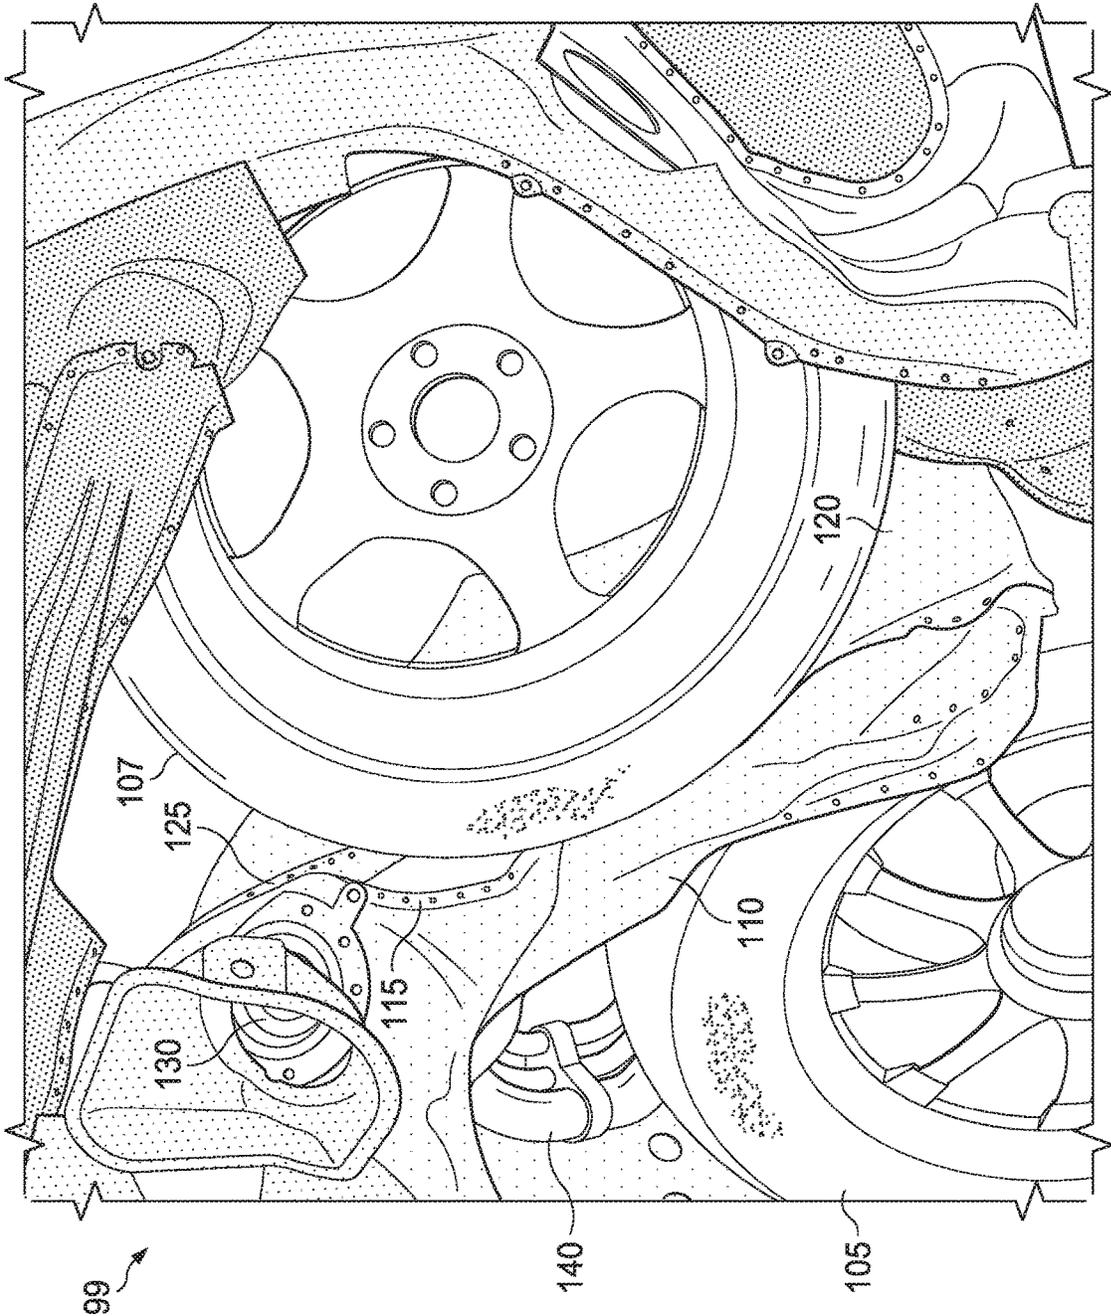
Fig. 3

FIG. 3 is a side rear perspective view of a baseline-case wheelhouse structure following a rear-impact collision, according to aspects of the present disclosure.

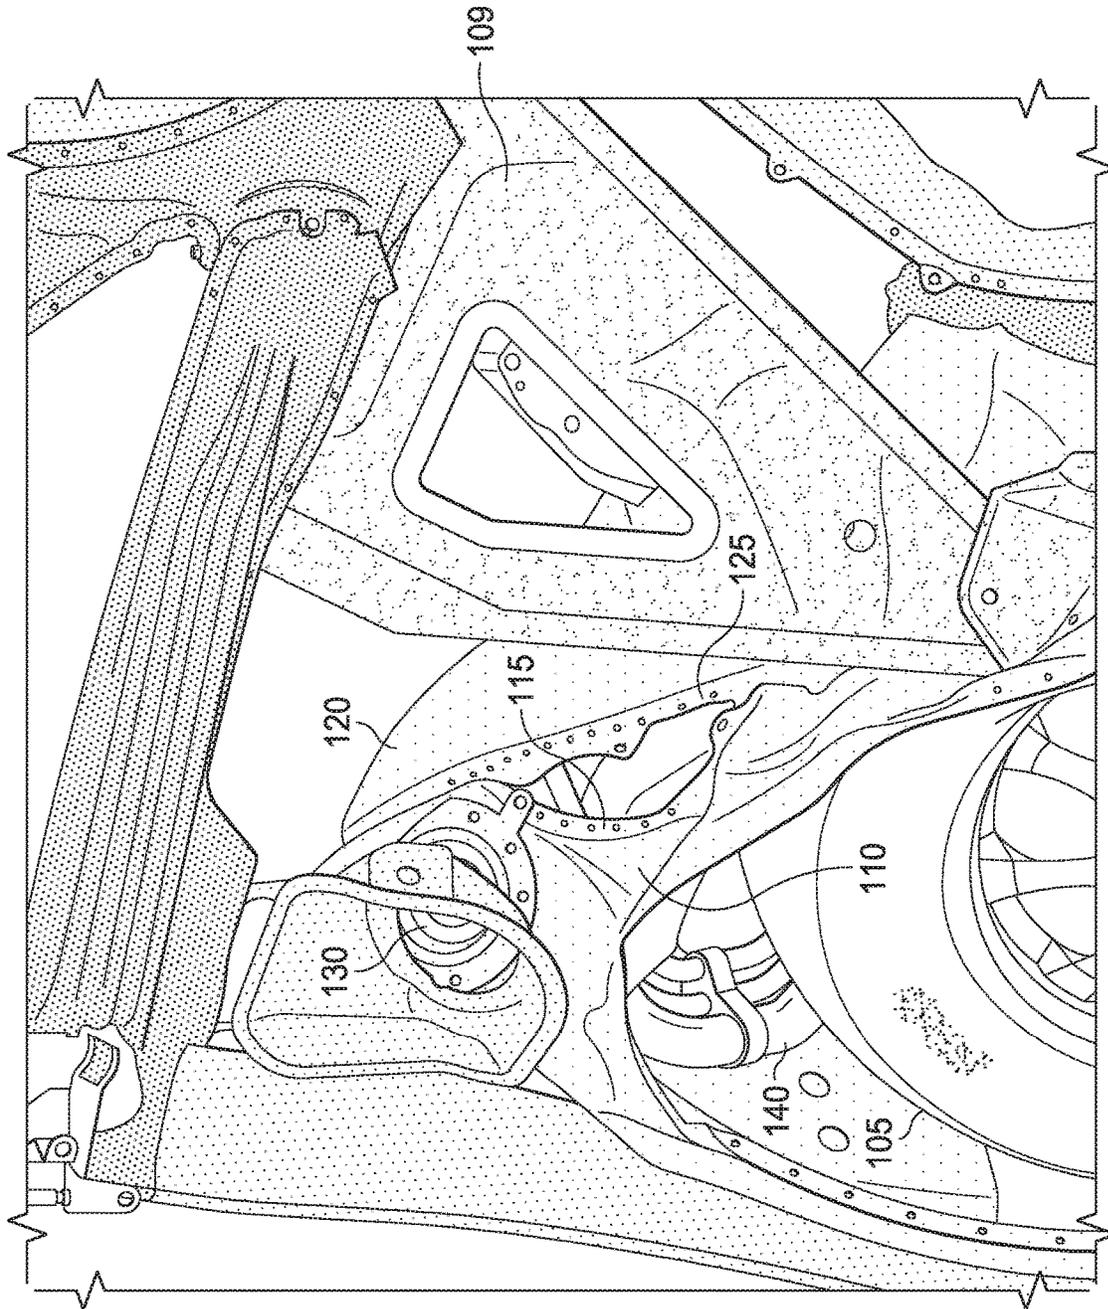
Fig. 4

FIG. 4 is a side rear perspective view of a baseline-case wheelhouse structure following a rear-impact collision, according to aspects of the present disclosure.

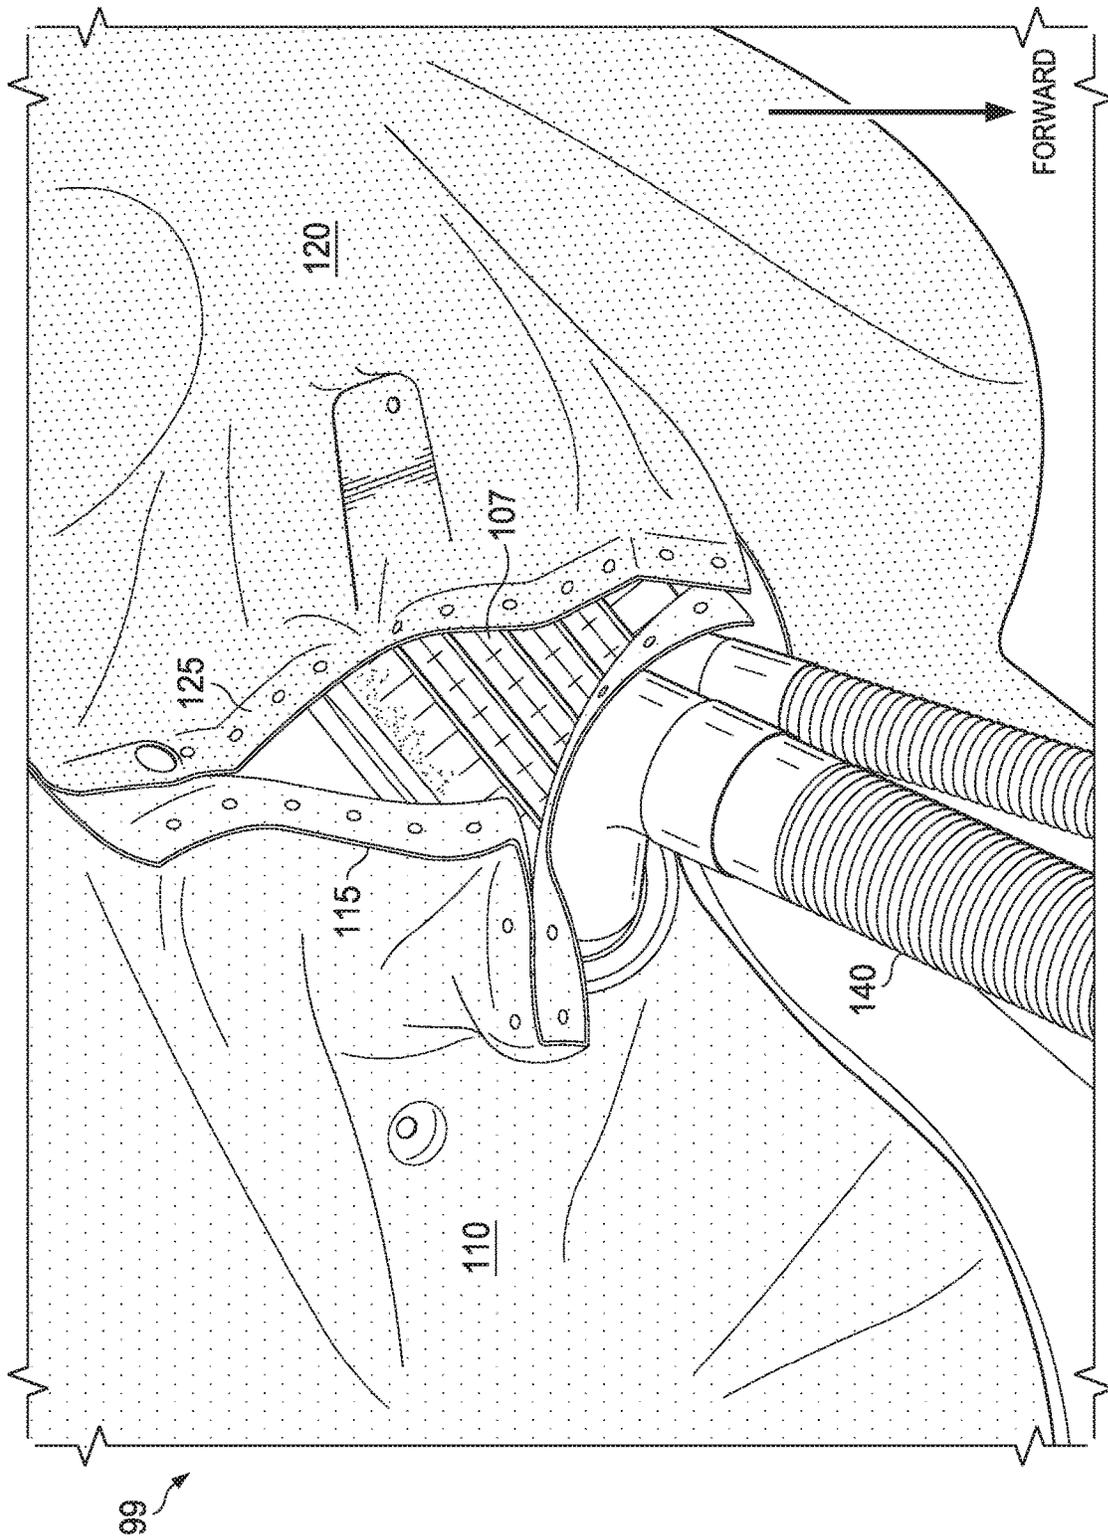
Fig. 5

FIG. 5 is an upward-facing inside view of a baseline-case wheelhouse structure following a rear-impact collision, according to aspects of the present disclosure.

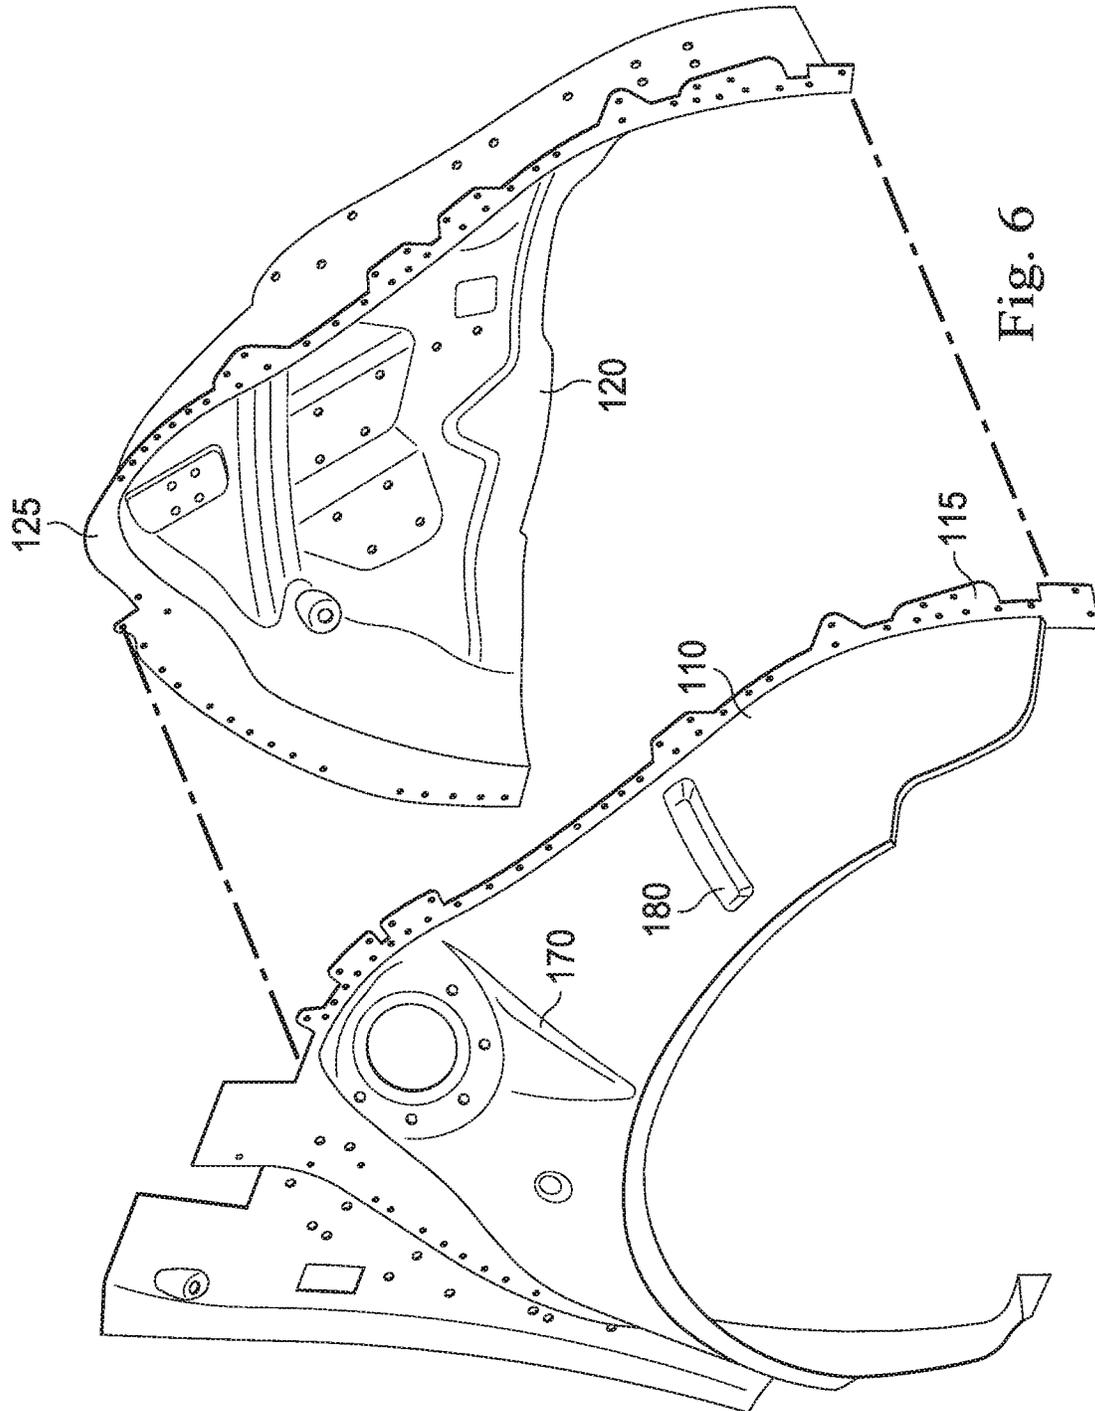
Fig. 6

FIG. 6 is a perspective, exploded view of an example deforming rear wheelhouse structure according to at least one embodiment of the present disclosure.

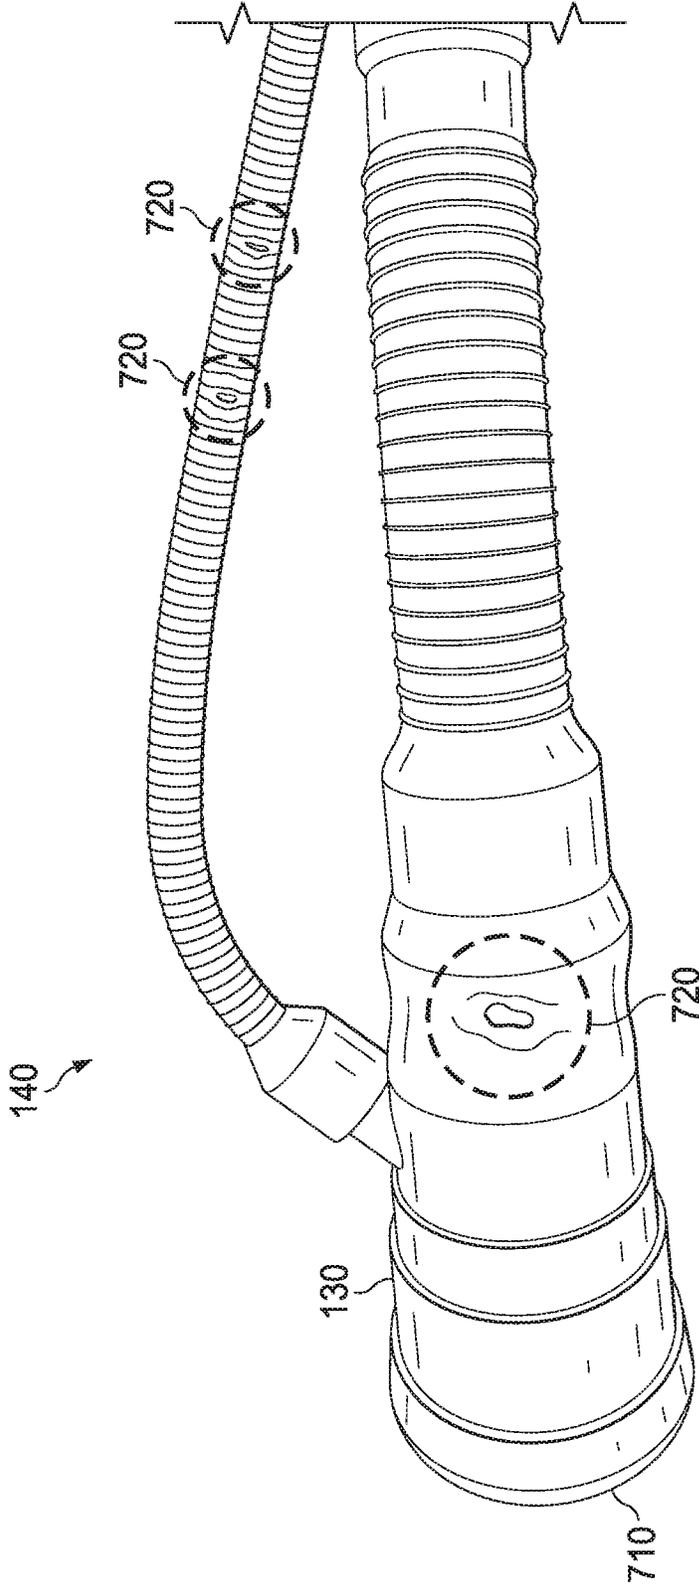
Fig. 7

FIG. 7 is a side perspective view of an example fuel pipe following a rear-impact collision in the baseline case, according to aspects of the present disclosure.

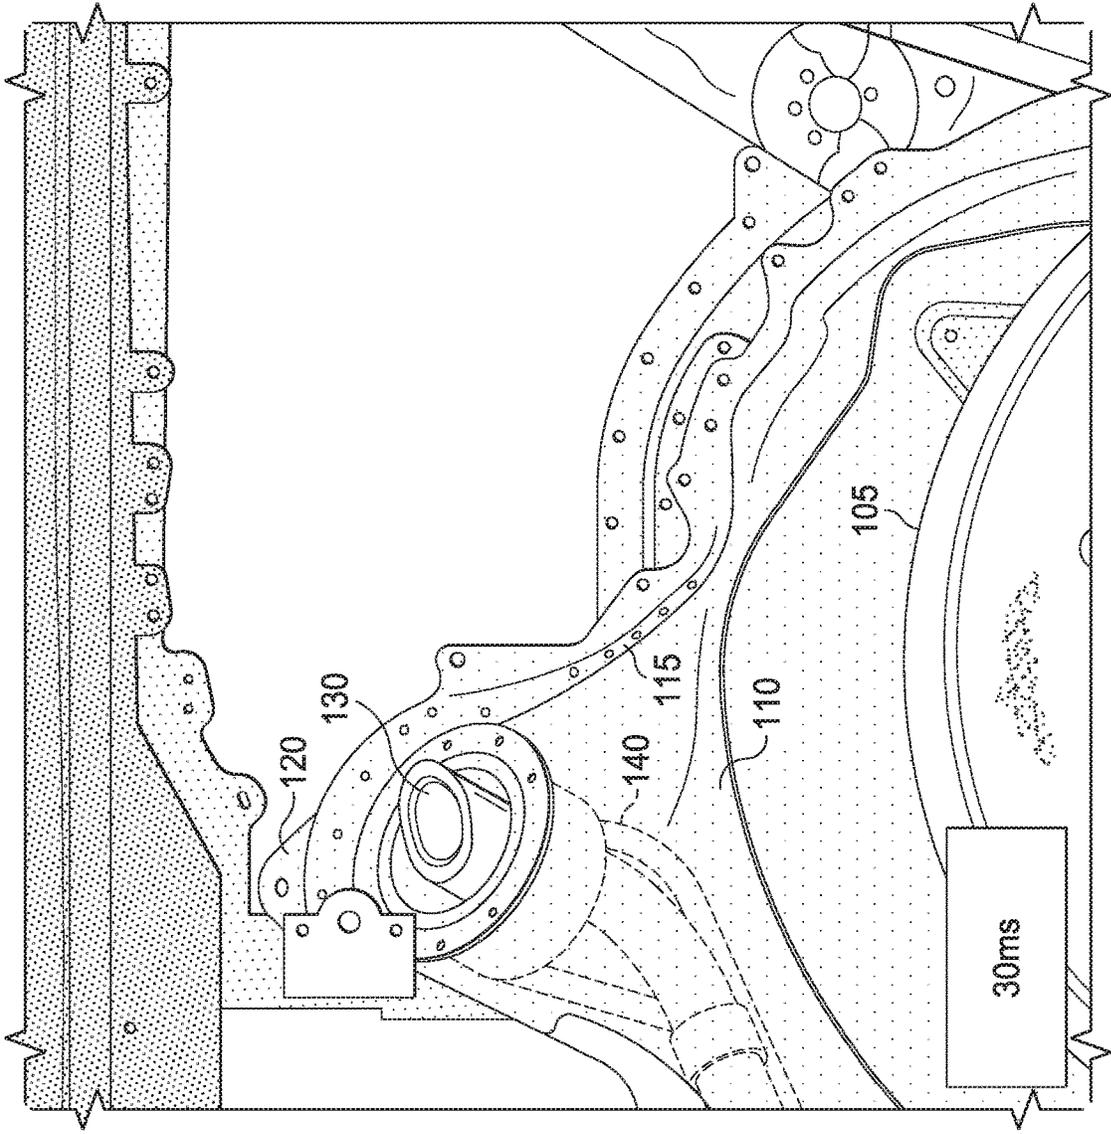
Fig. 8

FIG. 8 is a side perspective view of a baseline-case wheelhouse structure at a time point 30 milliseconds into a rear-impact collision event, according to aspects of the present disclosure.

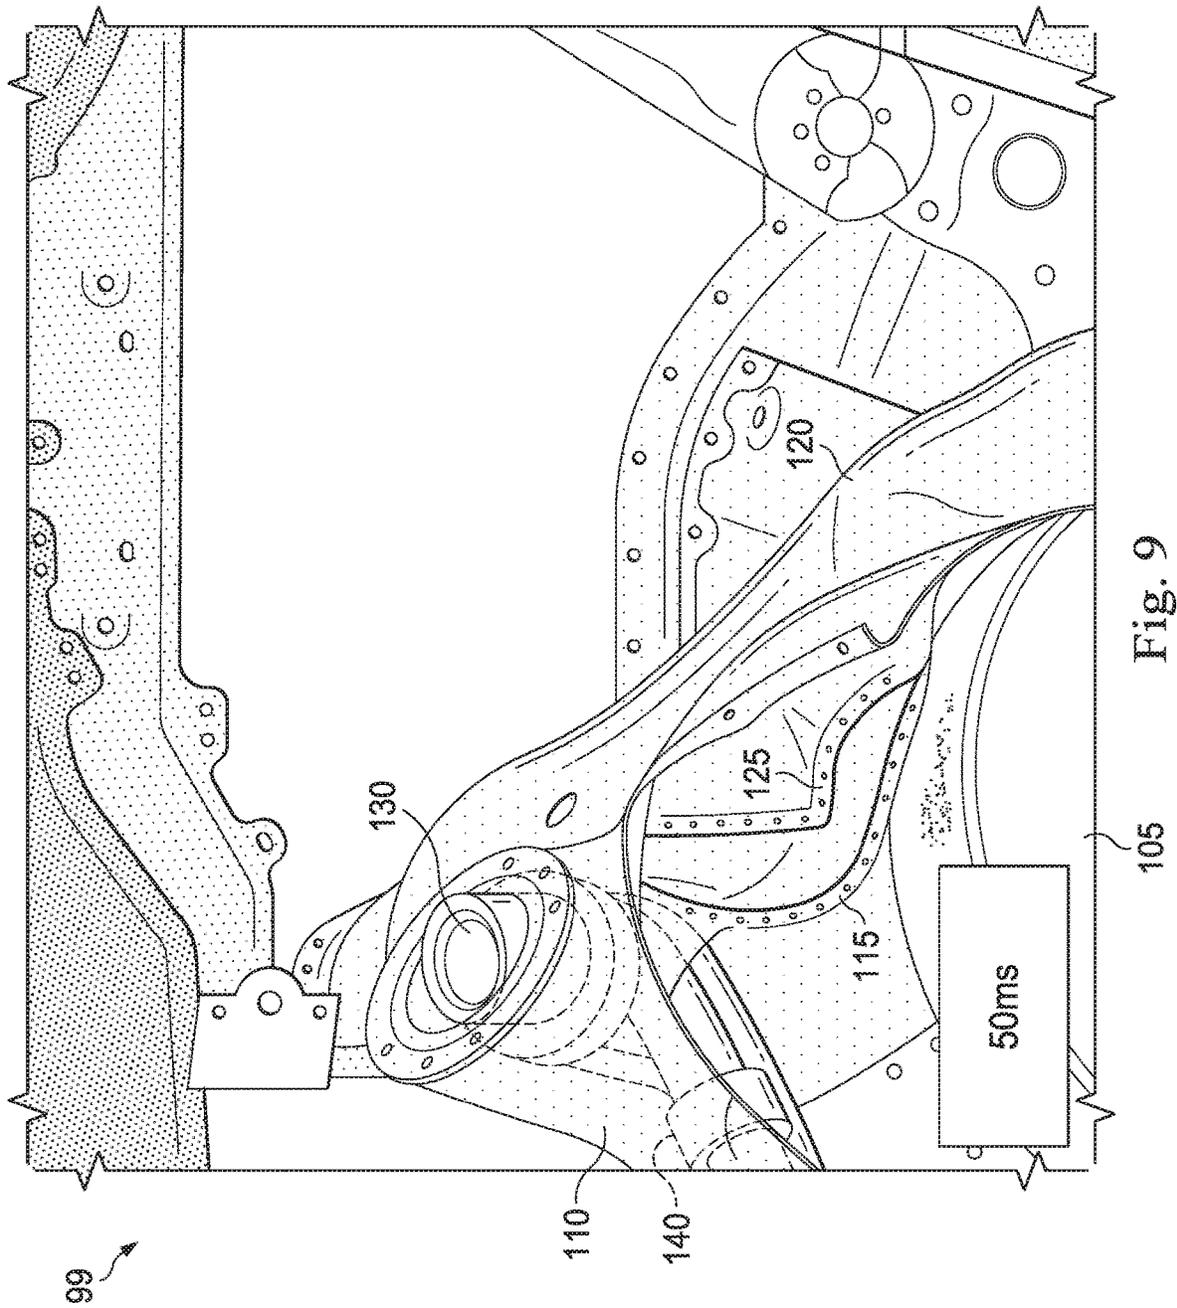
Fig. 9

FIG. 9 is a side perspective view of a baseline-case wheelhouse structure at a time point 50 milliseconds into a rear-impact collision event, according to aspects of the present disclosure.

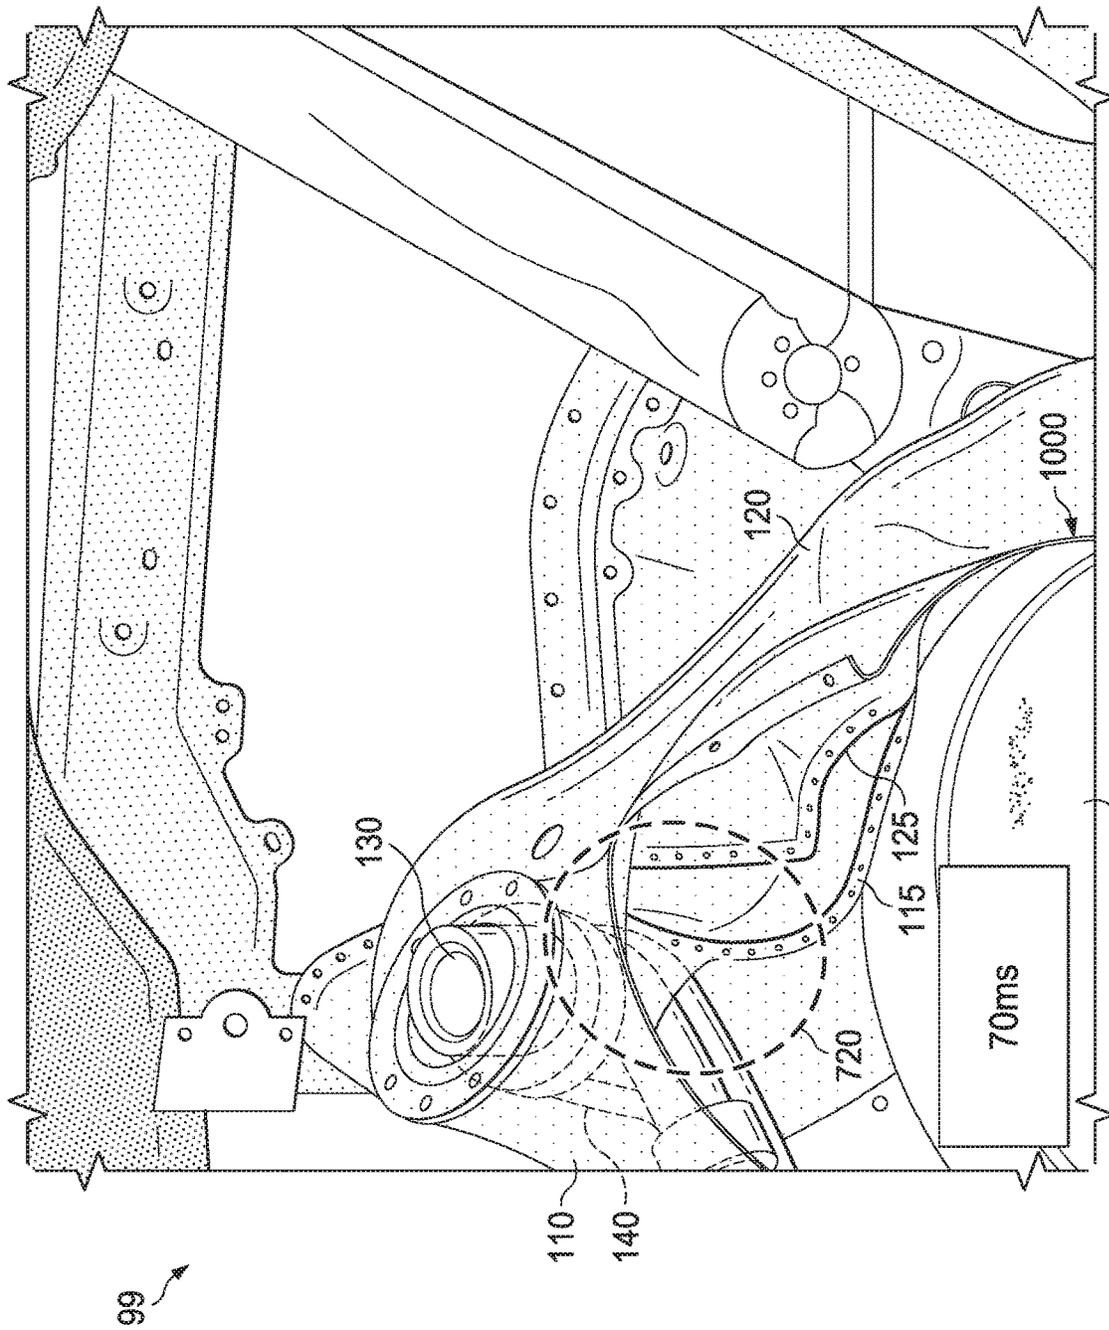
Fig. 10

FIG. 10 is a side perspective view of a baseline-case wheelhouse structure at a time point 70 milliseconds into a rear-impact collision event, according to aspects of the present disclosure.

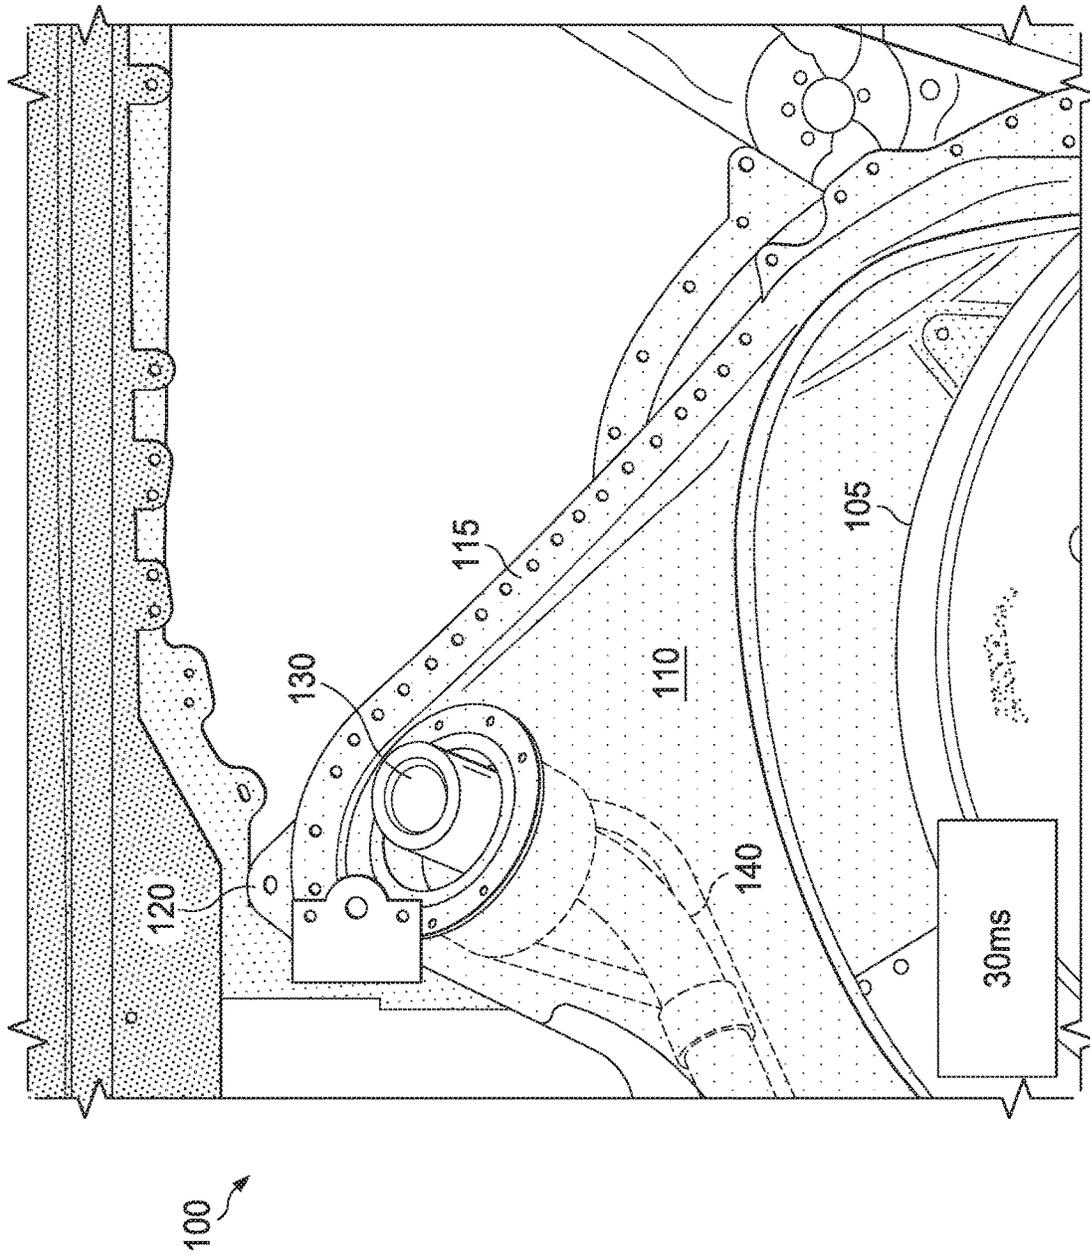
Fig. 11

FIG. 11 is a side perspective view of a countermeasure-case, deforming rear wheelhouse structure at a time point 30 milliseconds into a rear-impact collision event, according to at least one embodiment of the present disclosure.

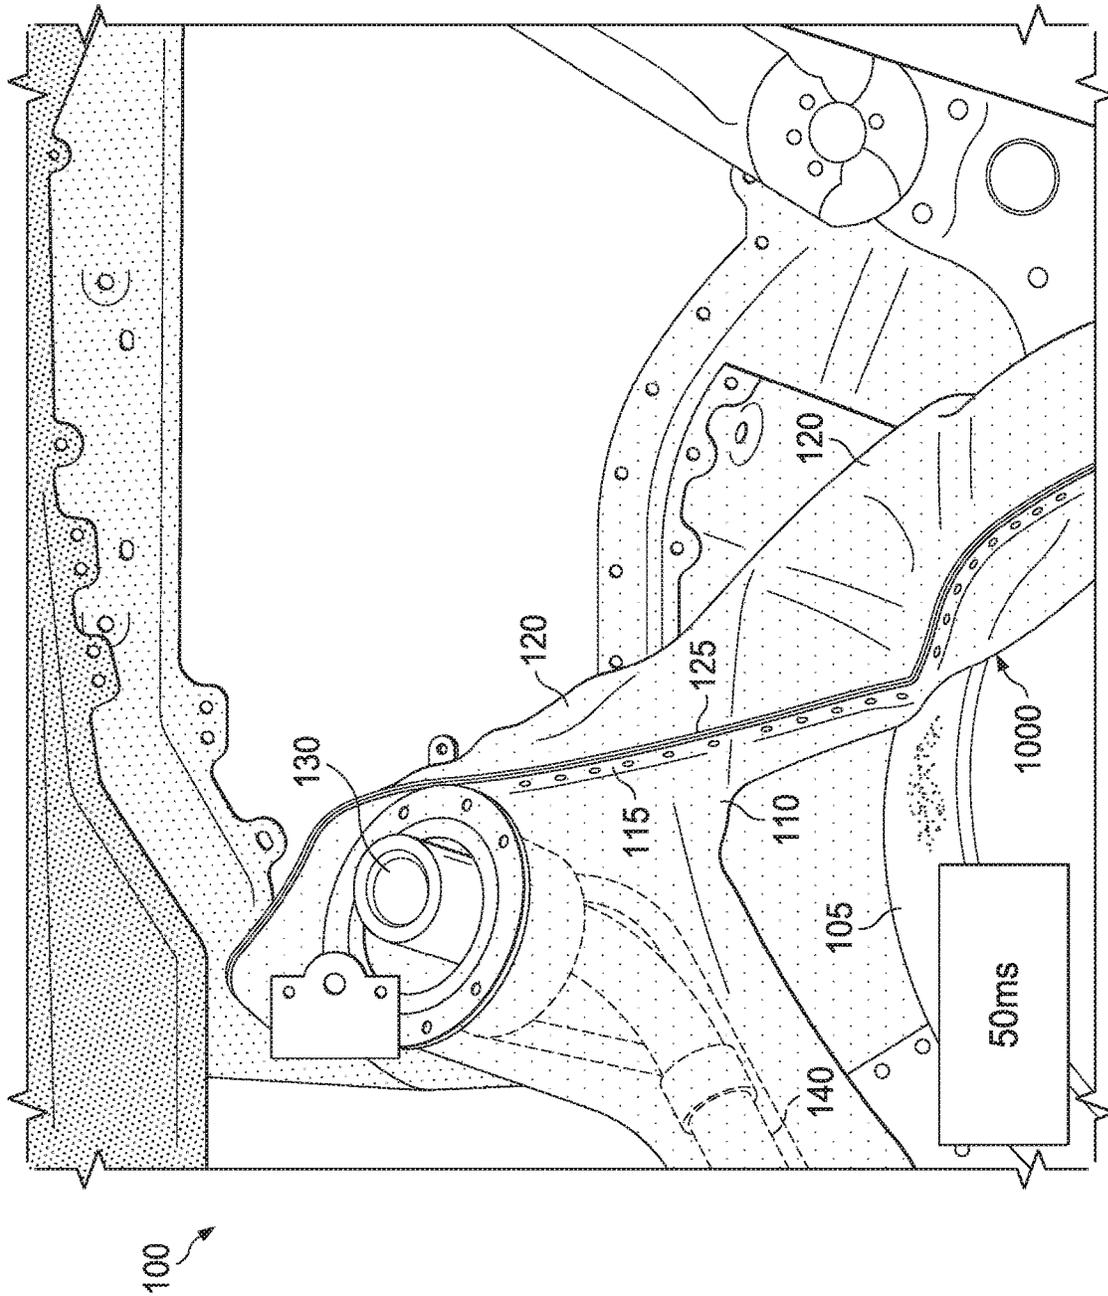
Fig. 12

FIG. 12 is a side perspective view of a countermeasure-case, deforming rear wheelhouse structure at a time point 50 milliseconds into a rear-impact collision event, according to at least one embodiment of the present disclosure.

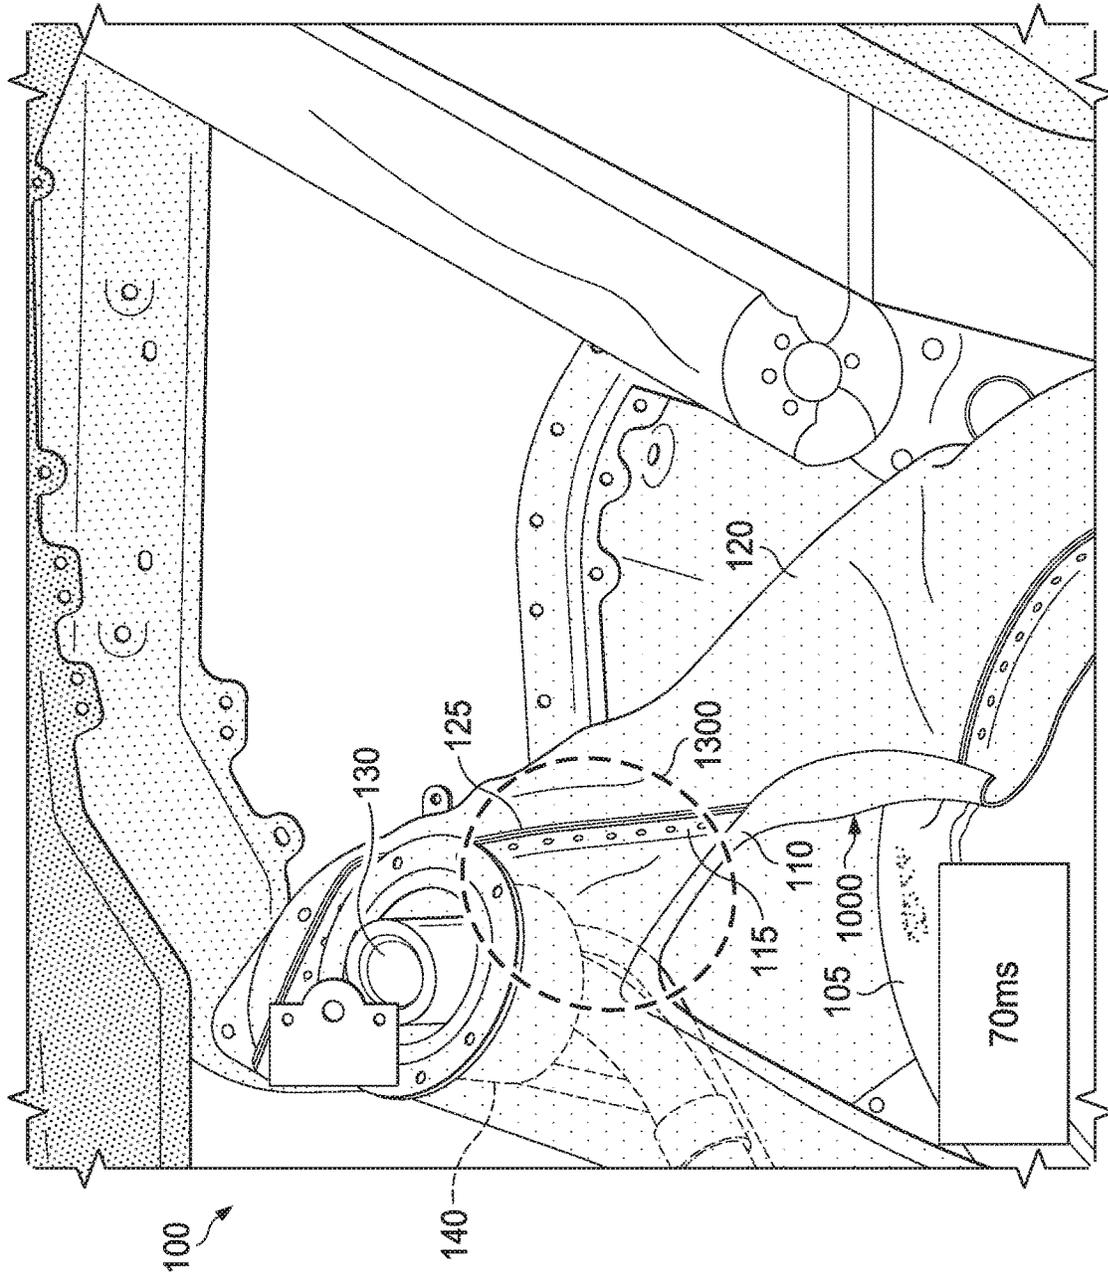
Fig. 13

FIG. 13 is a side perspective view of a countermeasure-case, deforming rear wheelhouse structure at a time point 70 milliseconds into a rear-impact collision event, according to at least one embodiment of the present disclosure.

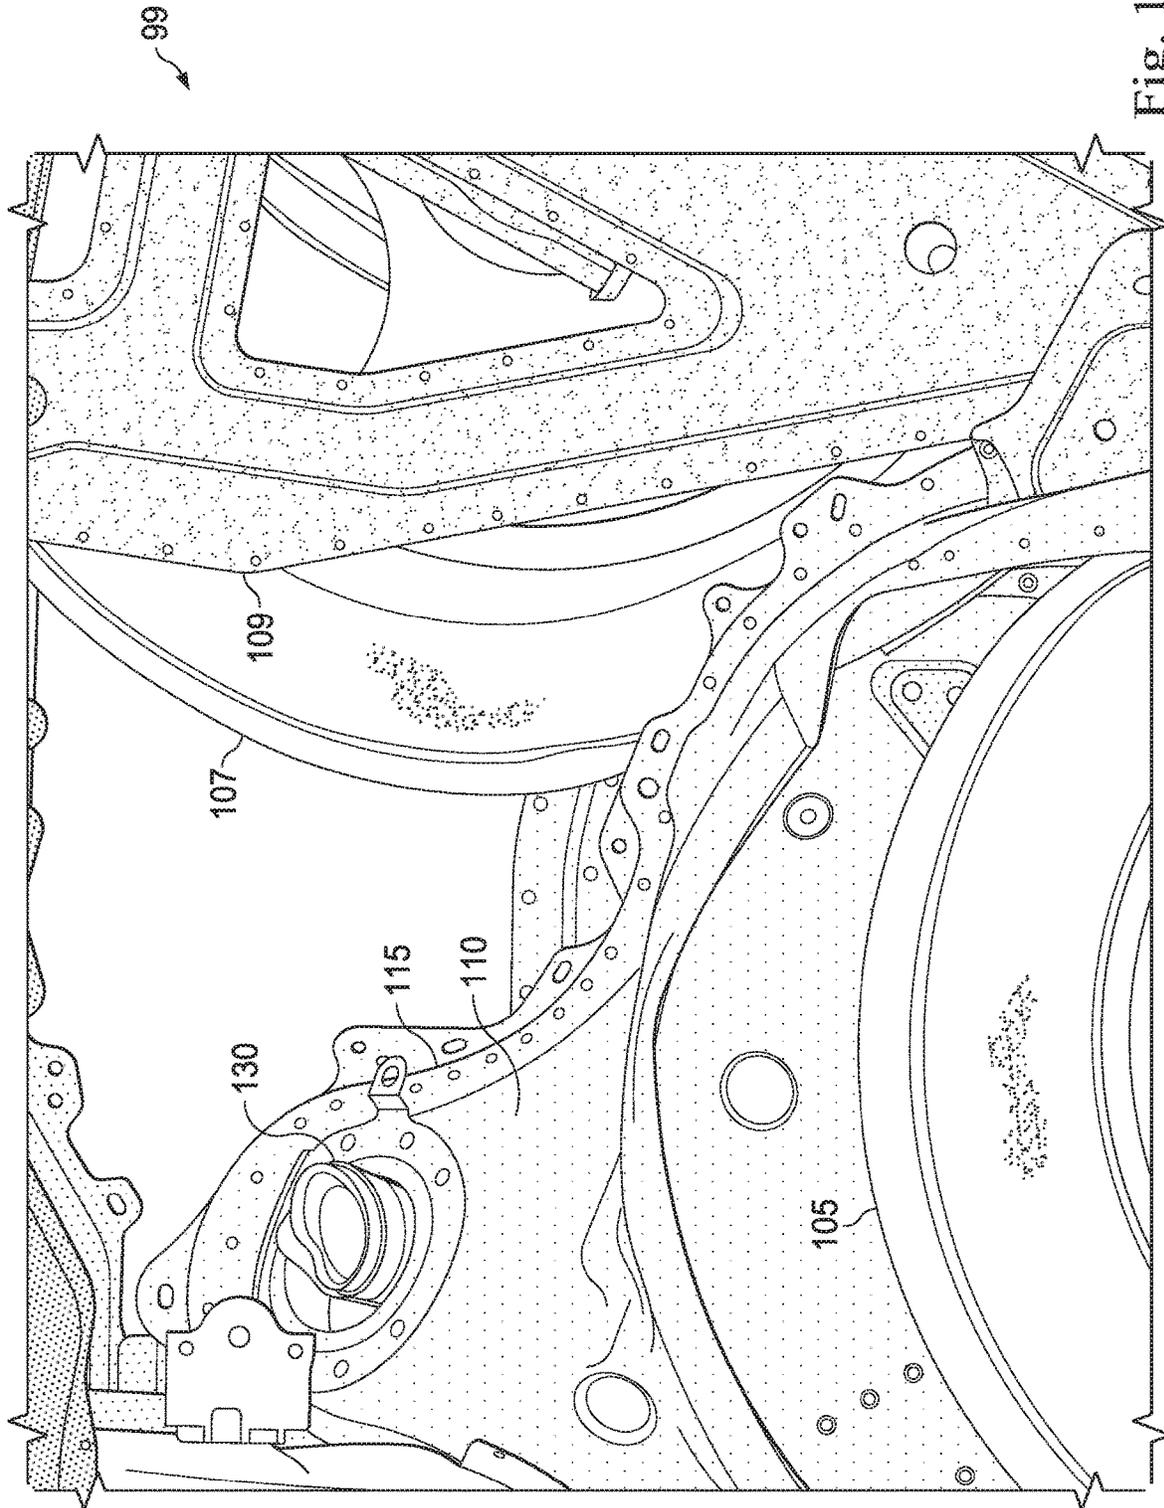
Fig. 14

FIG. 14 is a side perspective view of a baseline-case wheelhouse structure at a time point 30 milliseconds into a rear-impact collision event, according to aspects of the present disclosure.
