(10) **Patent No.:** **US 11,247,733 B2**

(54) **DEFORMING WHEELHOUSE STRUCTURE FOR A VEHICLE**

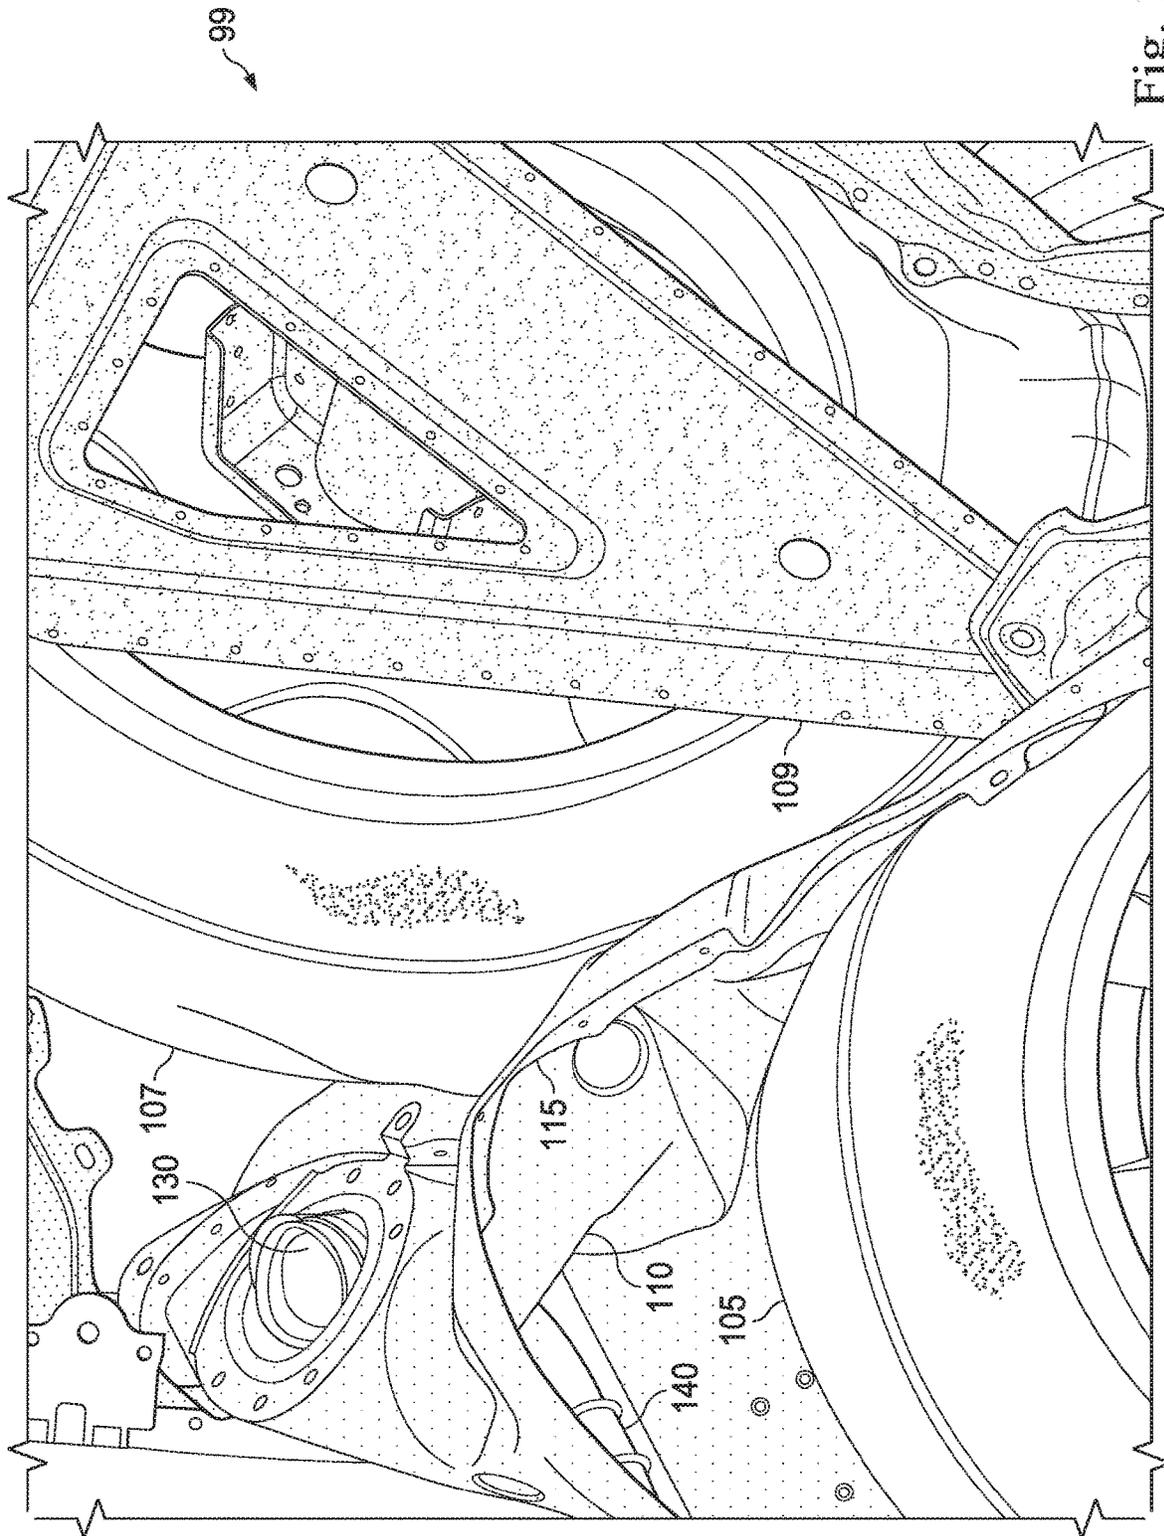
Fig. 15

FIG. 15 is a side perspective view of a baseline-case wheelhouse structure at a time point 50 milliseconds into a rear-impact collision event, according to aspects of the present disclosure.

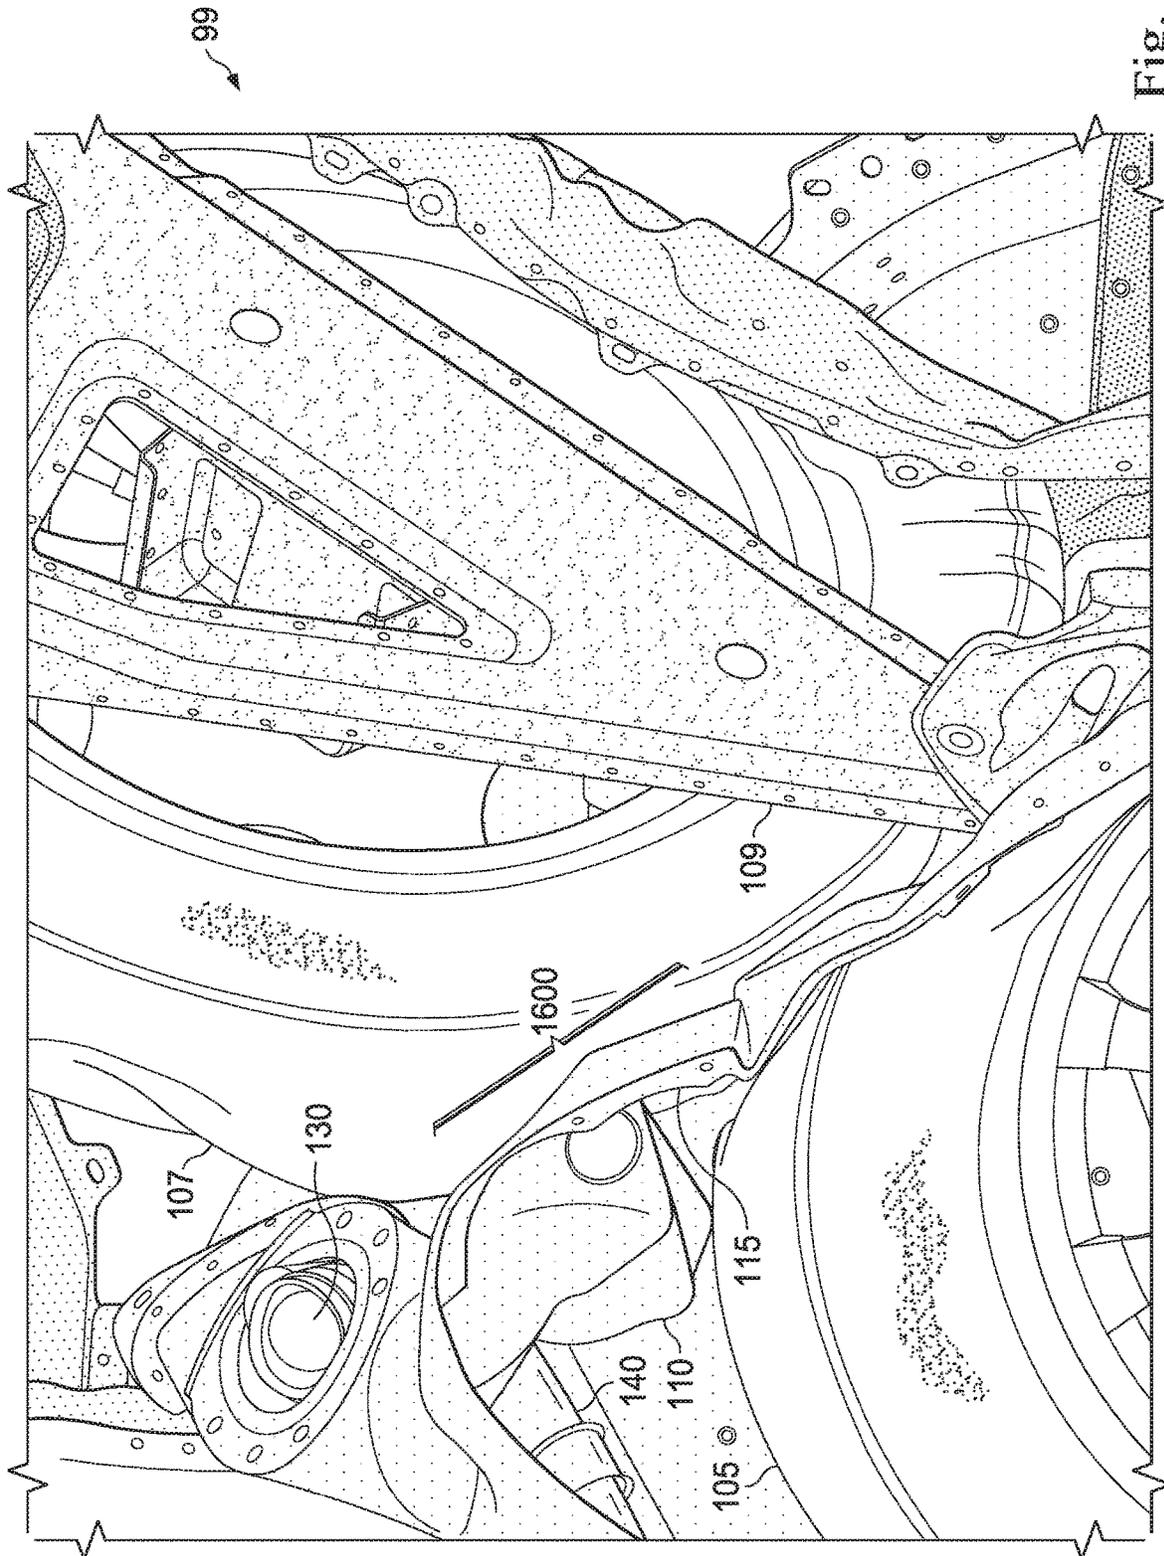
Fig. 16

FIG. 16 is a side perspective view of a baseline-case wheelhouse structure at a time point 70 milliseconds into a rear-impact collision event, according to aspects of the present disclosure.
