(54) RELIABILITY AND SERVICEABILITY ENHANCED ENGINE DRIVEN ELECTRICAL GENERATING SYSTEM

(57) ABSTRACT

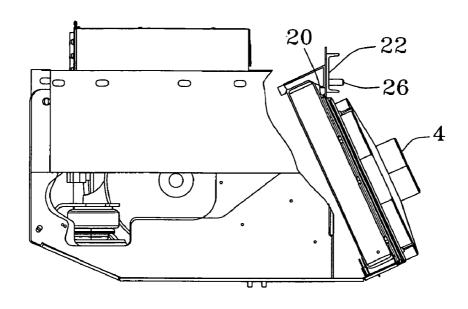
FIG. 2 is an engine side partial cutaway view of the genset and genset cradle:

Looking at FIGS. 2 and 5 The upper rear flange 22 of the 60 cradle 9 has a pair of cradle support and locating studs 26 that make for ease of removal and installation of the genset and cradle assembly 2 into the motorcoach's generator cavity, which has a mounting alignment bracket (not shown) with matingly conforming orifices. If a major repair requires the 65 genset be removed from the motorcoach, after the disconnection of the necessary electrical wires, the nuts removed from

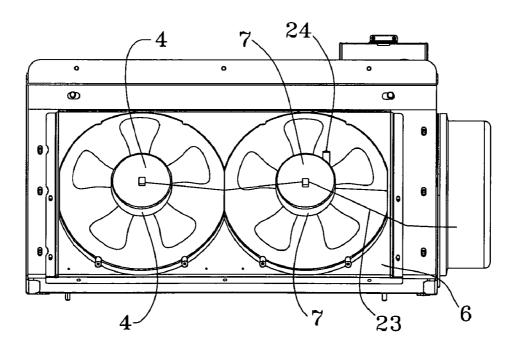
FIG. 3 is a back side view of the genset cradle and fan assembly;

Looking at FIG. 3 it can be seen that the set of cooling fans 4 and 7 have been located on a planar removable panel 6 with sets of oblong orifices that engage sets of locking tabs 8 on the 35 back plate 13 of the cradle 9. The removable panel 6 has a bottom flange 10 that extends normally from the bottom edge of the panel 6 having orifices therethrough to accommodate mechanical retaining fasteners 14 that connect the panel 6 to the bottom plate 15 of the cradle 9. The panel 6 also has a 40 small top flange 20 that engages behind the upper rear flange 22 of the cradle 6. This physical configuration allows a service person to slide under the genset and cradle assembly 2 and remove the retaining fasteners 14, slide the panel 6 downward until the oblong orifices are not obstructed by the lock- 45 ing tabs 8 and the top flange 20 is clear of the upper rear flange 22, and then remove the panel 6 with both fans 4 and 7 intact. At this time the electrical plugs 24 can be disconnected and the fan and panel assembly taken to another location for troubleshooting. To repair a fan (which generally is the 50 replacement because of the low cost of the fan units) the service person need only unbolt the fan retaining bolts 30 and remove the broken fan. The removal of the panel 6 is accomplished while the genset and cradle assembly 2 remain connected to the motorcoach. The dimensions of the genset cav- 55 ity and the genset cradle 9 are such that there is ample space to accomplish such an operation. A replacement fan is installed following the reverse procedure. FIGS. 6 and 7 show various stages of the panels removal.

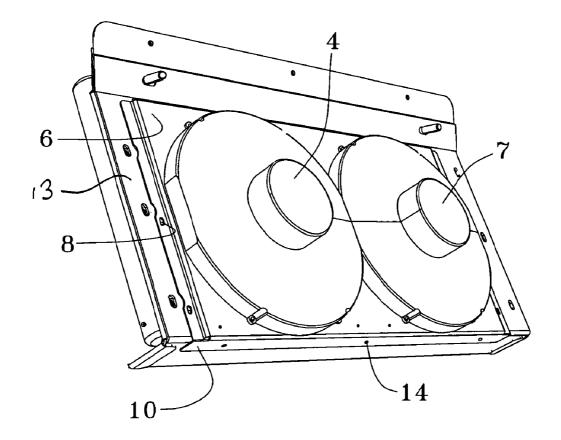
FIG. 4 is a perspective view of the fan assembly attached to the genset cradle rear mounting plate;

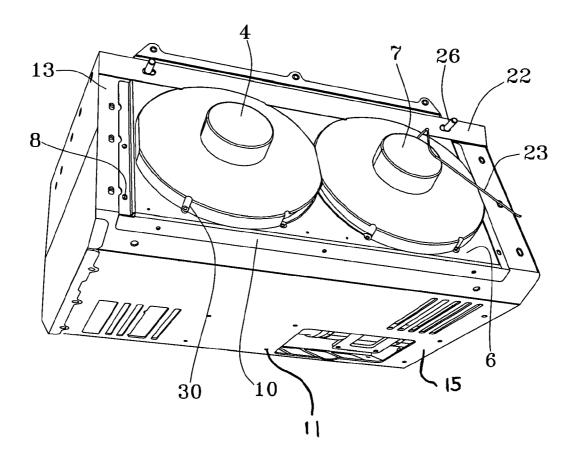
FIG. 5 is bottom rear perspective view of the genset in the genset cradle;

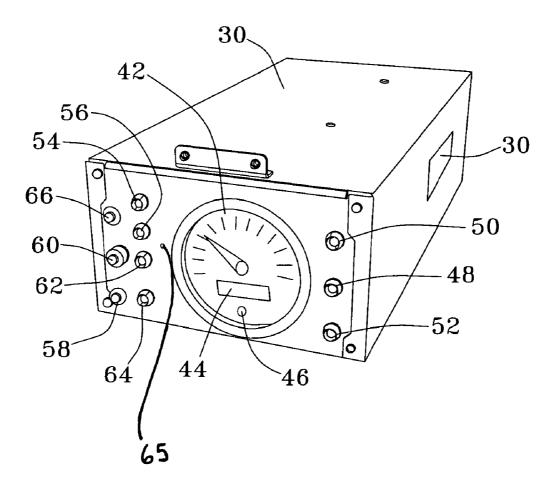
FIG. 8 is a front view of the VDO dual indication troubleshooting unit.

The signal output sent from the ECU 35 to the DC status module 30 may be viewed in several ways, both digitally and in analog format outputs. Looking at FIG. 8 it can be seen that a sweep scale analog tachometer 42 indicates the engine speed. A digital display 44 shows the engine speed numerically. Display pushbutton 46 may be depressed and released to cycle through a display of the following select engine parameters: oil pressure; coolant temperature; air intake temperature, battery voltage; engine rpm; engine torque; oil temperature and total engine operating hours.
