4,333,218

[54] **METHOD OF REPAIRING A BOX BEAM**

A method of repairing a box beam is disclosed in which a cracked or broken portion of a box beam may be repaired and the strength returned to normal by forming a pair of plates that fit snugly about at least one half of the box beam, the plates being welded to the box beam and to each other, each edge of the plates being either welded to its juxtaposed plate or to the box beam to provide full strength to the structure.

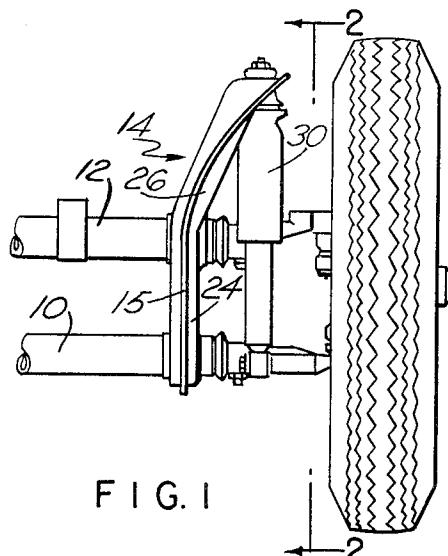
FIG. 1 is a front elevational view showing a box beam construction in the context of a front axle for an automotive vehicle;

Referring to FIG. 1, a portion of the front axle beam in an automotive vehicle is shown, which comprises a first tubular member 10 that encloses a torsion bar and

5 a second tubular member 12 in which is also received the second torsion bar, these two members being connected together at either end by a box beam structure generally designated 14, only one such structure being shown. The box beam structure has apertures with suitable bearings through which the torsion bar 16 (See FIG. 2) extends and through which the torsion bar 18 extends, each of these bars being respectively connected to torsion arms 20 and 22. The box beam is defined by a 10 lower portion 24 which extends between the portions 10 and 12 and continues upwardly with a portion 26 that has an aperture therein as at 28 into which the upper end of a shock absorber 30 is received.

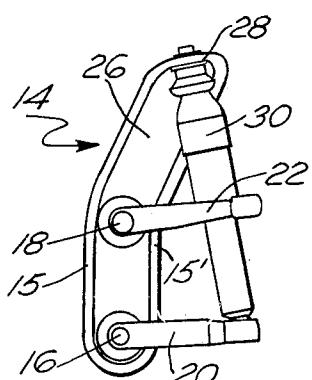
FIG. 2 is a sectional view taken on lines 2—2 of FIG. 1;

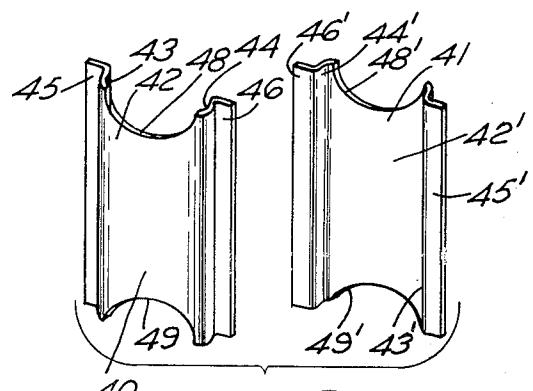
FIG. 3 is a detached perspective view of the repair plate;

20 In order to obviate a complete replacement there is formed from sheet material a pair of plates, designated 40 and 41, (see FIG. 3) which are identical plates and which as shown have in effect a face 42, 42' with an inturned edge such as 43, 44, 43', 44', and then outwardly turned lips 45, 45', 46, 46'. These plates 40, 41 are placed on either side of the box beam as seen in FIG. 5. The cut-outs as at 48 and 49 for example being adapted in this particular instance to fit about the bosses that are formed by the cylindrical members 10 and 11 passing through the box beam. In some instances the area about the cut-outs may be further formed to provide a proper fit, as for example, by flaring from the planar extent of face. It will of course be apparent that before the plates are positioned on the box beam and assuming that the box beam is rusted and has a coating of grease and other materials thereon it is first necessary to clean the box beam by the use of suitable degreasing compounds and then as necessary clean out any additional rust that may be present. At this point, if desired, the box beam may be painted in the central portion thereof leaving the ends where the upper and lower edges of the plates 40 and 41 will contact absolutely clean. The plates are then clamped in position and welding material is used to make joints as seen at 50, 51, 52, 53, 54, and 55 so that all of the edges of the plates 40 and 41 have been welded together and to the box beam structure. After the welding has been completed the repair may now be suitably painted with primer paint and then with undercoating material such as a tar-based compound or the like. The box beam has now been returned to its original strength and situation.

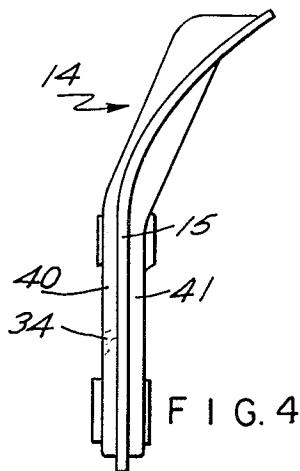
FIG. 4 is an elevational view of the box beam showing failures therein.

15 In structures of this nature and as a result of considerable stress as well as the effects of road salt, water and other elements, the box beam at the section 24 will develop cracks and other fatigue points as seen by the cracks shown at 34 in FIG. 4. It is to be appreciated that this considerably weakens the entire structure and support for the front end of the automotive vehicle, and under normal circumstances as the box beam and the tubular portions 10 and 12 are integral formed-up units, it may become necessary to replace the entire unit in order to make the automotive vehicle safe to drive.

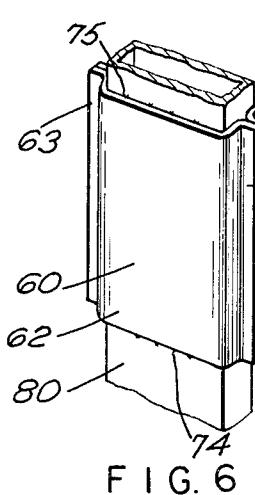
FIG. 6 is a perspective view showing the utilization of the repair device on any box beam structure.

portions such as 62 and downwardly turned side edges such as 63, 64. This type of structure can indeed be utilized for any type of box beam repair, and in the illustration of FIG. 6 the repair plate 40a is welded as at 74, 75 and the edges as at 70 are also welded to the box beam and also to a mating repair plate such as a repair plate 61 which would be identical to the illustrated plate 60 and utilized in precisely the same fashion as that described in connection with repair plates 40 and 41.
